# Arboricultural Survey

43-45 Pevensey Road  
Bognor Regis  
West Sussex  
PO21 5NY

14<sup>th</sup> July 2017

PJC ref: 4524/17-01

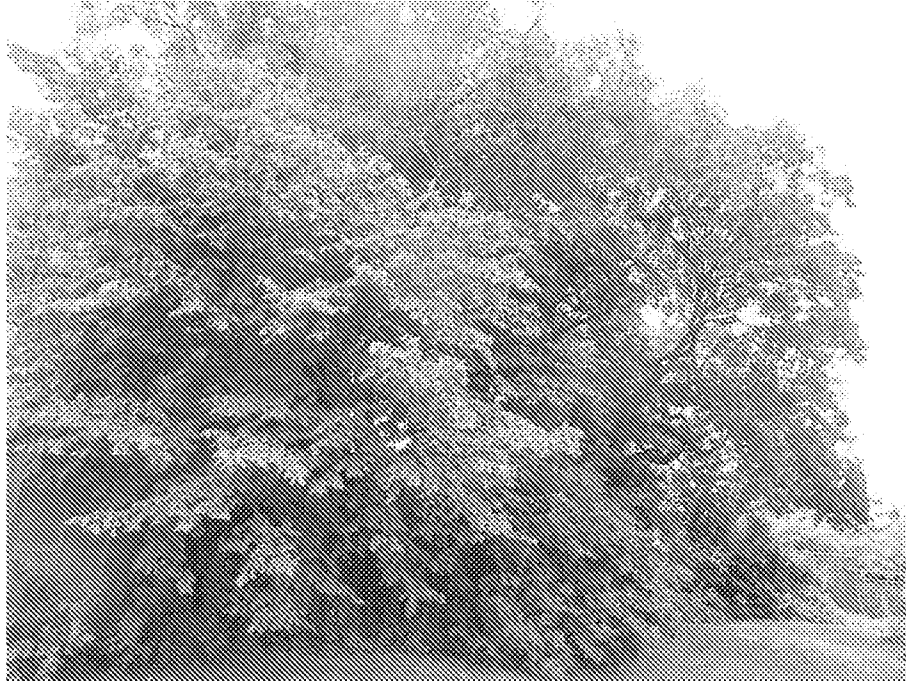
**Photograph 1 – Trees T1, T2 and T4**

**3.3** Trees T1 and T11 comprises a mature field maple and cherry tree on the eastern site boundary. The stems of both trees straddle both sides of the boundary fence, therefore ownership of the trees is unclear.

**3.4** Tree T2 is a third party ash tree located within the garden of No. 39. It was only viewed from within the site boundary. T2 is multi-stemmed with the majority of the crown bias over the neighbours garden. One stem was observed as having a significant decay cavity near the base, however the stem leans away from the site and is not therefore considered a safety concern from the proposed development area. T2 is also exhibiting minor dieback at its branch tips. It is not considered a high quality specimen and has been categorised as C. As a third party tree, (and covered by a TPO), T2 will still require all standard protection measures when the site is developed, regardless of its condition.

| | | | | Client: Mr John Parsons<br>Site: 43-45 Pevensey Road, Bognor Regis<br>Survey date: 13/07/2017<br>Surveyor: Peter Davies | | | | | | T: Individual tree or shrub<br>G: Group of 2 or more trees<br>H: Hedgerow<br>W: Woodland block | | | |
|---|---|---|---|---|---|---|---|---|---|---|---|---|---|
| T1 | Field maple (Acer campestre) | 10 | 500 est | N: 5<br>E: 3<br>S: 4<br>W: 4 | Crown: 0 south<br>Branch: 3 south | Over mature | Good | Fair | Previously crown lifted. North lean to 3m. Stem straddles boundary fence. Elder under-storey inhibits inspection. | No action required on date of survey. | B2 | 113.1 | 6.0 |
| T2 | Ash (Fraxinus excelsior) | 12 | 450, 400, 150 est | N: 4<br>E: 5<br>S: 5<br>W: 3 | Crown: 7 west<br>Branch: 2 average | Mature | Fair | Fair | Third party tree only viewed from site. Multi-stemmed. Decay cavity in main stem. Minor crown dieback. | TPO - No action required on date of survey. | C2 | 174.2 | 7.4 |

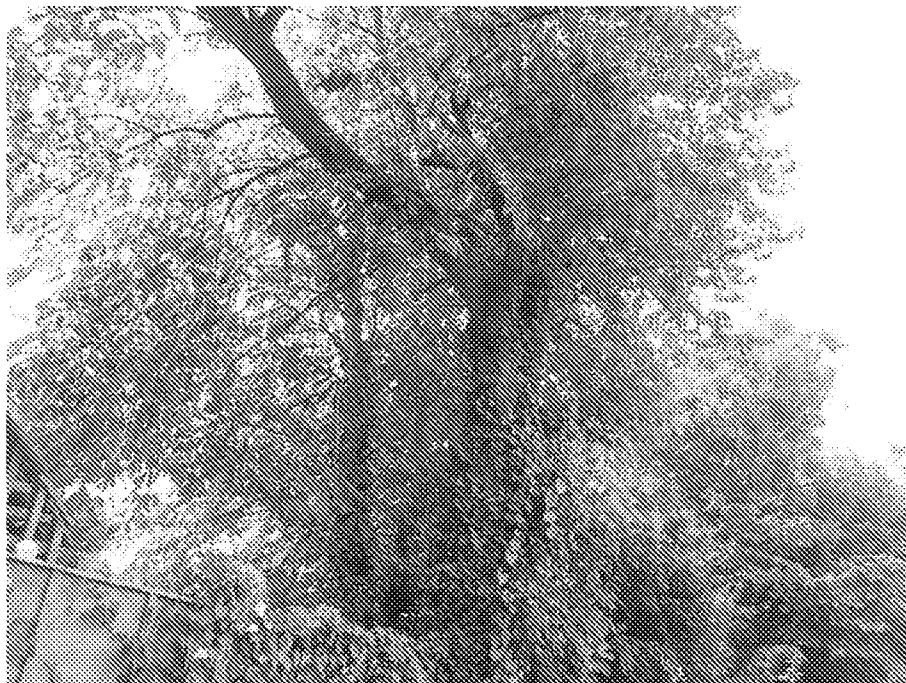
**Photograph 2 – Trees T11-T12**

3.5 Tree T12 is a third party walnut located within the garden of No. 39. As with T2, it was only viewed from within the site boundary. T12 is also a multi-stemmed tree, and the north stem has previously snapped at around 6m. Despite this defect, the tree exhibits good vitality and has been awarded category B.

| | | | | Client: Mr John Parsons<br>Site: 43-45 Pevensey Road, Bognor Regis<br>Survey date: 13/07/2017<br>Surveyor: Peter Davies | | | | | | | T: Individual tree or shrub<br>G: Group of 2 or more trees<br>H: Hedgerow<br>W: Woodland block | | |
|---|---|---|---|---|---|---|---|---|---|---|---|---|---|
| T11 | Cherry (Prunus avium) | 10 | 560 over ivy | N: 5<br>E: 5<br>S: 4<br>W: 2 | Crown: 2 east<br>Branch: 4 east | Mature | Good | Fair | Stem straddles boundary and is ivy clad. Previously heavily reduced over site. | Sever ivy around stem (above fence). | B2 | 141.9 | 6.7 |
| T12 | Walnut (Juglans regia) | 12 | 300, 450 est | N: 3<br>E: 4<br>S: 4<br>W: 3 | Crown: 1 average<br>Branch: 1 average | Mature | Good | Fair | Third party tree only viewed from site. 1x stem failed/pollarded. | TPO - No action required on date of survey. | B1/2 | 140.9 | 6.7 |

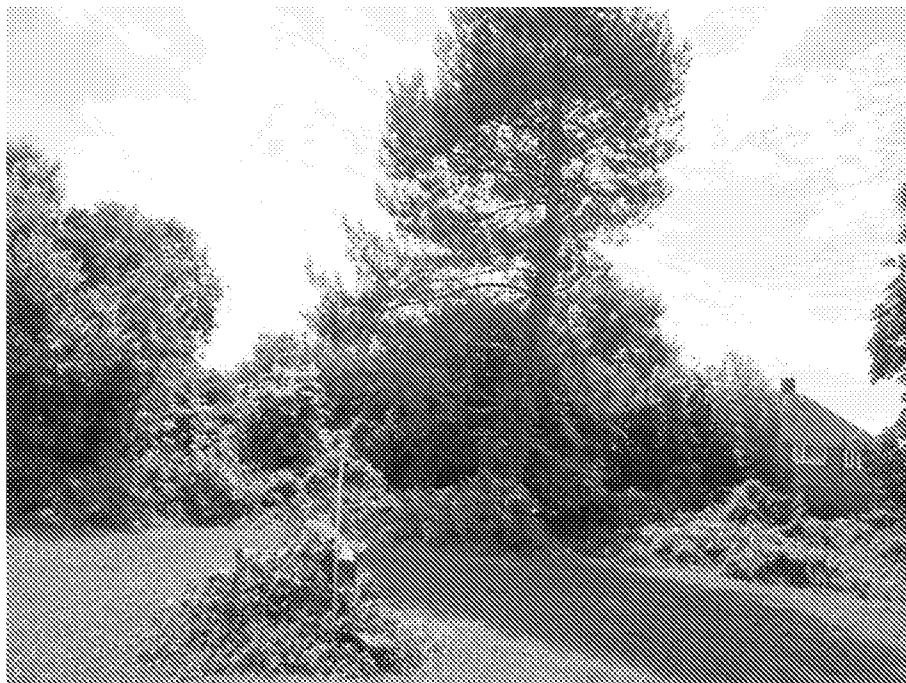
**Photograph 3 – Tree T13, T14 and T16**

3.8 T13 is a mature Scots pine located in the centre of the garden. It is of an open grown habit and possesses no major visible defects. There is a small amount of deadwood in its lower crown, which is recommended for removal on aesthetic grounds, and the ivy should be severed to facilitate a more comprehensive assessment of its buttress.

3.9 Tree T16 is an early mature ash located on the southern boundary of No. 45. It is of reasonable form and condition, and has the potential to mature into a prominent, high quality specimen. The remaining trees at the site are either small or of poor quality and potential longevity, so have been categorised as C and should not be considered a constraint to development.

| | | Client: Mr John Parsons<br>Site: 43-45 Pevensey Road, Bognor Regis<br>Survey date: 13/07/2017<br>Surveyor: Peter Davies | | | | | | | | T: Individual tree or shrub<br>G: Group of 2 or more trees<br>H: Hedgerow<br>W: Woodland block | | | |
|---|---|---|---|---|---|---|---|---|---|---|---|---|---|
| T13 | Scots pine ( <i>Pinus sylvestris</i> ) | 16 | 600 over ivy | N: 4<br>E: 5<br>S: 4<br>W: 3 | Crown: 4 east<br>Branch: 5 east | Mature | Good | Good | Ivy clad stem. Deadwood in lower crown. No major visible defects. | TPO - Remove deadwood for aesthetics. Sever ivy around base. | B1 | 162.9 | 7.2 |
| T16 | Ash ( <i>Fraxinus excelsior</i> ) | 9 | 340 | N: 4<br>E: 3<br>S: 3<br>W: 3 | Crown: 1 north<br>Branch: 1 north | Early mature | Good | Good | Reasonable form. Small deadwood due to suppression. No major visible defects. | No action required on date of survey. | B1/2 | 52.3 | 4.1 |

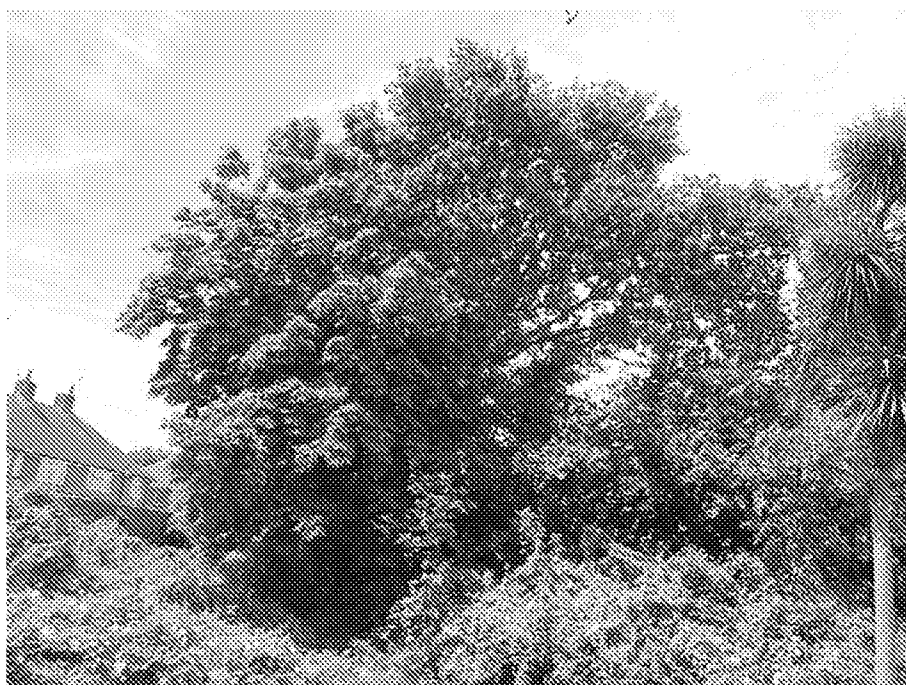
**Photograph 4 – Trees T19-T20**

3.6 The three most prominent trees located within the garden of No. 45 are T13, T19 and T20. T19 is a multi-stemmed horse chestnut. It is of reasonable form without any major visible defects. It is exhibiting some leaf damage associated with the leaf miner moth, which will reduce its visual amenity value in the latter half of the growing season, but despite this has been categorised as B.

3.7 T20 is a large oak (protected by the TPO) located on the site boundary. This tree has an uneven crown, heavily bias to the north (likely as a result of light suppression from the horse chestnut and a large willow, which was reported to have been removed during the past few years). T20 is also heavily ivy clad which inhibited a thorough assessment of its structural condition. It is recommended that the ivy be severed around the base of this tree to facilitate a more comprehensive assessment of its condition.

| | | Client: Mr John Parsons<br>Site: 43-45 Pevensey Road, Bognor Regis<br>Survey date: 13/07/2017<br>Surveyor: Peter Davies | | | | | | | | | T: Individual tree or shrub<br>G: Group of 2 or more trees<br>H: Hedgerow<br>W: Woodland block | | |
|---|---|---|---|---|---|---|---|---|---|---|---|---|---|
| T19 | Horse chestnut (Aesculus hippocastanum) | 15 | 390, 260, 330, 410 over ivy | N: 4<br>E: 6<br>S: 5<br>W: 5 | Crown: 1 east<br>Branch: 1 south | Mature | Good | Good | Multi-stemmed from 1m. Ivy clad stem. Leaf miner moth. No major visible defects. | Sever ivy around base. | B1/2 | 224.7 | 8.5 |
| T20 | Pedunculate oak (Quercus robur) | 17 | 700 over ivy | N: 7<br>E: 4<br>S: 2<br>W: 5 | Crown: 4 north<br>Branch: 2 north | Mature | Good | Good | Crown bias north due to suppression from T19. Ivy inhibits inspection. Crown lifted over neighbours garden. | TPO - Sever ivy around base. | B1 | 221.7 | 8.4 |

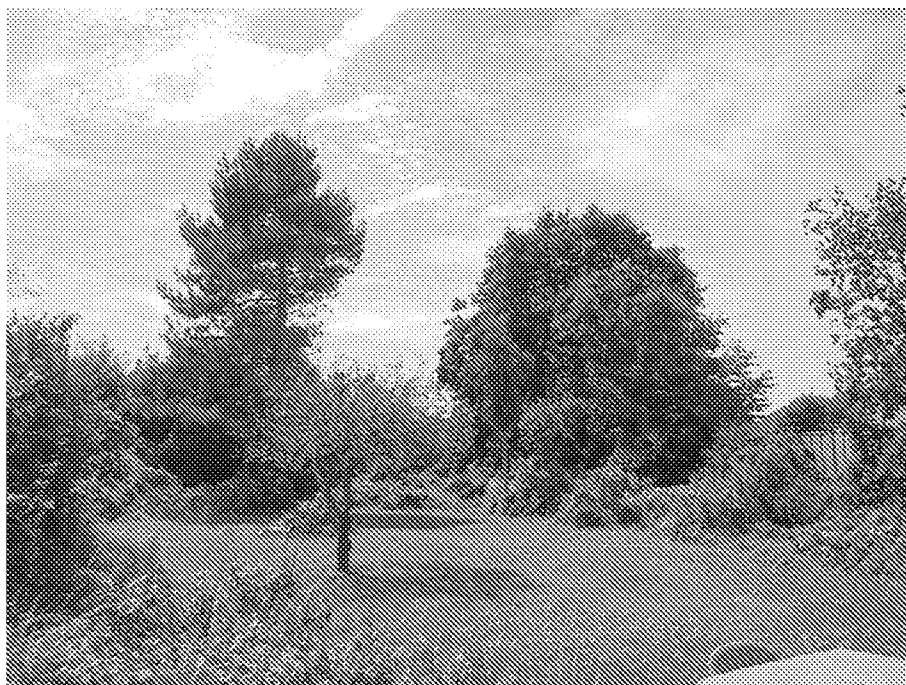
**Photograph 6 – Trees T13 and T18-T21**

| | | Client: Mr John Parsons<br>Site: 43-45 Pevensey Road, Bognor Regis<br>Survey date: 13/07/2017<br>Surveyor: Peter Davies | | | | | | | | T: Individual tree or shrub<br>G: Group of 2 or more trees<br>H: Hedgerow<br>W: Woodland block | | | |
|---|---|---|---|---|---|---|---|---|---|---|---|---|---|
| T18 | Apple ( <i>Malus</i> spp.) | 3 | 120, 130, 80 | N: 2<br>E: 2<br>S: 2<br>W: 2 | Crown: 2 average<br>Branch: 1 average | Semi mature | Poor | Fair | Previously crown lifted. Sparse foliage throughout crown. | No action required on date of survey. | U | 17.1 | 2.3 |

| | | Client: Mr John Parsons<br>Site: 43-45 Pevensey Road, Bognor Regis<br>Survey date: 13/07/2017<br>Surveyor: Peter Davies | | | | | | | | | T: Individual tree or shrub<br>G: Group of 2 or more trees<br>H: Hedgerow<br>W: Woodland block | | |
|---|---|---|---|---|---|---|---|---|---|---|---|---|---|
| T21 | Hazel (Corylus avellana) | 7 | 200 est | N: 3<br>E: 3<br>S: 2<br>W: 2 | Crown: 1 north<br>Branch: N/A | Mature | Fair | Fair | Dense under-storey prevents close inspection. Some crown dieback. | No action required on date of survey. | C2 | 18.1 | 2.4 |
