# Arboricultural Impact Assessment

43-45 Pevensey Road  
Bognor Regis  
West Sussex  
PO21 5NY

17<sup>th</sup> May 2018

PJC ref: 4858/18-01 Rev -

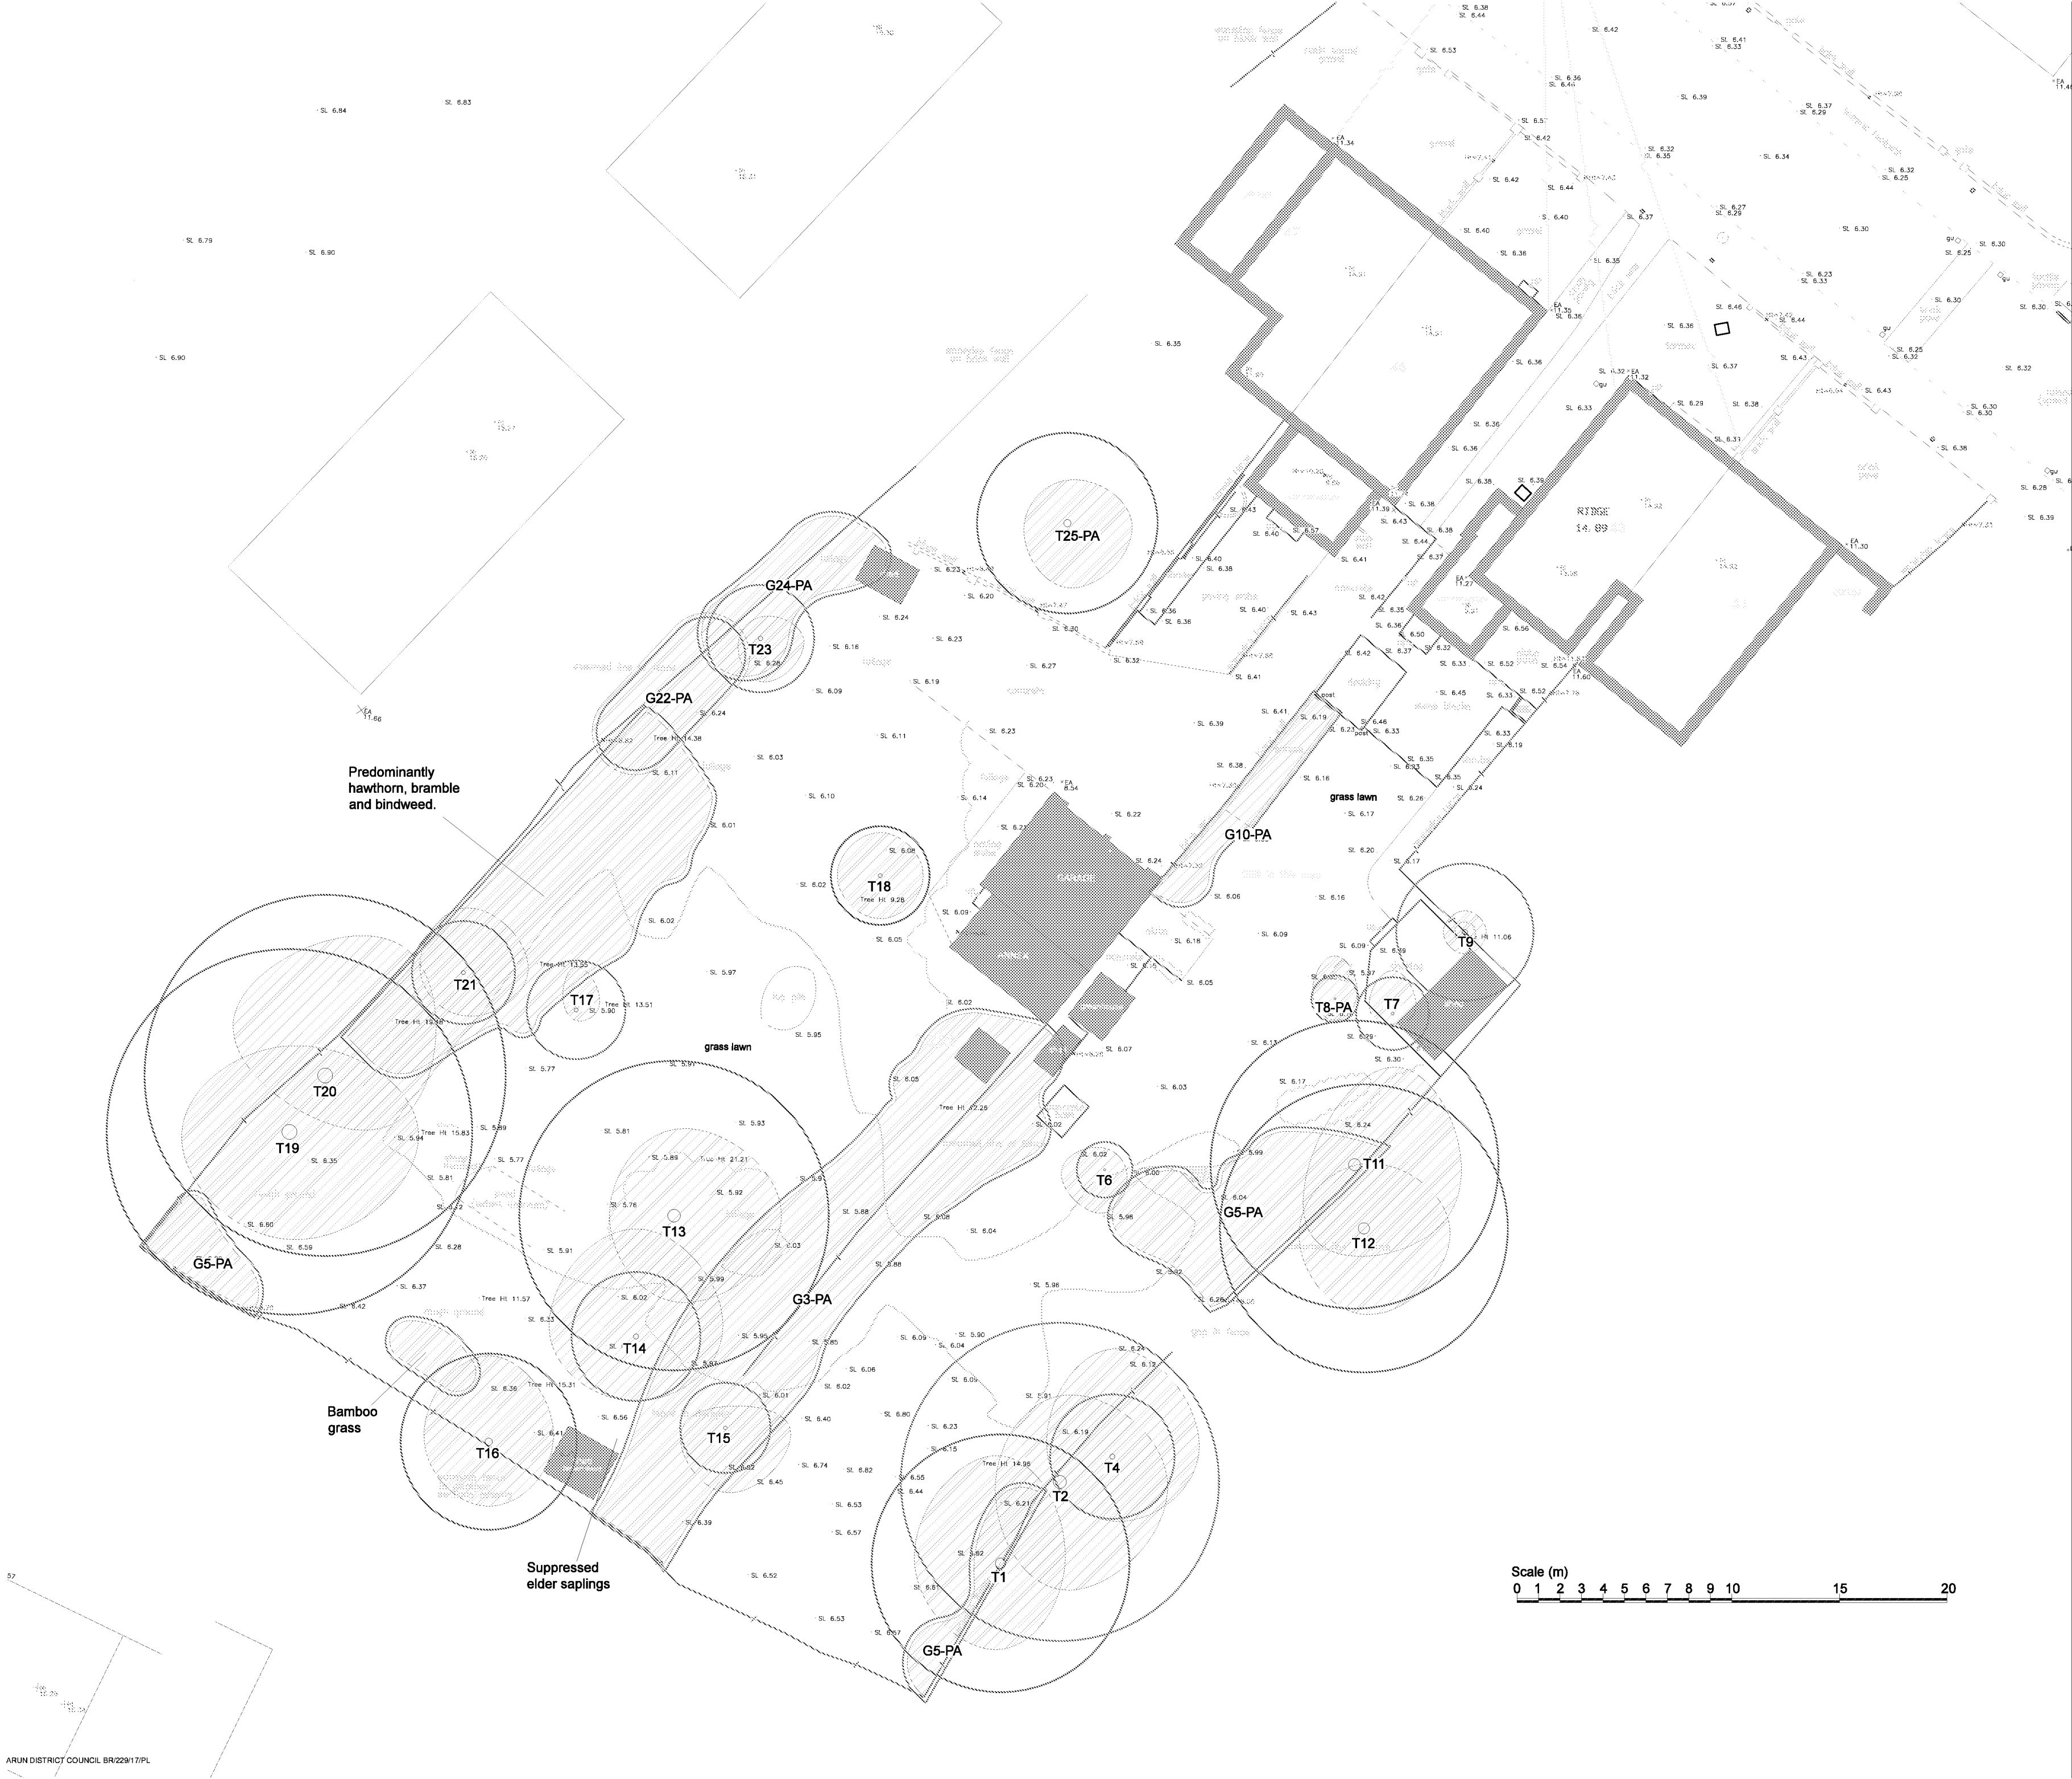
Drawing title: Tree Constraints Plan

**3.1 Tree removals:** Trees to be removed for the proposed development are shown with dashed outlines on the Tree Retention Plan in Appendix 1 and are shaded to indicate their BS5837 tree category. These comprise G3, G5, T6, T7, T8, T9, G10, T15, T17, T18, G22, T23 and G24 (seven trees and five groups categorised as C, and one tree categorised as U). A summary of the tree removals is shown below.

**3.9** The two new visitor parking bays and garden path to the north of plot 3 encroach the root protection areas of T11 and T12 in the areas highlighted green on the Tree Retention Plan. The hard standing encroaches the root protection area of T11 by 16.3% and T12 by 2.5%. In both cases the encroachment is below the 20% maximum recommended in BS5837: 2012, and both trees exhibited good vitality on the date of the initial tree survey.
