# Tree Survey Report

Proposed Residential Development

Durban Road, Bognor Regis PO22 9QT

November 2021

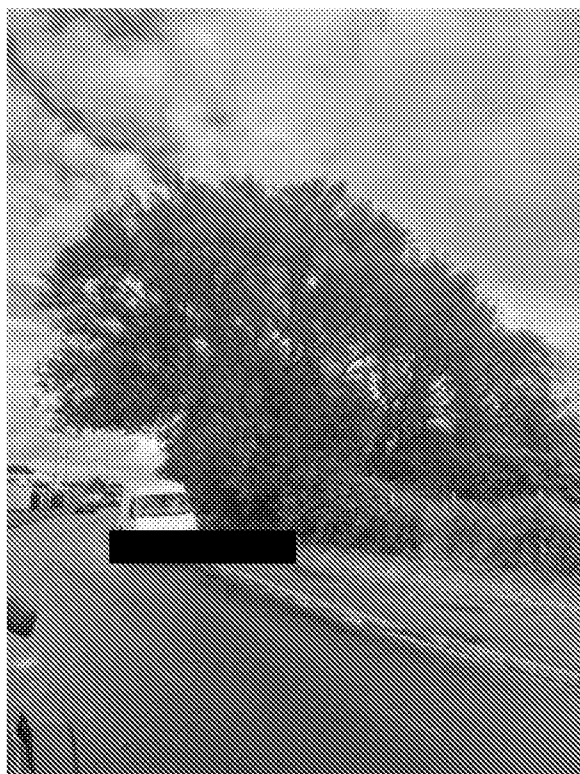
**Photo 1** - View of T1, T2 & T3 (left to right) willow trees looking north

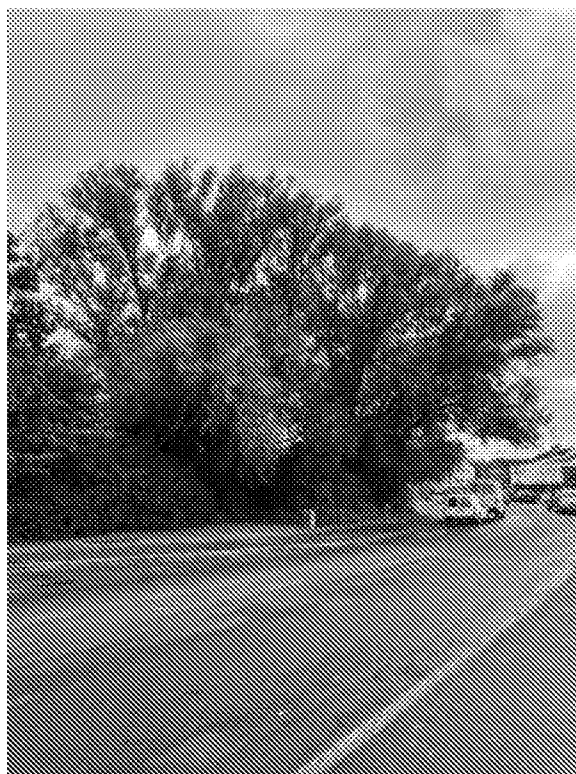
**Photo 2** - View of T3, T2 & T1 (left to right) willow trees looking south

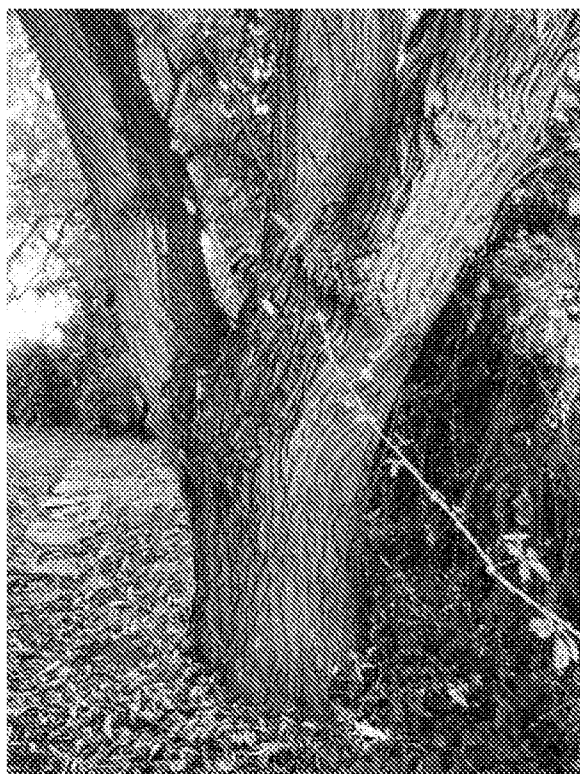
- 4.8 T2 forks into 2 large limbs which fork again into a further 2 large limbs and a large spreading canopy and is located beyond the site boundary fence.

**Photo 3** - View of T2 trunk to be retained

6.9 T1 and T3 are to be removed because they conflict with the layout of the new development. The new building encroaches into the RPA of T2 and has been calculated at 8% of the area of the RPA. BS5837 states that encroachment which is less than 20% is unlikely to have a detrimental impact to the survival of a tree. Therefore, as the encroachment is only 8%, T2 can be successfully retained as part of the development.

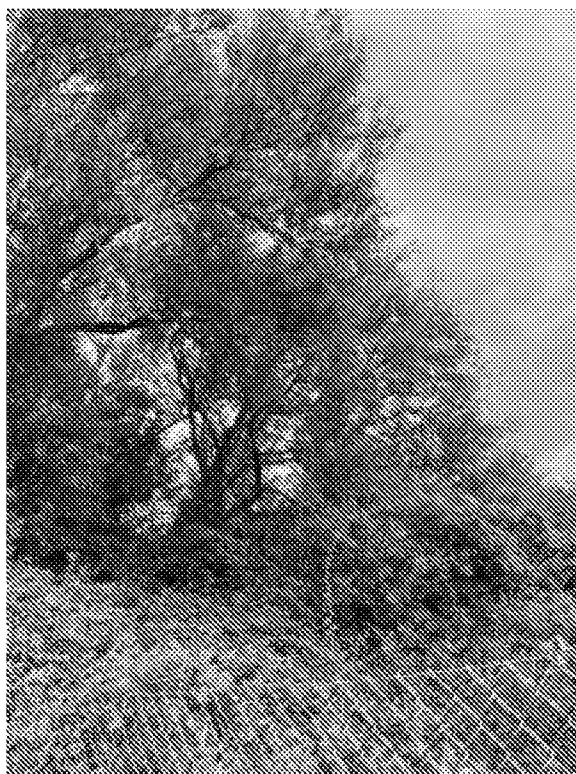
- 4.9 T3 is located within the site boundary fence. Dimensions have had to be estimated as there is no direct access to the trunk due to overgrown brambles and other vegetation.

| Ref | Species | Height<br>(m) | Stem<br>Diameter<br>(mm) | Branch spread (m) | | | | Height<br>crown<br>clearance<br>(m) | Age class | Condition & Comments | Years left | Category<br>grading | RPA<br>(m²) | RPA<br>radius |
|---|---|---|---|---|---|---|---|---|---|---|---|---|---|---|
| T3 | White Willow<br>(Salix alba) | 17 | 800 | 8.0 | 8.0 | 8.0 | 8.0 | 2 | OM | Unable to gain direct access to the trunk to take measurements due to overgrown branches and vegetation. Dimensions estimated based on visual comparison with T2. Located within boundary fence. | 20+ | B2 | 290 | 9.60 |

**Photo 4** - View of T3 to be removed
