PARKER DANN

LAND AT CHURCH LANE, CLIMPING, WEST  
SUSSEX

ARBORICULTURAL SURVEY REPORT  
REVISION 2

APRIL 2016

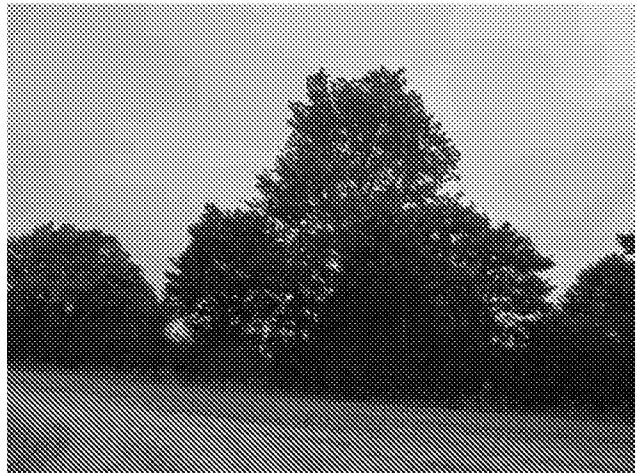
**Photograph 1:** Trees G11 and T12.

| | | | | Client: Phlorum<br>Site: Church Lane, Climping<br>Survey date: 03/07/2015<br>Surveyor: Peter Davies | | | | | | | T: Individual tree or shrub<br>G: Group of 2 or more trees<br>H: Hedgerow<br>W: Woodland block | | |
|---|---|---|---|---|---|---|---|---|---|---|---|---|---|
| T12 | Poplar (Populus canadensis) | 15 | 630 | N: 4<br>E: 6<br>S: 4<br>W: 3 | Crown: 1 east<br>Branch: 3 south | Mature | Good | Good | Under-storey inhibits inspection. No major visible defects. | No action required on date of survey. | B2 | 179.6 | 7.6 |

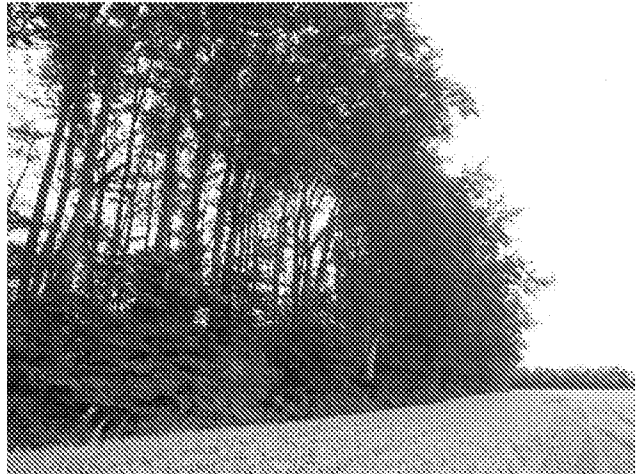
- 3.3 There is a long section of beech woodland adjacent to Crookthorn Lane. The trees in the northern half of this block are generally displaying good vitality, however the majority those in the south facing section of the woodland are exhibiting dieback. Furthermore many of the ash on the southern and western boundaries are also exhibiting dieback, quite significantly in W 29. The apparent cause of the dieback would be windburn as the site is located relatively close to the sea and the trees exhibiting dieback are those most exposed to the prevailing wind from the south west.

| | | | | Client: Phlorum<br>Site: Church Lane, Climping<br>Survey date: 03/07/2015<br>Surveyor: Peter Davies | | | | | | T: Individual tree or shrub<br>G: Group of 2 or more trees<br>H: Hedgerow<br>W: Woodland block | | | |
|---|---|---|---|---|---|---|---|---|---|---|---|---|---|
| W22 | Beech and ash | Up to 16 average | Up to 600 average | Refer to drawing | 0 average | Mature | Fair | Good | Dieback in all trees on south side of woodland belt (possibly associated with wind burn). Multiple compression forks. | Consider planting shelterbelt trees to the south such as Canadian poplar. | B1/2 | 162.9 average | 7.2 average |

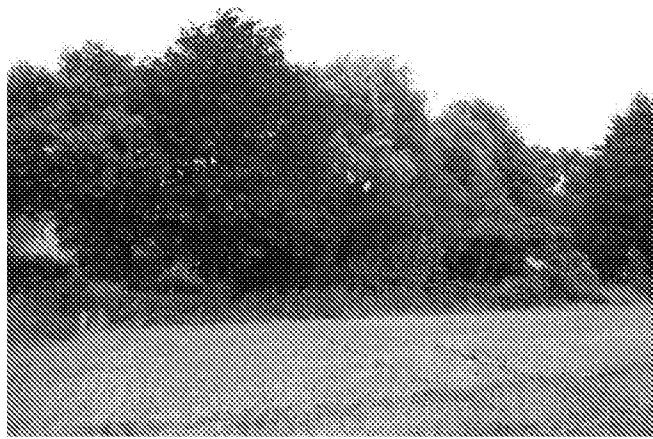
**Photograph 5:** Group G42.

| | | | | Client: Phlorum<br>Site: Church Lane, Climping<br>Survey date: 03/07/2015<br>Surveyor: Peter Davies | | | | | | | T: Individual tree or shrub<br>G: Group of 2 or more trees<br>H: Hedgerow<br>W: Woodland block | | |
|---|---|---|---|---|---|---|---|---|---|---|---|---|---|
| G42 | Sumach, silver birch, various willows, red Norway maple, oak, cypress | Up to 8 average | Up to 300 average | Up to 4 average | 1 average | Semi mature-mature | Good | Good | Third party trees only viewed from site. Appear of good condition. | No action required on date of survey. | B1/2 | N/A | 2m from field boundary |

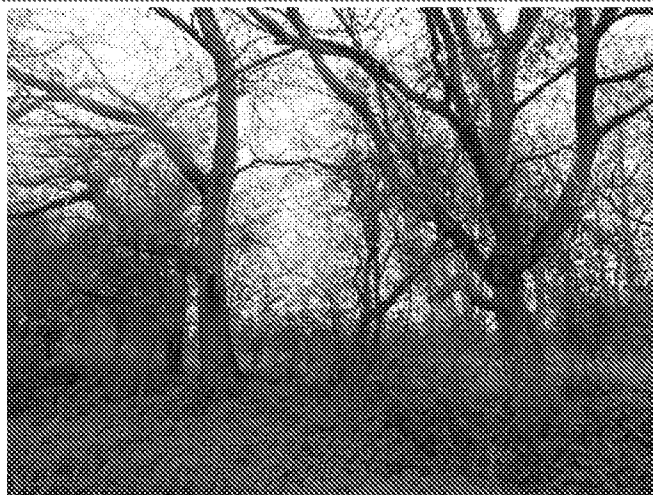
**Photograph 9:** T57 and T58.

| | | | | Client: Phlorum<br>Site: Church Lane, Climping<br>Survey date: 22/04/2016<br>Surveyor: Peter Davies | | | | | | T: Individual tree or shrub<br>G: Group of 2 or more trees<br>H: Hedgerow<br>W: Woodland block | | | |
|---|---|---|---|---|---|---|---|---|---|---|---|---|---|
| T57 | English oak (Quercus robur) | 11 | 530 | N: 2<br>E: 3<br>S: 7<br>W: 6 | Crown: 2 south<br>Branch: 2 south | Mature | Good | Good | Low deadwood. Slight south lean. No major visible defects. | No action required on date of survey. | B1/2 | 127.1 | 6.4 |
| T58 | English oak (Quercus robur) | 7 | 370 | N: 0<br>E: 3<br>S: 5<br>W: 2 | Crown: 2 south<br>Branch: 2 average | Semi mature | Good | Good | 1 sided crown. Slightly suppressed by T57. No major visible defects. | No action required on date of survey. | E2 | 61.9 | 4.4 |
