Details Pursuant to British Standard 5837:2012,  
Trees in relation to design, demolition & construction  
Change of Land Use Proposal for: Highdown-Land West of former McIntyre Nursery,  
Ferring, West Sussex BN12 6PB.

**BS5837:2012 Survey and Report**

August 2021

**DKS/Wood01**

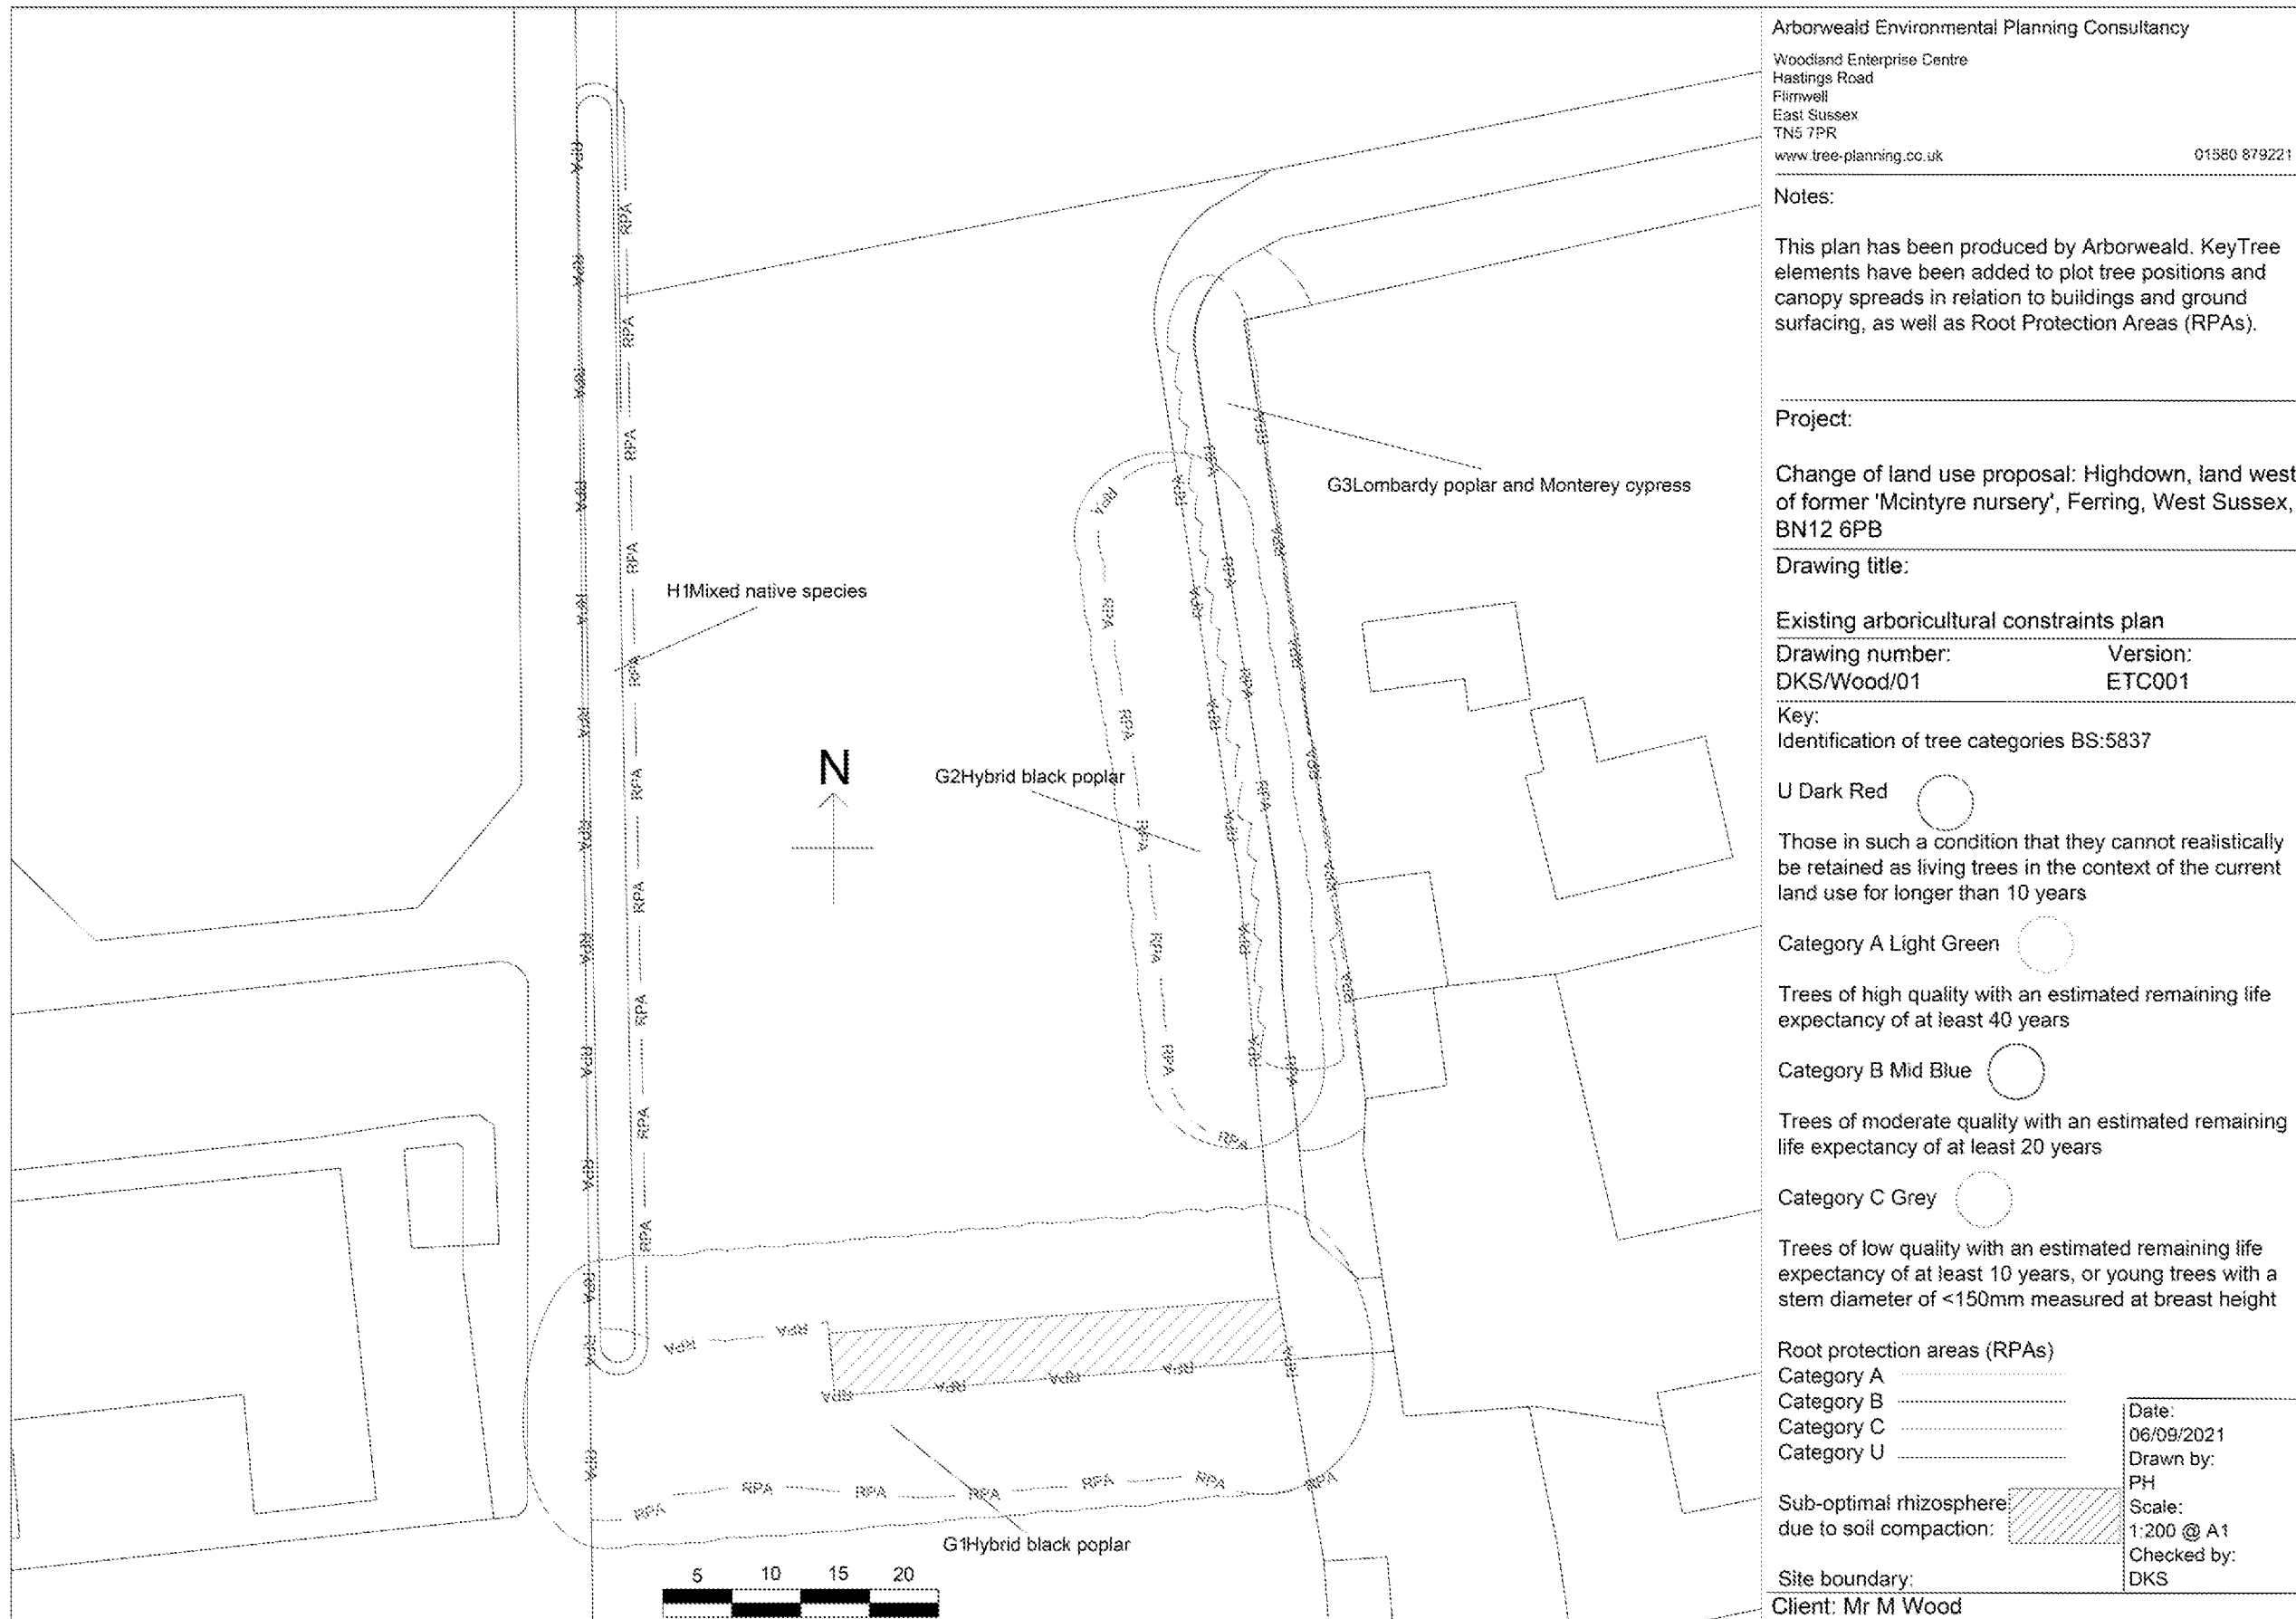
## Appendix 2: Existing Arboricultural Constraints

| Tree no. | Life stage | Sc | Pc | Eml | BS5837 Category | Comments |
|---|---|---|---|---|---|---|
| G1 | Early mature | Average | Average | 10 + | C2 | <p>Linear group of even aged hybrid black poplar at southern boundary of site of average form and vitality. Rooting limited north by historic compaction and east at access track, level change to S. with 0.3m drop some soil mounded at group bases signs of recent soil disturbance within neighbouring site south. Group has drawn up form with poor taper, early signs of stress with some tip die back top southern crowns, middle tree within group has lost top at 10m. Barbed wire fence attached to western most tree within group now starting to occlude and causing minor conflict with other trees within group. 6 eastern most trees have significant historic mechanical damage 2-10m N side up to 1/3<sup>rd</sup> circumference partially occluded.</p> <p><i>Remove barbed wire fence without damaging stems, fell smaller suppressed trees within group and implement staged cyclical reduction to bring down to 18m target height, then manage with cyclical reduction interventions every 5-7years. Monitor regularly if land use changes.</i></p> <p>Restack stored materials adjacent to group as specified within section 7.0. Crown raise north canopy to 5m limited to small diameter branches no larger than 1/3<sup>rd</sup> parent stem or branch to facilitate development; group can be effectively protected and sustainably retained with SPM implemented during security fence installation (section 7.0).</p> |

| Tree no. | Life stage | Sc | Pc | Eml | BS5837 Category | Comments |
|---|---|---|---|---|---|---|
| G2 | Early mature | Average | Average | 10+ | C2 | Linear group of even aged hybrid black poplar at eastern boundary of site adjacent to gravel access track group of average form and vitality. Rooting limited east by access track and sub optimal rooting west into site by historic compaction and material storage. Early signs of stress with some tip die back top crowns. Monitor regularly if land use changes. Conduct soil amelioration after removing building materials away from southernmost trees to improve rhizosphere (section 7.2.1) and clearly define site entrance to limit vehicle access. Crown raise east canopy to 5m limited to small diameter branches no larger than 1/3 <sup>rd</sup> parent stem or branch to facilitate access to development; group can be effectively protected and sustainably retained with SPM implemented during security fence installation (section 7.0). |
| G3 | Early mature | Average | Average | 10+ | C2 | Mixed linear group of even aged Lombardy poplar with interspaced Monterey cypress east of access track to screen adjacent industrial yards. Rooting limited west at access track and east within adjacent industrial areas. Signs of dieback and stress within group likely due to compaction and limited rooting area. Occasional standing dead trees within group- minimal risk due to size and companion shelter. Crown raise west canopy to 5m limited to small diameter branches no larger than 1/3 <sup>rd</sup> parent stem or branch; group can be effectively protected and sustainably retained. |
| H1 | Semi mature | Average-good | Good | 20+ | B2 | Amenable native hedge at western boundary of site. Maintain at current dimensions with annual cutting, hedge can be laid within the next 5 years which will ensure stock proofing and maintain density. Hedge can be effectively protected and sustainably retained. |
