ARBORICULTURAL REPORT

LAR2501-ARB-REP-0140

**Land adjoining No. 275 Goring Way
275 Goring Way, Ferring**

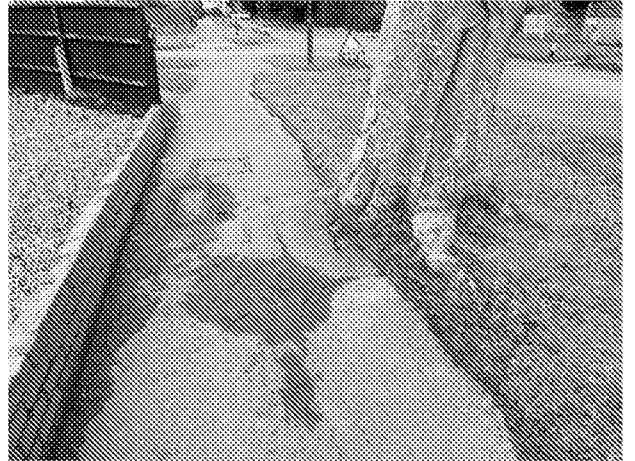
There is an inspection chamber in the footway next to the beech tree T01. There was no utility survey record available at the time of the arboricultural survey to understand the nature and direction of the service channel. Depending on the time of installation of the apparatus, the works might have influenced the development of the root system of the tree through excavation or soil compaction resulting from backfilling.

Photograph 2. T01 - stem close to footpath and manhole covers indicating utilities close to tree.

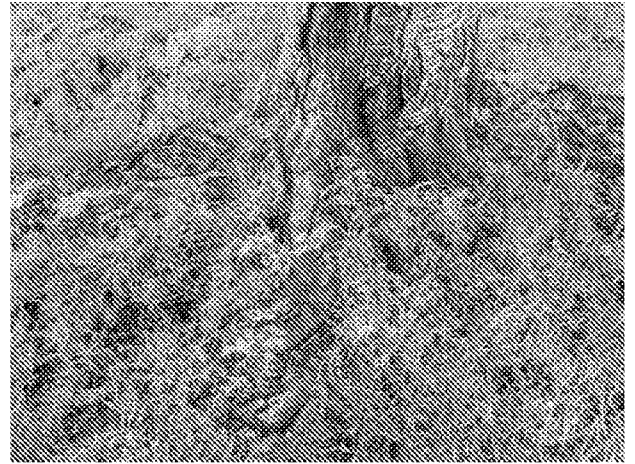
Trees in genus *Prunus* are known to develop shallow root systems. Due to the presence of the network of footways, it is believed that the root system is primarily concentrated within the more favourable conditions of the grassland area and that the effective RPA deviates from the calculated circle accordingly.

Photograph 5. T03 - shallow and exposed roots

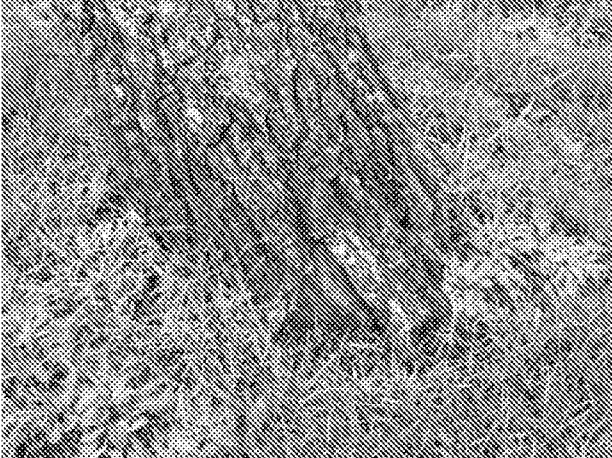
Photograph 7. T04 - base of stem with exposed wood

T04	Silver birch <i>Betula pendula</i>	324	R: 3.9 A: 48	7.5 1.2	N: 3.0 E: 3.5 S: 3.0 W: 2.0	EM	F F	C1 10+ years	Crown: Minor deadwood present. Fungal bodies on the branch with missing apex. Cracked lowest branch with rotting wood visible. Stem: Leans NE. Exposed wood at base on west side. Two codominant leaders. Wide fork Roots: No comments
T05	Silver birch <i>Betula pendula</i>	380	R: 4.8 A: 72	8.5 2.0	N: 4.0 E: 4.5 S: 5.0 W: 5.0	EM	G G	B1 20+ years	Crown: Lowest western branch grows horizontally for 1.5 m. Some branches removed Stem: No comments Roots: No comments
T06	Silver birch <i>Betula pendula</i>	361	R: 4.5 A: 64	8.3 2.2	N: 3.0 E: 3.0 S: 3.0 W: 3.0	EM	G G	B1 20+ years	Crown: Bird's nest present. Two codominant leaders. Minor deadwood. Stem: Leans slightly NE. Bark damage at base with exposed wood Roots: No comments

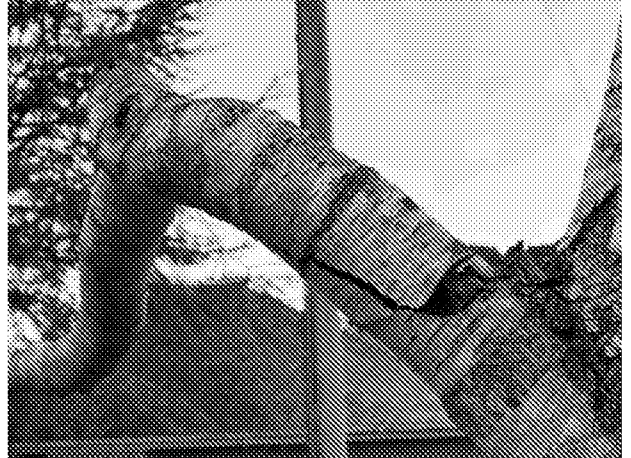
Photograph 8. T04 - cracking lowest branch. Rotting wood visible.

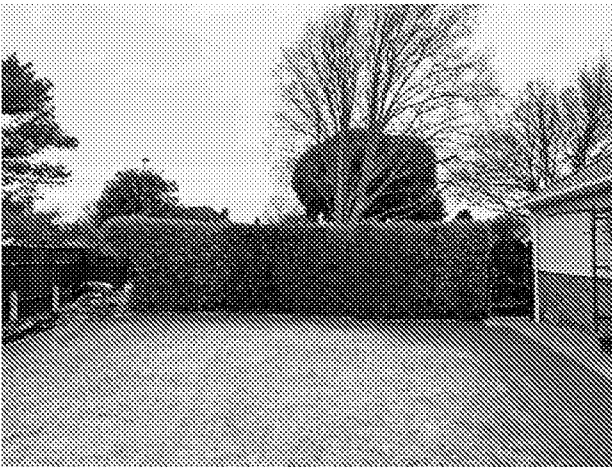
Photograph 10. H07 hedge

There are no trees within the site requiring removal to implement the proposal. However, a section of mixed-species hedgerow along the northern edge of the garden would be removed.

Ref	Species	Notes
H07	<i>Griselinia littoralis</i> , <i>Viburnum tinus</i> , <i>Ligustrum sp.</i>	Requires removal
SH08	Hydrangea	No action required
SH09	Hydrangea	No action required

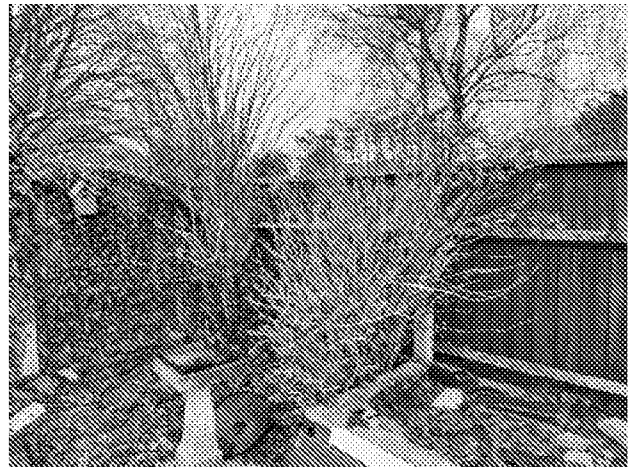
Photograph 11. Hydrangeas at the back of garden
