ARBORICULTURAL IMPACT ASSESSMENT & METHOD  
STATEMENT version 2  
*(Tree Survey & Constraints Plan)*

Demolition of existing bungalow & Construction of two single storey dwellings. Ref FP/180/17/PL November 2017

Address: 84 Flansham Lane Felpham Planning Application: FP/180/17/PL

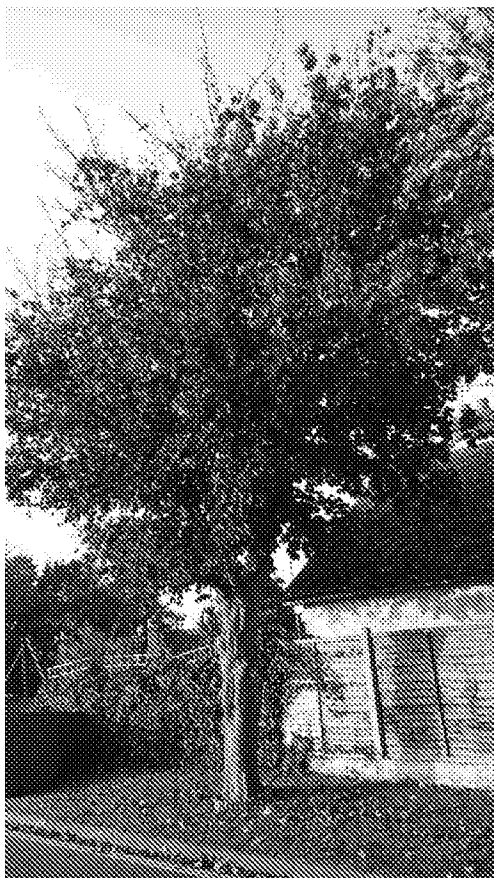
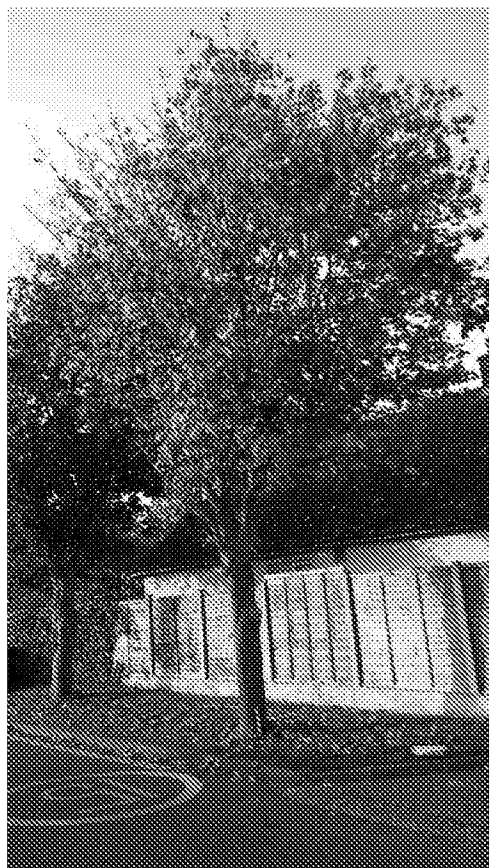
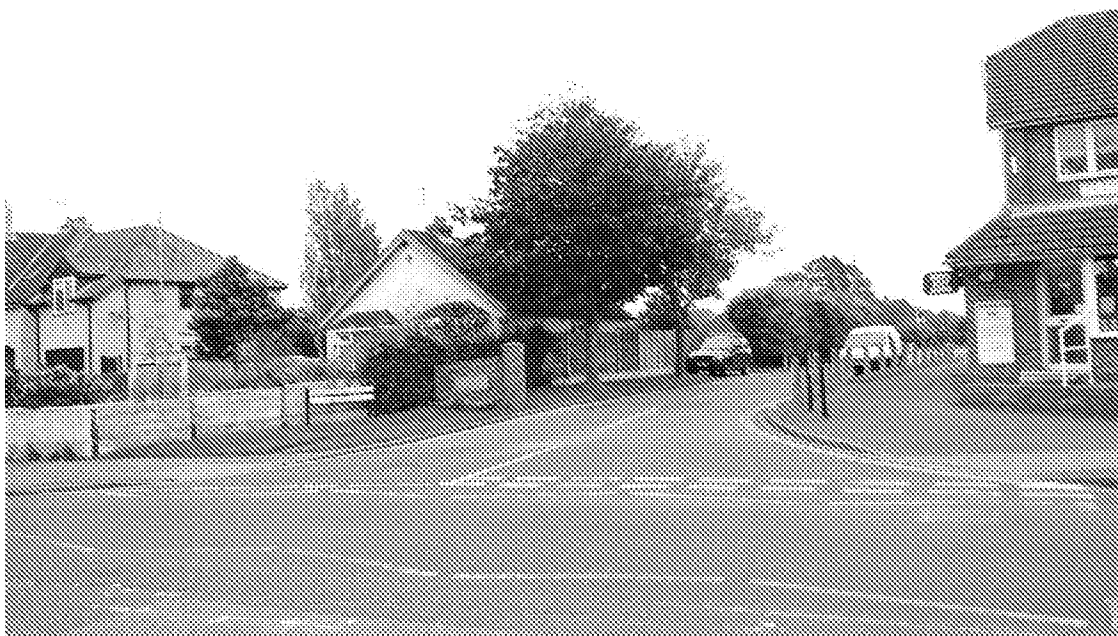
T1 and T2 are Norway Maples (*Acer platanoides* - see section 17 for photos). T1 is a purple cultivar, the second green leaved is of the species type. Both trees are relatively young, were planted at or near the same time given their similar height spread and girth. The trees are 7 metres in height. A mature specimen can reach a height of between 25-30 metres.

The existing Norway Maples provide amenity and landscape value. Both trees assessed are associated with RPAs which intrude into the development area. The Norway Maples are outside the construction area separated by a two-metre panel fence within a grass verge.

Above: T1 & T2 Norway Maple Subject Trees

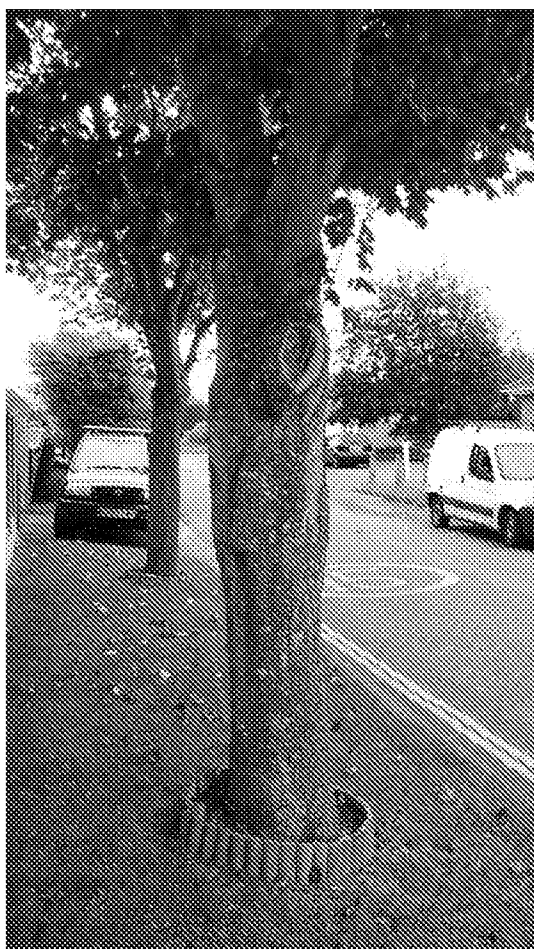
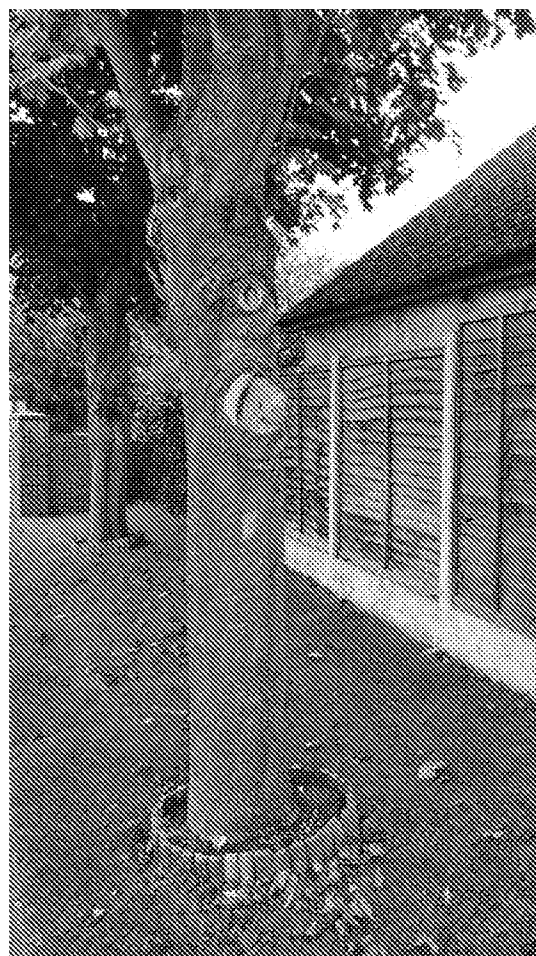
The trees are both around 7 metres in height but have been crown lifted in recent years with several cuts close to the main stem. Poor tree surgery has led to some unsightly callousing of the wounds, with some cuts made very close to the trunk without a collar where callousing is only partial.

Above: Unsympathetic tree surgery work

Both trees are healthy individuals despite the unsympathetic tree work mentioned previously. The trees benefit the community, because of their amenity and visual (landscape) value which is enjoyed by passers-by crossing the entrance to Summerhill Drive. Views into the drive of the Maples are afforded, the reason why they have been classed as category 'B1' trees. It is not envisaged that the trees will require tree surgery works in the near future.

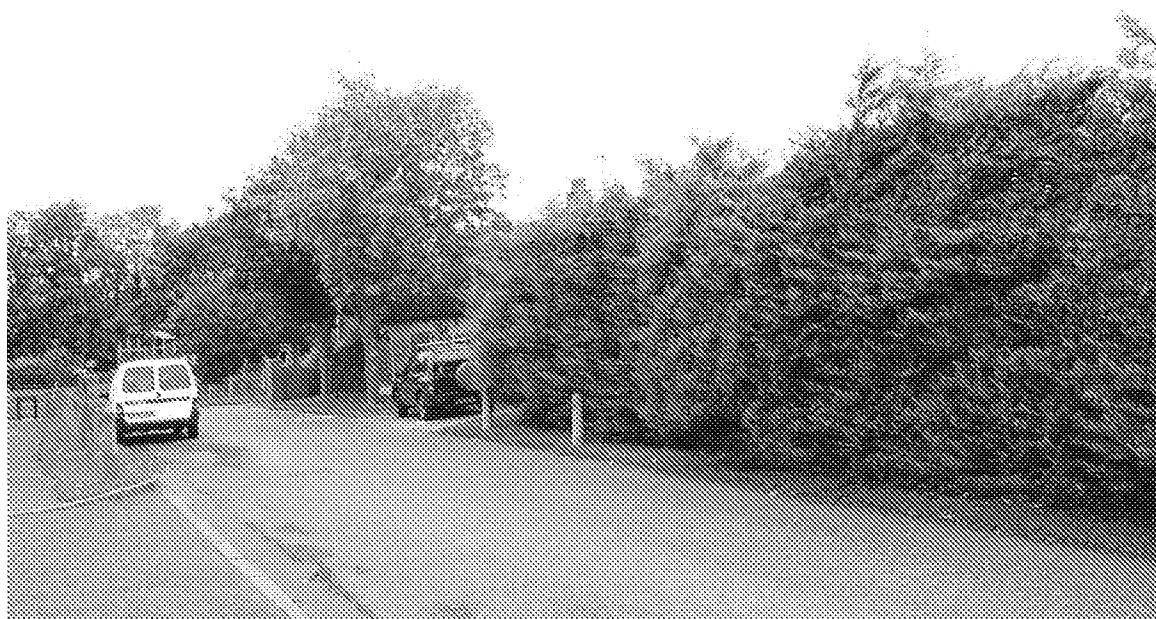
The residents' association's letter states that the conifer hedge on the West boundary West should be removed providing a landscape scheme replaces the planting.

Below: Hedge to be removed
