Prepared by David Meagher Environment Consultants for  
AM Design Architects Limited's client - Mr. Michael Roberts

1.0 Summary and recommendations to retain and protect trees during demolition and construction. (following Arboriculture officer's comments).

4.0 Description of the Development: demolition of existing dwelling and construction of two bungalows

This report contains the supporting tree information relating to the study area located at land adjacent to 84 Flansham Lane, Bognor Regis, West Sussex PO22 6AH and the proposal to demolish existing bungalow and replace with two detached residential units.

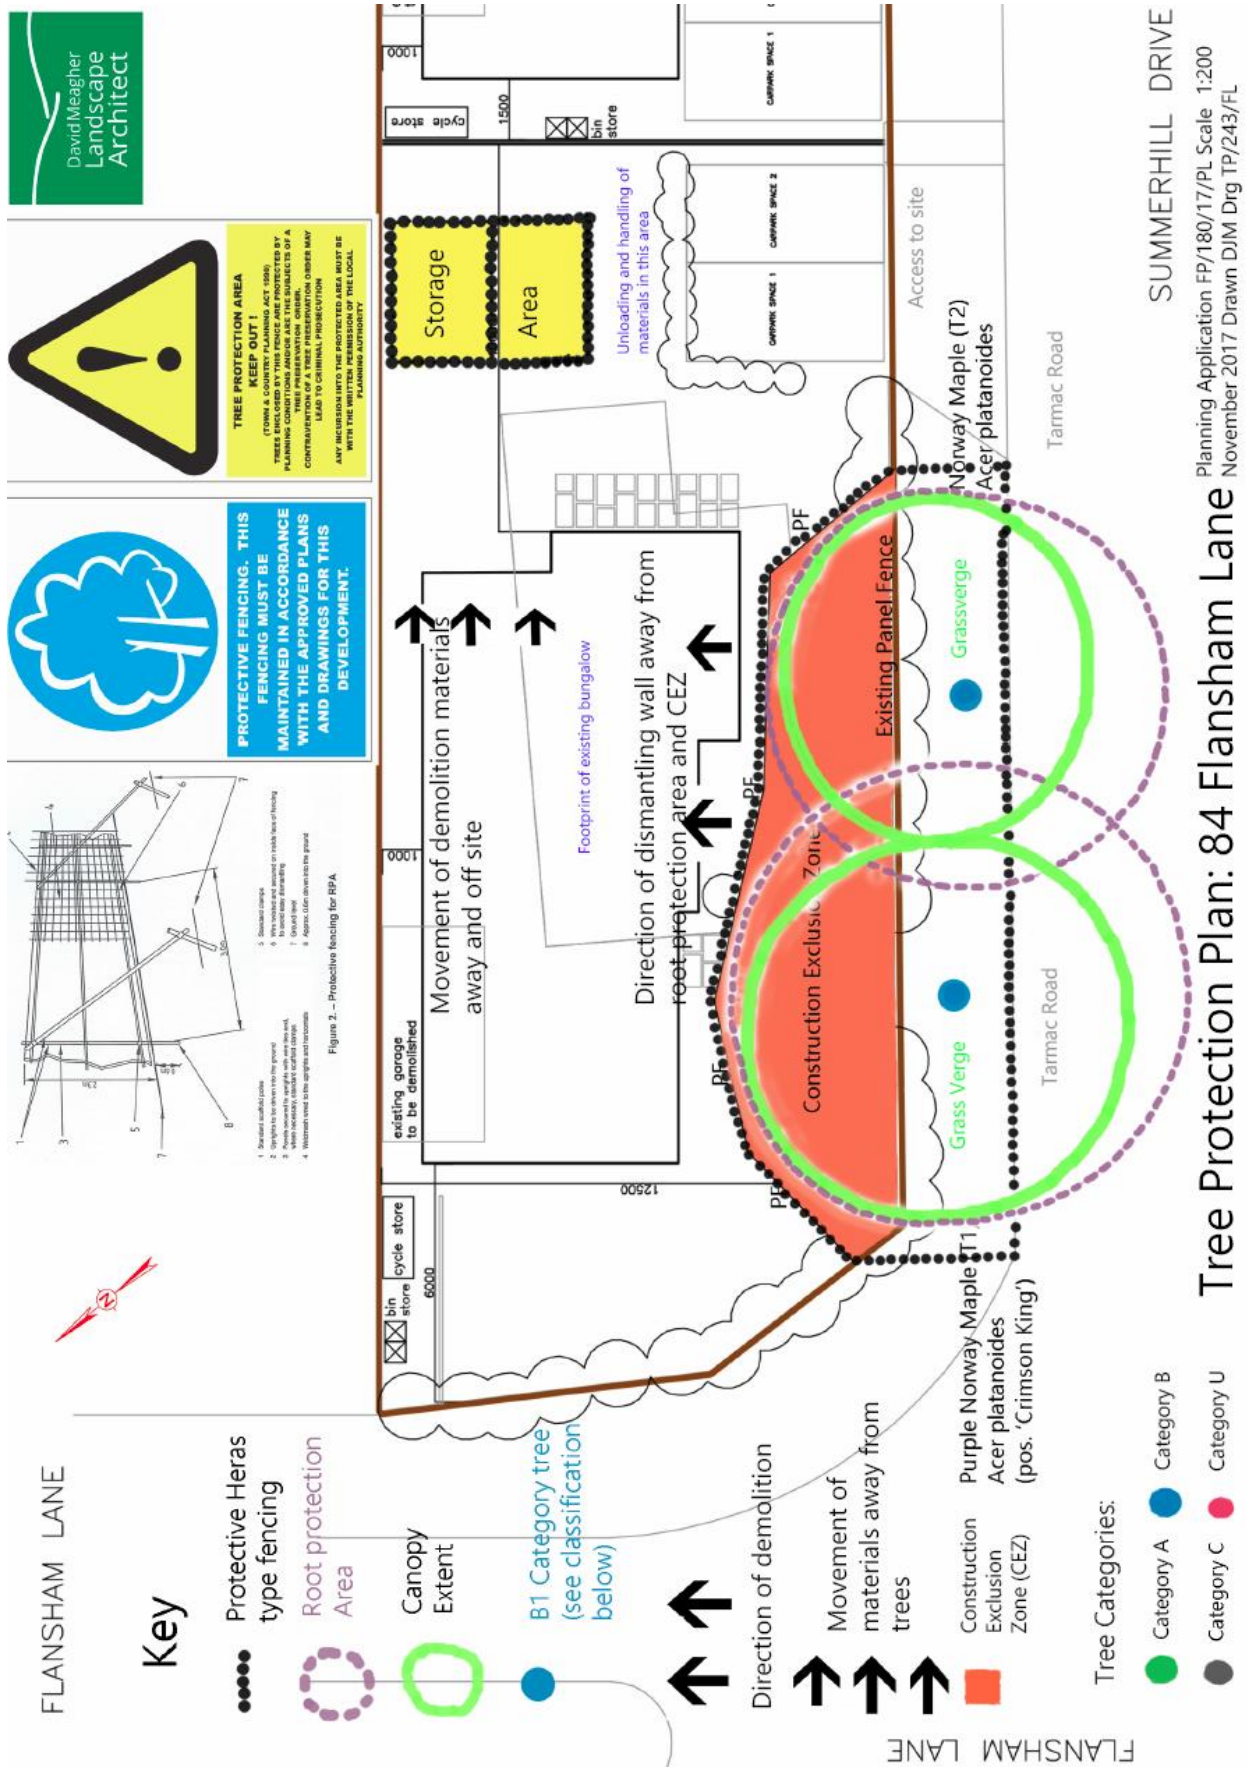
16.0 Tree Protection plan (see also stand alone copy) FP/180/17/PL

Tree roots have intruded into the root protection area and canopies extend over the footprint of the existing bungalow to be demolished. The trees require protection during the construction process, with the erection of protective barriers and the designation of a construction exclusion zone (see Tree Protection Plan and Appendix 6 ref: TP/243/FL for details BS 5837:2012) to prevent root damage by soil compaction or machinery storage of materials or any other practices harmful to the tree's structure. In addition, extra measures, including a detailed breakdown of the demolition process to enable the trees to survive, can be found (comments Mr Harverson: *What I wanted to see was how they would demolish the building carefully pulling it in on its own footprint away from the trees and then once they have exposed bare earth erect protective fencing at the full distances specified in their schedules or lay ground protection etc. etc.'*). The recommendations in addition include designated areas for storage and materials handling and routes for the passage of materials (as detailed on the TP Plan) as well as direction which the demolition should proceed.

The first construction act of construction is to erect and fence off the Root Protection Zones and provide barriers to provide a tree safe construction exclusion zone (see tree plan TP/243/FL) to isolate the two Norway maples from any form of construction interference, to prevent incursion into the root protection zone or within reach of the canopies where site activities may cause damage to the trees above ground. (T1 & T2 see tree protection plan TP/243/FL )

The barriers are to continue into Summerhill Drive to protect the grass verge where the trees are located from vehicles which are liable to cause damage when parking close to the site. Fencing to remain in place during the life of the project and be constructed in the same manner as above.

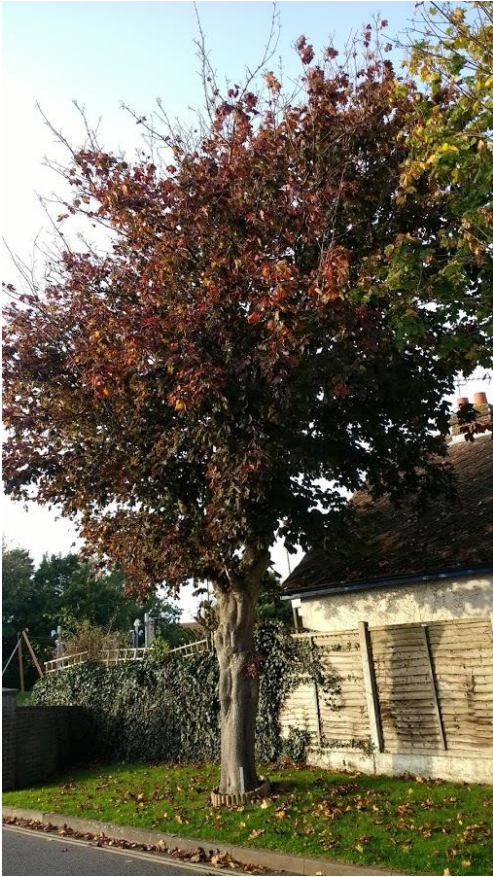
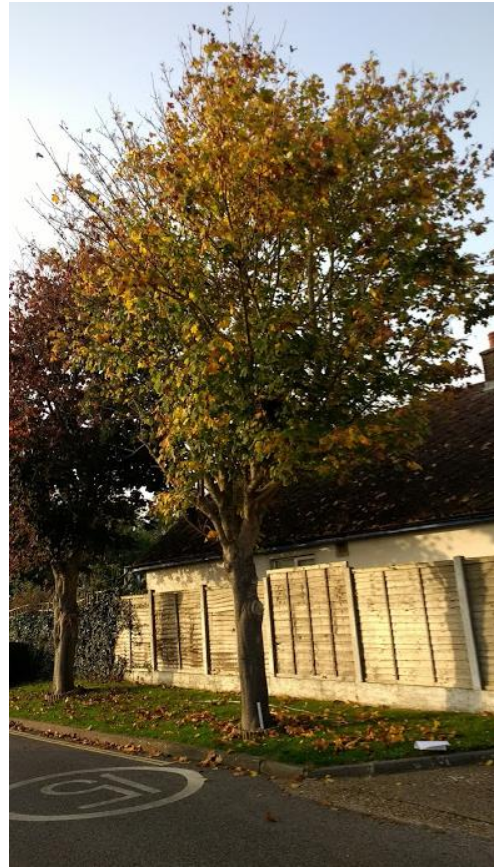
T1 and T2 are Norway Maples (*Acer platanoides* - see section 17 for photos). T1 is a purple cultivar, the second green leaved is of the species type. Both trees are relatively young, were planted at or near the same time given their similar height spread and girth. The trees are 7 metres in height. A mature specimen can reach a height of between 25-30 metres.

The trees are both around 7 metres in height but have been crown lifted in recent years with several cuts close to the main stem. Poor tree surgery has led to some unsightly callousing of the wounds, with some cuts made very close to the trunk without a collar where callousing is only partial.

Both trees are healthy individuals despite the unsympathetic tree work mentioned previously. The trees benefit the community, because of their amenity and visual (landscape) value which is enjoyed by passers-by crossing the entrance to Summerhill Drive. Views into the drive of the Maples are afforded, the reason why they have been classed as category 'B1' trees. It is not envisaged that the trees will require tree surgery works in the near future.

Above: T1 & T2 Norway Maple Subject Trees

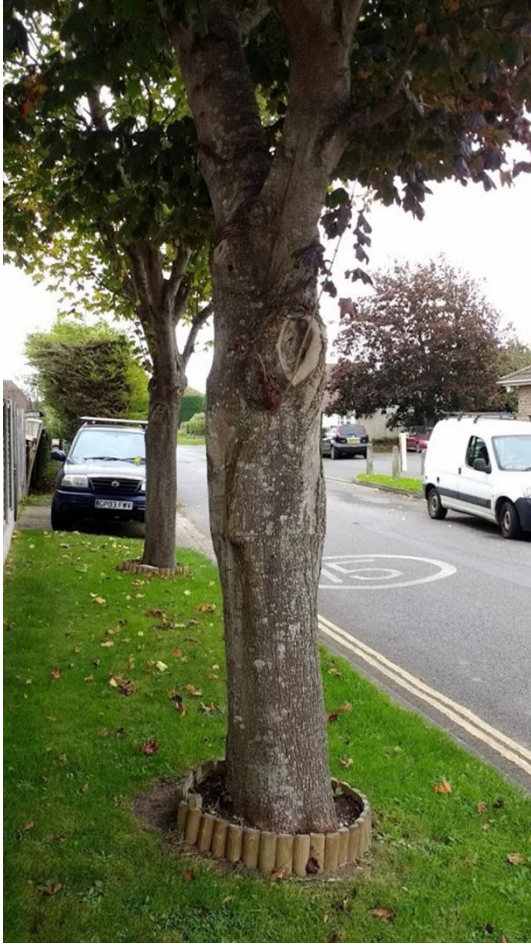
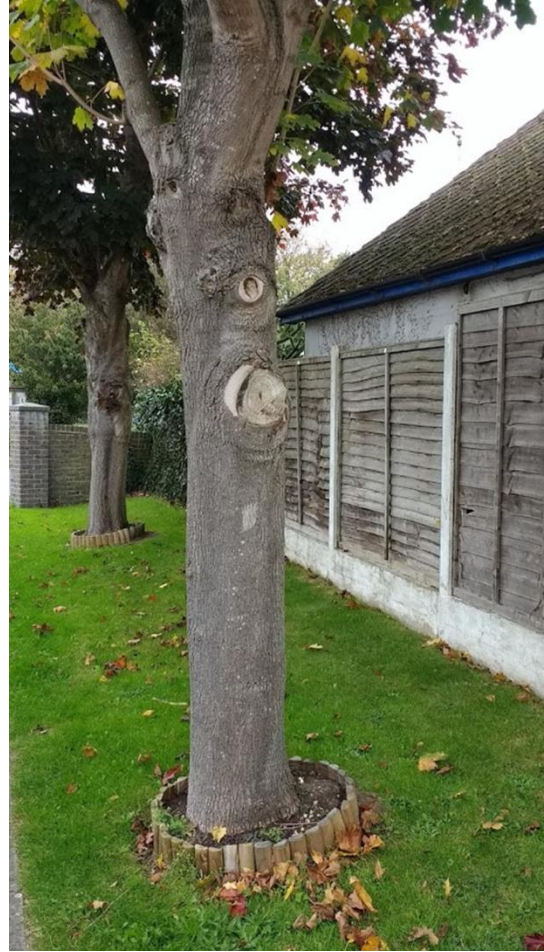
Above: Unsympathetic tree surgery work

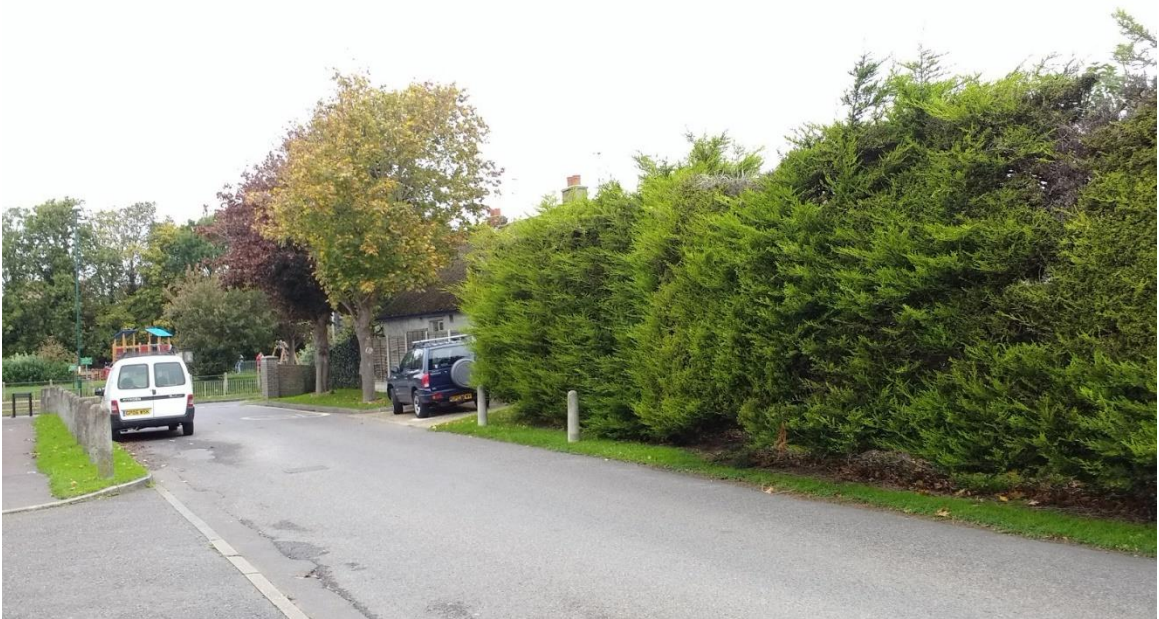
The residents' association's letter states that the conifer hedge on the West boundary West should be removed providing a landscape scheme replaces the planting.

Below: Hedge to be removed

The residents' association has a pragmatic approach to the removal of the existing boundary hedge: *that two bungalows are now proposed on the development site the Residents Association are happy for the conifer hedge to be removed and the frontage of the bungalows to be visible from Summerhill Drive which will incorporate the properties better into the street scene. In these circumstances it is important that the boundary provided is a dwarf wall similar to that provided for other adjacent properties and elsewhere on the Estate. It is also important that the verge is suitably landscaped with trees/shrubs to aesthetically enhance the development.*
