## B. J. UNWIN FORESTRY CONSULTANCY

**Waterbury House, Ford, Arundel, BN18 0BH – BS5837 Tree Constraints, Impact Assessment & Tree Protection Method Statement, for new care home development.**

4.5.2 **Waterbury House - BS5837 Inspection - BJUFC – 27<sup>th</sup> June 2018**

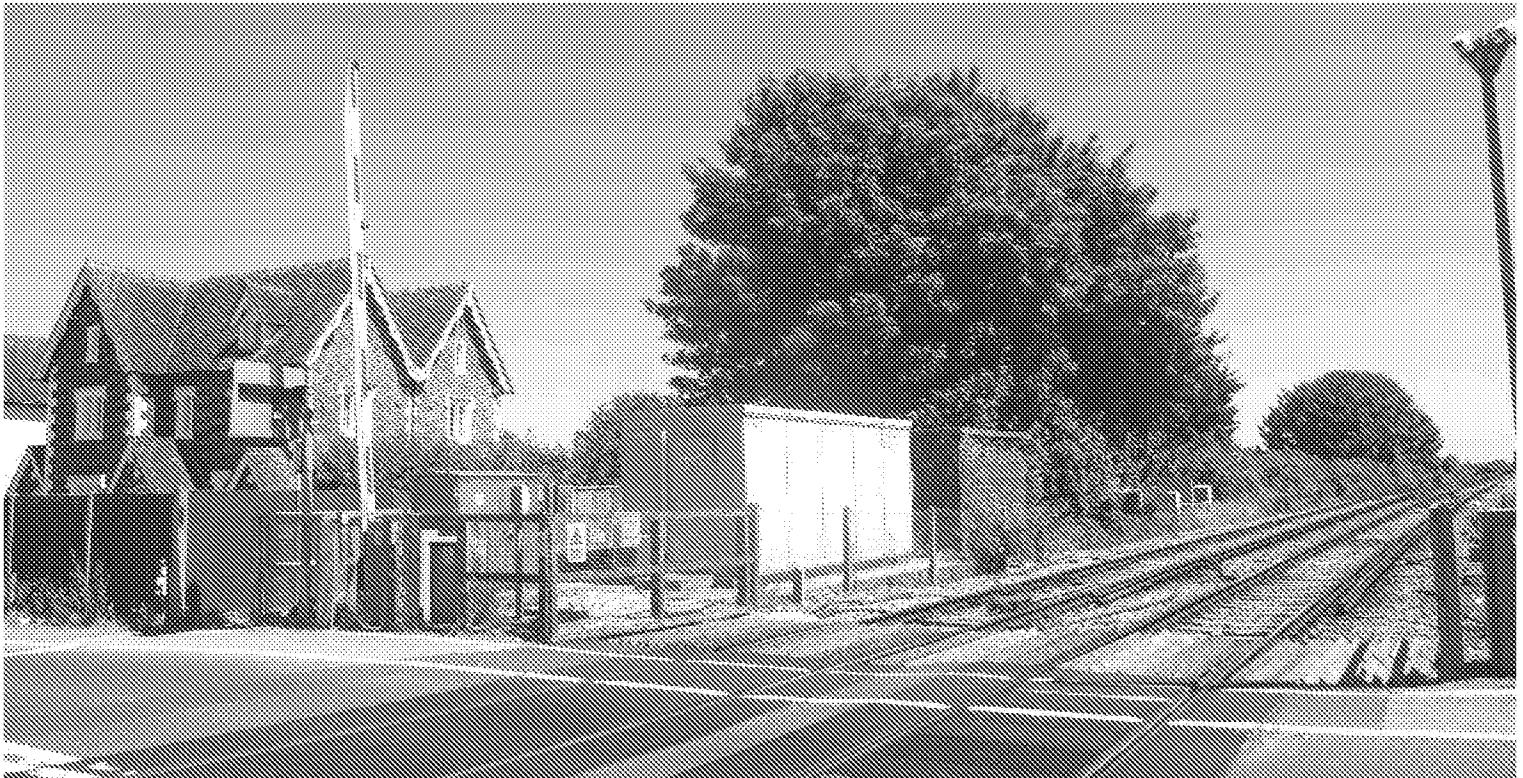
- The sycamores, Leylandii and Lawson cypress provide visual screening between railway and Waterbury House.
- The sycamores present a large local landscape feature.

**4.4.1 View north east to sycamore clump. Sycamores on right are a long way off-site.**

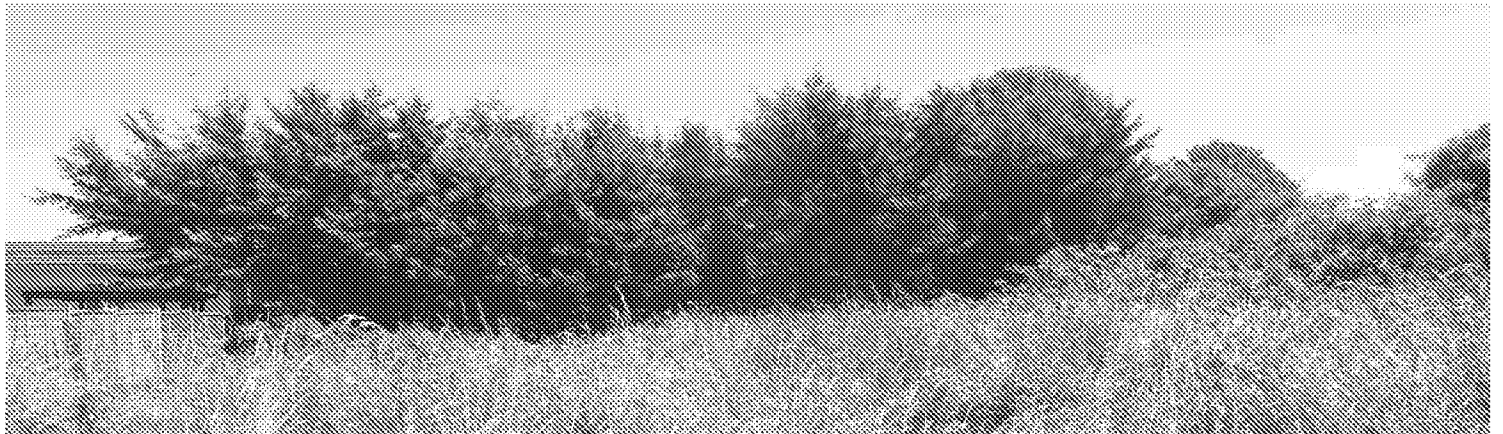
**4.4.2 View east to eastern-boundary golden Leyland cypress hedge.**

| H15 | Golden Leyland cypress | 300 | 5 | 1 | 7 | 2.5 | 2.5 | 2.5 | 2.5 ext | Em | F | P/<br>F | 10-20 | Wide-spaced "hedge". Topped but sides not trimmed, so broad.<br>Ugly, but screens mobile homes. | C2 | 3.6 | Trim sides and tops to improve shape. |

| No | Species | RPA<br>radius m. | Work for<br>landscape / tree health. | <u>ADDITIONAL WORK FOR<br/>DEVELOPMENT</u> |
|---|---|---|---|---|
| H15 | Golden Leyland<br>cypress | 3.6 | Trim sides and tops to<br>improve shape. | |

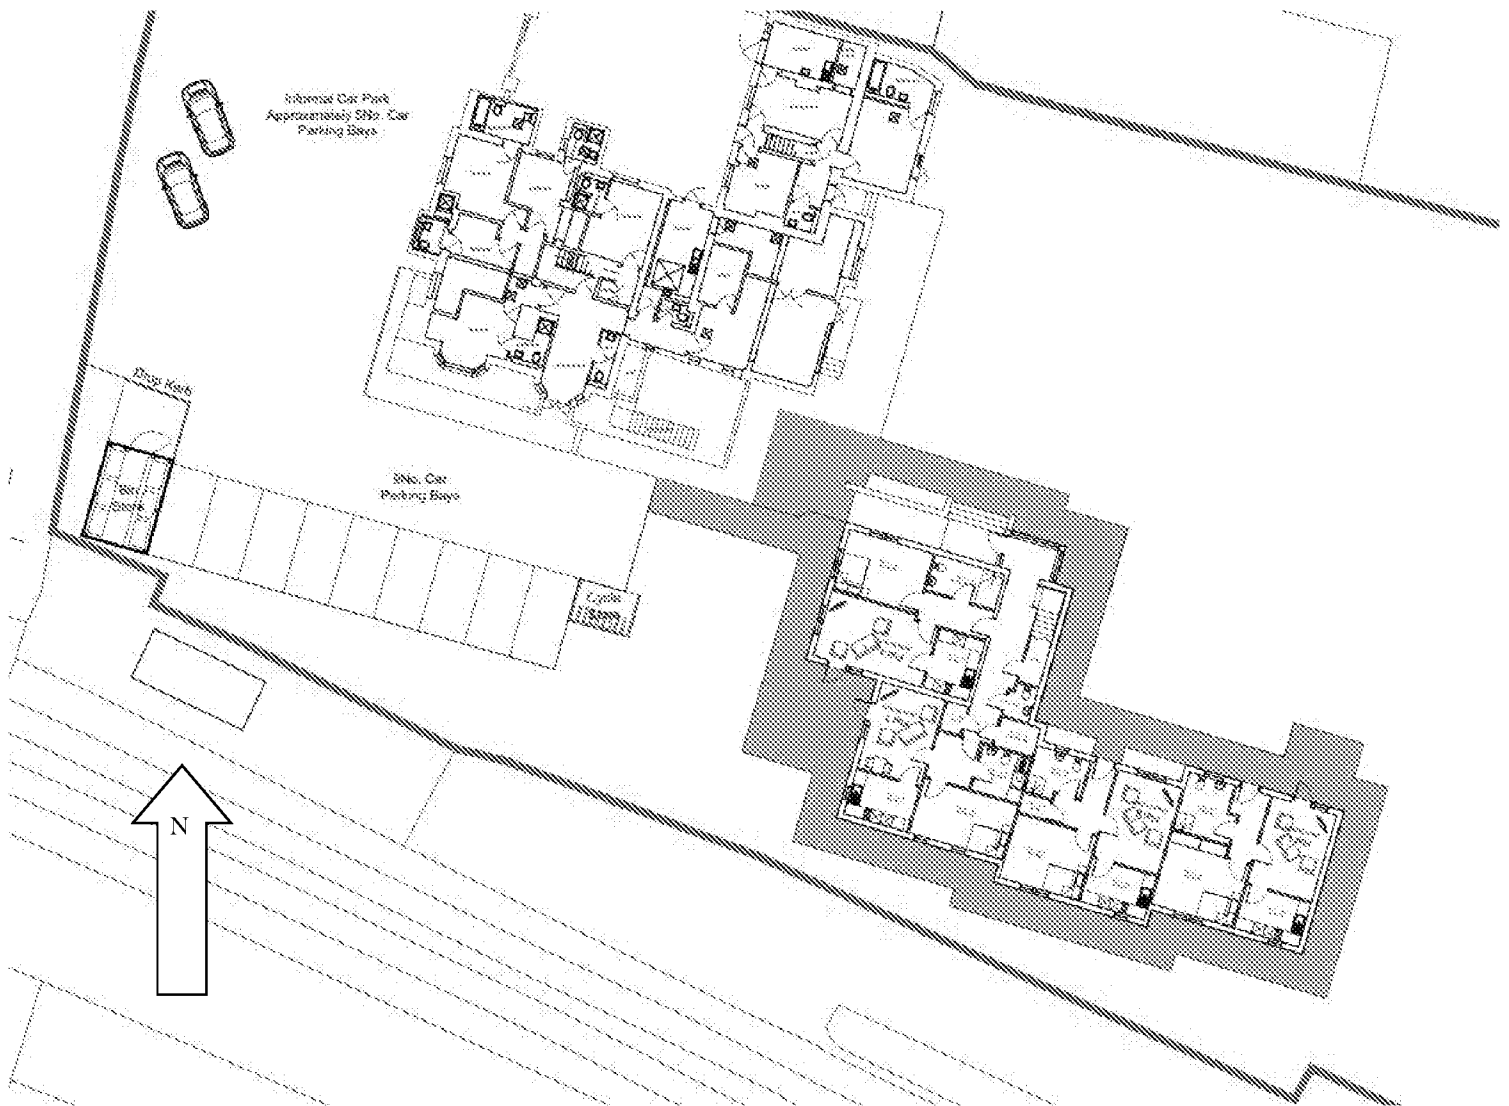
- 5.1.1 The **Proposed Site Plan by ADG Architects H-17-37 / 9-4 Rev B of 24/4/18**, extract below, shows the proposal.
- 5.1.2 The development comprises five new flats, and parking. An acoustic fence may be needed.
- 5.1.3 Access uses the existing road entrance.

- Sycamores T3-T6 will need minor crown lifting to clear the new parking.
- Scrub SG1 is all replaced by development.

- Sycamore T3-T6 RPAs are slightly within new parking. This is not significant intrusion.
- Sycamore T10 has minor intrusion of RPA into corner of new building and paths. Minimal-dig needed for paths. See 6.9 below.
- Leylandii T11-T13 have severe RPA intrusion into path and new building. Recommend removal.
- An acoustic fence (about 2m high) would require hand-digging of post holes within RPAs. See 6.6 of method statement below.
