Ref: 10<sup>th</sup> July 2018 rev 7<sup>th</sup> May 2019- BJU/mmi

To: **Caring Homes**

**Waterbury House, Ford, Arundel, BN18 0BH – BS5837 Tree Constraints, Impact Assessment & Tree Protection Method Statement, for new care home development.**

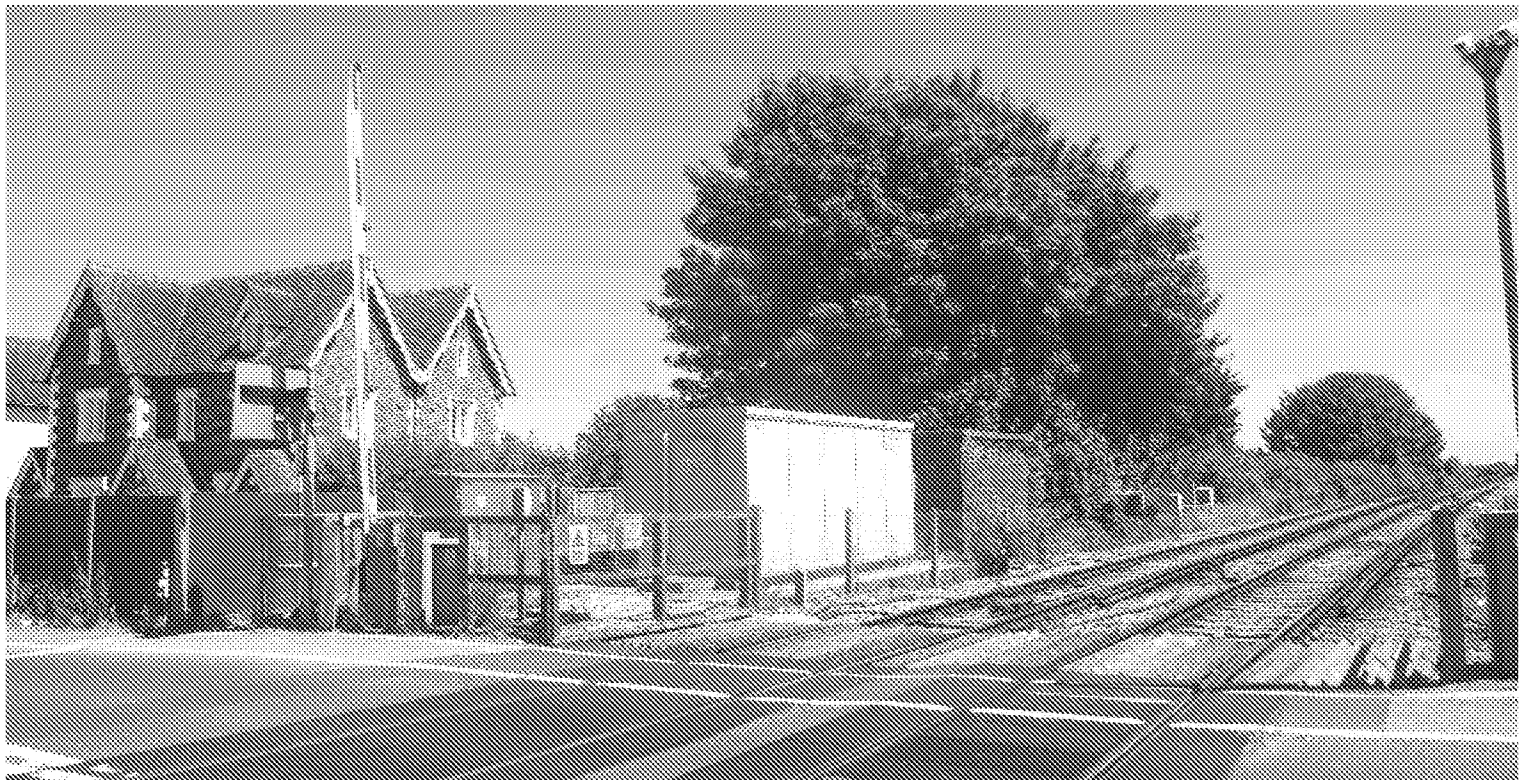
- The sycamores, Leylandii and Lawson cypress provide visual screening between railway and Waterbury House.
- The sycamores present a large local landscape feature.

**4.4.1 View north east to sycamore clump. Sycamores on right are a long way off-site.**

| No | Species | RPA radius m. | Work for landscape / tree health. | <u>ADDITIONAL WORK FOR DEVELOPMENT</u> |
|---|---|---|---|---|
| T3<br>-<br>T10 | Sycamores | 6.2 | | <u>CROWN LIFT TO 6M GROUND CLEARANCE AT BRANCH TIPS ON NORTH SIDE.</u><br><br><u>IF REQUIRED: ADDITIONAL PRUNING NE SIDE OF T10 TO GIVE 2M CLEARANCE FROM CORNER OF BUILDING.</u> |

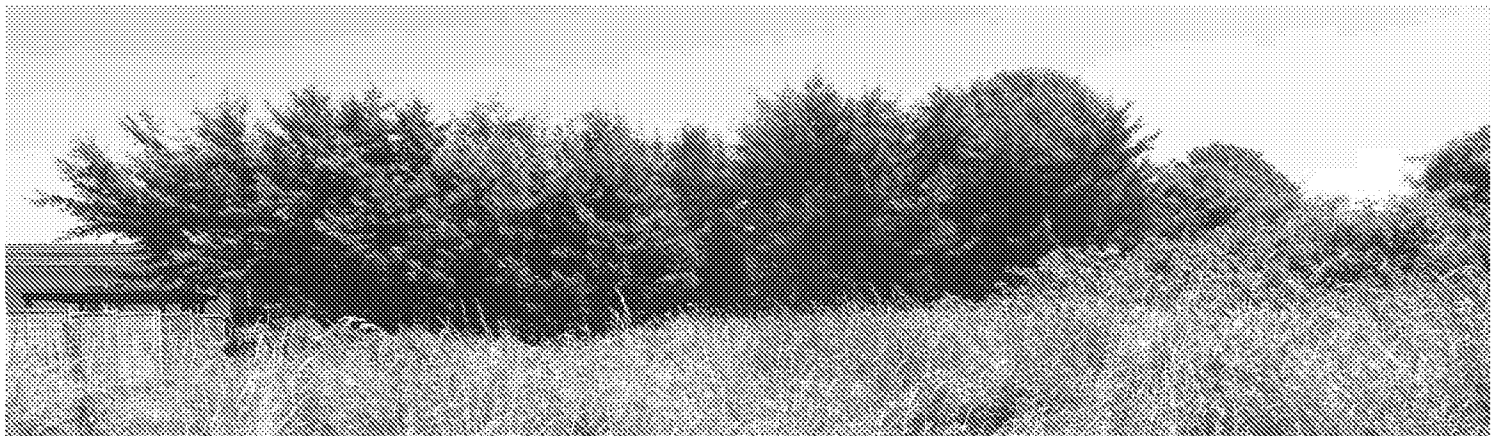
**4.4.2 View east to eastern-boundary golden Leyland cypress hedge.**

| H15 | Golden Leyland cypress | 300 | 5 | 1 | 7 | 2.5 | 2.5 | 2.5 | 2.5 ext | Em | F | P/<br>F | 10-20 | Wide-spaced "hedge". Topped but sides not trimmed, so broad.<br>Ugly, but screens mobile homes. | C2 | 3.6 | Trim sides and tops to improve shape. |

| No | Species | RPA radius m. | Work for landscape / tree health. | <u>ADDITIONAL WORK FOR DEVELOPMENT</u> |
|---|---|---|---|---|
| H15 | Golden Leyland cypress | 3.6 | Trim sides and tops to improve shape. | |

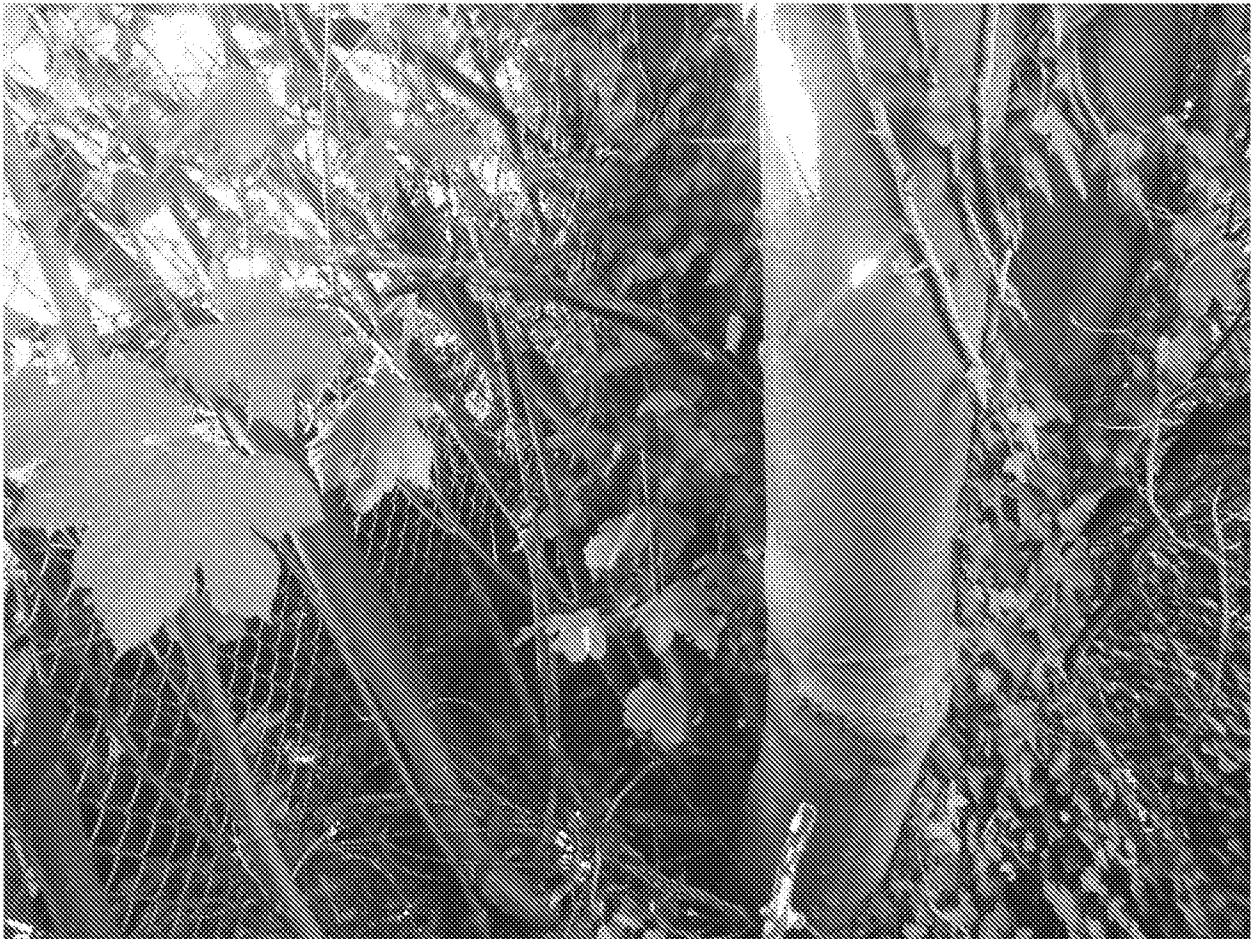
**4.4.3 View west to base of sycamore T4 showing railway fence to the south of the tree.**

| No.<br>T=tree<br>S= shrub<br>H= hedge<br>G= group | Species | Dbh<br>(stem diam<br>@<br>1.5m<br>ht)<br>mm. | Total height. Ht<br>to base of<br>crown.<br>Est Ht in<br>10 yrs.<br>m. | | | Crown radii m. | | | | Age class | Health | Structural Condition | SULE | Comment<br><br>(All are in average to good health<br>and condition, unless stated<br>otherwise.) | Retention category<br>A (best) to C. U = (remove)<br>Sub-category 1, 2 or 3 | BS 5837 Root Protection<br>Area Radius. m. | Recommended WORK<br>excluding development. |
|---|---|---|---|---|---|---|---|---|---|---|---|---|---|---|---|---|---|
| T3<br>-<br>T10 | Sycamores | 3<br>stems<br>avg.<br>300 | 15-17 | 1.5 | 17-18 | 7.5 | 5 | 4 | 6 ext | Em | F | F | 20-<br>40 | Big canopy.<br>Self-sown just north side or<br>growing in railway chain-link<br>fence.<br>Multi-stem. Unsure how they<br>originated. | B2 | 6.2 | |

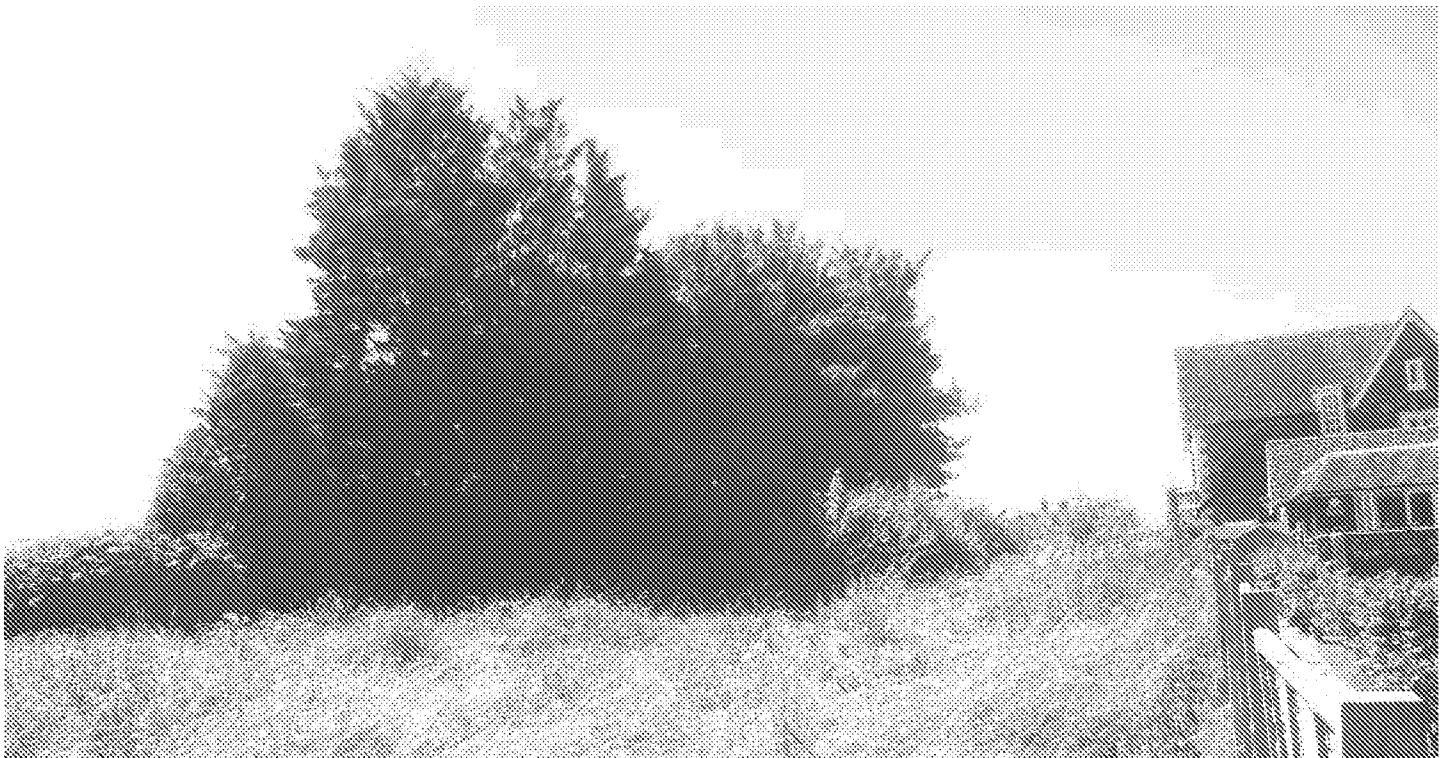
**4.4.4 View west to small Lawson T14 left, then three Leylandii and sycamores behind.**

| No.<br>T=tree<br>S= shrub<br>H= hedge<br>G= group | Species | Dbh<br>(stem diam<br>@<br>1.5m<br>ht)<br>mm. | Total height. Ht<br>to base of<br>crown.<br>Est Ht in<br>10 yrs.<br>m. | | | Crown radii m. | | | | Age class | Health | Structural Condition | SULE | Comment<br><br>(All are in average to good health<br>and condition, unless stated<br>otherwise.) | Retention category<br>A (best) to C. U = (remove)<br>Sub-category 1, 2 or 3 | BS 5837 Root Protection<br>Area Radius. m. | Recommended WORK<br>excluding development. |
|---|---|---|---|---|---|---|---|---|---|---|---|---|---|---|---|---|---|
| T11<br>-<br>T13 | Leyland<br>cypress | Avg.<br>550<br>basal | 16 | 1 | 17 | 5 | 4 | 4 | 3 ext | Em | F | F | 10-<br>20 | Planted 0.9m north of<br>chain-link fence. | C2 | 5.5 | |

| T14 | Lawson cypress | 400 basal | 7 | 0.5 | 9 | 4 | 3 | 2 | 2 | Em | F | F | >40 | Planted 0.9m north of chain-link fence. | B2 | 4.0 | |

- The three Leylandii T11-T13 would cast year-round shade onto the building. Remove.
- The eight sycamores will cast summer shade. Crown lifting needed.

| No | Species | RPA radius m. | Work for landscape / tree health. | <u>ADDITIONAL WORK FOR DEVELOPMENT</u> |
|---|---|---|---|---|
| T11<br>-<br>T13 | Leyland cypress | 5.5 | | <u>REMOVE.</u> |
| T14 | Lawson cypress | 4.0 | | <u>TRIM SOUTHERN SIDE IF AN ACOUSTIC FENCE IS REQUIRED.</u> |

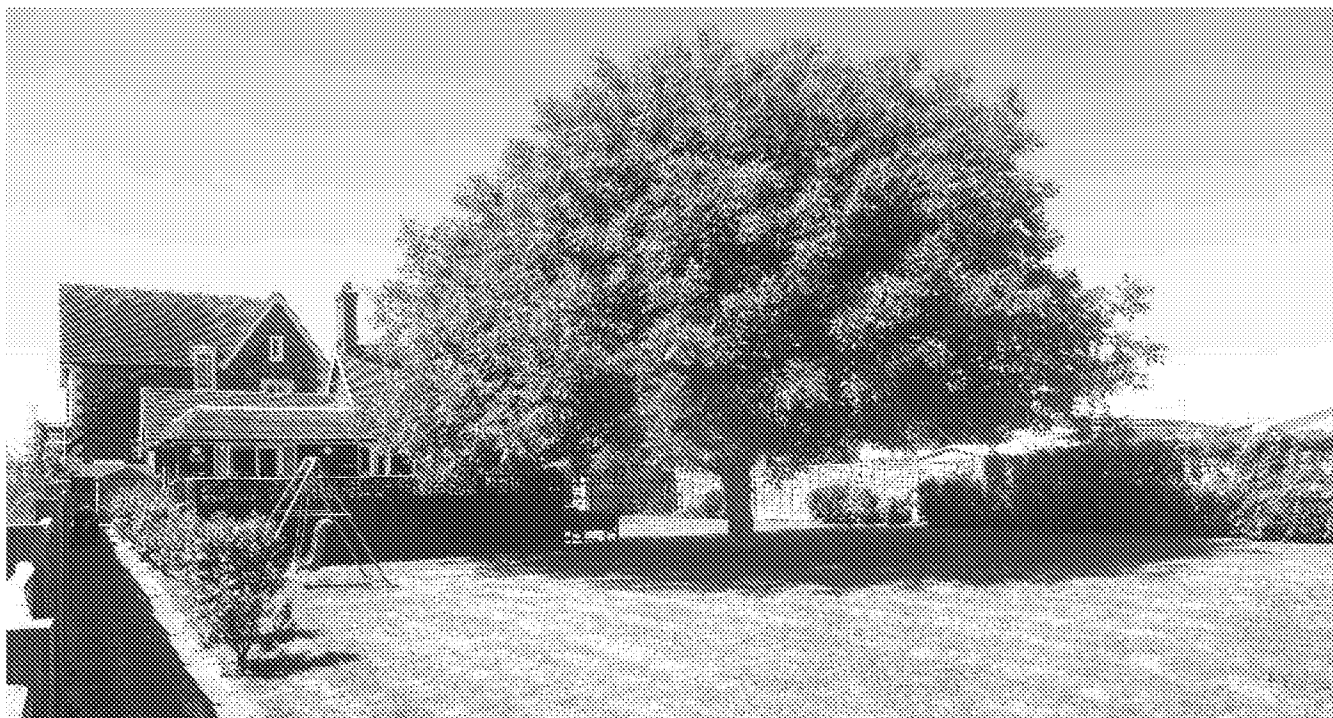
#### 4.4.5 View west to T17 walnut.

| T17 | Walnut | 460 | 9 | 2 | 11 | 5 | 5 | 5 | 5 | Em | F | F | >40 | In rear garden. Broad and good. | A1 | 5.5 | |
