## Preliminary Roost Assessment

57 River Road, Littlehampton, West Sussex, BN17 5BF

Partial demolition of the existing structure, and external and internal alterations to the remainder. Redevelopment into six apartments with amenity space, parking and cycle storage.

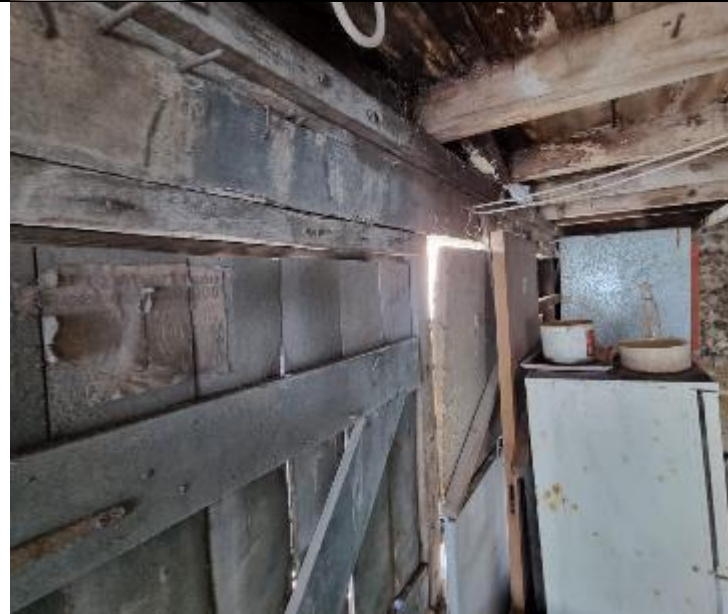
The middle floor is one large open space. There are light-coloured dusty carpets and sheeting on the floors which would show any evidence of bat or rodent usage for example droppings and feeding remains, however no such evidence was present (which indicates a lack of void dwelling bat presence but does not indicate an absence of crevice dwelling). This floor was very bright, having several uncovered windows. There are many gaps, primarily along the south-western elevation, and a portion of the window on that elevation is broken.

Middle floor gaps and missing portion of window

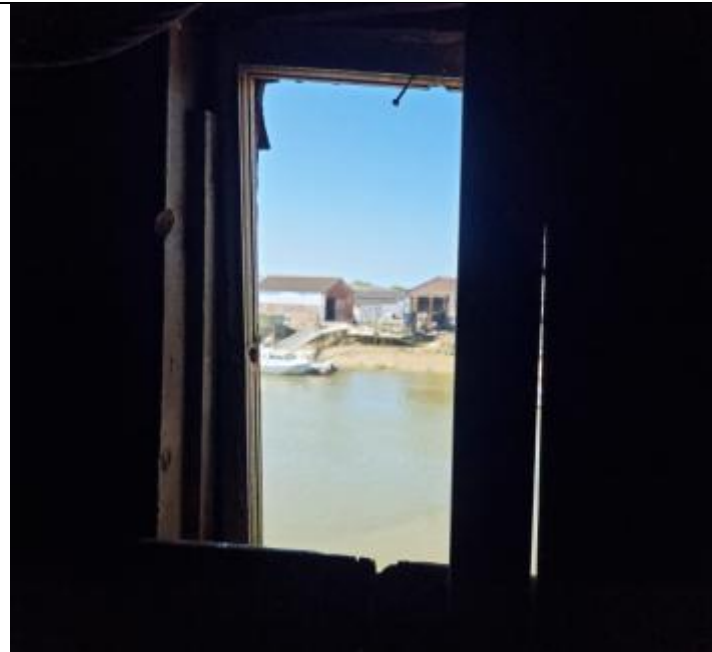
The top floor (approximately 12m(L) x 7.5m(W) x 6m(H)) is also one large open space. There is a broken window on the south-western elevation, and a large portion of the roof slates are missing above it at the western corner of the building, allowing light into the floor. The second storey of the entire south-western wall is made from wooden boards clad in corrugated iron, and the third storey just single sheet corrugated iron. The ridge and gables are well sealed and the bitumen lining is in good condition apart from the holes mentioned. No bat droppings or feeding remains were observed, nor any rodent droppings. There were large amounts of bird droppings under each gable end. Remains of a dead pigeon was found in the centre of the floor, and there were cat and fox footprints in the dust throughout the entire floor suggesting frequent use by predatory animals.

Top floor open window

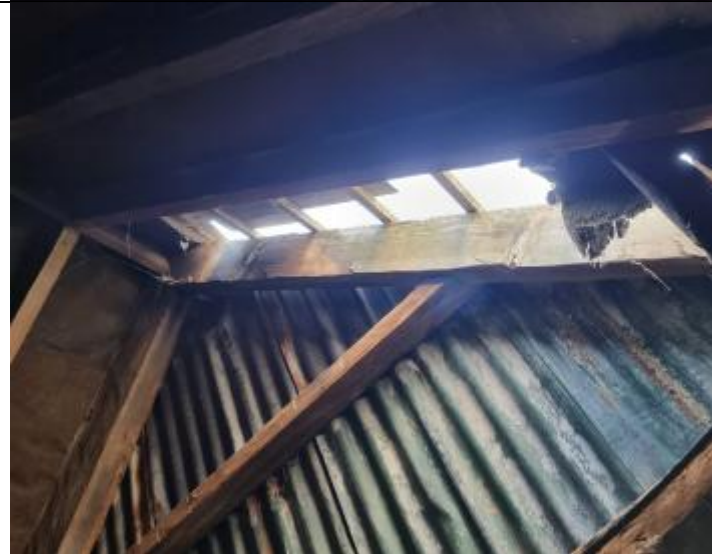
Top floor missing roof slates/damage

The roof is covered with slate tiles. There are several raised slates which provide gaps and access to space between the tiles and lining which could be used by crevice dwelling bats, and any droppings would be trapped within and not visible. There are large open portions of roof at the western corner allowing access into the loft and into the roof between the slates and lining. The ridge-line is well sealed and there is no mortar missing along the length.

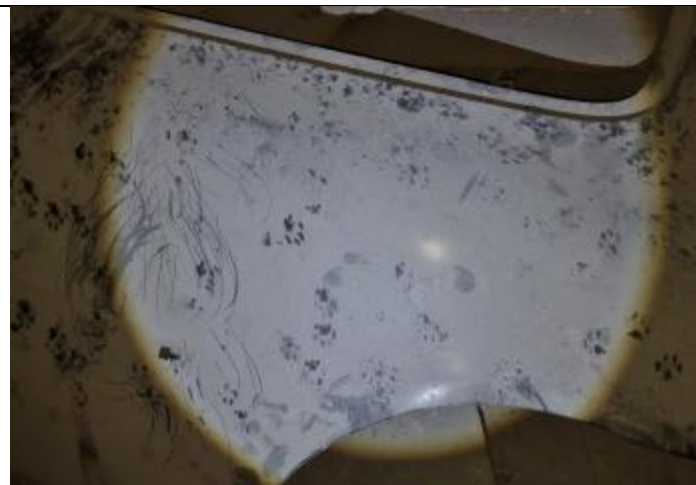
Evidence of usage by predatory animals

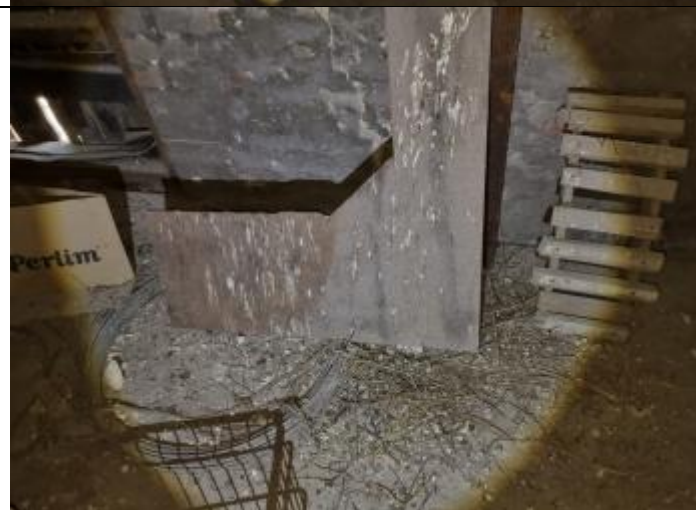
Bird droppings

| Summary of Survey Findings | A nesting pigeon was observed in the inner stonework at the north-east gable. Bird droppings indicate pigeons have been nesting at both internal gables. | | |

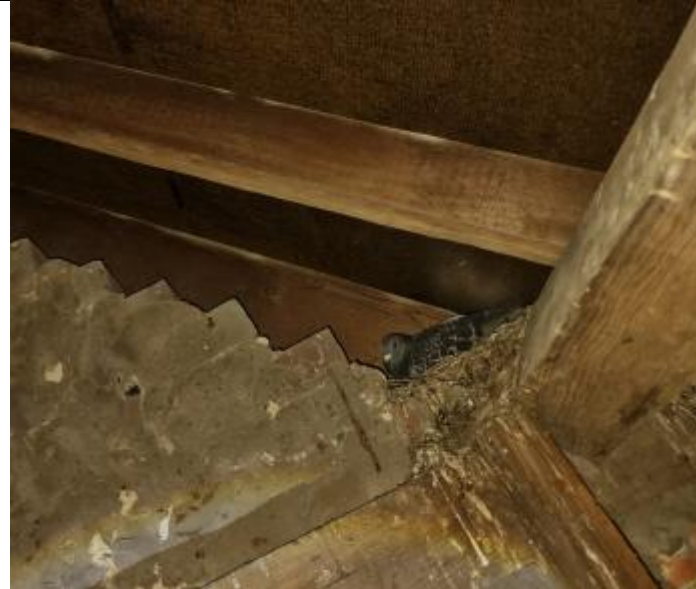
A pigeon was observed nesting high in the stonework on the north-eastern corner.

Nesting pigeon

| Recommendations | Any works to B1 should be undertaken outside the period 1st March to 31st August. Regardless of the time of year, because pigeons can nest all year round a close inspection of the building should be undertaken immediately prior to the start of works by a qualified ecologist. All active nests will need to be retained with a 5m buffer until the young have fledged. | | |

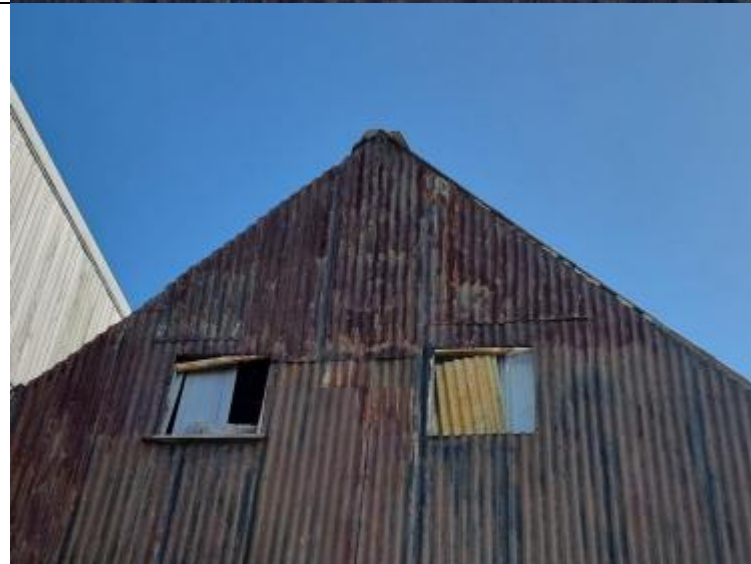
The walls are of mixed stone and red brick construction apart from the south-western elevation. The stone wall on this elevation stops at the top of the ground floor and continues as wooden boards clad in corrugated sheeting, however crevice-dwelling bats could crawl down inside the cladding and access the wall tops.

There are numerous gaps between the sheeting and wooden boards suitable for roosting crevice-dwelling bats.

Corrugated cladding

| <p><b>B1 Impacts</b></p> <p>The proposed works involve demolition and remodelling of large areas of B1. Any bats roosting in the aforementioned crevices could be killed or injured during the work.</p> <p><b>Recommendations</b></p> <p><b>B1</b></p> <p>Two dusk emergence surveys will be required to identify and characterise any roosts within this building. These surveys will be conducted in the optimal bat season (Mid-May to August) with a minimum of three weeks between them. If the two visits indicate that bats are roosting on site, or if a higher level of activity than expected is recorded, a third survey will be required.</p> |

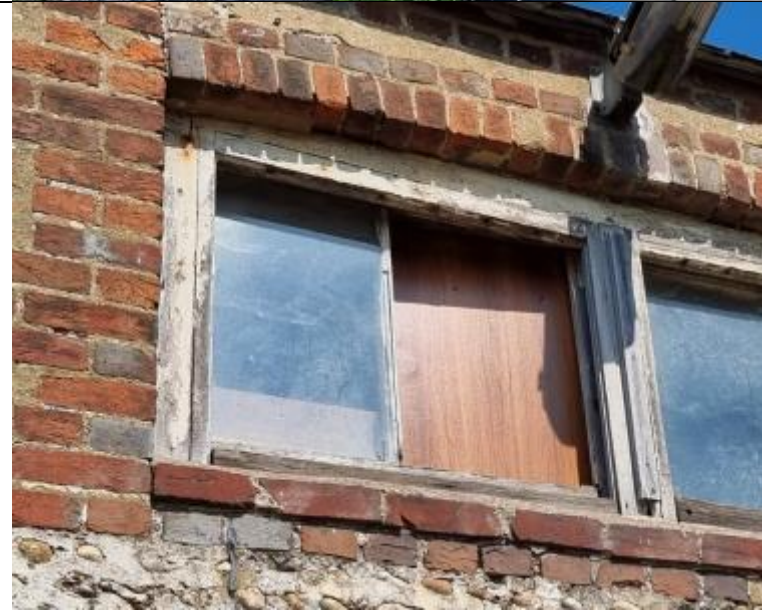
The brick and stone walls of the south-eastern elevation are well sealed, however there are gaps suitable for roosting crevice-dwelling bats around the window lintels.

Example of gaps around SE windows

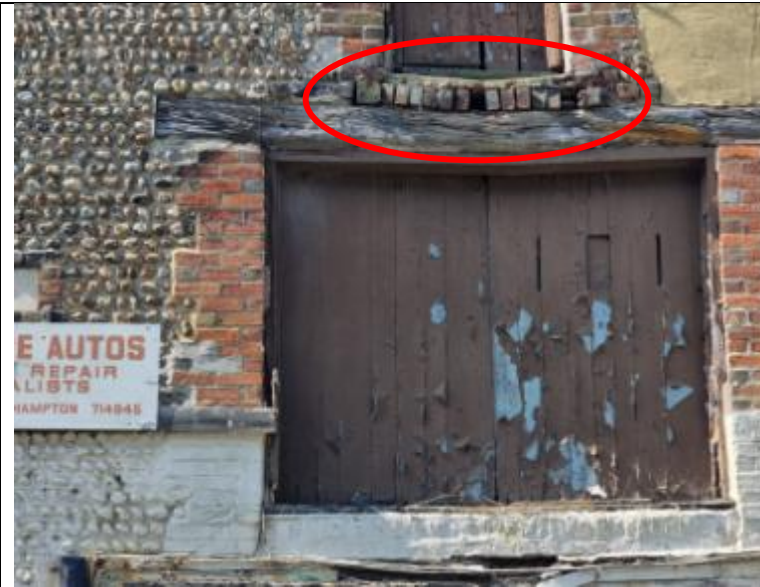
The wall of the north-east elevation itself is well sealed, however there are multiple gaps around the first and second floor doors, in particular above the wooden lintel that separates them where several bricks are missing.

Gaps in lintels between NE doors

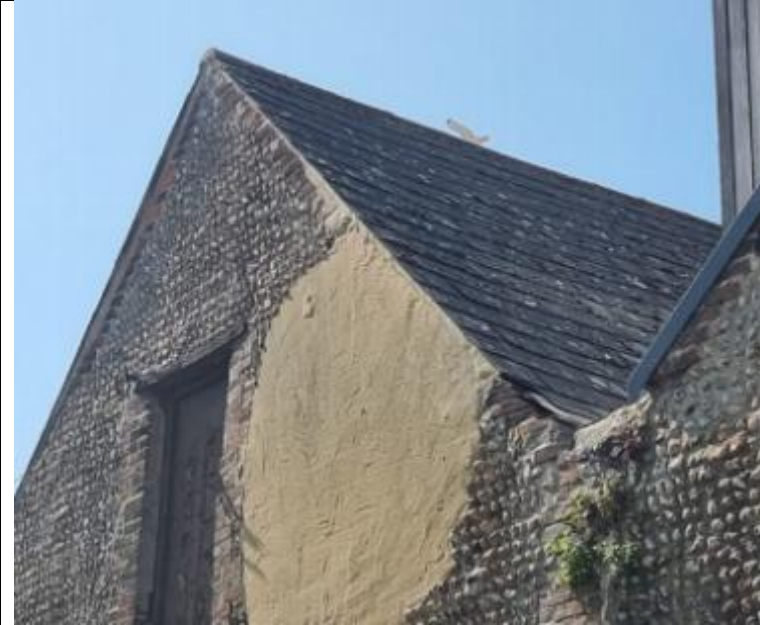
The verges and gable of the north-eastern elevation are well sealed apart from an area of raised tiles at the northern corner which could allow access to the roosting space between the slates and lining.

Access under slates at northern corner
