28<sup>th</sup> July 2017

Our ref. JB/17/LP1425

**Re: BRE 365 Borehole Soakage Testing – Courtwick Cottages**

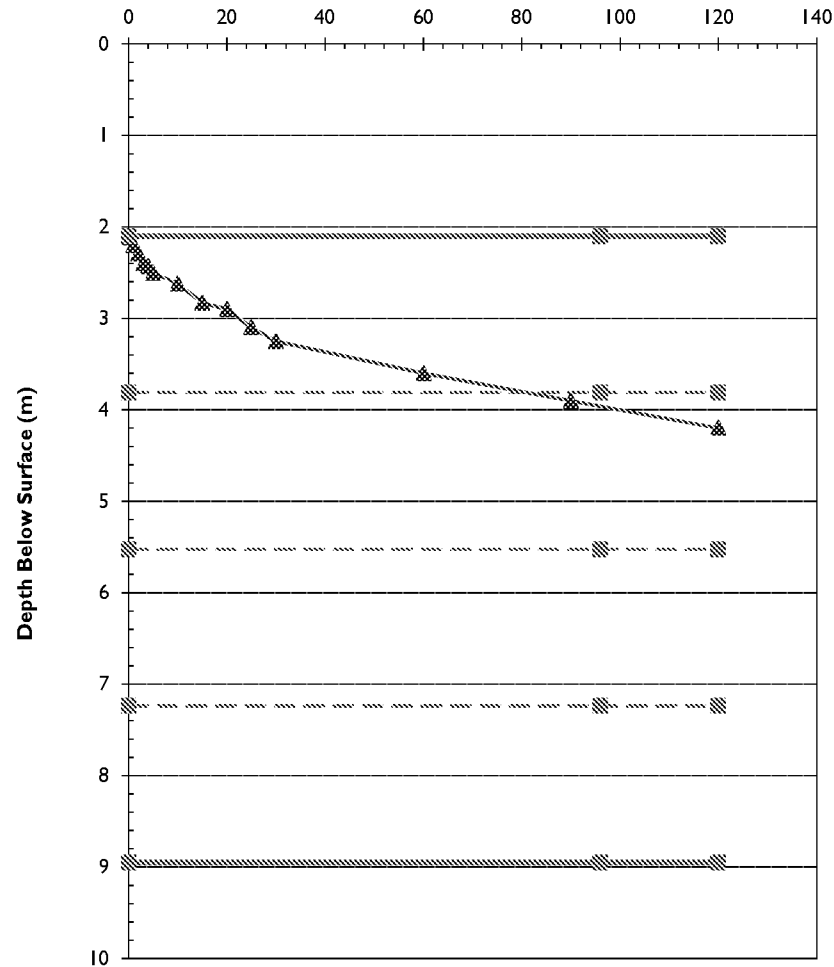
Test Hole No: BHI  
Test No: Test No 1

The falling head test conducted in BHI indicates that a rate of 0.065 l/m<sup>2</sup>/min was achieved within the deeper raised beach deposits and chalk. Based on local experience and CIRIA C574, these results are comparable with matrix dominated chalk (Grade Dm), which typically behaves as a fine soil for engineering purposes.

Water level fell to 75% -- 50% max water depth, calculations were based on actual fall of water level achieved.  
Result not compliant with BRE365 requirement since water did not fall to 25% max water depth.

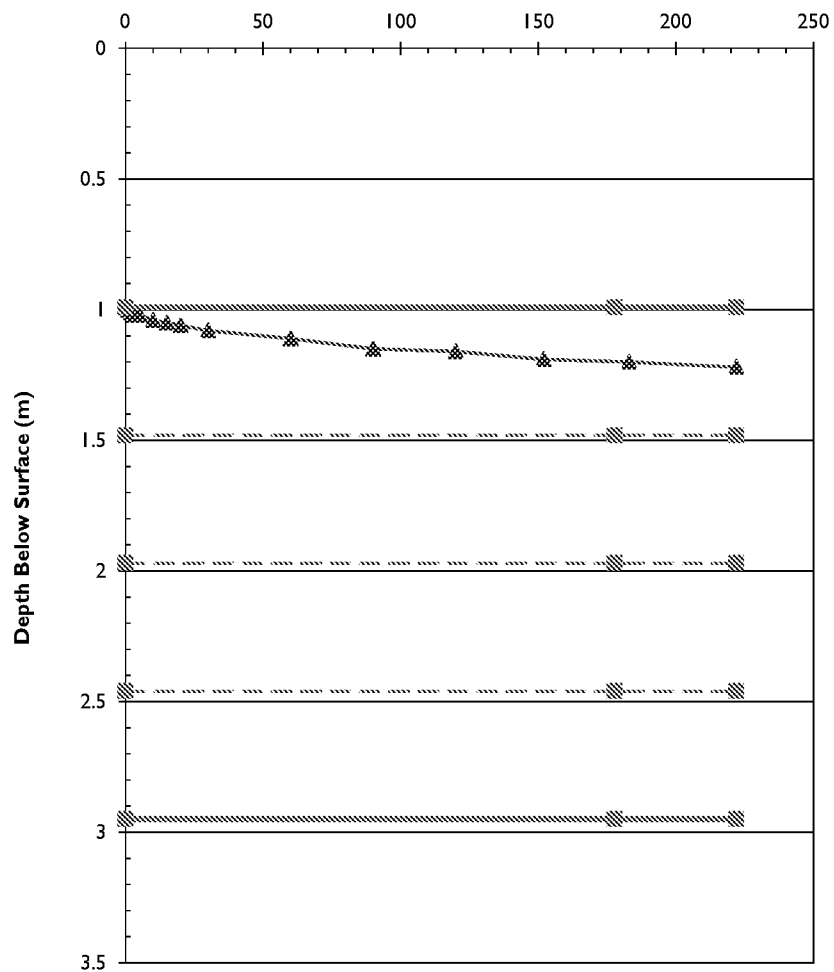
Test Hole No: TPS1  
Test No: Test No 1

The results indicate that a poor infiltration rate of 0.08 l/m<sup>2</sup>/min was achieved within the top 3.0m of the Raised Beach Deposits in TPS1, locally comprising silty sands and silty sandy clays. This is thought

to be indicative of the locally high fines content of these soils. The result did not comply with BRE365 guidelines as the water did not drop below 75% of the starting level.

Water level did not fall to 75% max water depth, calculations were based on actual fall of water level achieved.  
Result not compliant with BRE365 requirement since water did not fall to 25% max water depth.
