**ARBORICULTURAL IMPLICATIONS ASSESSMENT  
FOR PROPOSED  
EIGHT UNIT REDEVELOPMENT**

**LAND TO NORTH OF NO. 67 GREENFIELDS  
LITTLEHAMPTON**

**Our ref: J48.22  
6<sup>th</sup> February 2014**

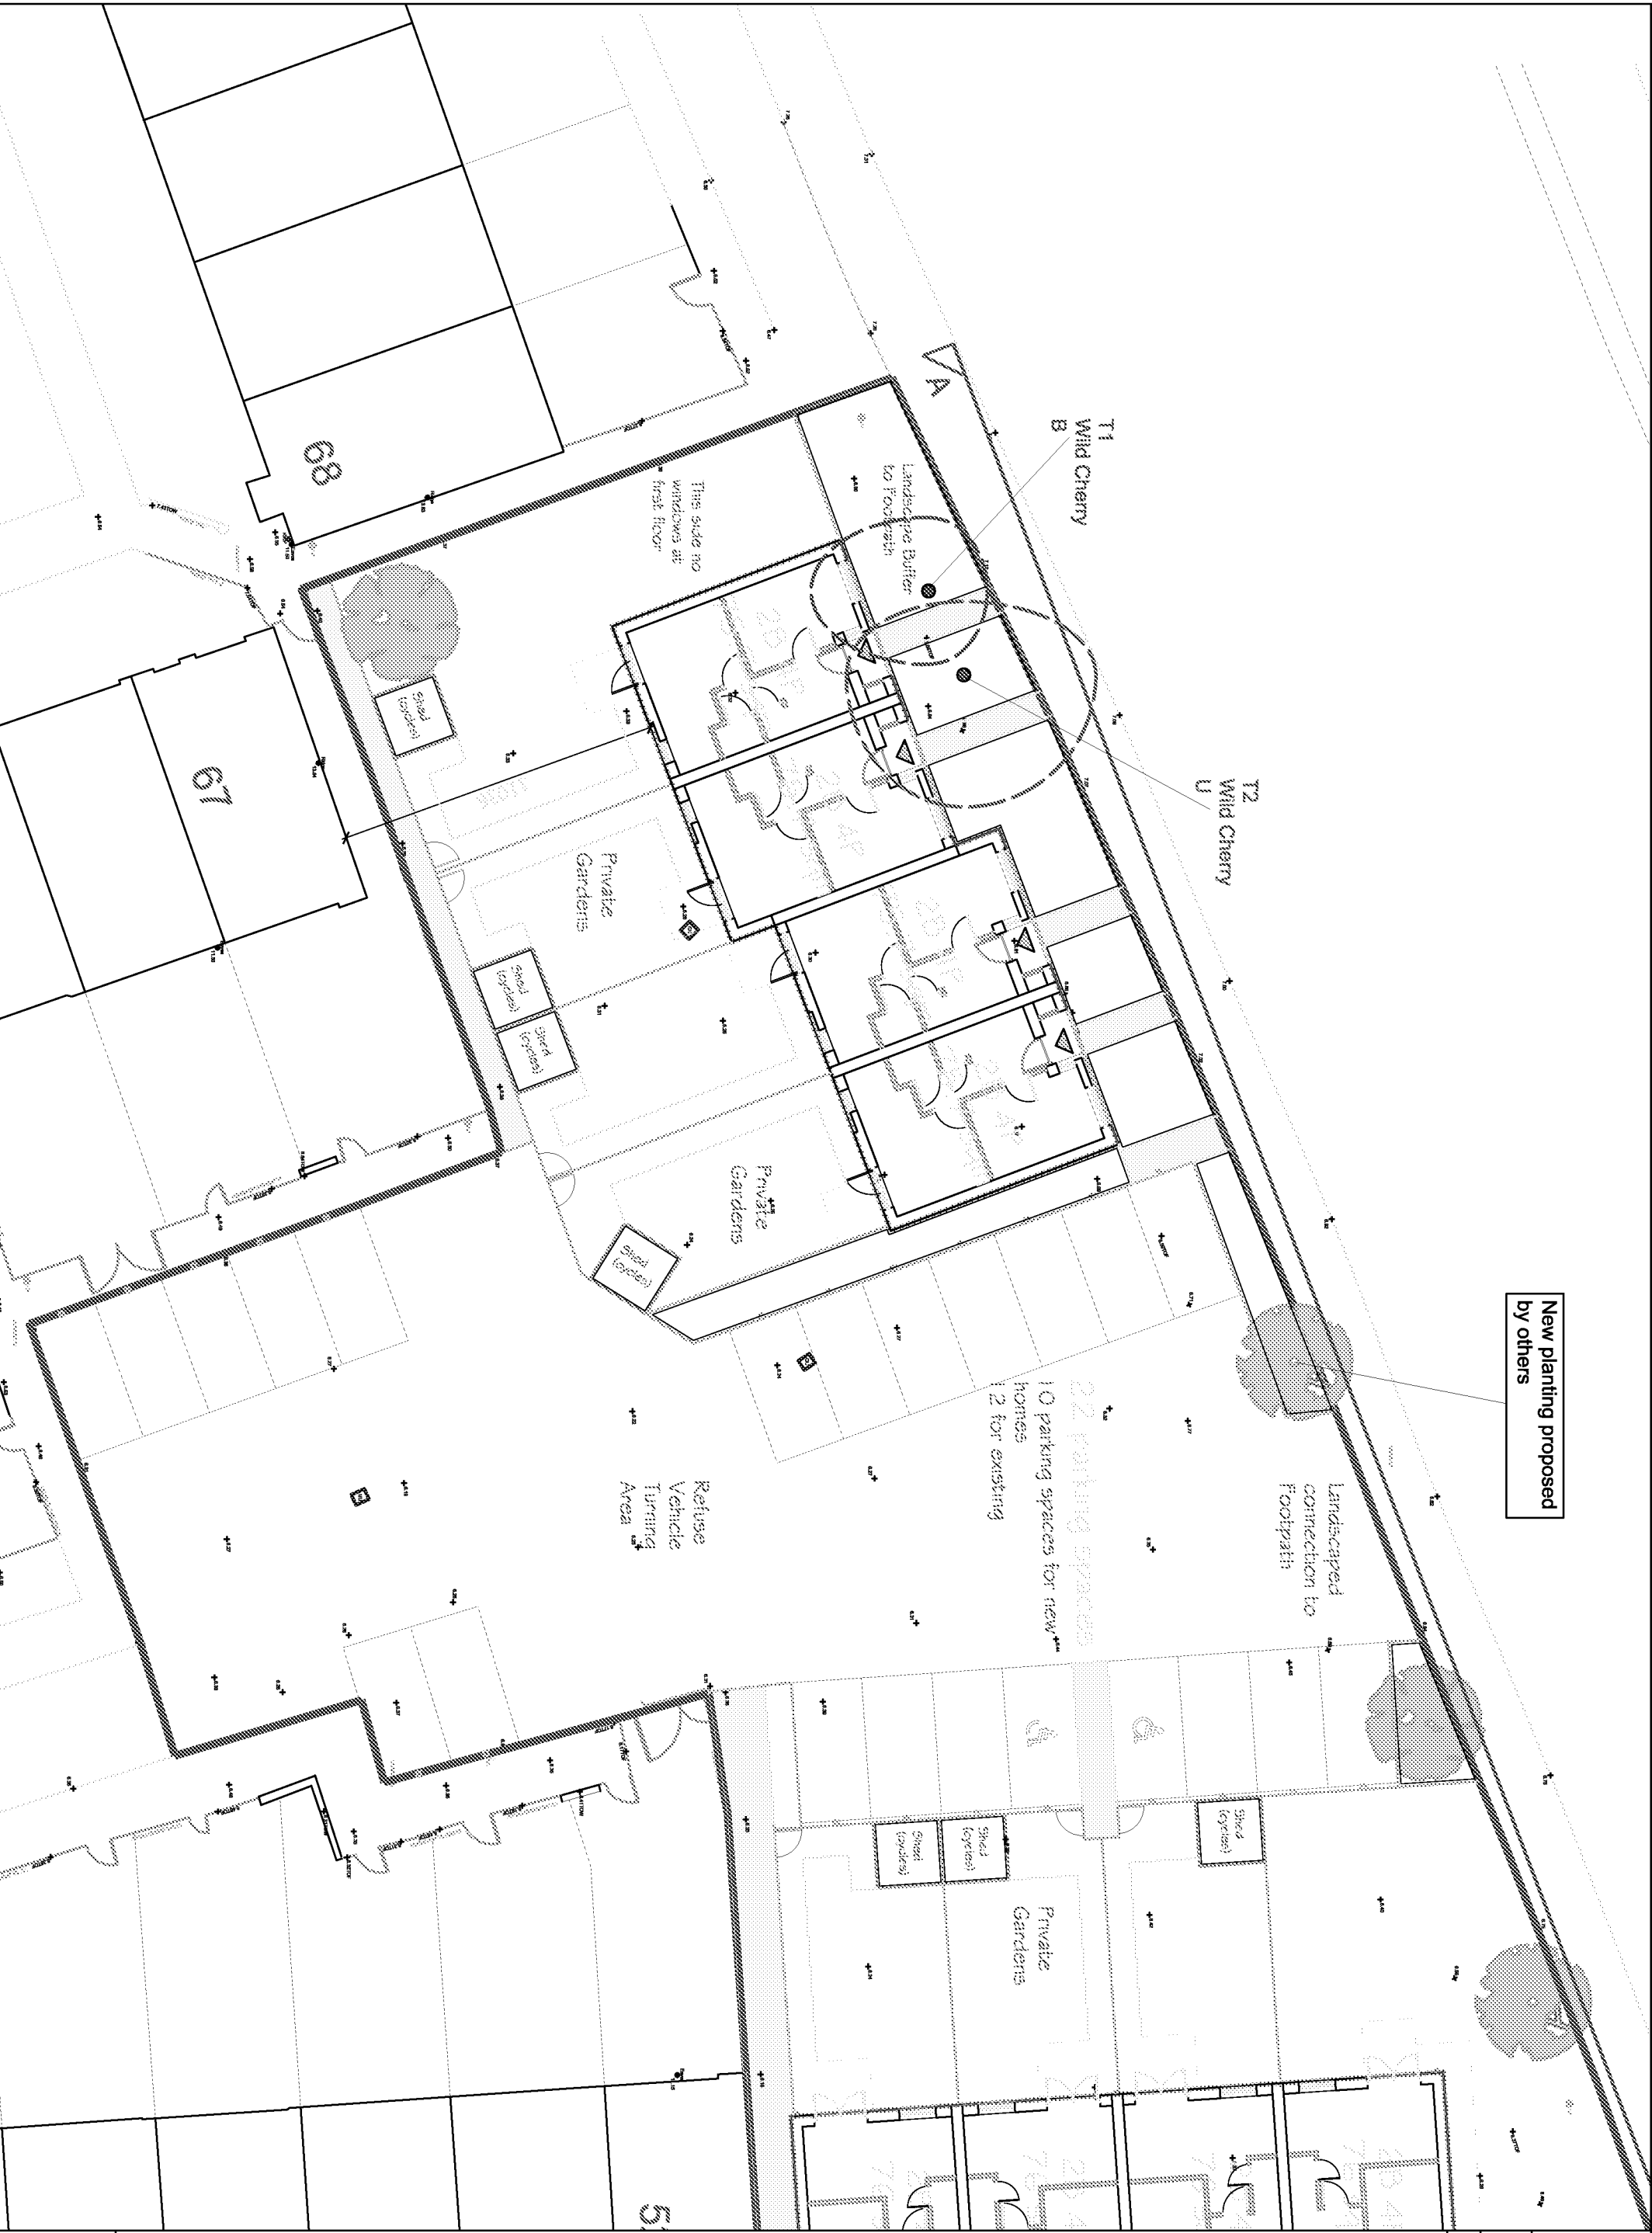
DRAWING NO. J48.22/02  
Scale: 1:200 at A3  
Added to by: NL  
03/02/2014

- 9.1 At present tree no. T2 represents a high risk of shedding stems into the existing parking area or onto the well used cycle/footpath which could represent a risk to vehicles and users. As such risks will increase annually as increased branch and foliar weight/leverage are added it has a short safe lifespan and removal would be recommended on safety grounds.
- 9.2 Tree no. T2 is indicated for removal on safety grounds on the Tree Protection Plan with a red dashed crown outline.

- 10.1 The remaining tree no. T1 would need to be removed for the redevelopment to proceed due to its proximity to the proposed building and new footpath.
- 10.2 Whilst this is a BS Category B tree it is still relatively young and of limited dimensions and not of such size and visual amenity value as to represent a significant loss. New proposed feature trees indicated on the Tree Protection Plan by others could readily replace the tree lost and the tree to be removed on safety grounds, provided they are of appropriate size, species and quality. Such replacements could be covered in a specifically worded landscaping Condition.
- 10.3 The tree for removal to facilitate the redevelopment is indicated as such on the Tree Protection Plan with a blue dashed crown outline.
