# BS 5837:2012 Arboricultural Survey

DBN3 Norway Lane, Littlehampton

Presented to Gleave Partnership

Delta-Simons Project No. 19-0138.02

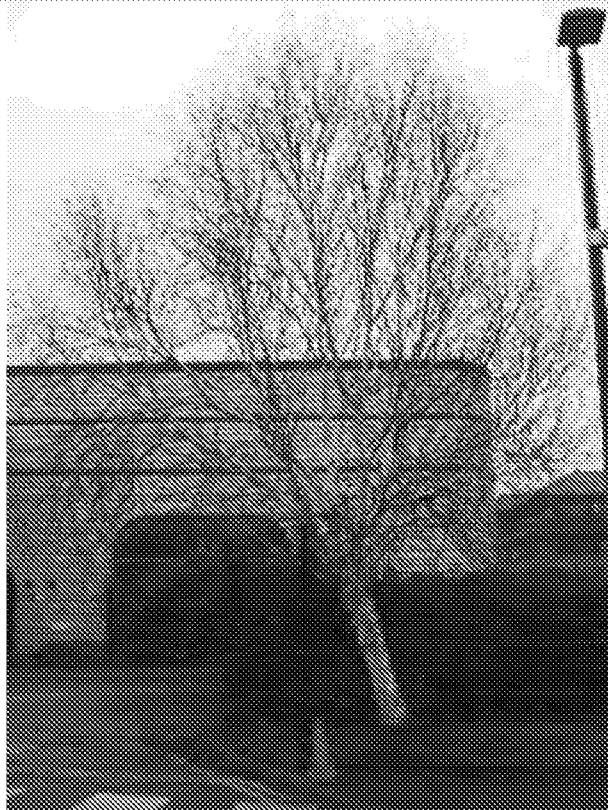
Photograph 1 – Tree (T)1

| Tree Number | Tree Species | | Measurements | | | | Crown (m) | | | | | Tree Condition | | | | | | | | | | Management |
|---|---|---|---|---|---|---|---|---|---|---|---|---|---|---|---|---|---|---|---|---|--|---|
| T1 | Silver birch | <i>Betula pendula</i> | SM | 7 | 1 | 275 | 2 | 3 | 3 | 3 | 3 | No obvious visual damage | Single stem. Vertical. | Balanced. | | G | 20-40 | B | 3.3 | | | |

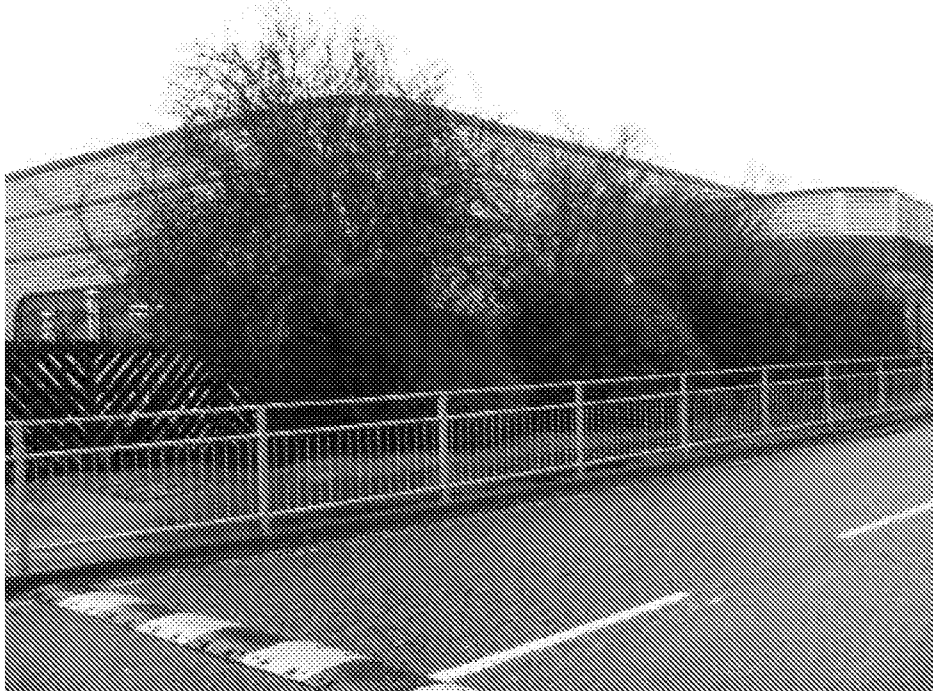
Photograph 2 – TG2

| Tree Number | Tree Species | | Measurements | | | | Crown (m) | | | | | Tree Condition | | | | | | | | | | Management |
|---|---|---|---|---|---|---|---|---|---|---|---|---|---|---|---|---|---|---|---|---|--|---|
| TG2 | Hawthorn | <i>Crataegus monogyna</i> | SM | 6 | 1 | AV 225 | 1 | 3 | 5 | 3 | 3 | No obvious visual damage | Single stem. Vertical | Balanced. Read as one. | | F | 20-40 | B | 2.7 | | | |

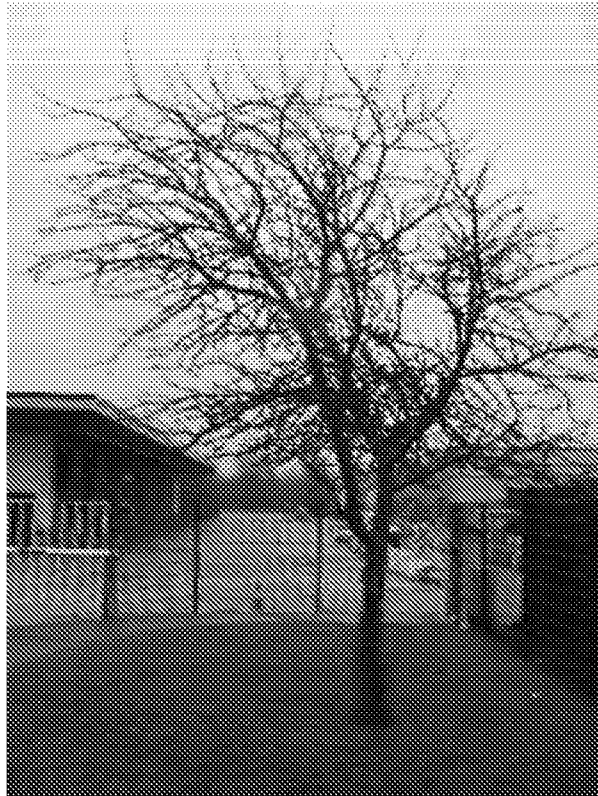
Photograph 3 – T3

| Tree Number | Tree Species | | Measurements | | | | Crown (m) | | | | | Tree Condition | | | | | | | | | | Management |
|---|---|---|---|---|---|---|---|---|---|---|---|---|---|---|---|---|---|---|---|---|--|---|
| T3 | Apple | <i>Malus sp.</i> | SM | 5 | 1 | 150 | 2 | 3 | 3 | 3 | 2 | No obvious visual damage | Single stem. Vertical | Spreading. Scattered deadwood. | Bark damage on stem | F | 20-40 | C | 1.8 | | | |

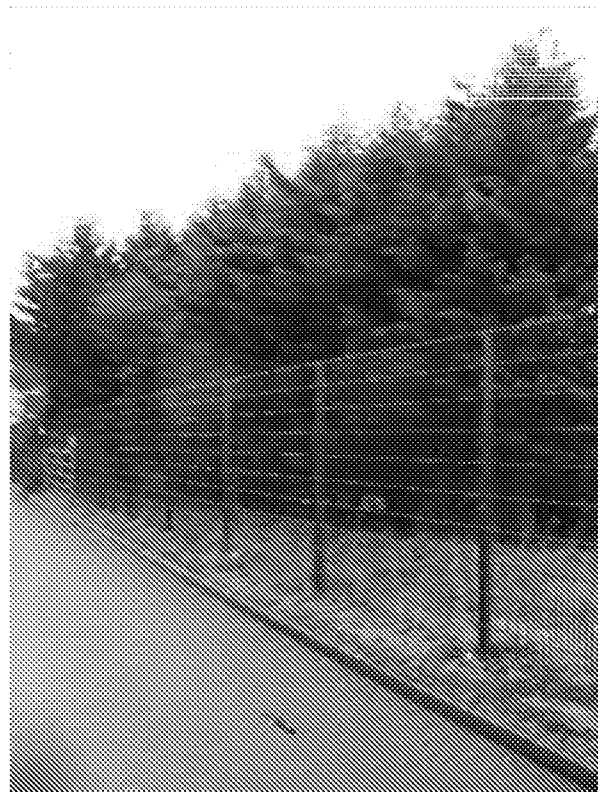
Photograph 4 – TG4

| Tree Number | Tree Species | | Measurements | | | | Crown (m) | | | | | Tree Condition | | | | | | | | | | Management |
|---|---|---|---|---|---|---|---|---|---|---|---|---|---|---|---|---|---|---|---|---|--|---|
| TG4 | Leyland cypress | <i>X Cupressocyparis leylandii</i> | SM | 8 | 1 | Av 300 | 0 | 3 | 3 | 3 | 3 | No obvious visual damage | Single stems. Vertical | Balanced. Reads as one. | | G | 20-40 | B | 3.6 | | | |

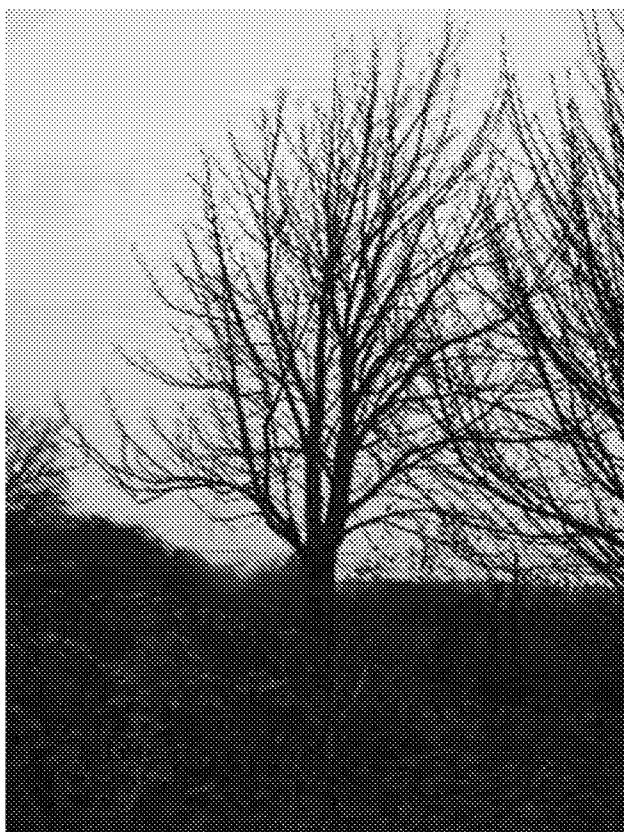
Photograph 5 – T5

| Tree Number | Tree Species | | Measurements | | | | Crown (m) | | | | | Tree Condition | | | | | | | | | | Management |
|---|---|---|---|---|---|---|---|---|---|---|---|---|---|---|---|---|---|---|---|---|--|---|
| T5 | Horse chestnut | <i>Aesculus hippocastanum</i> | SM | 9 | 1 | 350 | 3 | 5 | 5 | 5 | 5 | No obvious visual damage | Single stem. Vertical | Balanced. | | G | 20-40 | B | 4.2 | | | |

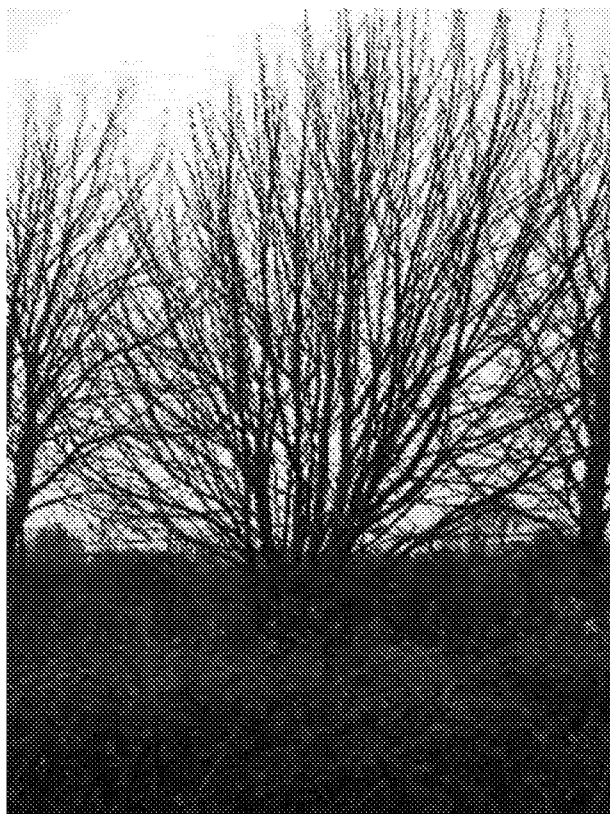
Photograph 6 – T6

| Tree Number | Tree Species | | Measurements | | | | Crown (m) | | | | | Tree Condition | | | | | | | | | | Management |
|---|---|---|---|---|---|---|---|---|---|---|---|---|---|---|---|---|---|---|---|---|--|---|
| T6 | Horse chestnut | <i>Aesculus hippocastanum</i> | SM | 8 | M S | 350 | 0 | 3 | 5 | 5 | 5 | No obvious visual damage | Multi-stemmed from base. Vertical | Balanced. | | F | >40 | B | 4.2 | | | |

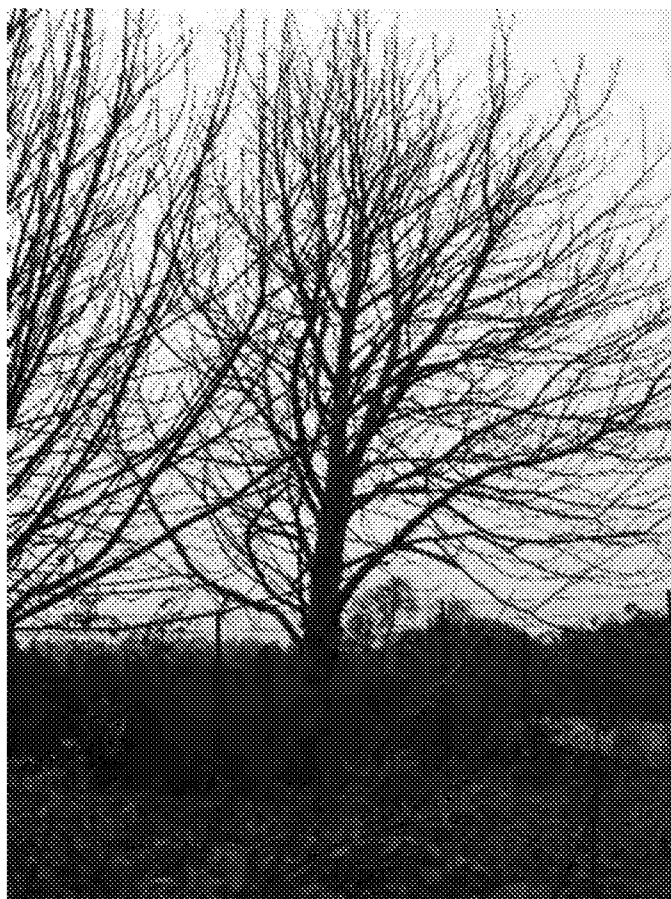
Photograph 7 – T7

| Tree Number | Tree Species | | Measurements | | | | Crown (m) | | | | | Tree Condition | | | | | | | | | | Management |
|---|---|---|---|---|---|---|---|---|---|---|---|---|---|---|---|---|---|---|---|---|--|---|
| T7 | Horse chestnut | <i>Aesculus hippocastanum</i> | SM | 9 | 1 | 350 | 2 | 5 | 5 | 5 | 5 | No obvious visual damage | Single stem. Vertical | Balanced. | | G | >40 | B | 4.2 | | | |

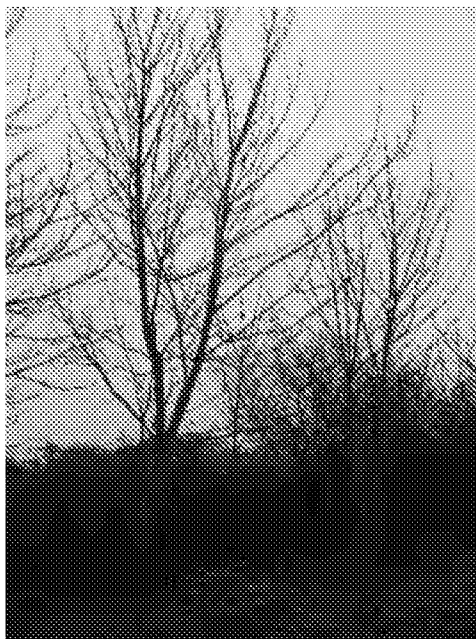
Photograph 8 – T8 & T9

| Tree Number | Tree Species | | Measurements | | | | Crown (m) | | | | | Tree Condition | | | | | | | | | | Management |
|---|---|---|---|---|---|---|---|---|---|---|---|---|---|---|---|---|---|---|---|---|--|---|
| T8 | Norway maple | <i>Acer platanoides</i> | Y | 9 | 1 | 200 | 1 | 3 | 3 | 3 | 1 | No obvious visual damage | Single stem. Vertical | Slightly unbalanced | | F | >40 | B | 2.4 | | | |
| T9 | Norway maple | <i>Acer platanoides</i> | Y | 8 | 3 | 3 x 100 | 0 | 1 | 1 | 1 | 1 | No obvious visual damage | Trifurcated at 0.5 m. Vertical | Balanced. | | F | 20-40 | B | 2.1 | | | |

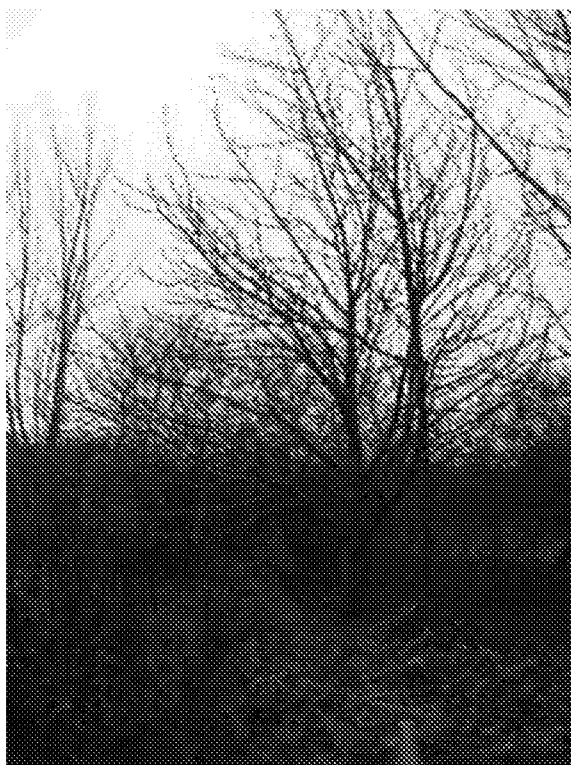
Photograph 9 – T10

| Tree Number | Tree Species | | Measurements | | | | Crown (m) | | | | | Tree Condition | | | | | | | | | | Management |
|---|---|---|---|---|---|---|---|---|---|---|---|---|---|---|---|---|---|---|---|---|--|---|
| T10 | Horse chestnut | <i>Aesculus hippocastanum</i> | Y | 8 | 3 | 150<br>100<br>175 | 1 | 4 | 4 | 4 | 4 | No obvious visual damage | Single stem. Vertical | Balanced. | | F | 20-40 | B | 3.0 | | | |

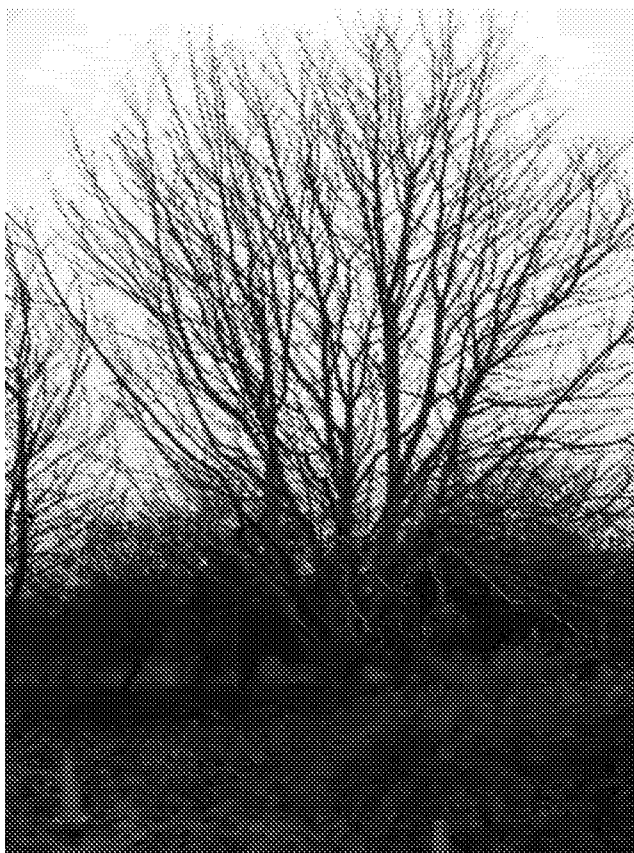
Photograph 10 – T11

| Tree Number | Tree Species | | Measurements | | | | Crown (m) | | | | | Tree Condition | | | | | | | | | | Management |
|---|---|---|---|---|---|---|---|---|---|---|---|---|---|---|---|---|---|---|---|---|--|---|
| T11 | Horse chestnut | <i>Aesculus hippocastanum</i> | Y | 9 | 4 | 150<br>300<br>250<br>150 | 1 | 5 | 5 | 5 | 5 | No obvious visual damage | Single stem. Vertical | Balanced. | | G | >40 | B | 5.4 | | | |

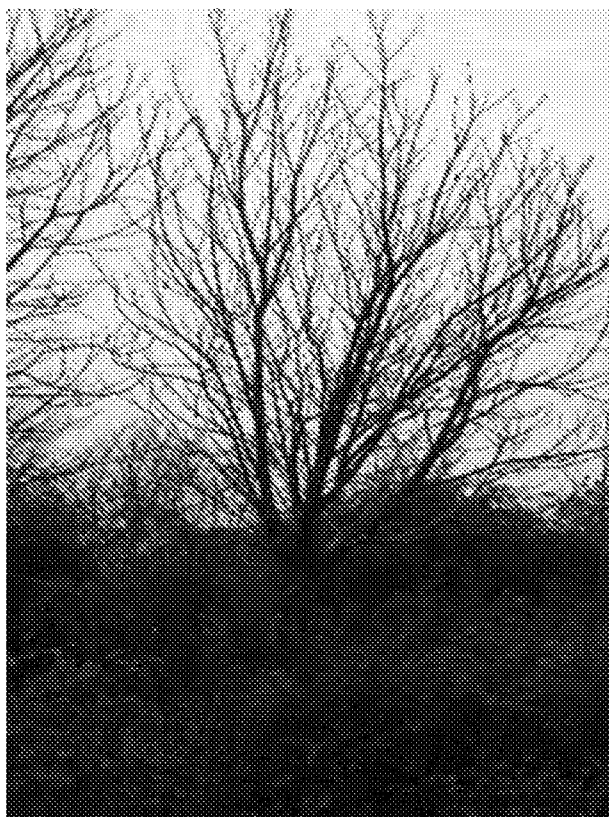
Photograph 11 – T12

| Tree Number | Tree Species | | Measurements | | | | Crown (m) | | | | | Tree Condition | | | | | | | | | | Management |
|---|---|---|---|---|---|---|---|---|---|---|---|---|---|---|---|---|---|---|---|---|--|---|
| T12 | Horse chestnut | <i>Aesculus hippocastanum</i> | Y | 9 | 1 | 300 | 2 | 5 | 5 | 5 | 5 | No obvious visual damage | Single stem. Vertical | Balanced. | | F | >40 | B | 3.6 | | | |

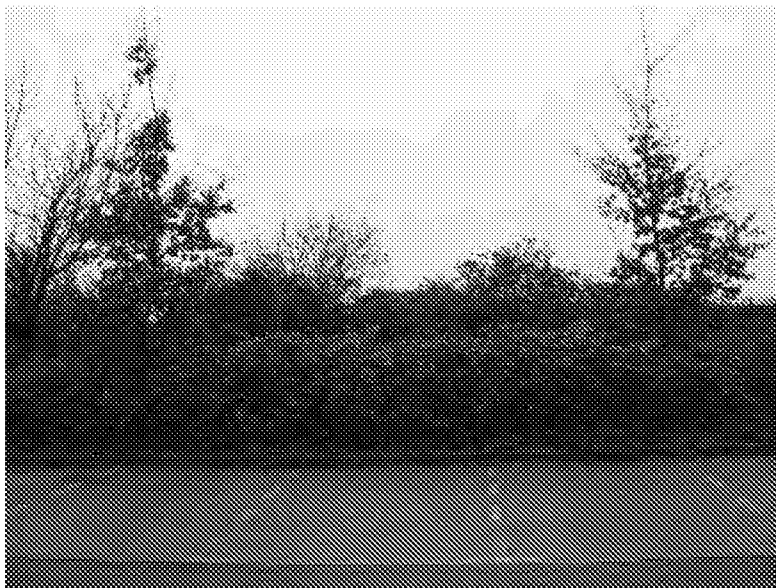
Photograph 12 – TG13

| Tree Number | Tree Species | | Measurements | | | | Crown (m) | | | | | Tree Condition | | | | | | | | | | Management |
|---|---|---|---|---|---|---|---|---|---|---|---|---|---|---|---|---|---|---|---|---|--|---|
| TG13 | Horse chestnut | <i>Aesculus hippocastanum</i><br><i>Quercus robur</i> | Y | 5 | 1 | Av 100 | 1 | 1 | 1 | 1 | 1 | No obvious visual damage | Single stems. Vertical | Balanced. | Tree guards present | F | >40 | B | 1.2 | | | |

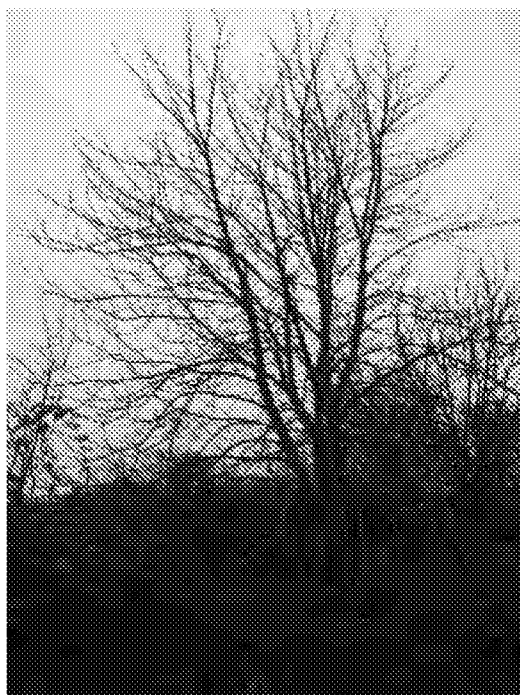
Photograph 13 – T14

| T14 | Horse chestnut | <i>Aesculus hippocastanum</i> | Y | 5 | 1 | 300 | 0 | 5 | 5 | 5 | No obvious visual damage | Single stem. Vertical | Balanced. | Trifurcated at 2 m | F | >40 | B | 4.2 | | |

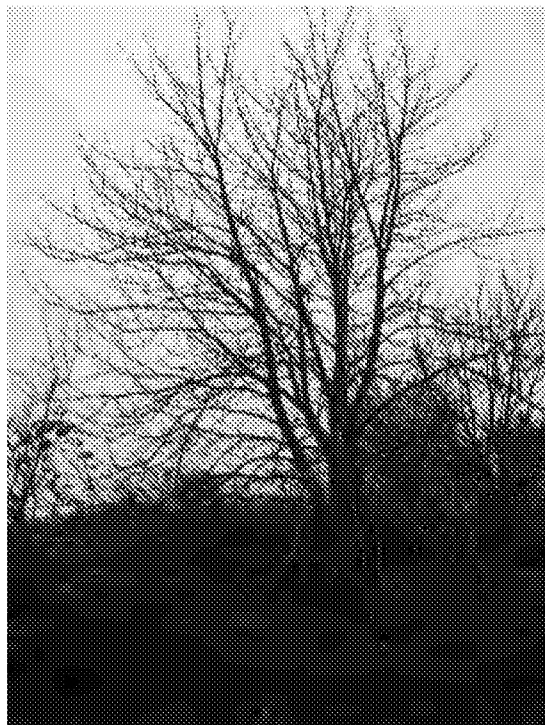
Photograph 14 – T15

| T15 | Horse chestnut | <i>Aesculus hippocastanum</i> | Y | 5 | 4 | 175<br>125<br>275<br>150 | 2 | 1 | 5 | 1 | 1 | No obvious visual damage | Single stem. Vertical | Unbalanced. | Stubs present | F | >40 | B | 4.8 | |

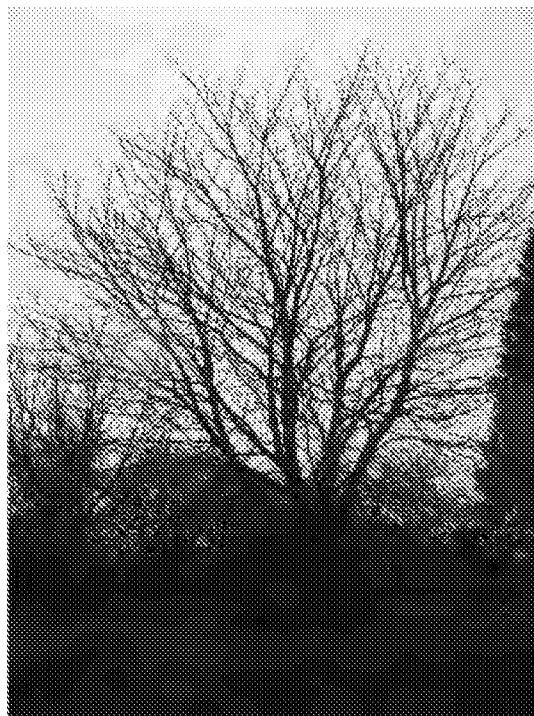
Photograph 15 – T16

| T16 | Horse chestnut | <i>Aesculus hippocastanum</i> | Y | 5 | 1 | 400 | 1 | 3 | 3 | 6 | 3 | No obvious visual damage | Single stem. Vertical | Spreading | | G | >40 | B | 4.8 | |

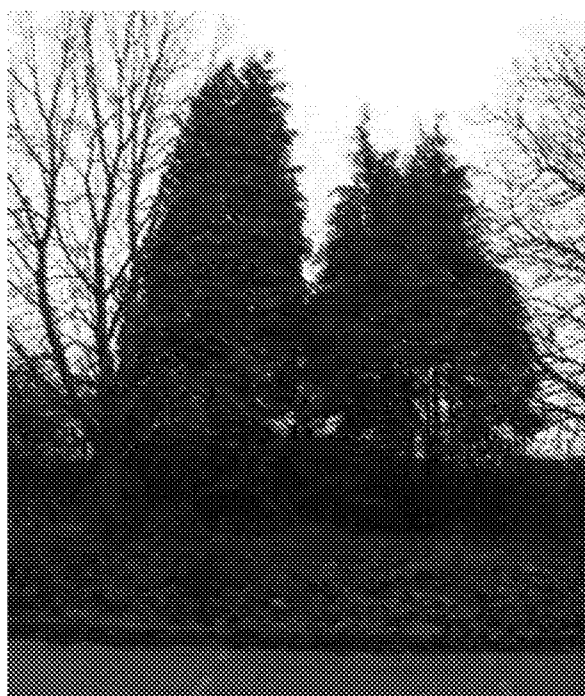
Photograph 16 – TG17

| TG17 | Leyland cypress | X<br><i>Cupressocyparis leylandii</i> | Y | 11 | 1 | Est 375 | 0 | 3 | 3 | 3 | 3 | No obvious visual damage | Single stem. Vertical | Balanced. | | F | 20-40 | B | 4.5 | |

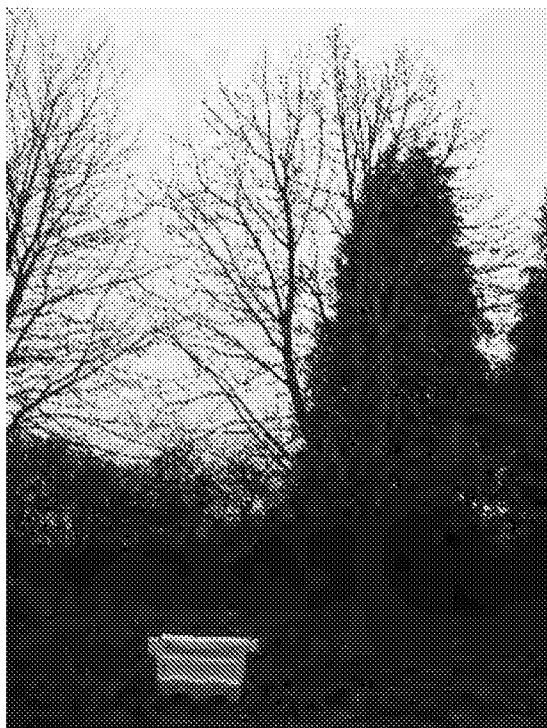
Photograph 17 – T18

| T18 | Horse chestnut | <i>Aesculus hippocastanum</i> | Y | 9 | 1 | 300 | 1 | 4 | 4 | 4 | 4 | No obvious visual damage | Single stem. Vertical | Balanced. | | F | 20-40 | B | 3.6 | |

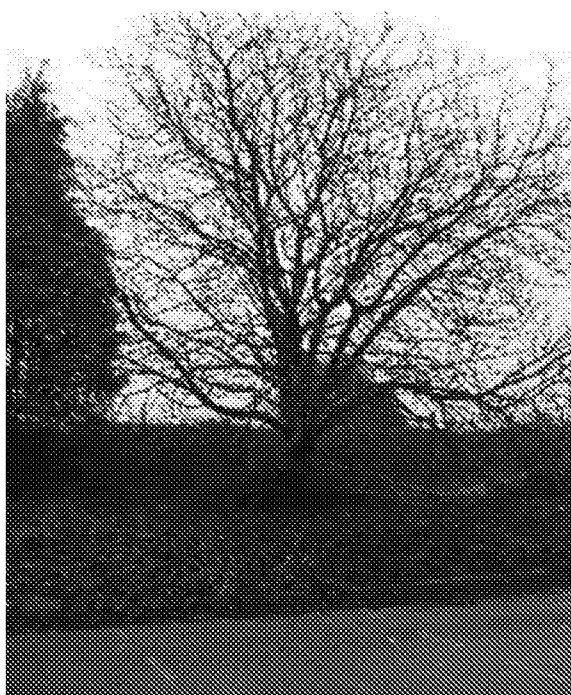
Photograph 18 – T19

| T19 | Horse chestnut | <i>Aesculus hippocastanum</i> | Y | 8 | 1 | 450 | 0 | 6 | 6 | 6 | 6 | No obvious visual damage | Single stem. Vertical | Spreading. Balanced. | | G | >40 | B | 5.4 | |

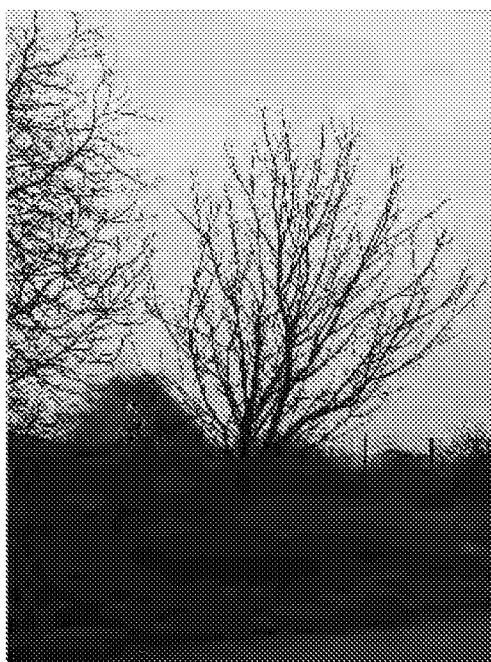
Photograph 19 – T20

| T20 | Horse chestnut | <i>Aesculus hippocastanum</i> | Y | 6 | 1 | 250 | 0 | 3 | 3 | 3 | 3 | No obvious visual damage | Single stem. Vertical | Balanced. | | F | 20-40 | B | 3.0 | |

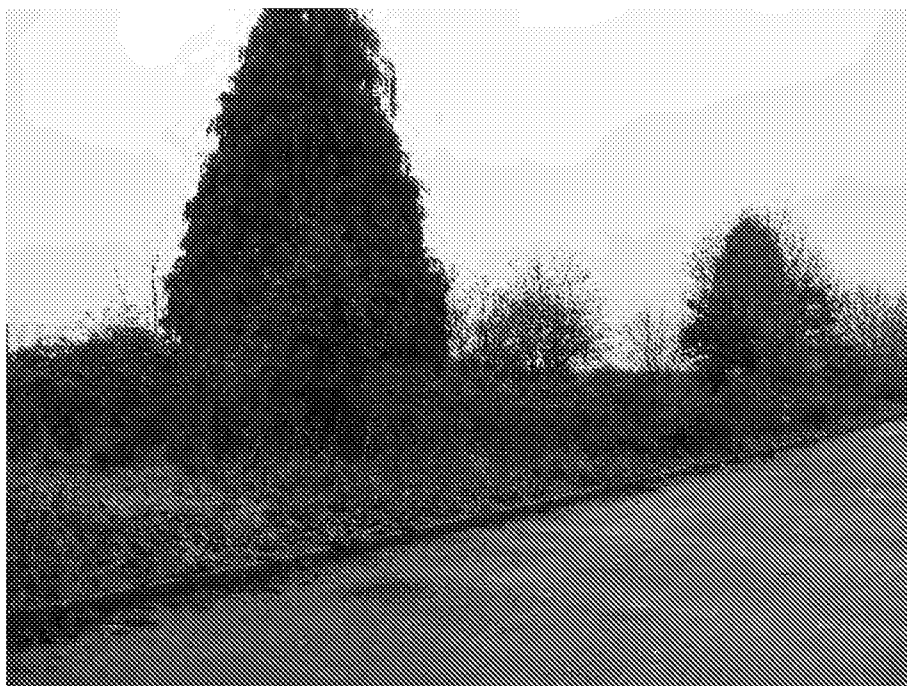
Photograph 20 – TG21

| TG21 | Horse chestnut | <i>Aesculus hippocastanum</i> | Y | 2 | 1 | 100 | 0 | 1 | 1 | 1 | 1 | No obvious visual damage | Single stem. Vertical. | Balanced | | G | >40 | B | 1.2 | |

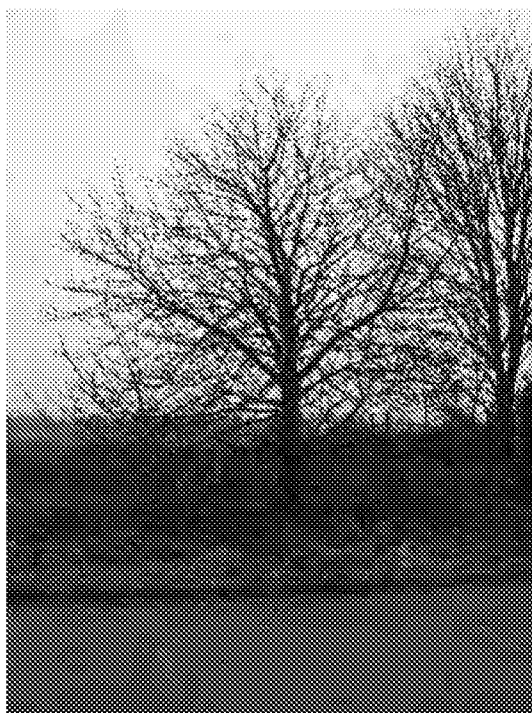
Photograph 21 – T22

| T22 | Leyland cypress<br>Beech<br>Hazel | X<br><i>Cupressocyparis leylandii</i><br><i>Fagus sylvatica</i><br><i>Corylus avellana</i> | Y | 8 | 1 | Est 300 | 0 | 3 | 3 | 3 | 3 | No obvious visual damage | Single stem. Vertical | Balanced. | | F | 20-40 | B | 3.6 | |

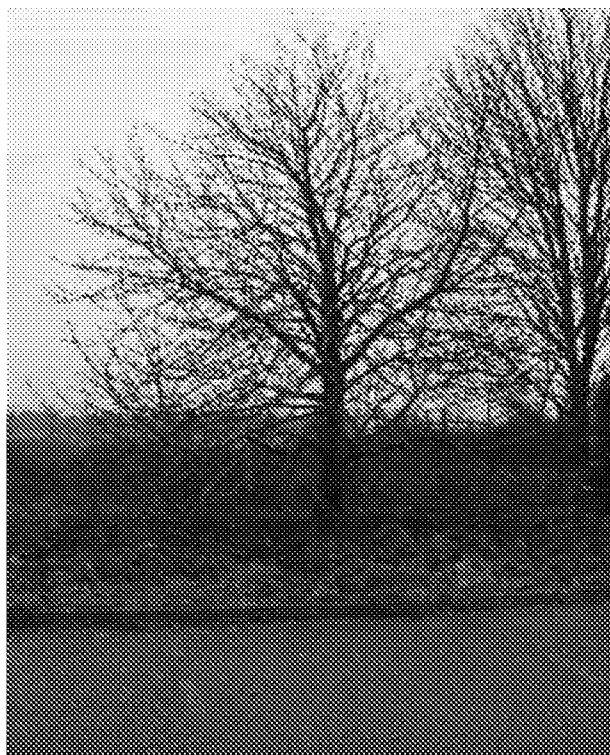
Photograph 22 – T23

| T23 | Horse chestnut | <i>Aesculus hippocastanum</i> | Y | 7 | 1 | 300 | 1 | 5 | 5 | 5 | 5 | No obvious visual damage | Single stem. Vertical | Balanced. | | F | >40 | B | 3.6 | |

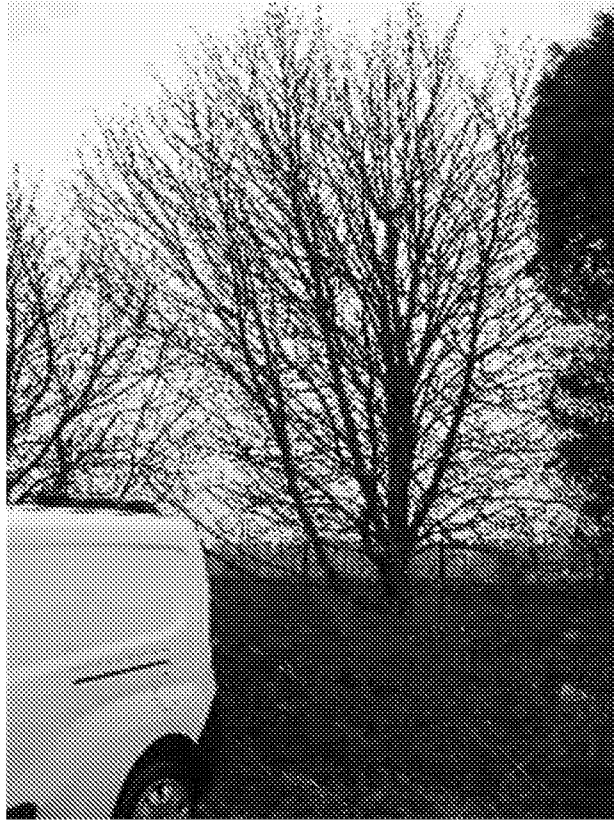
Photograph 23 – T24

| T24 | Horse chestnut | <i>Aesculus hippocastanum</i> | Y | 8 | 1 | 300 | 1 | 5 | 3 | 5 | 3 | No obvious visual damage | Single stem. Vertical | Slightly unbalanced | | F | 20-40 | B | 3.6 | |

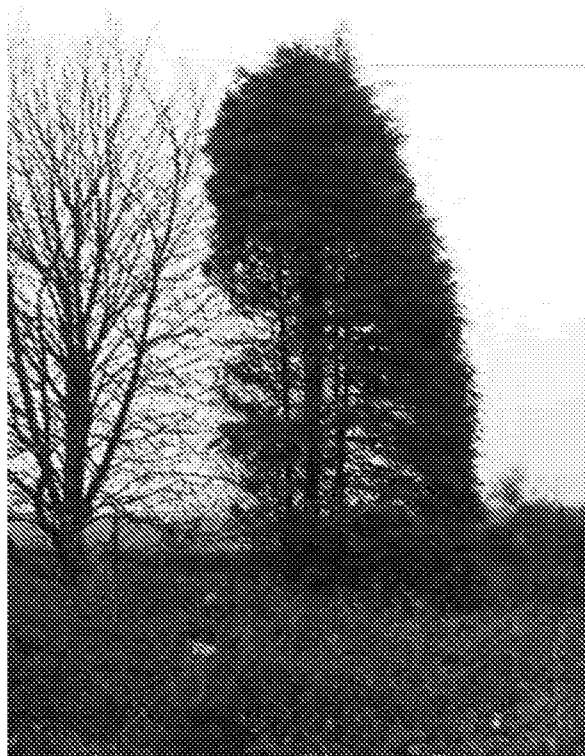
Photograph 24 – T25

| T25 | Leyland cypress | X<br><i>Cupressocyparis leylandii</i> | Y | 9 | 1 | Av 300 | 1 | 1 | 2 | 1 | 1 | No obvious visual damage | Single stems. Vertical | Suppressed by adjacent tree. | | F | 20-40 | C | 3.6 | |

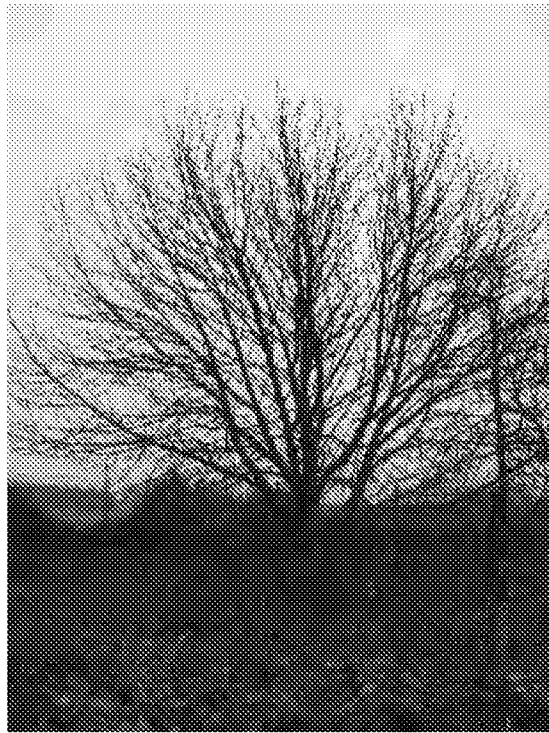
Photograph 25 – T26

| T26 | Horse chestnut | <i>Aesculus hippocastanum</i> | Y | 8 | 3 | 250<br>325<br>250 | 0 | 5 | 5 | 5 | 5 | No obvious visual damage | Trifurcated at 1.5 m. Vertical | Balanced | | F | >40 | B | 4.8 | |

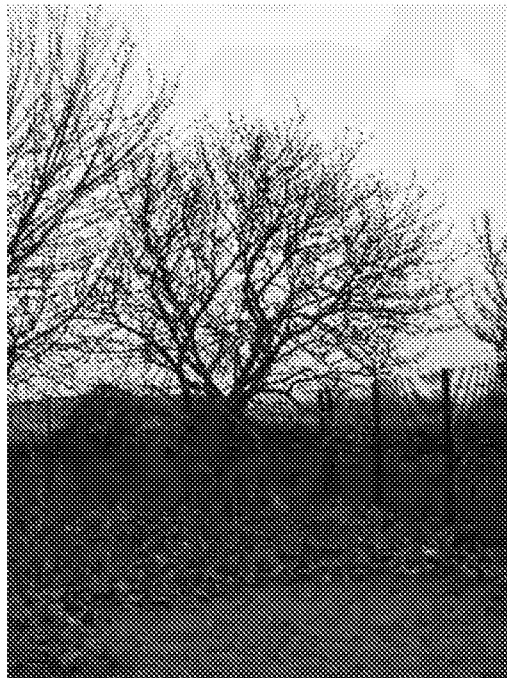
Photograph 26 – T27

| T27 | Horse chestnut | <i>Aesculus hippocastanum</i> | Y | 6 | 3 | 150<br>150<br>250 | 0 | 3 | 5 | 3 | 3 | No obvious visual damage | Trifurcated at 1 m. Vertical | Balanced | | F | >40 | B | 2.4 | |

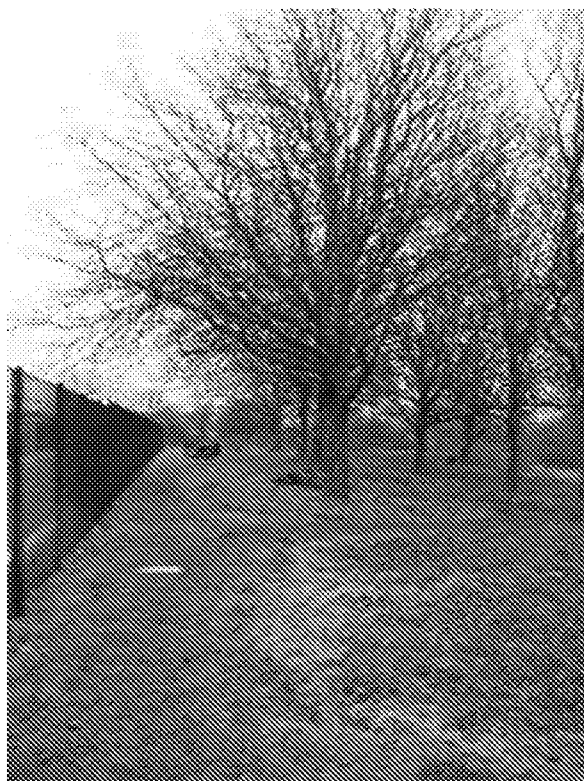
Photograph 27 – TG28

| TG28 | London plane | <i>Platanus x acerifolia</i> | SM | 11 | 1 | Av 450 | 3 | 6 | 6 | 6 | 6 | No obvious visual damage | Single stem. Vertical | Spreading. Scattered deadwood | Canopies read as one. | F | >40 | B | 5.4 | |

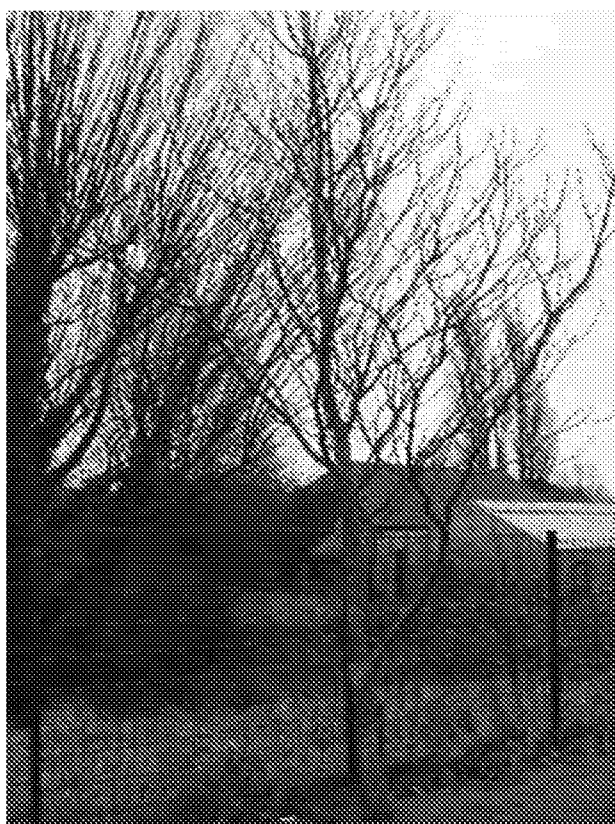
Photograph 28 – T29

| T29 | Indian bean tree | <i>Catalpa bignonioides</i> | Y | 7 | 1 | 125 | 2 | 3 | 3 | 3 | 3 | No obvious visual damage | Single stem. Vertical | Spreading. Well balanced. | Memorial tree | F | >40 | A | 1.5 | |

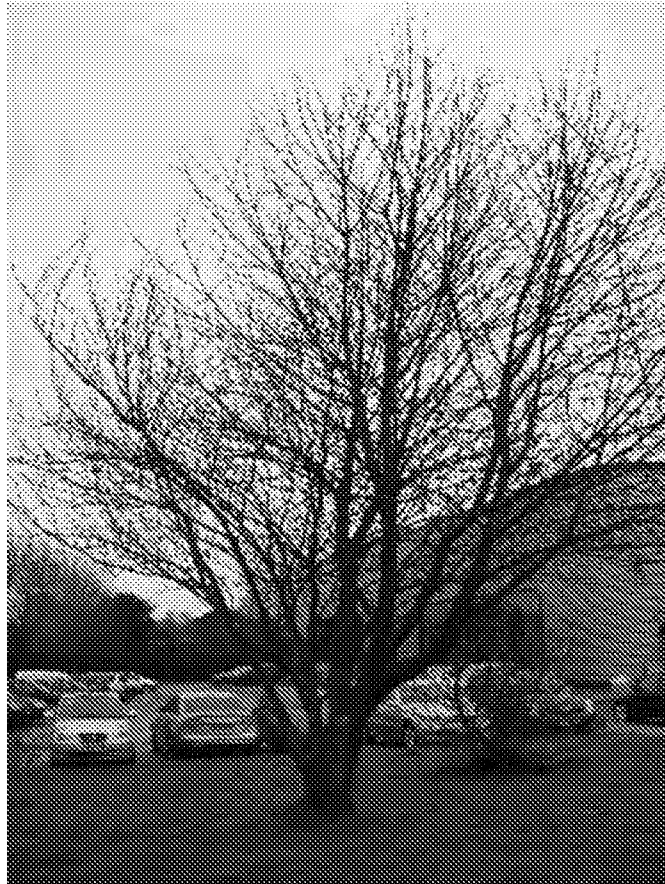
Photograph 29 – T30

| T30 | Cherry | <i>Prunus sp.</i> | SM | 8 | 5 | 150<br>175<br>250<br>225<br>250 | 2 | 6 | 6 | 6 | 6 | No obvious<br>visual<br>damage | Multi-stemmed<br>from base | Spreading.<br>Minor<br>deadwood | Several<br>branches<br>removed.<br>Stubs present | F | 20-40 | B | 6.3 | |

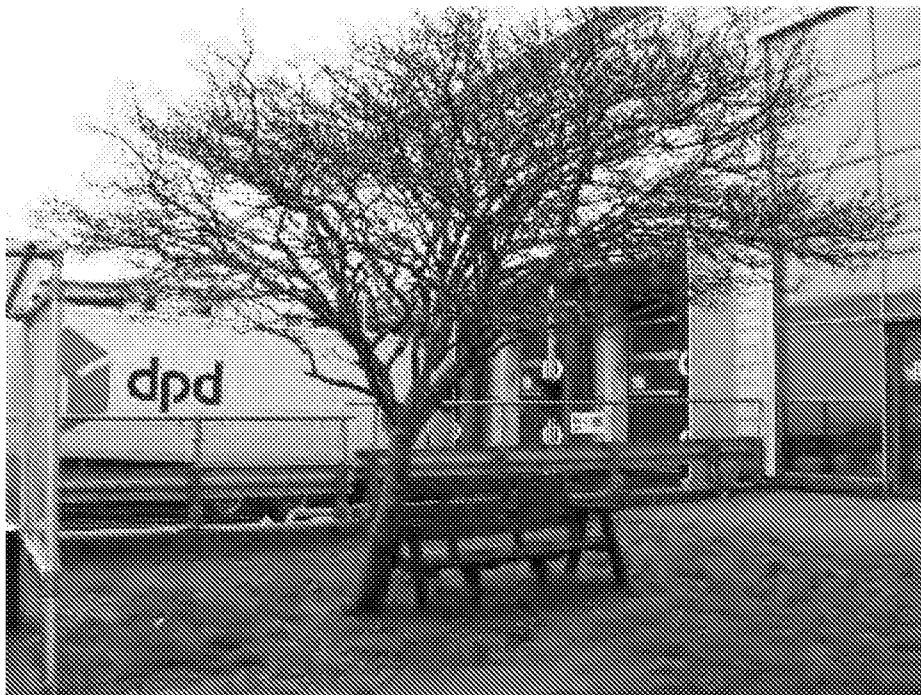
Photograph 30 – T31

| T31 | Plum | <i>Prunus Sp.</i> | SM | 4 | 1 | 150 | 2 | 3 | 3 | 3 | 3 | No obvious<br>visual<br>damage | Single stem.<br>Vertical | Spreading. Well<br>balanced. | | F | >40 | B | 1.8 | |

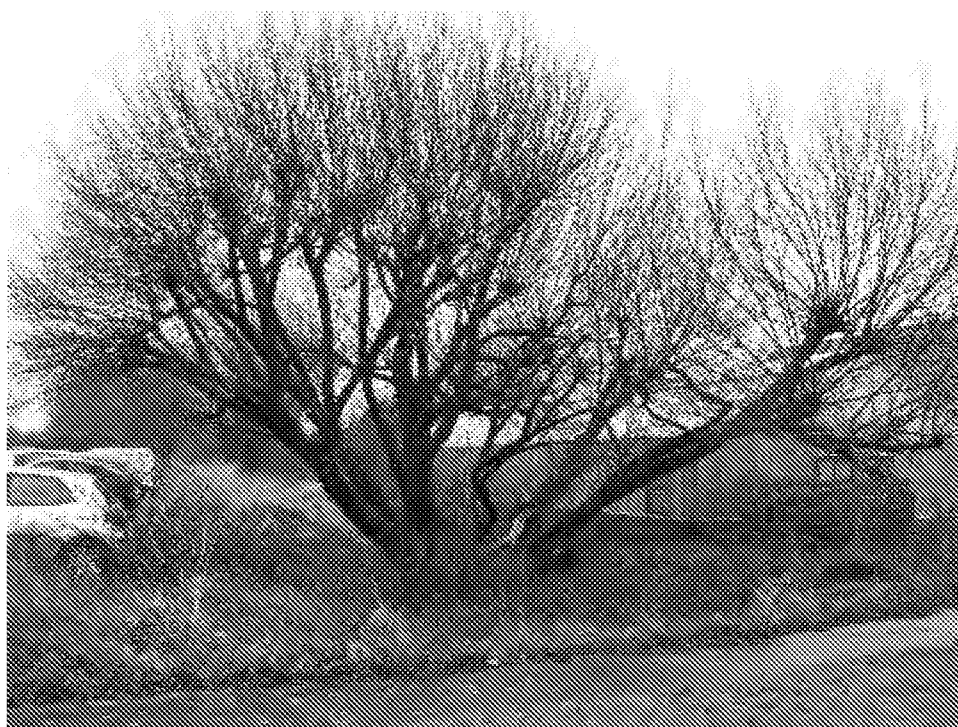
Photograph 31 – TG32

| TG32 | Crack willow | <i>Salix fragilis</i> | M | 12 | M<br>S | 10 x<br>300 | 2 | 7 | 7 | 7 | 7 | No obvious<br>visual<br>damage | Multi-stemmed<br>from base<br>Vertical | Crown lifted to 6<br>m, stubs<br>present.<br>Spreading.<br>Occasional<br>deadwood | Hazard beam<br>present<br>Low BRP | F | >40 | C | 6.6 | |

TG32 was assessed as having low BRP due to the presence of a hazard beam that had split. None of the other trees were found to support potential features suitable for roosting bats.
