ARBORICULTURAL ASSESSMENT

Hallway Properties Limited

**Land at Norway Lane,
Littlehampton**

April 2025

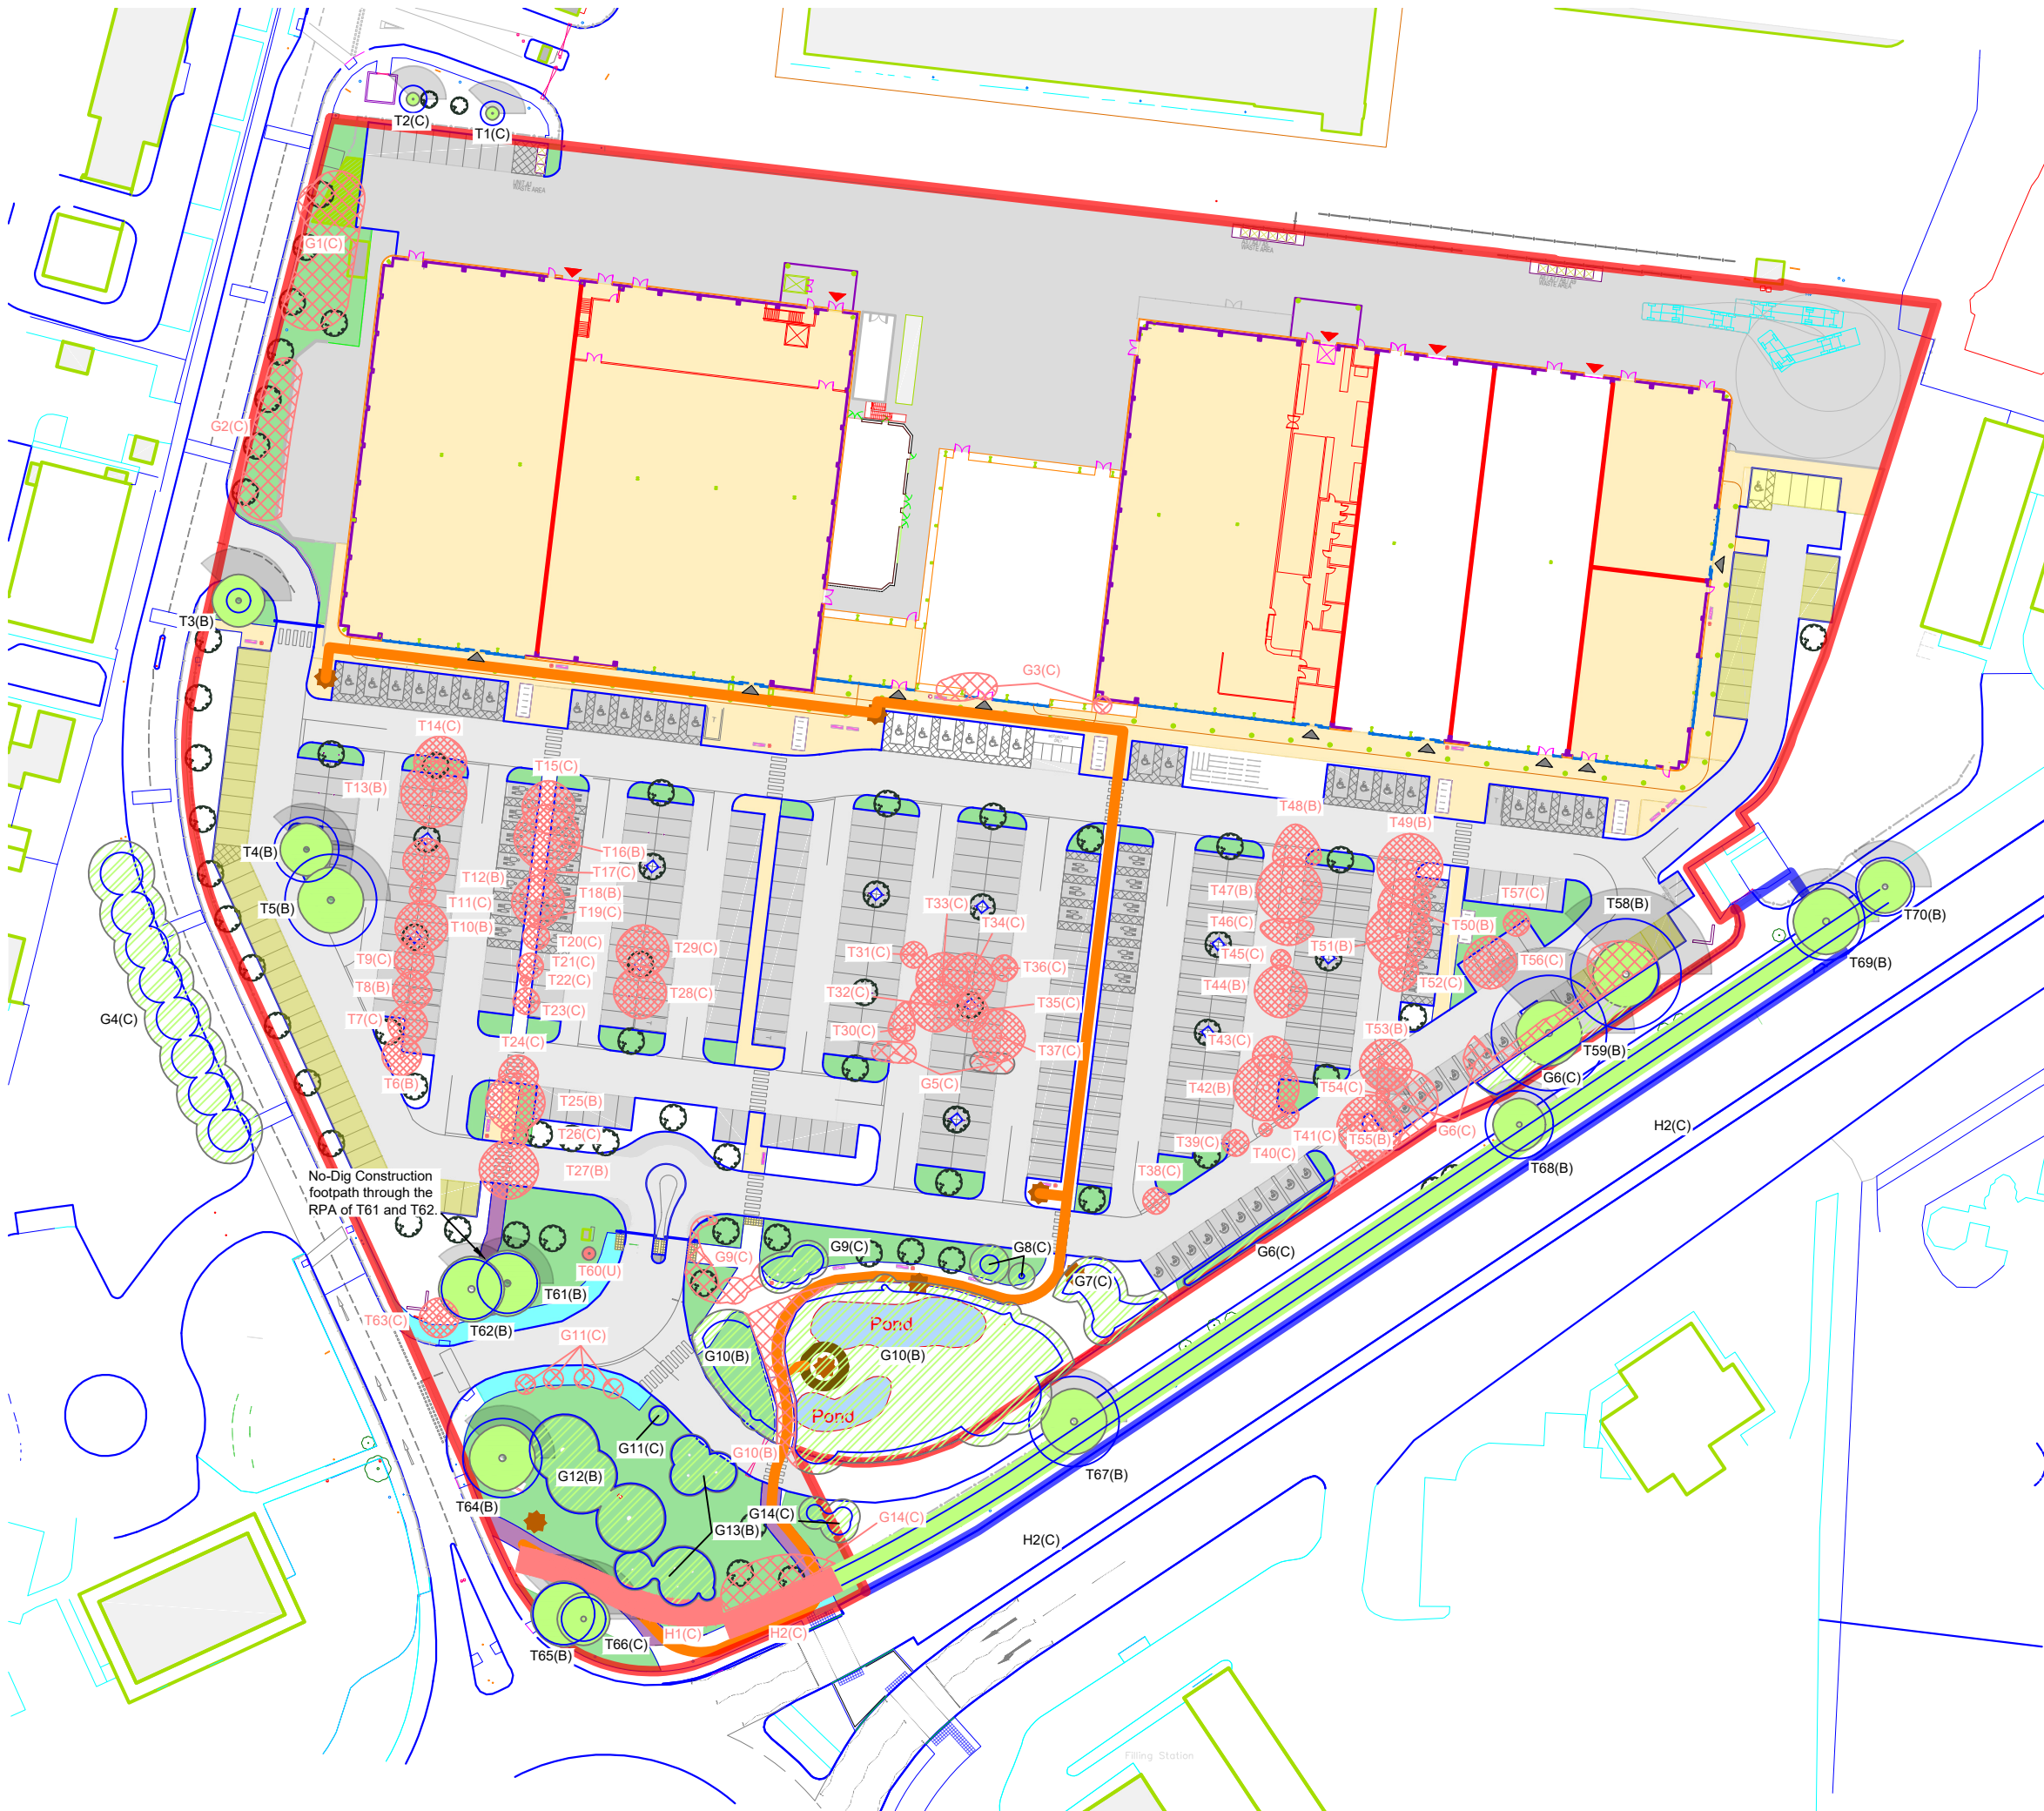
number
 12641-T-02 status
 - rev
 A

- 5.10 Three groups, G9, G10 and G14 will require partial removal to facilitate the new footpaths through the groups. These losses will cause minimal impacts to the group as the design of the path has worked around the majority of tree stock within the group.

- 5.15 T58 and T59 also have both existing and proposed parking spaces within their RPA and will follow the same methodology outlined above.
- 5.16 It is proposed that T61 and T62 will have a footpath pass between the two trees within their RPA's. This path will be constructed using a no-dig specification to minimise root damage through excavation and compaction.
