## 9. Appendix

**9.2. Report 20<sup>th</sup> May 2019 by Mr. Uwe Dornbusch, Environment Agency. (See slides below)**

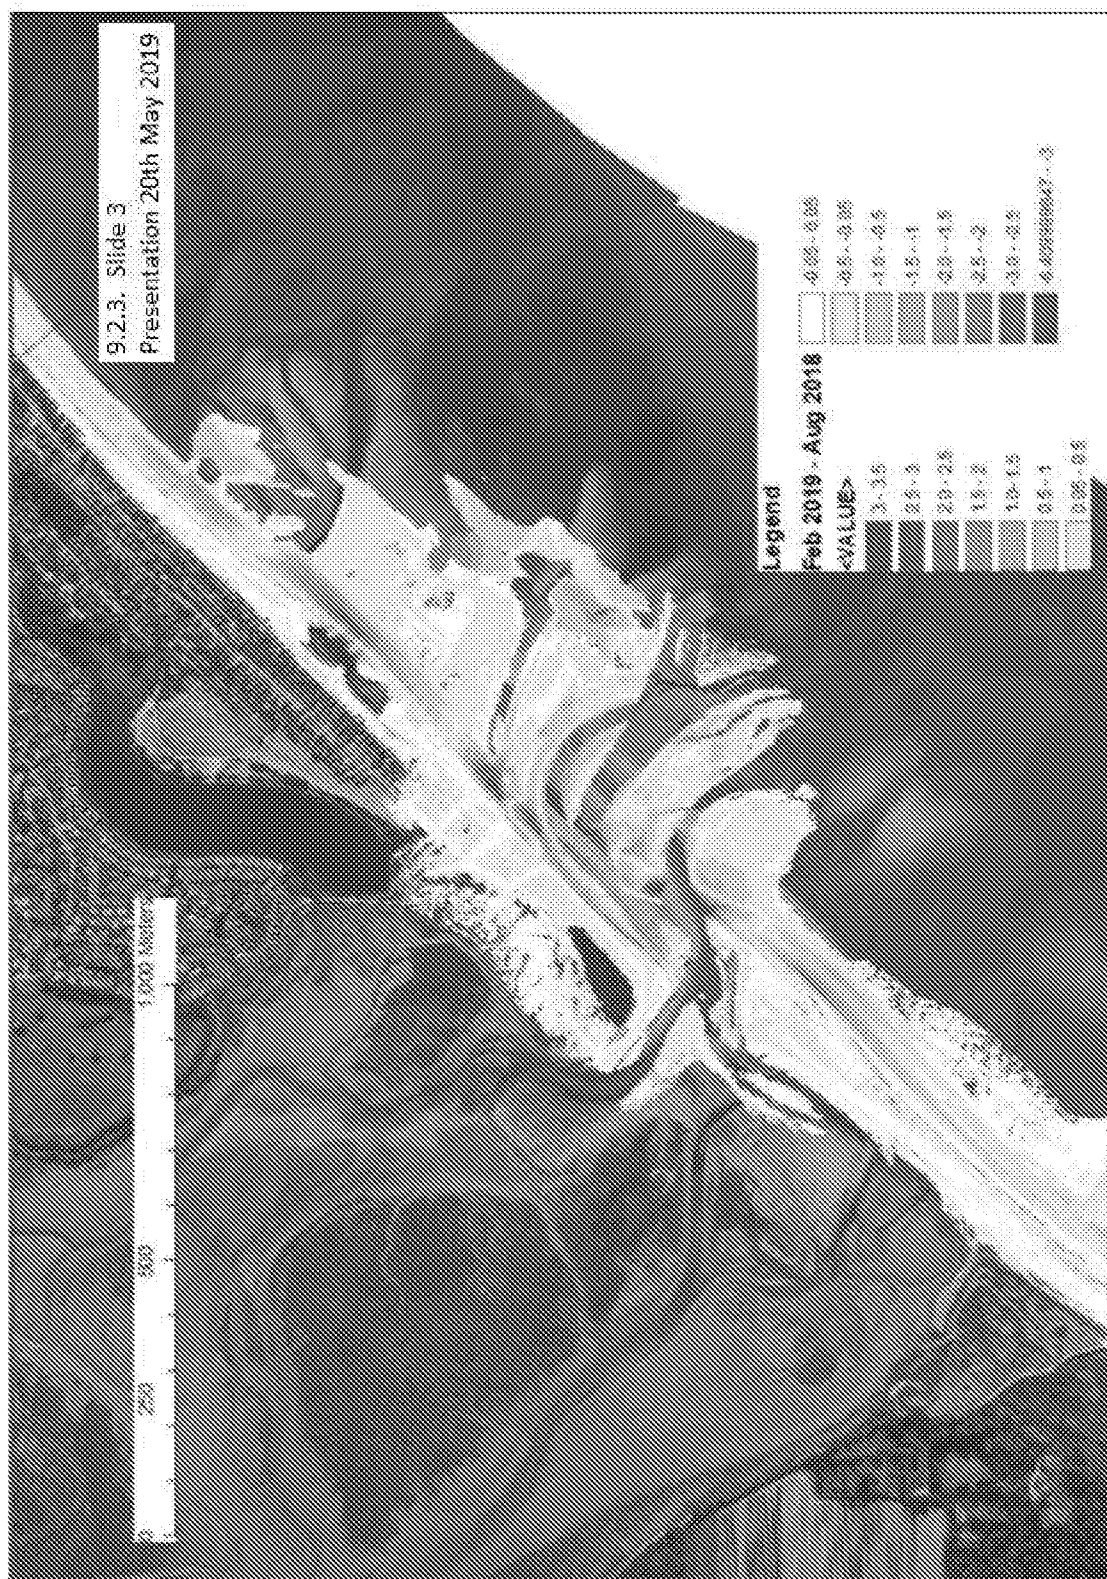
9.2.3. Slide 3  
Presentation 20th May 2019

- 9.2.3. The changed described in the previous slide can be seen in the elevation difference. In addition erosion of about 5 metres has taken place in front of the old CNS leading to a more 'straight' alignment. Likewise, the roll back in front of the lagoon was accompanied by an increase in beach with north up to the sailing club.

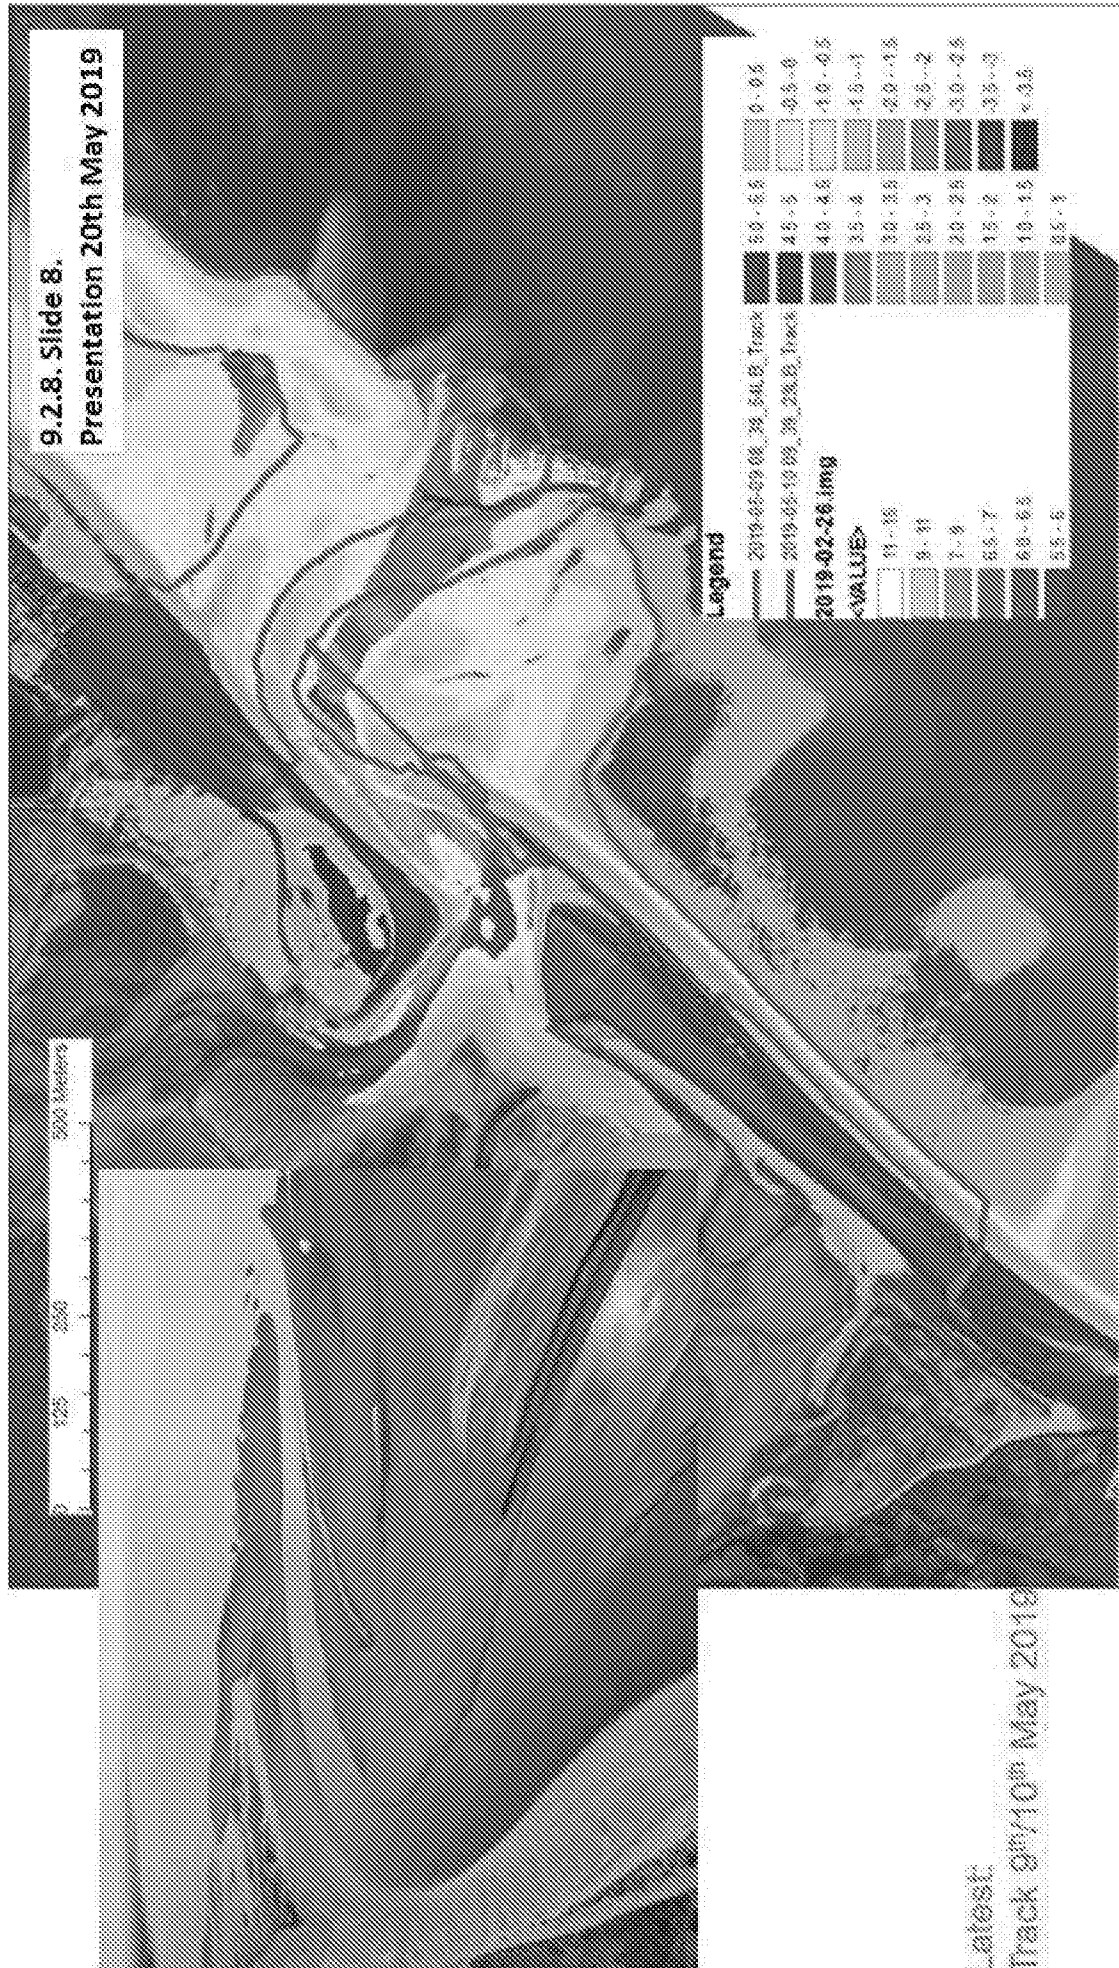
9.2.8. Slide 8.  
Presentation 20th May 2019

- 9.2.7. Cross section of the spit. Showing the changes 17/4/19 to 01/05/19
- 9.2.8. The latest tracks (9<sup>th</sup>/10<sup>th</sup> May superimposed on map. Showing close co-ordination.

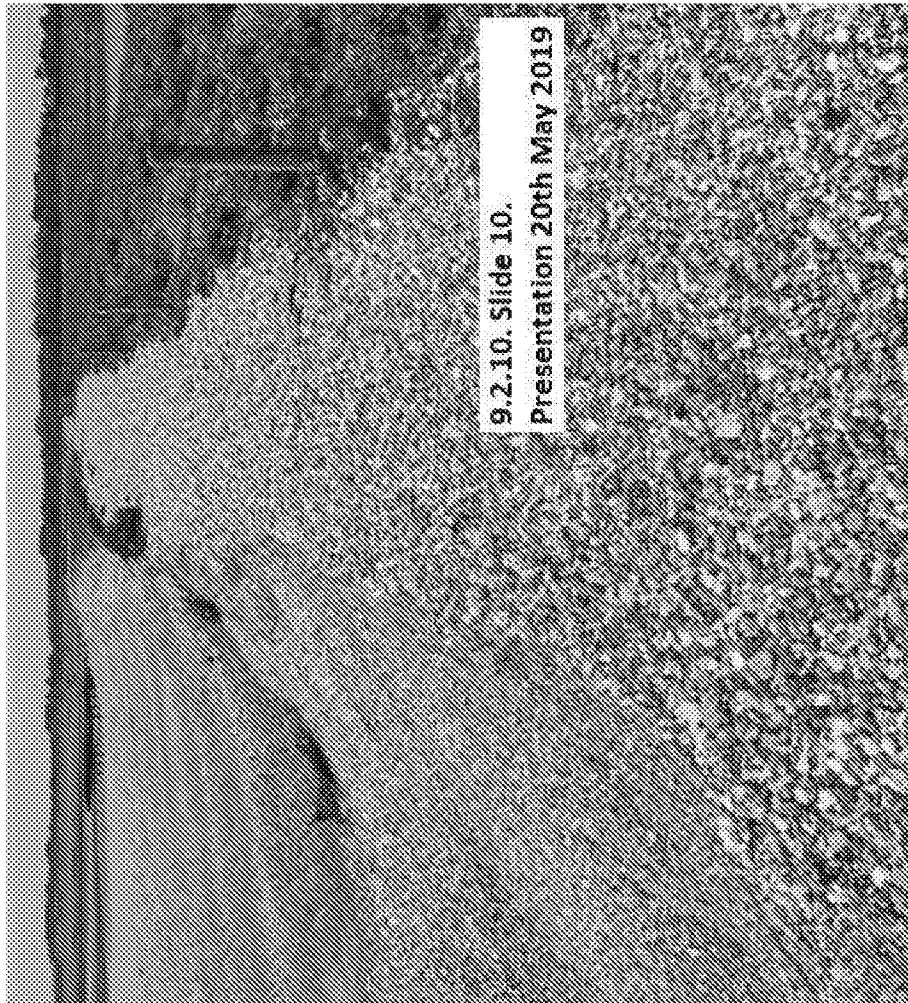
9.2.10. Slide 10.  
Presentation 20th May 2019

- 9.2.9. Further tracks superimposed on the map.
- 9.2.10. Photo showing the erosion near the little lagoon in just a few weeks.
- 9.2.11. Tide gauge readings showing the harbor emptying to the levels before the spit growth.

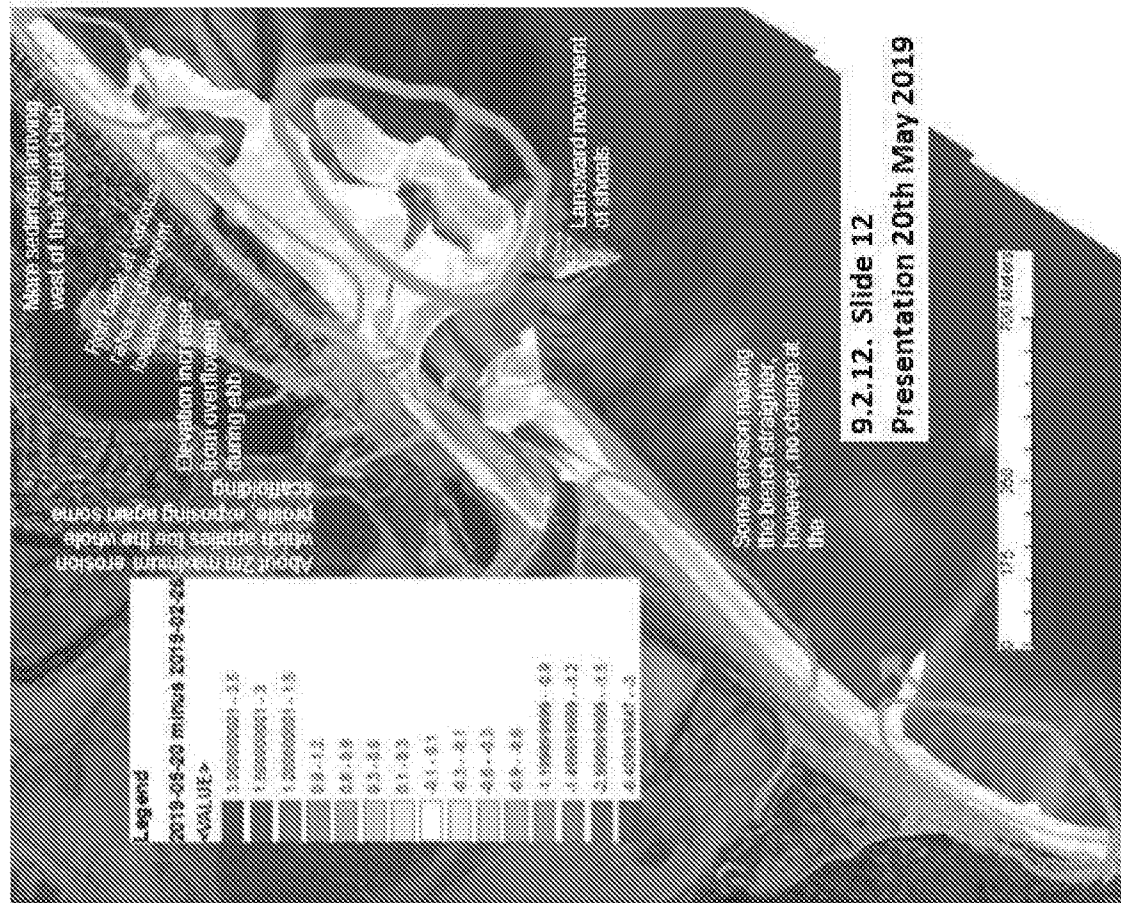
9.2.12. Slide 12  
Presentation 20th May 2019

- 9.2.12. Summary of the changes February to May.
- 9.2.13. Erosion near the little lagoon between 26/02/2019 and 17/04/2019.
