## Tree Care Consultant

### ARBORICULTURAL REPORT AND STATEMENT IN RELATION TO DEVELOPMENT PROPOSALS TO BS5837: 2012

**REF:** RH/130/2018

**Location:** Rustington Hall, Station Road, Rustington, West Sussex, BN16 3AY.

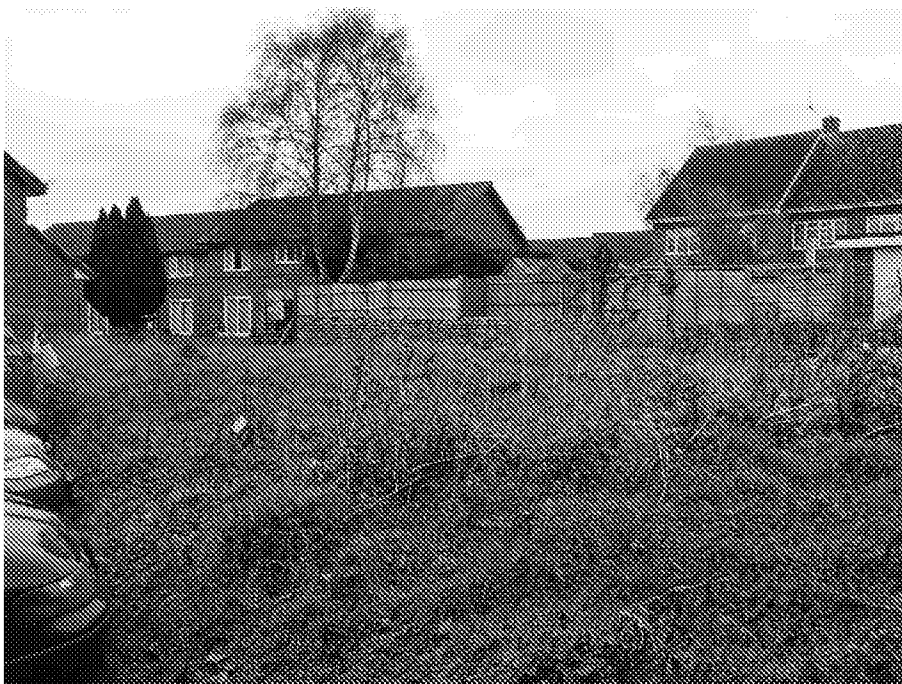
**Fig 1 View of site**

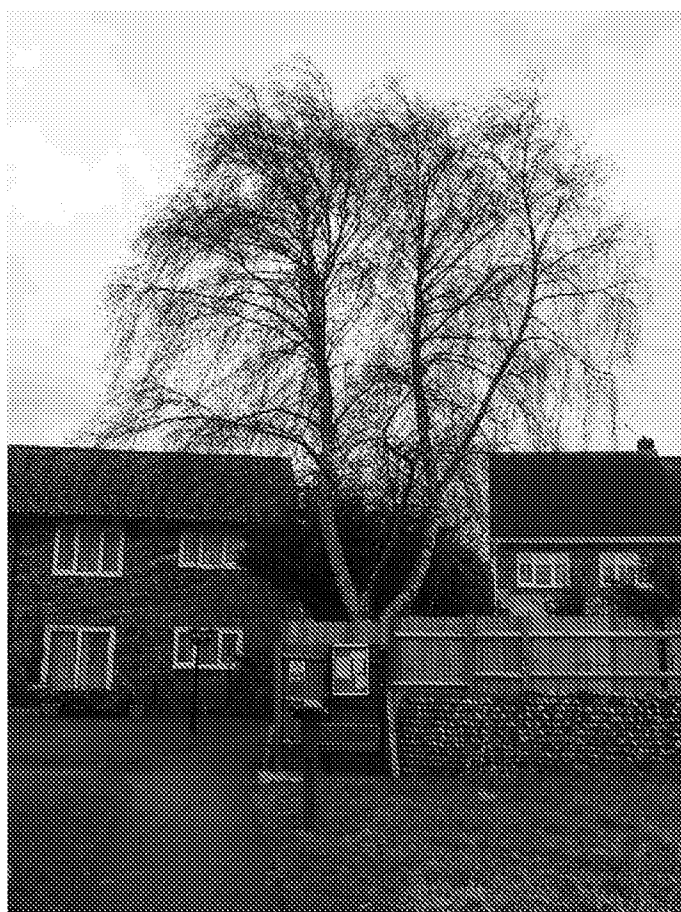
**Fig 2 T1 Silver Birch in adjoining property**

| Tree ID | Common Name | Maturity | Height (m) | Stem Diameter | Crown Spread (m) | | | | BS Cat | Life Expectancy | Physical Condition | Condition comments | Recommended work |
|---|---|---|---|---|---|---|---|---|---|---|---|---|---|
| T1 | Birch | Mature | 13 | 400 (est) | 3 | 3 | 3 | 3 | A (2) | 10 to 20 yrs | Good | Good form forms two stems at 2m. In neighbouring property. | RPA will require protection on site only. |

5.2 Root Protection Area (**RPA**) of The RPA of T1 a mature Silver Birch in the garden of 7a Paddock Green will be partly over the new footpath at rear of proposal and can be adequately protected with fencing and ground protection specified at paragraph 8.0. T2 a Yew in the south west corner of site close to parking bays can be adequately protected by fencing off one parking bay. T3 & T4 both in poor condition and of low amenity value will be removed.

- 8.1 Root Protection Area (**RPA**) of T1 will put a small constraint on the new tarmac foot path to service the rear of units. It is recommended to use a geotextile with a 50mm deep cellular confinement system over the existing surface to prevent damage to tree roots. Any excavations over this area must be carried out by hand and any exposed roots protected by covering with damp hessian. It may be necessary to raise level of path to avoid damage to roots to allow for depth of materials used. For further information and advice, we recommend contacting companies supplying materials for this purpose [info@geosyn.co.uk](mailto:info@geosyn.co.uk). or <https://www.wrekinproducts.com/>

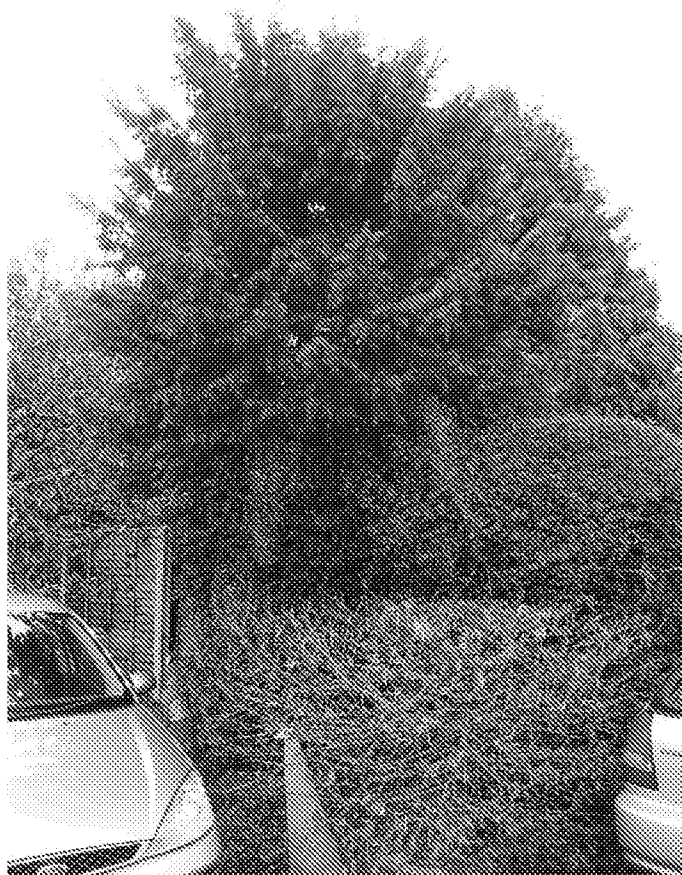
**Fig 3 T2 Yew**

| Tree ID | Common Name | Maturity | Height (m) | Stem Diameter | Crown Spread (m) | | | | BS Cat | Life Expectancy | Physical Condition | Condition comments | Recommended work |
|---|---|---|---|---|---|---|---|---|---|---|---|---|---|
| T2 | Yew | Mature | 5 | 150 | 1 | 2 | 1 | 1 | A (2) | >40 yrs | Good | No action | RPA will require protection |

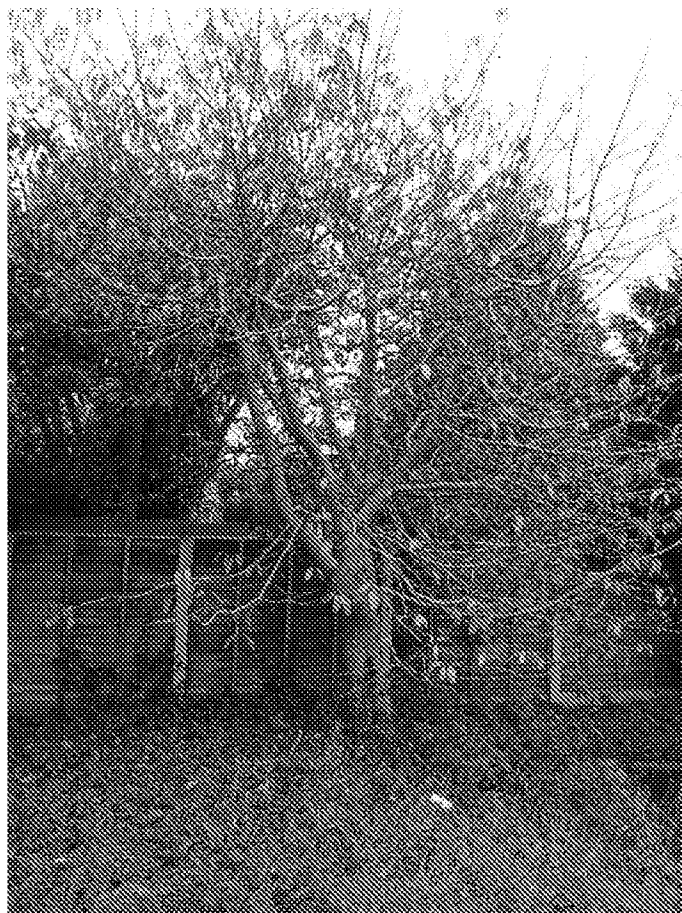
**T3 Laurel**

| Tree ID | Common Name | Maturity | Height (m) | Stem Diameter | Crown Spread (m) | | | | BS Cat | Life Expectancy | Physical Condition | Condition comments | Recommended work |
|---|---|---|---|---|---|---|---|---|---|---|---|---|---|
| T3 | Portuguese Laurel | Mature | 4.6 | 290 | 3 | 2 | 2 | 2 | U | <10 yrs | Poor | In decline, thinning crown density & stem has bleeding canker | Fell tree and remove stump |

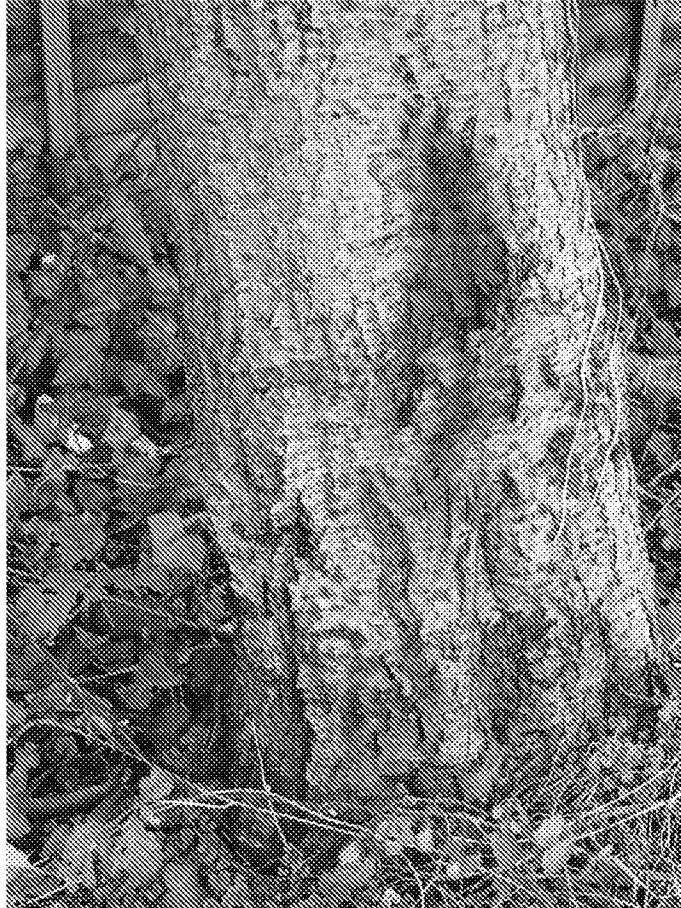
**T3 showing stem bleeding**

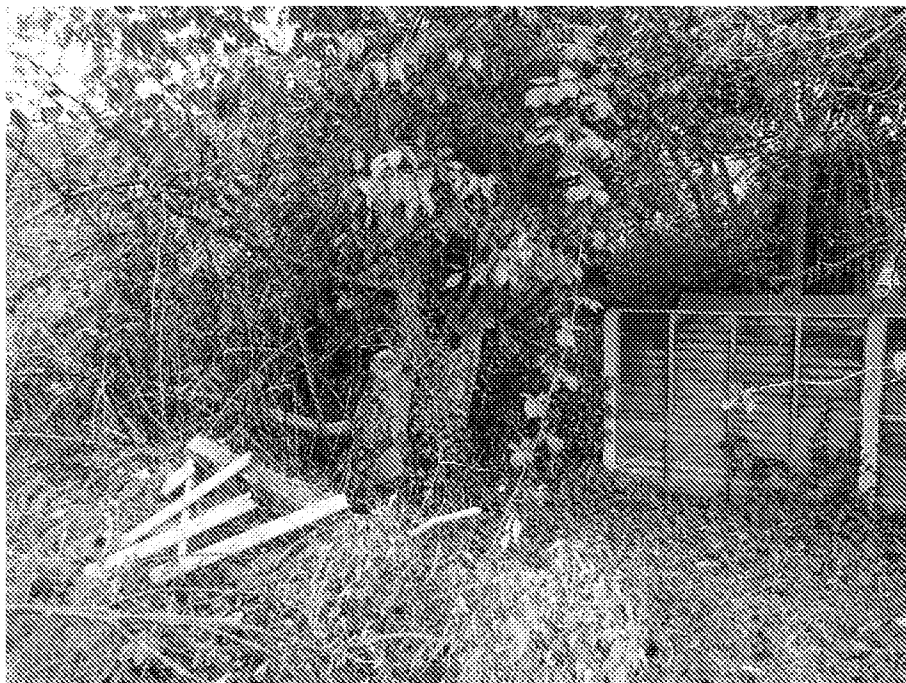
**Fig 4 T4 Laurel regrown stump**

| Tree ID | Common Name | Maturity | Height (m) | Stem Diameter | Crown Spread (m) | | | | BS Cat | Life Expectancy | Physical Condition | Condition comments | Recommended work |
|---|---|---|---|---|---|---|---|---|---|---|---|---|---|
| T4 | Portuguese Laurel | Over Mature | 4 | 690 | 3 | 2 | 2 | 2 | U | <10 yrs | Poor | Poor form, stump with regrowth | Fell tree and remove stump. |
