39 Park Drive BN16 3DY

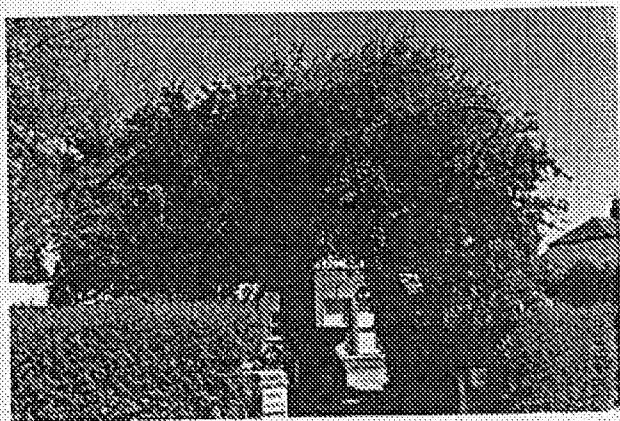
T1

The first two trees are a cherry plumb and a Hawthorne in good health located at each side of the driveway, both trees are in good health but are in need of maintenance, the proposed work would be to crown reduce both trees by 1.5 metres in order in maintaining them long term.

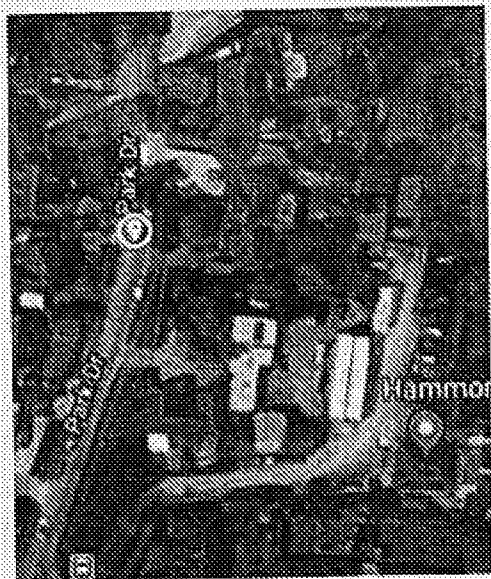
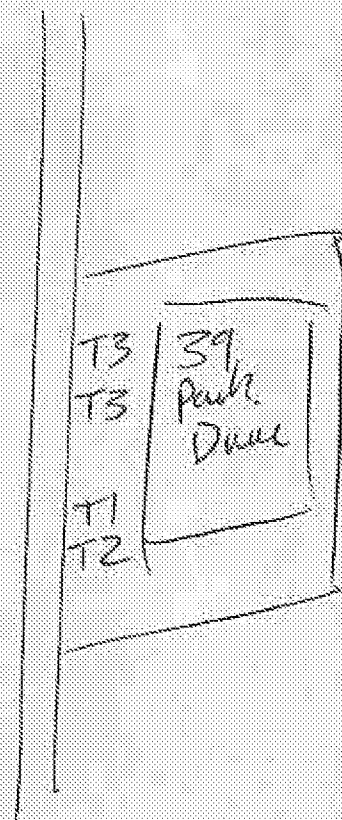
The other trees are two *Robinias* again in good health, the proposed work would be to crown reduce both trees by 1.5 metres in order in maintaining them long term and remove all dead wood.
