Green Lane Forestry LLP

## Application for tree works: work to tree(s) in a conservation area

**Location:** The Old Apple Store, The Street, Walberton, West Sussex, BN18 0PJ

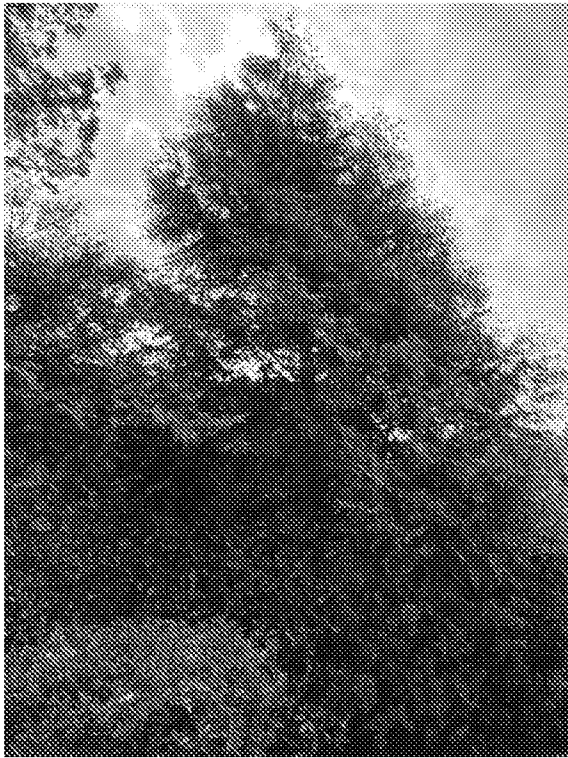
*Figure. 1 Cypress (T3)*

**4.2.1** Causing damage to wall; The roots of the tree are causing subsidence damage with the trunk pushing against the wall in the wind (*Figures. 1 & 11*).

**4.1** Removal of entire tree.

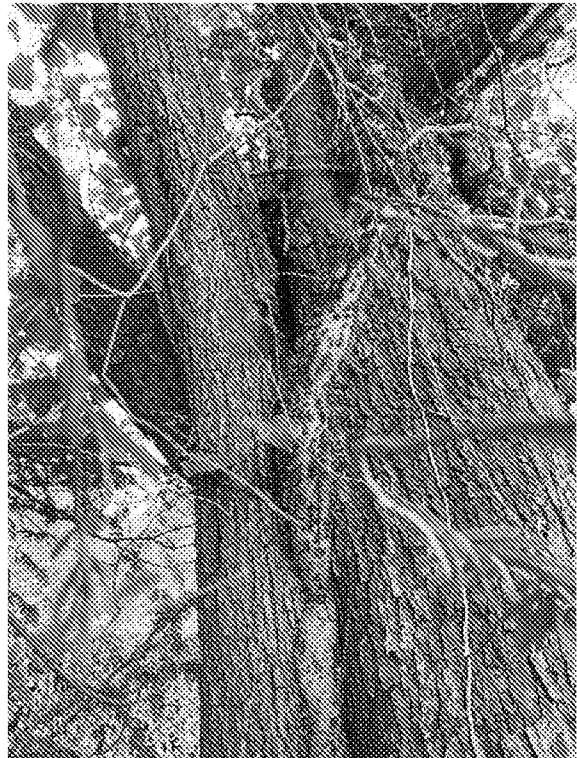
**1.2.2** Damage to the stem; several small wounds on the trunk are allowing water ingress and rot.

*Figure. 2 Hawthorn trunk (T5)*

##### 1.1 Removal of the entire tree.

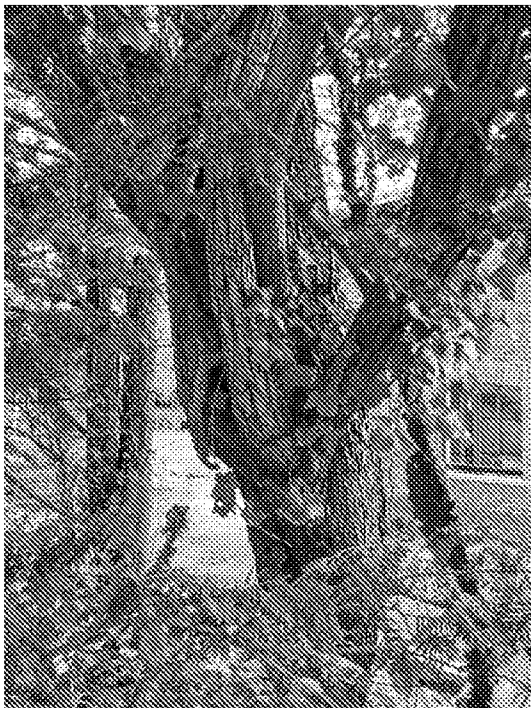
*Figure. 3 Hawthorn stem (T5)*

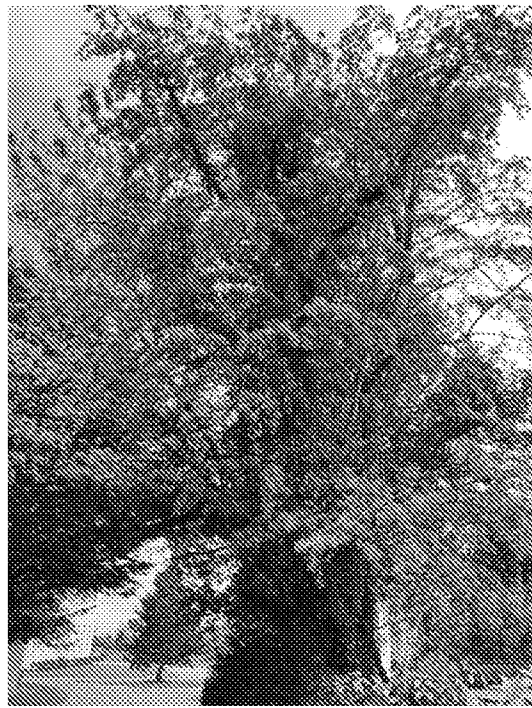
*Figure. 4 Hawthorn (T5)*

**1.2.1** T5 is situated next to a building and driveway, falling limbs and deadwood are causing damage to the driveway.

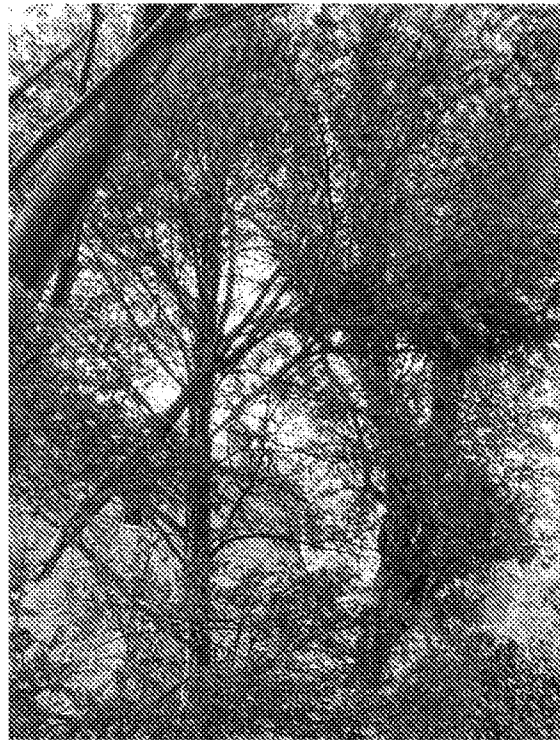
**3.2.1** Dead wood and dying off, this tree comprises of 70% dead or dying to 30% living wood. The tree regularly drops its dead limbs on to the driveway. If the tree is not removed it will eventually drop limbs on the buildings.

*Figure. 6 Dead branch from Maple (T1)*

**3.1** Removal of entire tree.

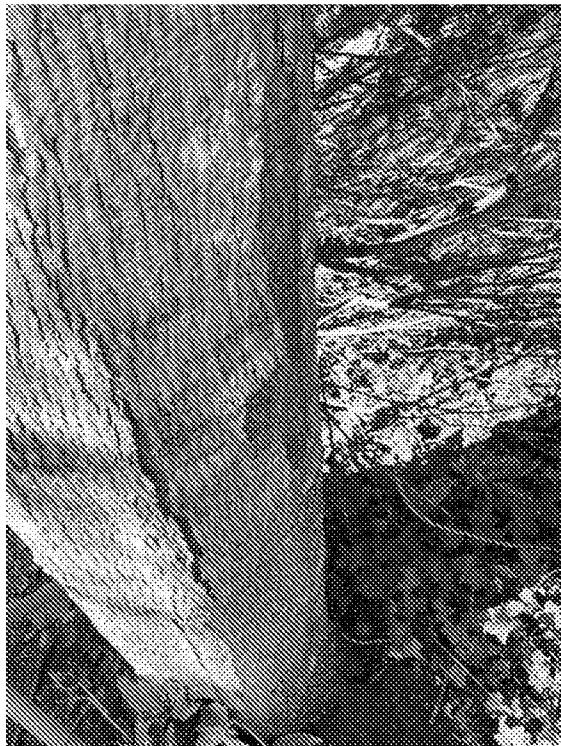
*Figure. 7 Maple stem (T1)*

**3.2.2** Heavily leaning, this tree is heavily leaning and has cracks appearing on the stem, it will likely fall if left (*Figures. 7, 9, 10, 13*).

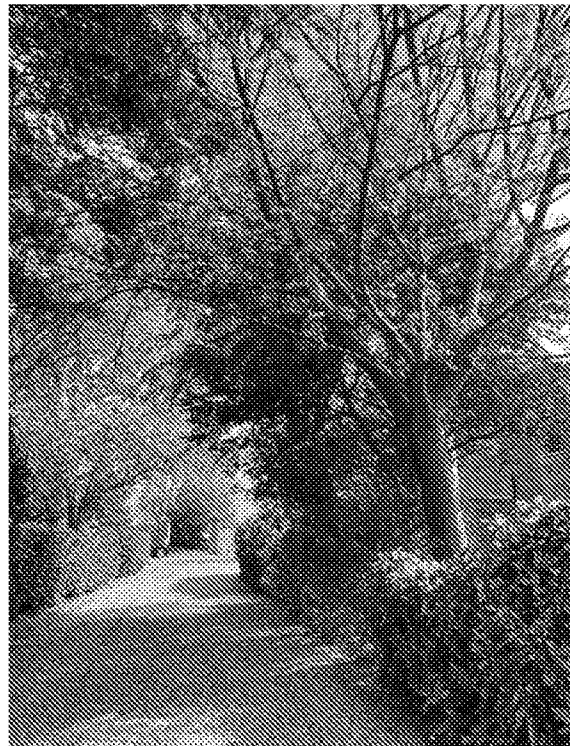
**2.2.2** Shadowing the ground; the shadow cast by this tree and others is preventing anything from growing under the canopy, ground-level plant growth would greatly benefit the area (*Figure. 8*).

*Figure. 8 Trees overhanging driveway*

**2.1** Removal of the entire tree.

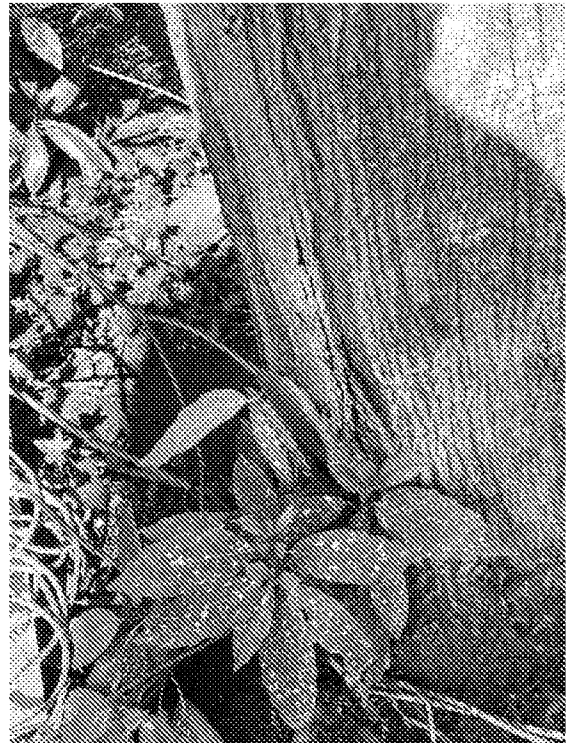
*Figure. 10 Maple stem damage (T1)*

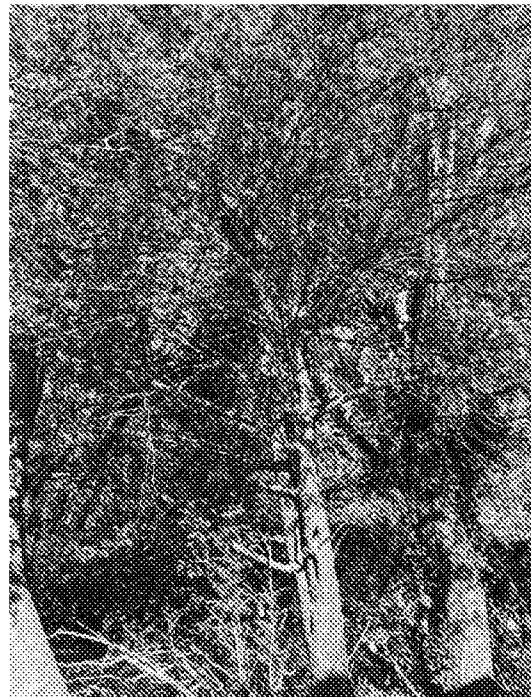
*Figure. 12 Yew (T2)*

**2.2.1** Light starved and unhealthy; this tree is situated underneath two other trees and has started to decay and die off due to lack of light.

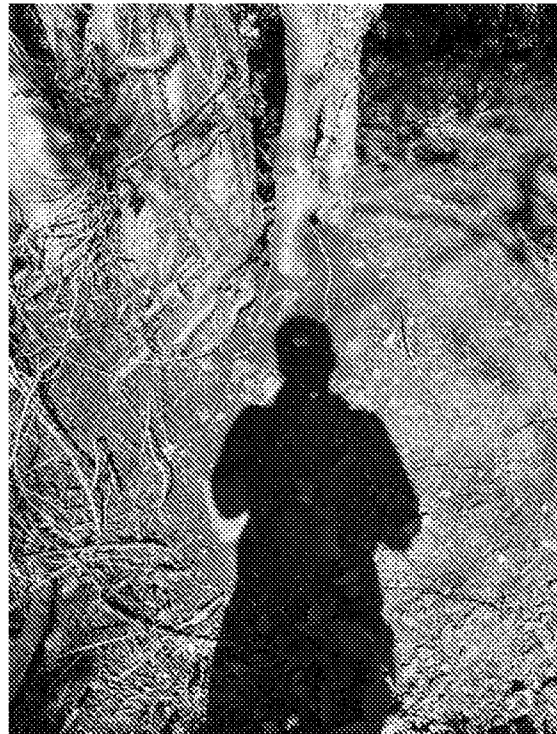
*Figure. 14 Holly Stem (T4)*

**5.2.1** Heavily leaning and uprooting; this very leggy multi-stemmed holly tree is situated underneath a large lime tree, this has led the tree to look for light elsewhere, causing it to be weighted heavily on one side. Roots are starting to lift (*Figure. 14*).

#### **5.1 Removal of entire tree.**

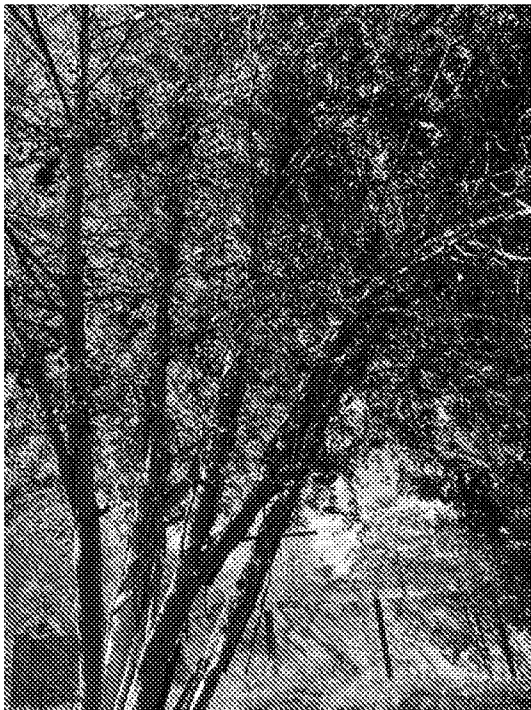
*Figure. 15 Holly (T4)*

**5.2.2** Interfering with other trees, as the grows towards available light, it is growing into other, healthier trees (*Figure. 15*).

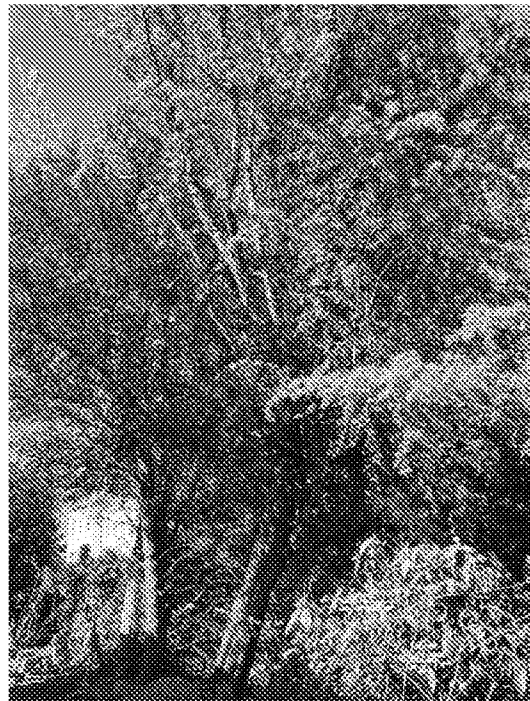
*Figure. 16 Hawthorn (T5)*

**1.2.3** Competing with other trees (*Figure. 16*); this tree is positioned next to other equally unhealthy trees and in the shadow of other much larger trees situated to the east. This is causing the tree to recede, and slowly die off.
