## SUPPLEMENTARY BAT SURVEY

LANES END  
WEST WALBURTON LANE  
FONTWELL

Survey Dates: 9<sup>th</sup> July to 12<sup>th</sup> August 2020  
Report Date: 24<sup>th</sup> August 2020

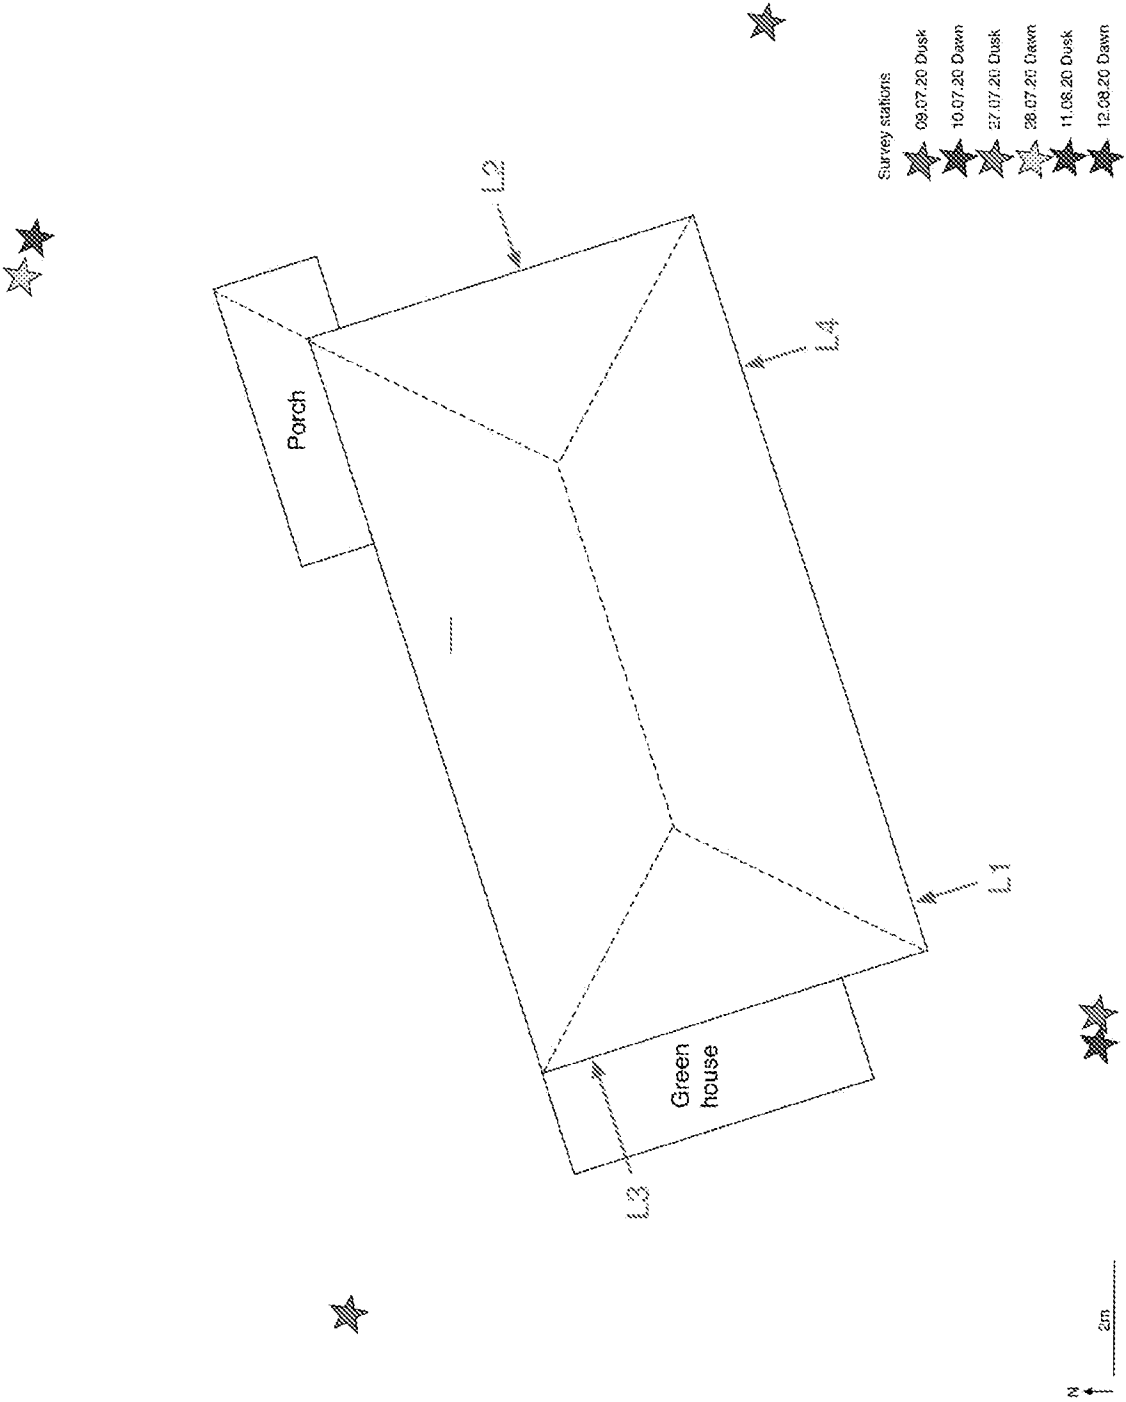
**Figure 1. Site Plan**

Two surveyors were present (Peter Webb, licensed, and Lottie Frears, unlicensed) were present on the nights of the 9<sup>th</sup>/10<sup>th</sup> July and the 11<sup>th</sup>/12<sup>th</sup> August 2020 (stationed on opposite corners of the dwelling so as to, between them, watch all relevant parts of it – see Figure 1) and a single surveyor on the night of the 27<sup>th</sup>/28<sup>th</sup> July (stationed at one corner for the dusk watch and the opposite corner for the dawn watch – see Figure 1).

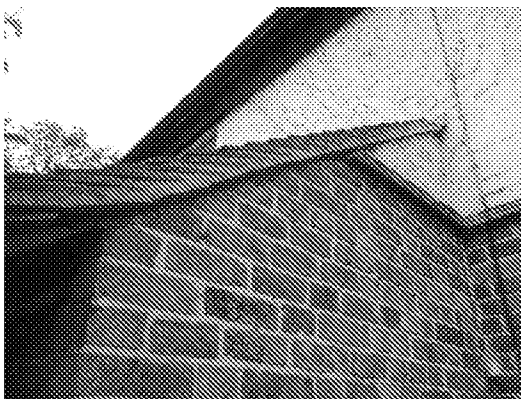
| Building | Details | Potential suitability |
|---|---|---|
| Dwelling | <p>Occupied</p> <p>Fully accessible for survey</p> <p>No flying access</p> <p>Single large roof space present (accessible for survey)</p> <p>Brick-work secure</p> <p>Window and door frames sound and sit flush in surrounding masonry</p> <p>Exposed edge tiles (on gable end of porch) well-bedded</p> <p>Roof pitched and fitted with plain clay tiles</p> <p>Roof tiles lie flush against on another</p> <p>Ridge tiles well-bedded</p> <p>Hip tiles well-bedded</p> <p>Roof flashing tight</p> <p>Eaves overhang. Ends of rafters protrude (see P7, Figure 2). Occasional tight gaps along rear of soffit (between adjacent rafters – see P8, Figure 2)</p> | High |

P5. Well-bedded edge tiles on roof of porch. P6. Typical view of main roof. Note the lack of gaps.

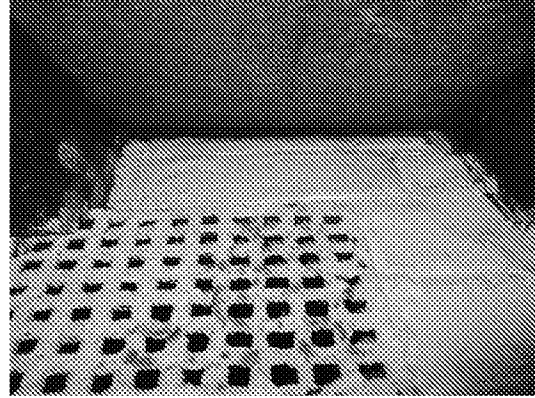
| Date | Survey | Surveyors | Location | Species | Number | Details |
|---|---|---|---|---|---|---|
| 09.07.20 | Dusk | 2 | L1 | Long-eared | 2 | Emerged from below eaves approximately 35-36 minutes after sunset |

P8. One of various gaps along eaves (this one

- c) careful removal of (some or all) fascias/soffits by hand by or under the direction of the ECoW;
  - iv. in compensation for the loss of the two roosts alternative provision be made for bats to roosts within the new build in the form of several external crevices suitable for use as a day roost by pipistrelle and/or long-eared bats. Such provision could include one or more of the following:

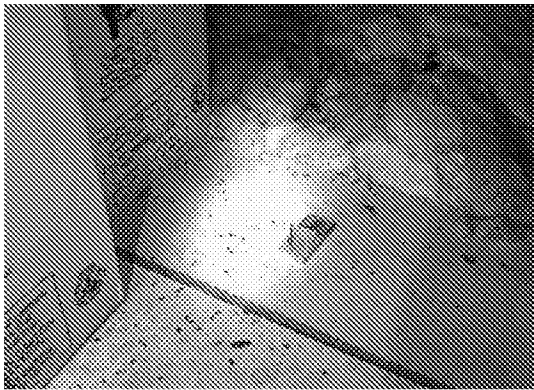
**ESL (2020) noted the presence of bat (most likely Brown long-eared) droppings within the roof space of the existing dwelling and consequently recommended the carrying of 'Bat Emergence Surveys'. Reference should be made to ESL (2020) for further detail.**

| Date | Survey | Location | Species | Details |
|---|---|---|---|---|
| 13.01.20 | ESL (2020) | Roof space | Long-eared sp? | 'Numerous' droppings scattered on floor |

P9. Scattered bat droppings n roof space  
(from ESL 2020)

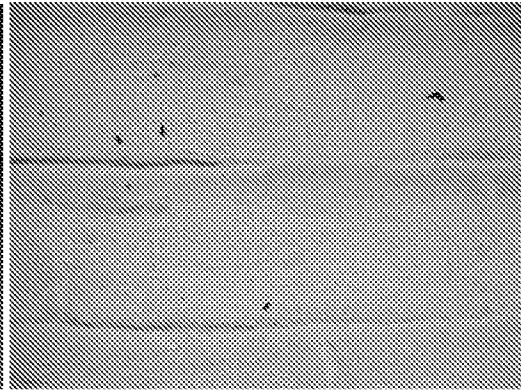
| Date | Survey | Location | Species | Details |
|---|---|---|---|---|
| 09.07.20 | Current | L1 | Long-eared/Pipistrelle sp? | Around 20-30 droppings stuck to external wall below tight gap behind soffit |

P10. Bat droppings stick to external wall.
