**ARBORICULTURAL IMPLICATIONS ASSESSMENT  
FOR PROPOSED 5 HOUSE RESIDENTIAL REDEVELOPMENT**

**MORELANDS  
ARUNDEL ROAD  
FONTWELL  
WALBERTON  
ARUNDEL  
BN18 0SB**

**Our ref: J61.19  
18<sup>th</sup> January 2022**

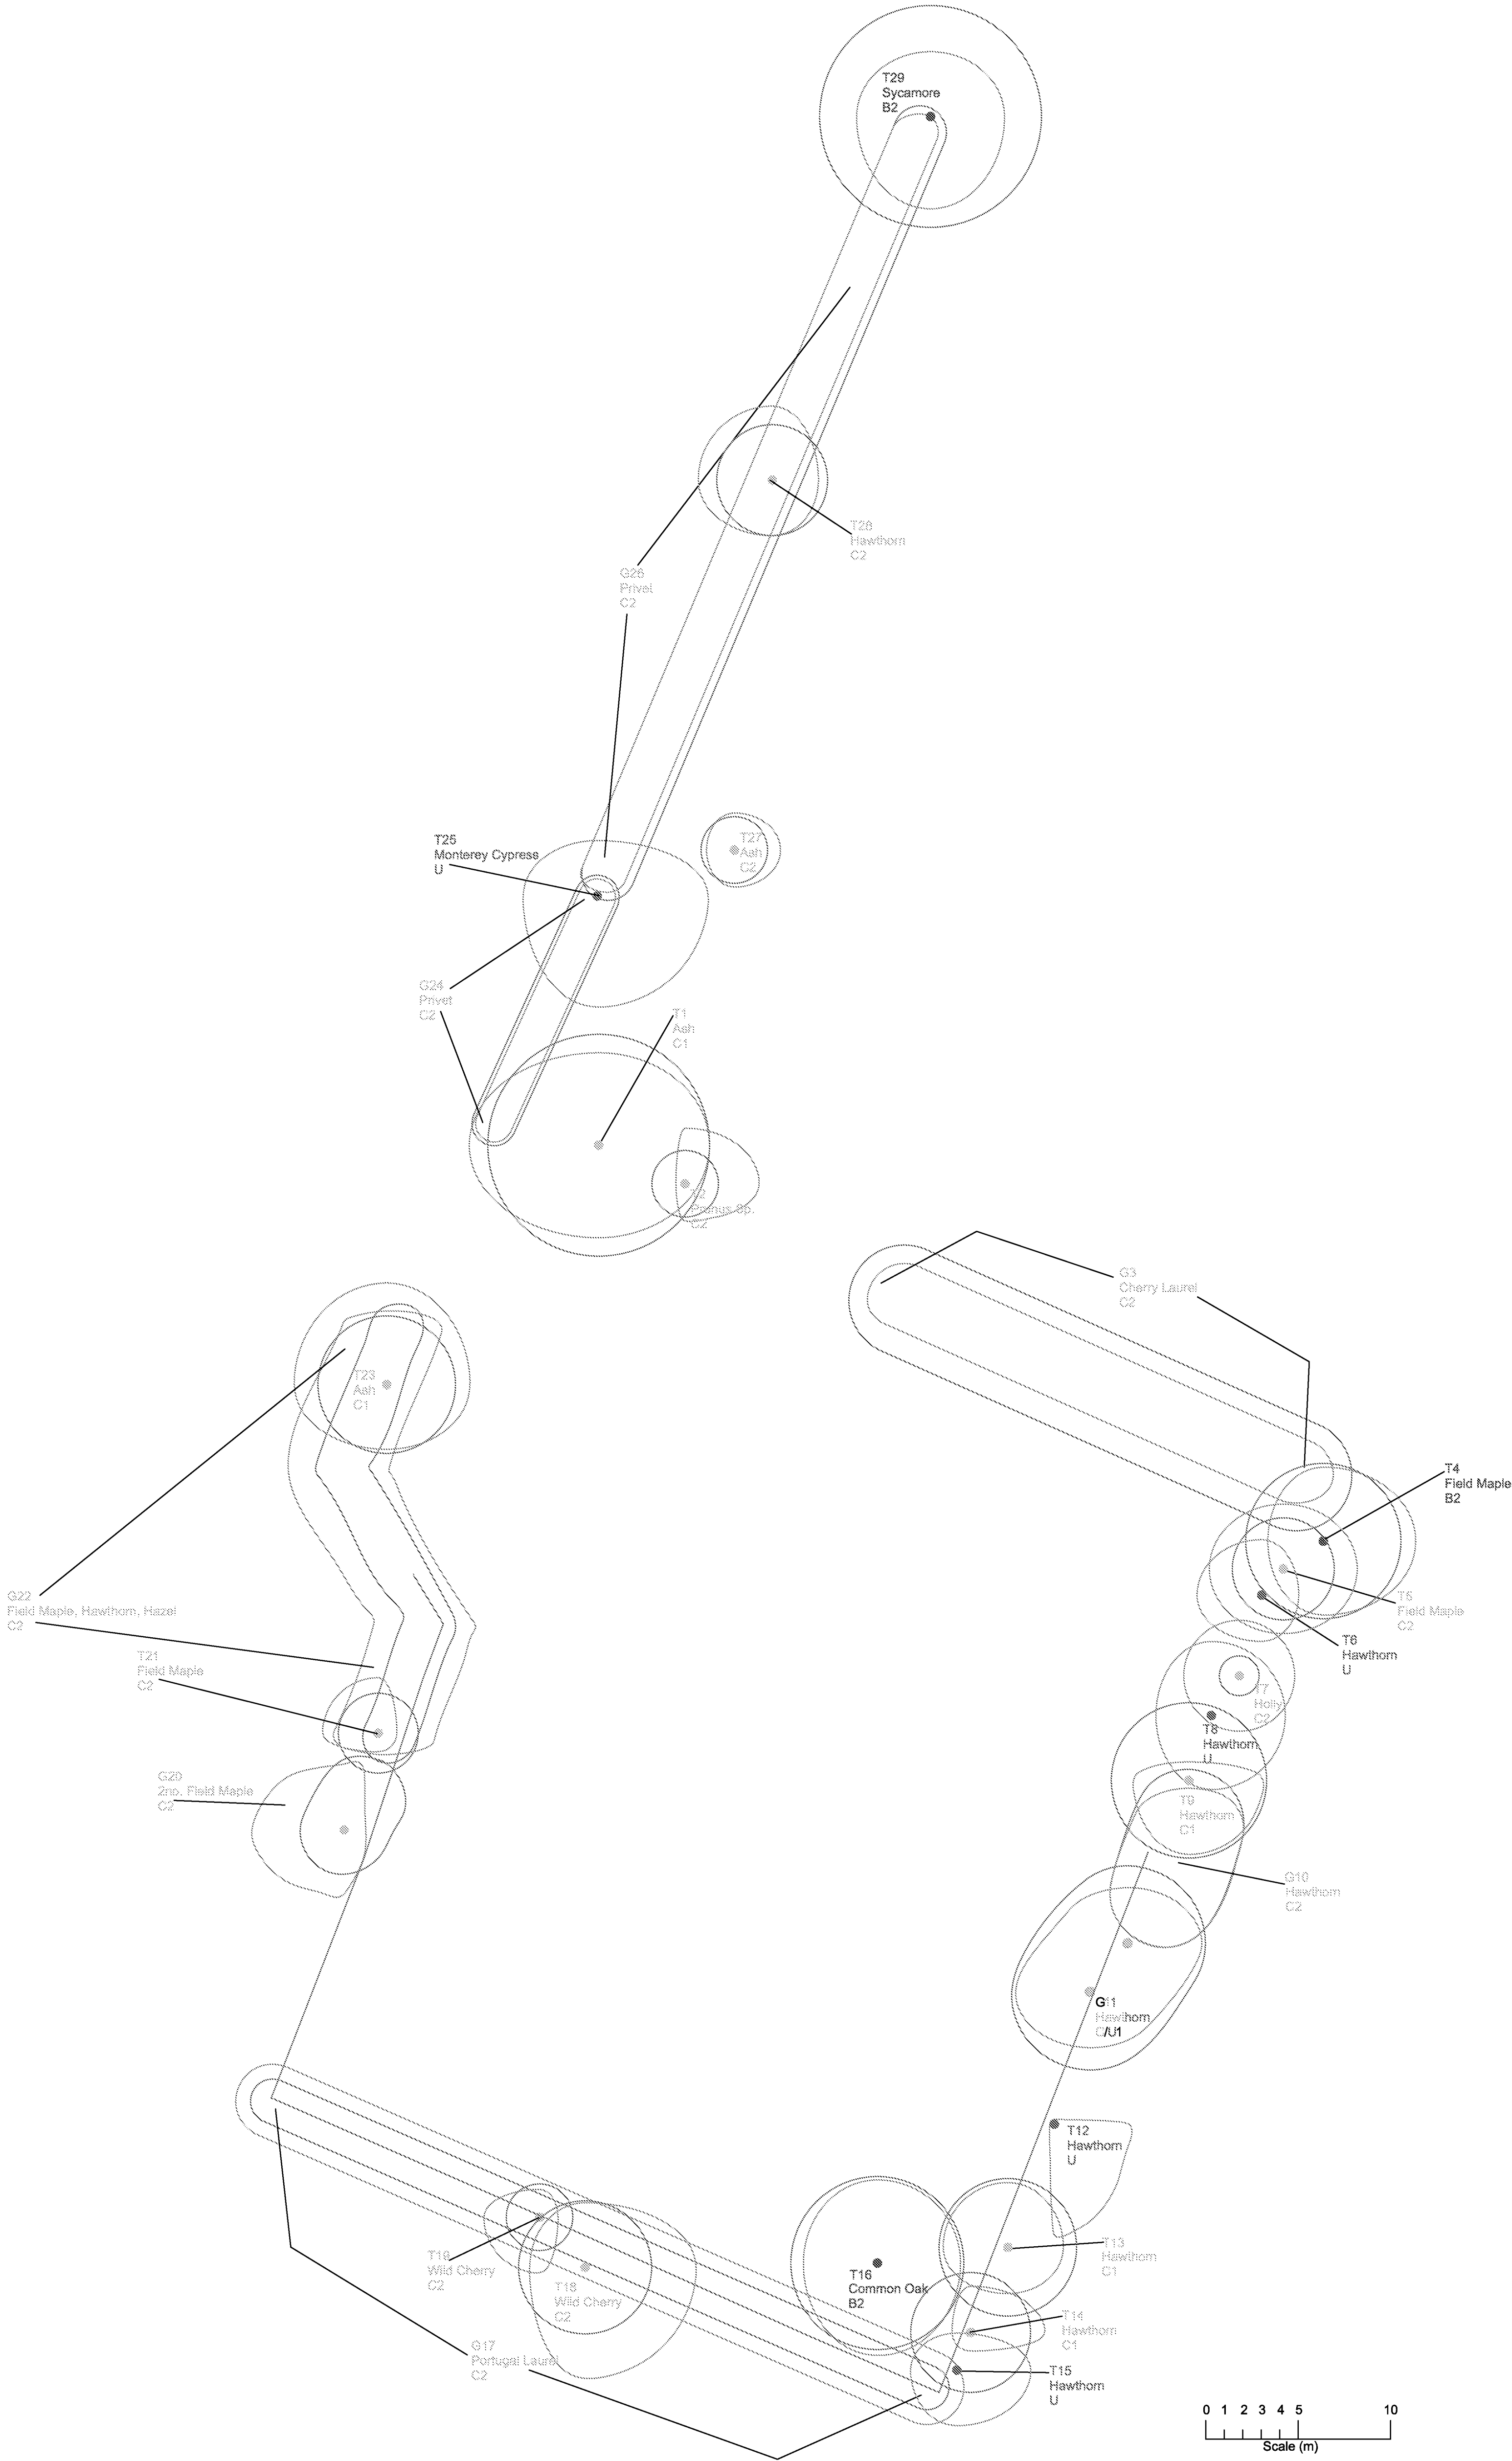
TREE CONSTRAINTS PLAN

- 4.2 The tree survey followed the numbered sequence from T1-T29 inclusive. Tree numbers, together with BS recommended colour coding of condition, have been added to the Tree Constraints Plan, our drawing no. J61.19/01 Rev. B in Appendix 2. This drawing also includes crown spreads based on four compass points and BS calculated root protection areas.
- 4.3 The following categories of information were obtained for each tree. Separate detailed tree survey sheets are attached in Appendix 1, together with comprehensive explanatory sheets which cover the details of the categories listed below.
