# **Bat & Barn Owl Assessment**

**Fairmeads Farm**

**Binsted Lane  
Binsted  
Arundel  
West Sussex  
BN18 0LH**

**Brigitte de Coriolis  
16-049-BA  
October 2016**

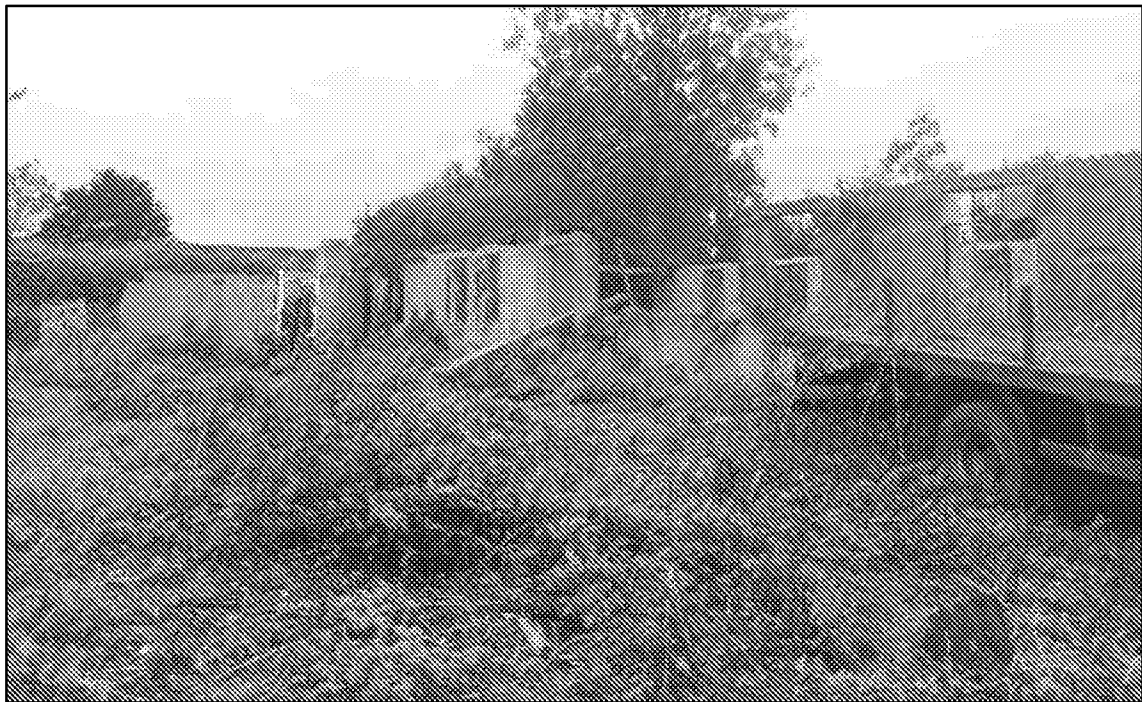
- 2.4 Building 1 is a large, L-shaped building of block construction. The building is in extremely poor condition, and only one area in the southern corner still has the corrugated asbestos roof present (Figure 3).

**Figure 3:** The western elevation of Building 1, showing the poor condition and missing roof over much of the building.

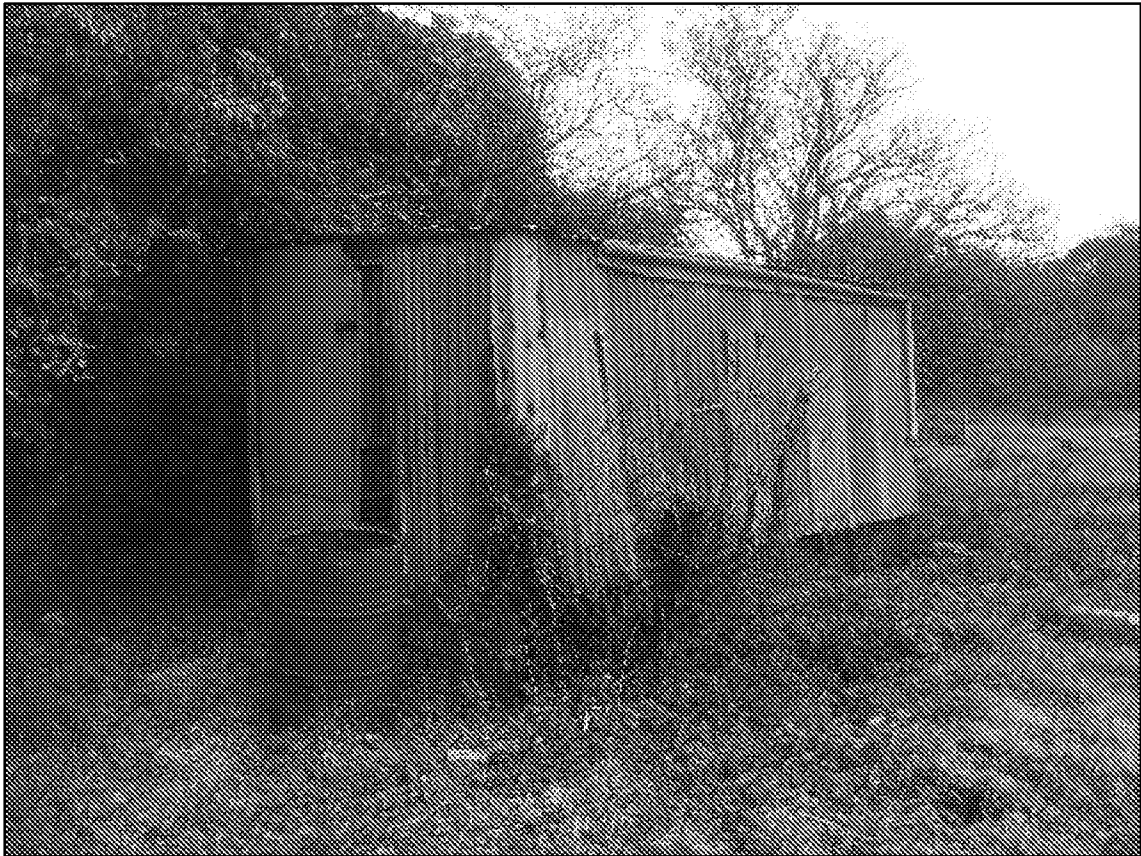
- 2.5 Building 2 is a small storage shed constructed from brick and corrugated metal sheeting near the northern boundary of the site (Figure 4).

**Figure 4:** Showing the southern elevation of Building 2.

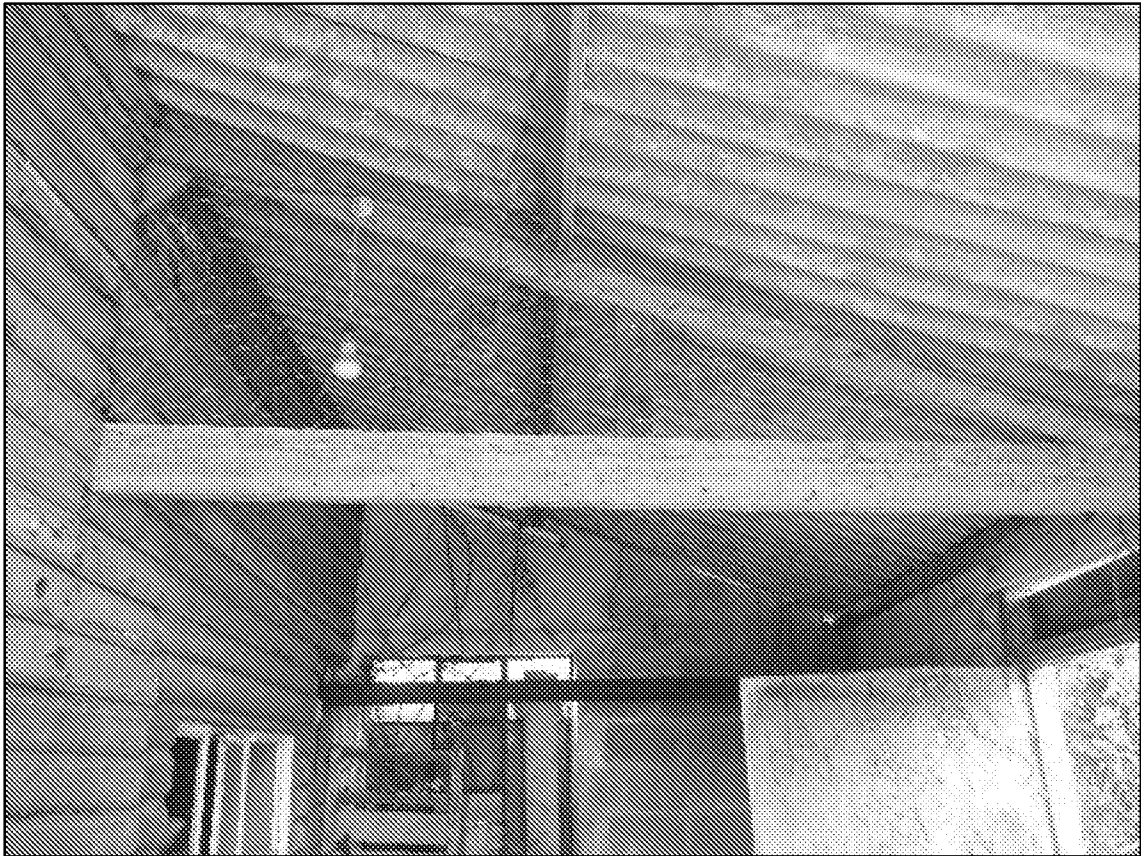
- 4.3 The roof is unlined and ivy has been growing internally for some time. Broken windows, open doorways and missing sections of timber provide easy access into the interior for both bats and barn owls. All areas were bright and draughty with thick, dusty cobwebs present (Figures 6 and 7).

**Figure 6:** Covered area at the southern end of Building 1.

- 4.4 There were no crevices suitable for roosting bats present and no bats or evidence of bats were identified internally or externally around Building 1.

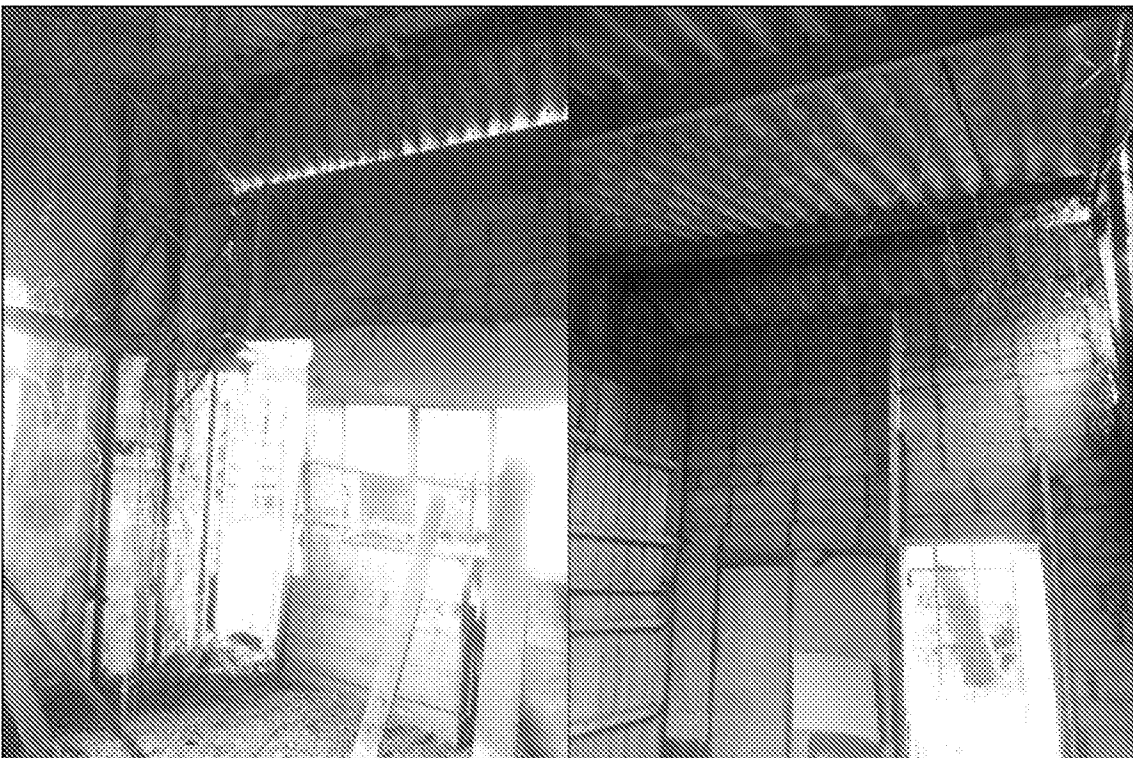
**Figure 7:** The two storage rooms at the southern end of Building 1.

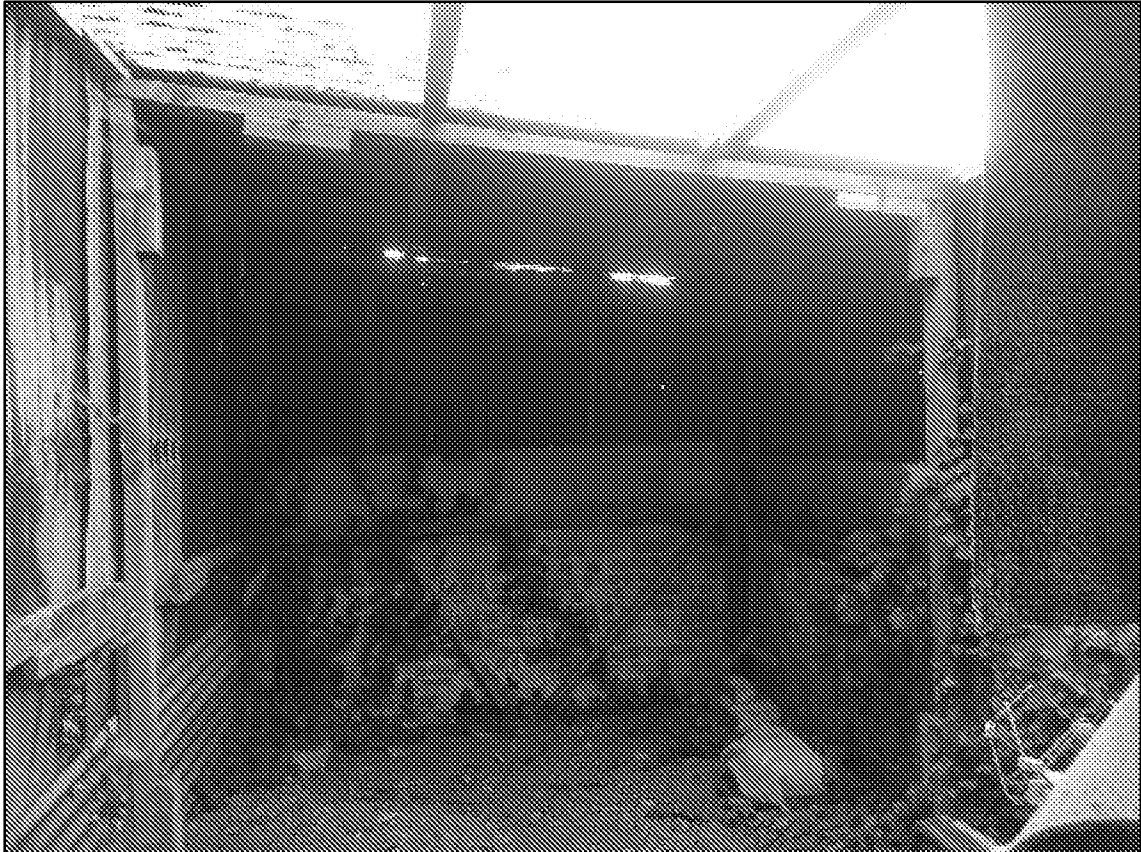
**Figure 8:** Showing the interior of Building 2 with gaps at the wall tops.

- 4.7 The metal structure of the building creates temperature fluctuations and is generally not considered suitable for bats. There were no crevices suitable for roosting bats present and no bats or evidence of bats were identified internally or externally around Building 2.
- 4.8 There were no ledges or perching opportunities suitable for barn owls, and no owls or evidence of owls was identified at any point in Building 2.

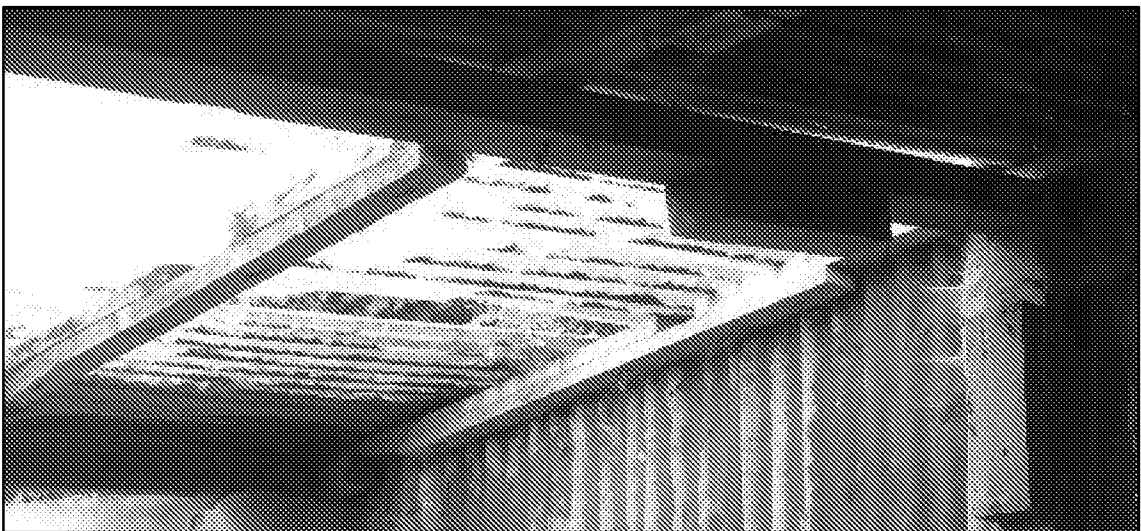
- 4.5 There were no ledges suitable for nesting barn owls, and limited perching opportunities in exposed, draughty areas. No owls or evidence of owls was identified at any point in Building 1.
- 4.6 Building 2: The building has brick lower walls on three sides, with corrugated metal upper walls. The sloped roof is half corrugated metal and half plastic roof light, making the interior very bright (Figure 8). There are gaps at the wall tops and the plastic roof light is broken leaving a long, narrow opening (Figure 9) enabling access into the interior.

**Figure 9:** Showing the opening in the roof light of Building 2.
