## **Bat & Barn Owl Assessment**

**Fairmeads Farm**

**Binsted Lane  
Binsted  
Arundel  
West Sussex  
BN18 0LH**

**Brigitte de Coriolis  
16-049-BA  
October 2016**

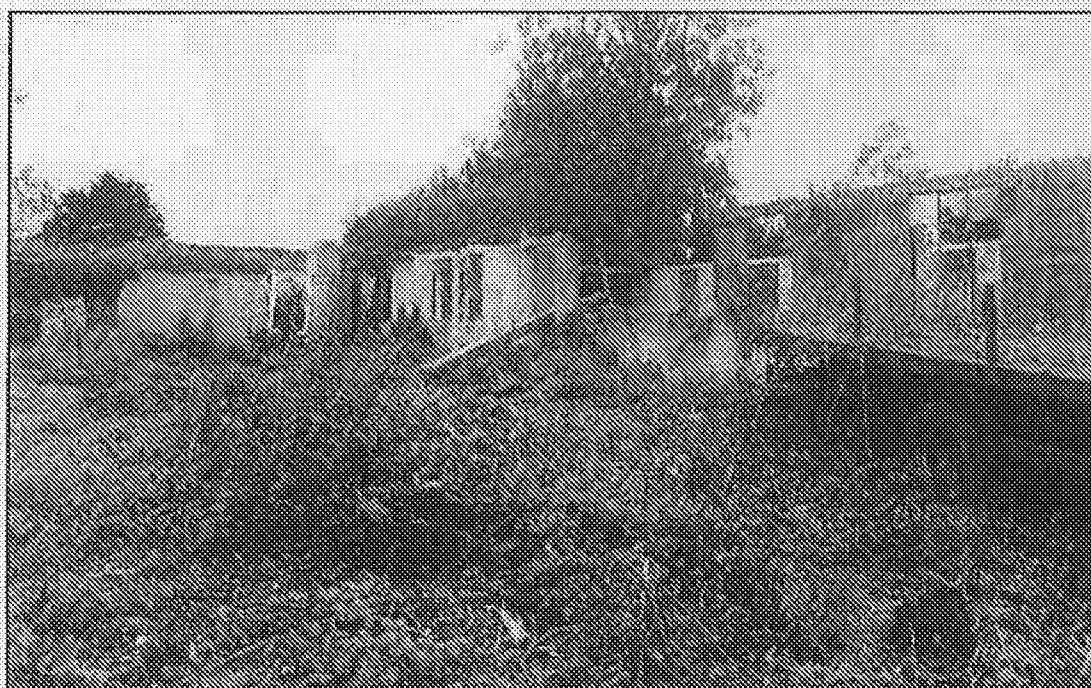
- 2.4 Building 1 is a large, L-shaped building of block construction. The building is in extremely poor condition, and only one area in the southern corner still has the corrugated asbestos roof present (Figure 3).

Figure 3: The western elevation of Building 1, showing the poor condition and missing roof over much of the building.

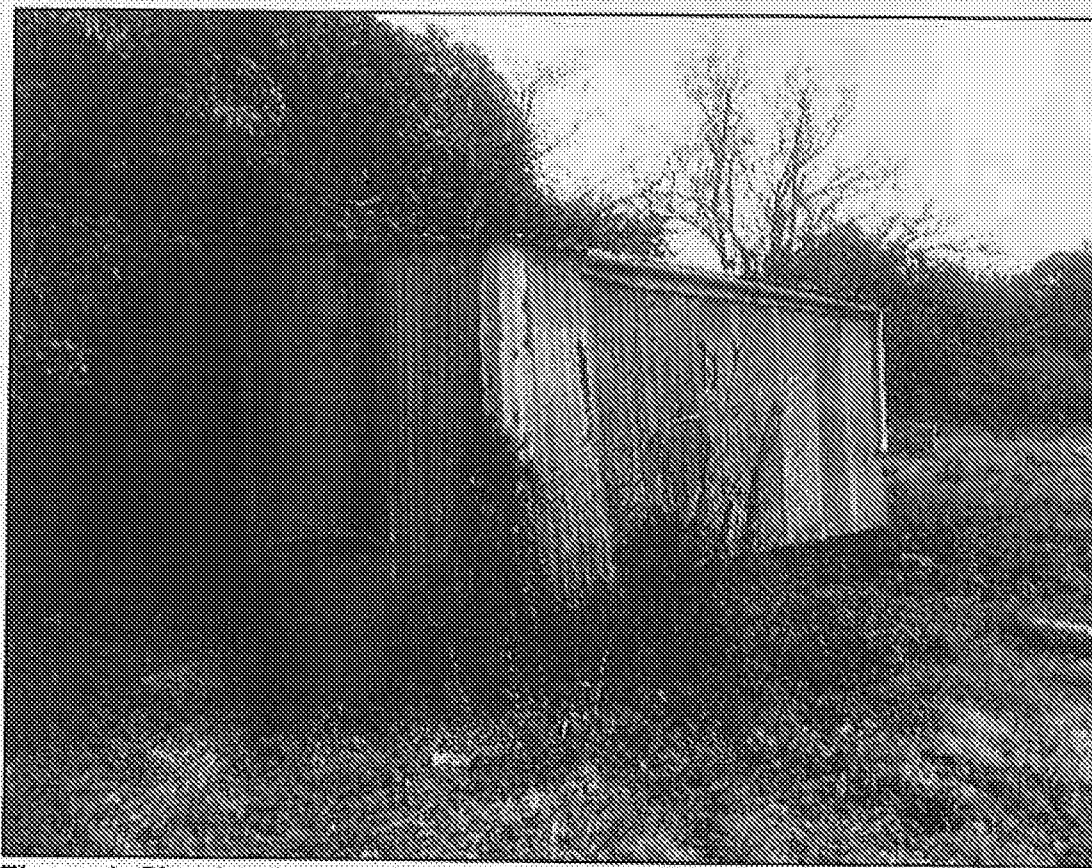
- 2.5 Building 2 is a small storage shed constructed from brick and corrugated metal sheeting near the northern boundary of the site (Figure 4).

Figure 4: Showing the southern elevation of Building 2.

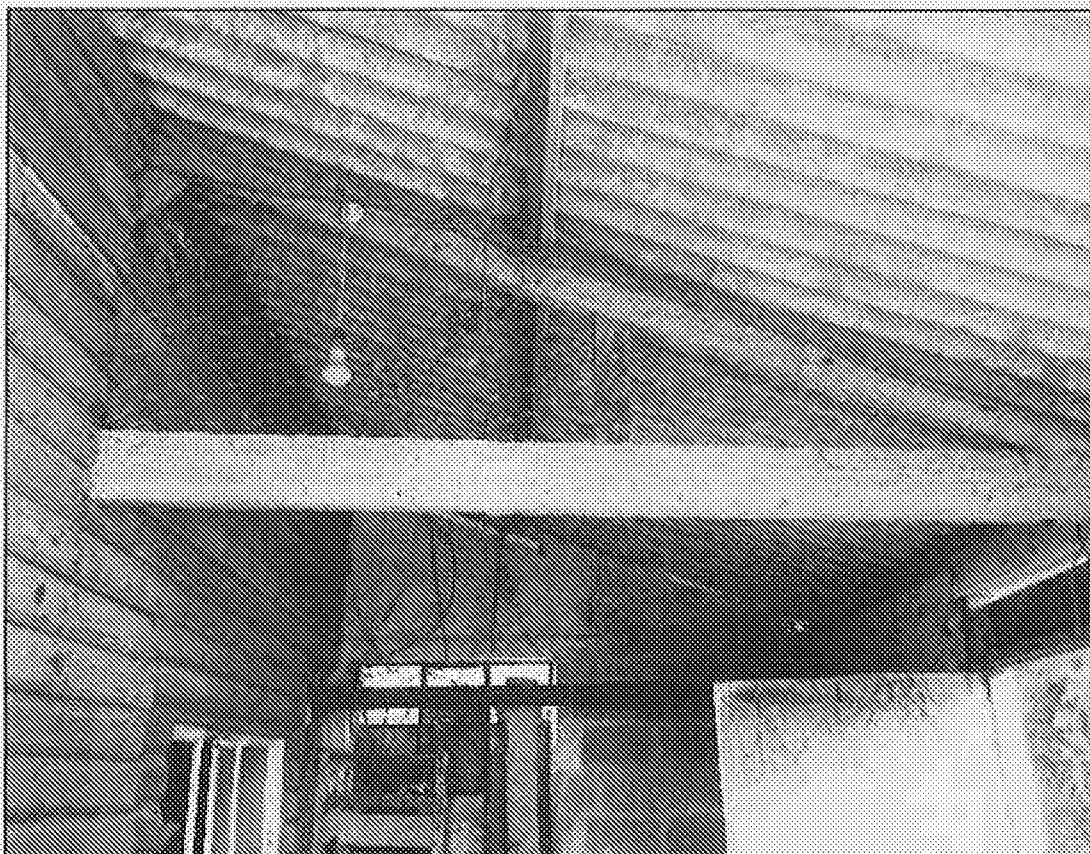
- 4.3 The roof is unlined and ivy has been growing internally for some time. Broken windows, open doorways and missing sections of timber provide easy access into the interior for both bats and barn owls. All areas were bright and draughty with thick, dusty cobwebs present (Figures 6 and 7).

**Figure 6:** Covered area at the southern end of Building 1.

- 4.4 There were no crevices suitable for roosting bats present and no bats or evidence of bats were identified internally or externally around Building 1.

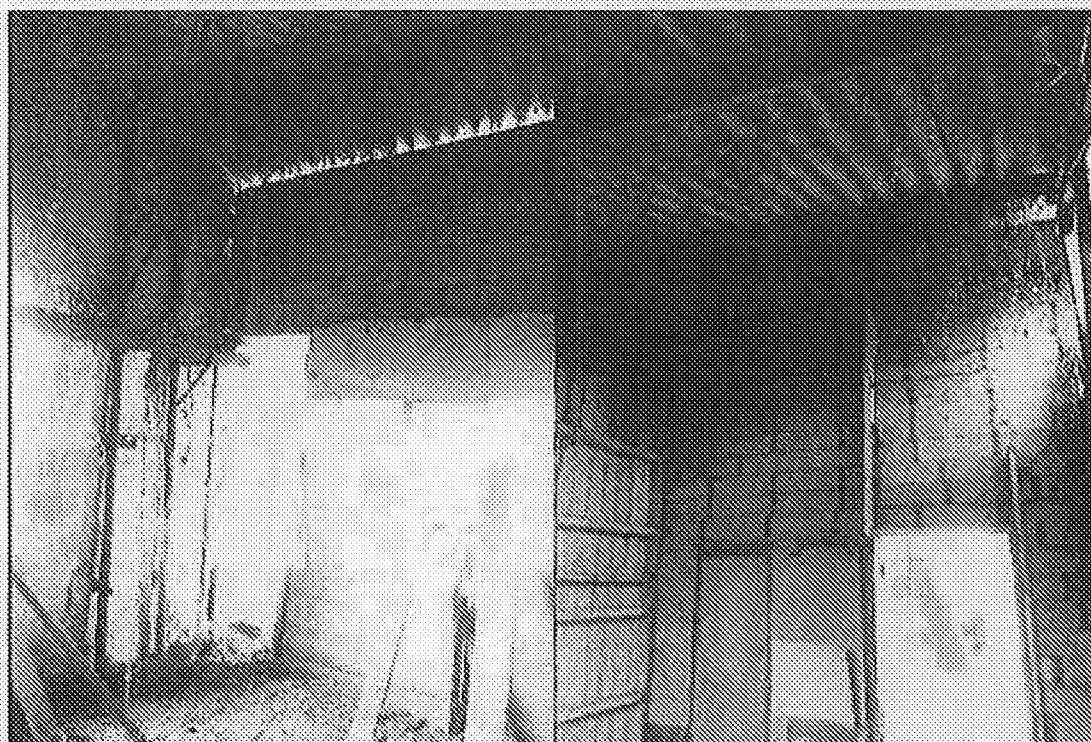
**Figure 7:** The two storage rooms at the southern end of Building 1.

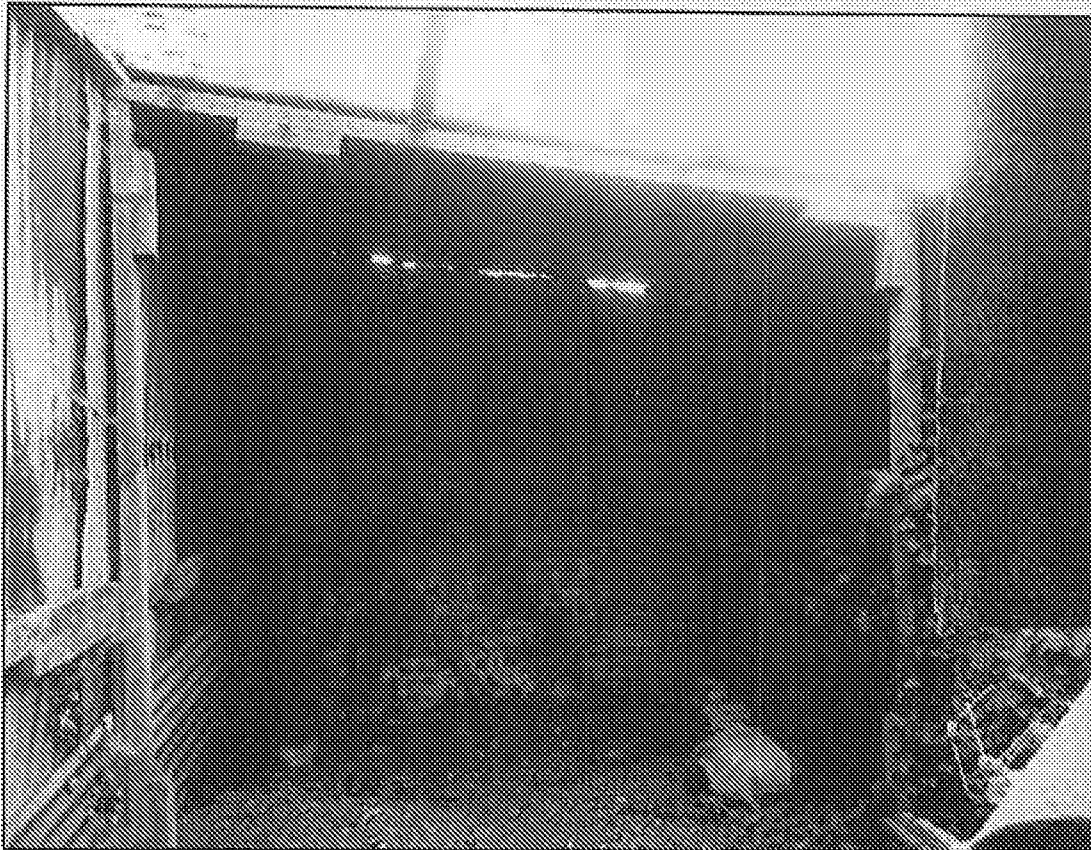
Figure 8: Showing the interior of Building 2 with gaps at the wall tops.

- 4.7 The metal structure of the building creates temperature fluctuations and is generally not considered suitable for bats. There were no crevices suitable for roosting bats present and no bats or evidence of bats were identified internally or externally around Building 2.
- 4.8 There were no ledges or perching opportunities suitable for barn owls, and no owls or evidence of owls was identified at any point in Building 2.

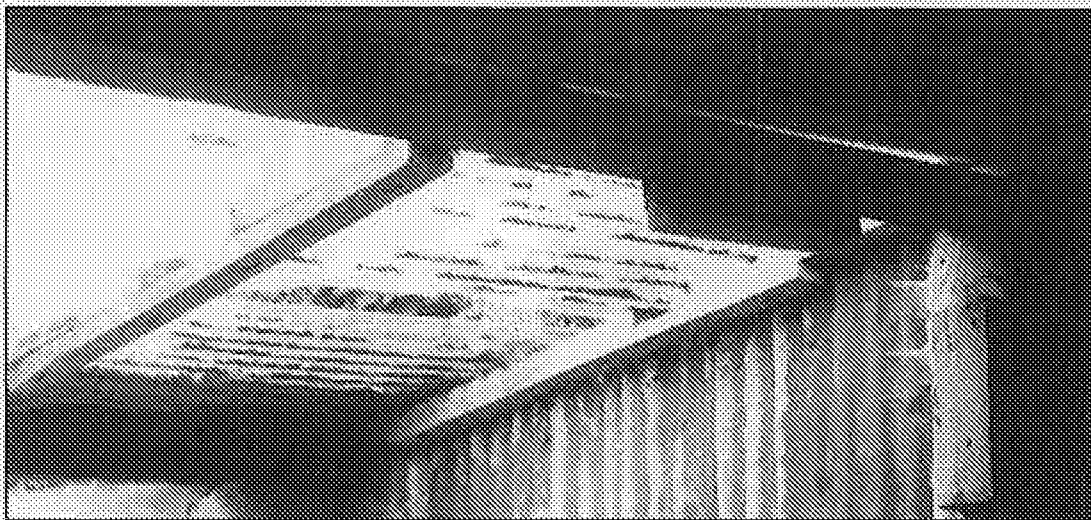
- 4.5 There were no ledges suitable for nesting barn owls, and limited perching opportunities in exposed, draughty areas. No owls or evidence of owls was identified at any point in Building 1.
- 4.6 Building 2: The building has brick lower walls on three sides, with corrugated metal upper walls. The sloped roof is half corrugated metal and half plastic roof light, making the interior very bright (Figure 8). There are gaps at the wall tops and the plastic roof light is broken leaving a long, narrow opening (Figure 9) enabling access into the interior.

Figure 9: Showing the opening in the roof light of Building 2.
