# ARBORICULTURAL SURVEY, IMPACT ASSESSMENT AND PROTECTION PLAN

RESERVED MATTERS SUBMISSION FOR THE CONSTRUCTION  
OF 175 DWELLINGS AND ASSOCIATED INFRASTRUCTURE

LAND EAST OF TYE LANE,  
WALBERTON, ARUNDEL

LINDEN HOMES SOUTH

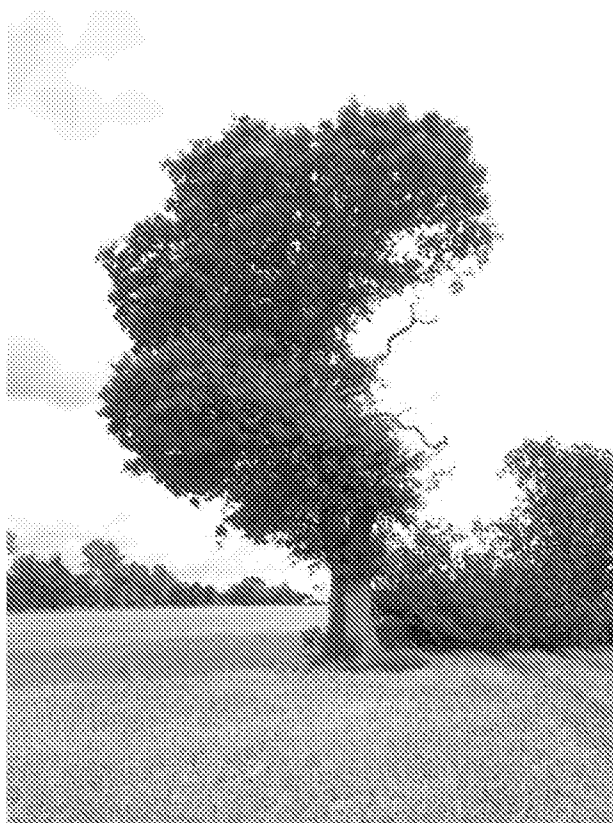
*Photoview 1: Looking east at T28, image taken on 14/9/18, illustrating the more recent tear out/failure. (TPO/WA/3/17)*

- 10.8 Some minor facilitation pruning in the form of crown raising and possible reduction of lateral spread of G21 will be required over the proposed footpath.
- 10.9 T28 will require crown reduction/veteranisation in order to re-balance its canopy after the recent failure of a significant structural limb. The anticipated reduced canopy dimensions are indicated on the Combined Tree Retention/Removal and Protection Plan at **APPENDIX 3**. The photosheet at **APPENDIX 4** illustrates the extent of the pruning works proposed for T28 in order to retain the tree within the context of the development. A combination of pruning cuts made to BS:3998 and veteranisation techniques e.g. tear cuts/coronet cuts should be employed during the tree works. This should assist in promoting the longevity of tree along with its ecological value.

- 13.5 T28 will require crown reduction/veteranisation in order to re-balance the canopy after the recent failure of a significant structural limb. A combination of pruning cuts made to BS:3998 and veteranisation techniques e.g. tear cuts/coronet cuts should be employed during the tree works. This should assist in promoting the longevity of tree along with its ecological value.

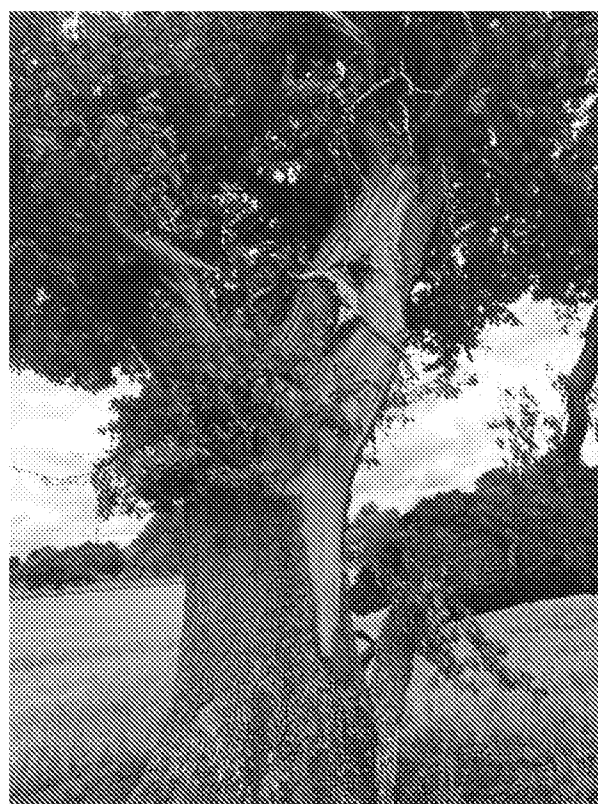
*Photoview 2: close up of the point of failure and subsequent tearing of structural branch, stem and cambium. (TPO/WA/3/17)*

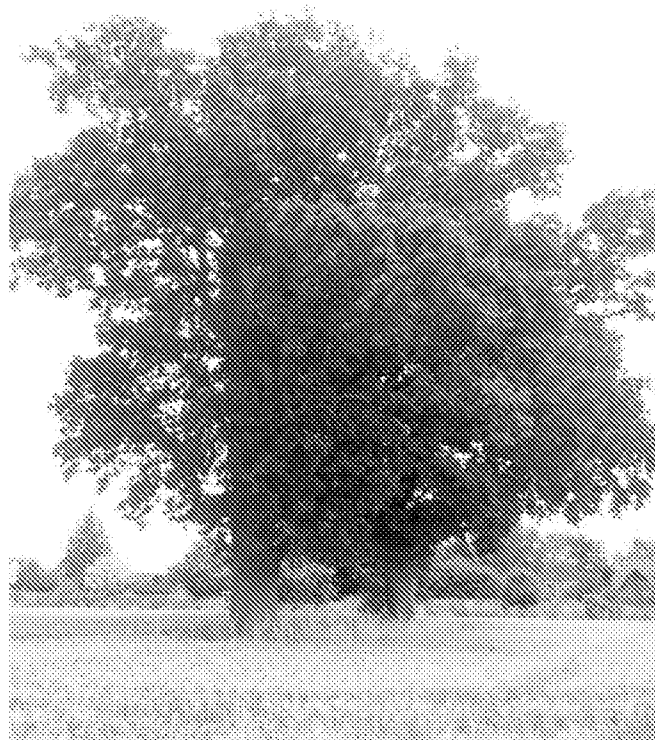
*Photoview 3: Looking east at the 2 Category A (high quality) English oak trees T39,T40. (TPO/WA/1/16)*

| Ref | Species | Height (m) | No. of Stems | Est diam? | Calc. / Actual Stem Dia. (mm) | Crown radii (m) N-E-S-W | Avg. Canopy Height (m) | 1st branch ht (m) | 1st branch dir. | Life Stage | General Observations | Health & vitality | Struct. cond. | Estimated Remaining Contribution (Years) | BS5837 Category | RPA Radius (m) | RPA m² | TPO |
|---|---|---|---|---|---|---|---|---|---|---|---|---|---|---|---|---|---|---|
| T39 | English oak | 16.5 | 1 | - | 1400 | 9.50-8.00-11.00-10.00 | 5.0 | 3 | S | M | Significant tree with no visible defects other than medium diameter historic branch tear outs in the N canopy. Crown is slightly more sparse in foliage in comparison to the neighbouring oak. | Good | Good | 40+ | A2 | 1.7 | 9 | Yes |
| T40 | English oak | 18.0 | 1 | - | 1280 | 13.00-11.00-11.50-9.50 | 5.0 | 4 | S | M | Significant tree with no visible defects, forming a cohesive canopy with the neighbouring oak. | Good | Good | 40+ | A2 | 15.0 | 707 | Yes |

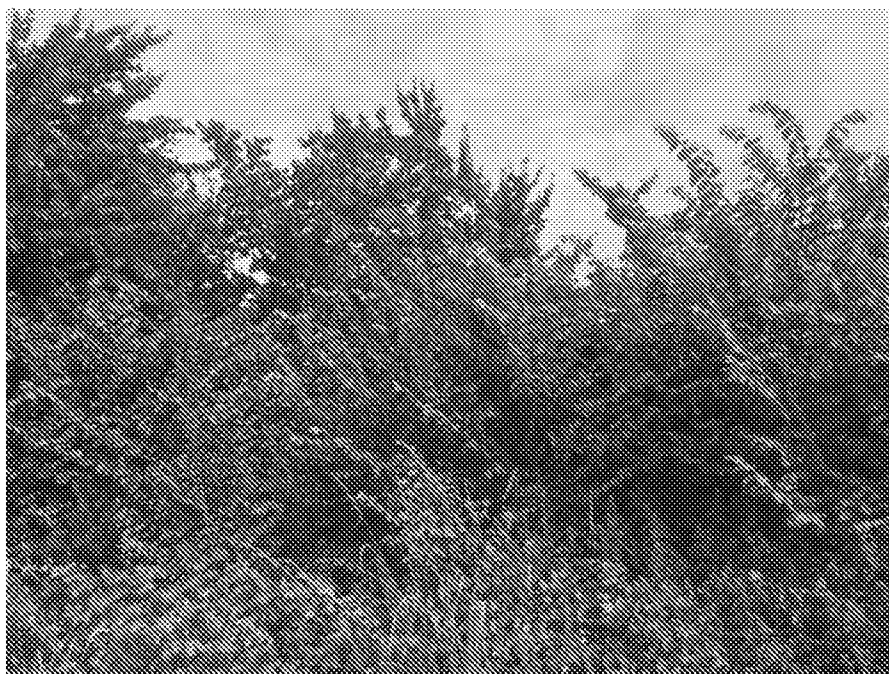
*Photoview 4: Looking east at G23, low quality group requiring removal to facilitate the visibility splay for the site access.*

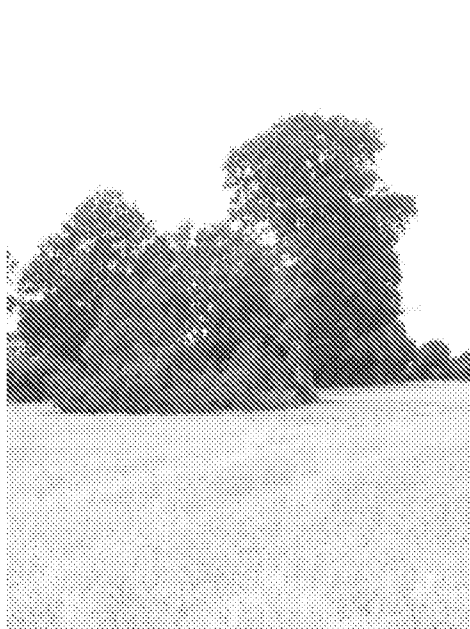
Image 1: View of T28 from the east showing the failed portion of the tree on the ground.

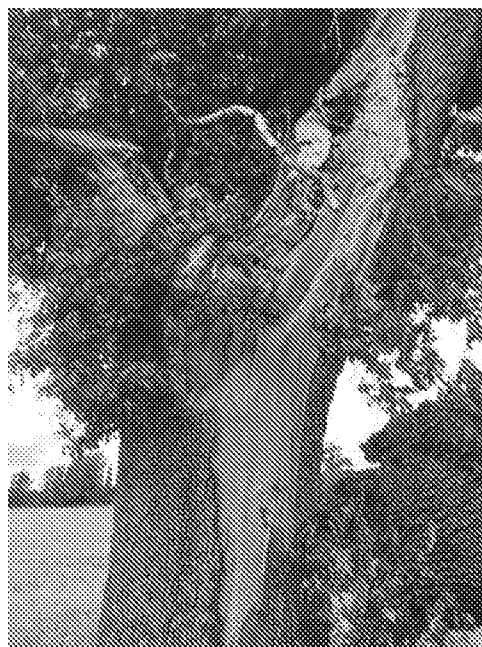
Image 2: View of southern side of the trunk of T28 showing the large branch tear out wound

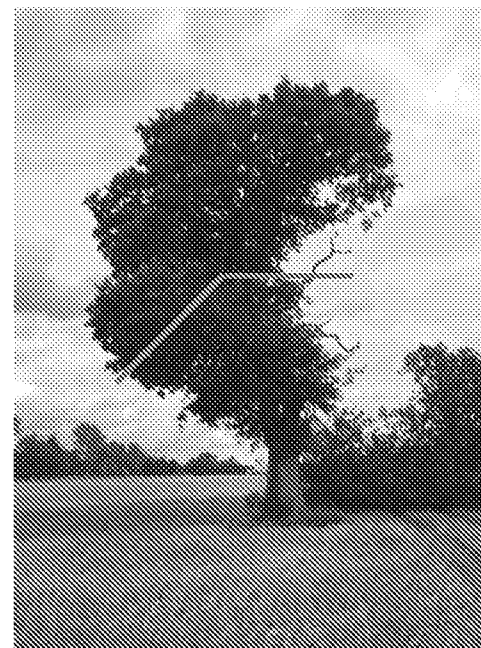
Image 3: View of T28 from the west showing the significant disfiguration to the canopy shape and the extent of the tree works (canopy reduction) required to retain the tree in a safe and appropriate form,

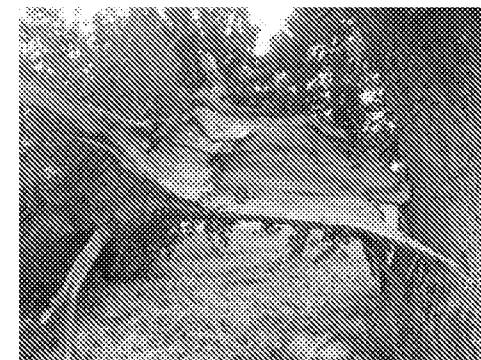
Image 4: Close up of the failed stem on the gourd with mobile phone shown for scale.
