Barton Hyett  
Arboricultural Consultants

# ARBORICULTURAL SURVEY, IMPACT ASSESSMENT AND PROTECTION PLAN

RESERVED MATTERS SUBMISSION FOR THE CONSTRUCTION  
OF 175 DWELLINGS AND ASSOCIATED INFRASTRUCTURE

LAND EAST OF TYE LANE,  
WALBERTON, ARUNDEL

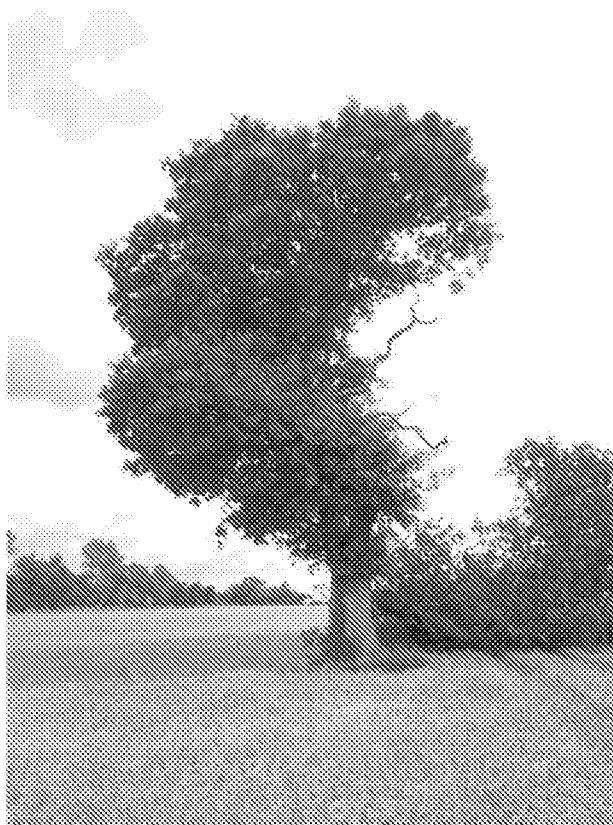
*Photoview 1: Looking east at T28, image taken on 14/9/18, illustrating the more recent tear out/failure. (TPO/WA/3/17)*

- 10.8 Some minor facilitation pruning in the form of crown raising and possible reduction of lateral spread of G21 will be required over the proposed footpath.
- 10.9 T28 will require crown reduction/veteranisation in order to re-balance its canopy after the recent failure of a significant structural limb. The anticipated reduced canopy dimensions are indicated on the Combined Tree Retention/Removal and Protection Plan at **APPENDIX 3**. The photosheet at **APPENDIX 4** illustrates the extent of the pruning works proposed for T28 in order to retain the tree within the context of the development. A combination of pruning cuts made to BS:3998 and veteranisation techniques e.g. tear cuts/coronet cuts should be employed during the tree works. This should assist in promoting the longevity of tree along with its ecological value.

- 13.4 T28 will require crown reduction/veteranisation in order to re-balance the canopy after the recent failure of a significant structural limb. A combination of pruning cuts made to BS:3998 and veteranisation techniques e.g. tear cuts/coronet cuts should be employed during the tree works. This should assist in promoting the longevity of tree along with its ecological value.

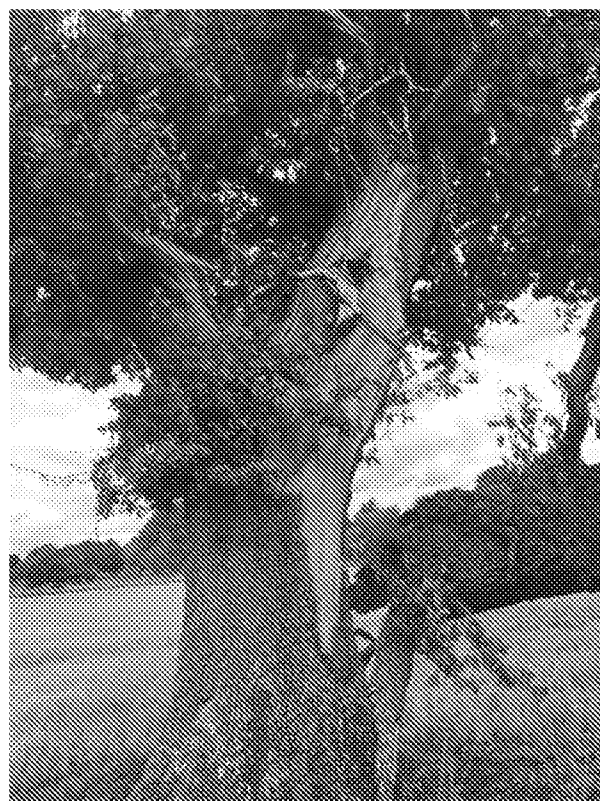
*Photoview 2: close up of the point of failure and subsequent tearing of structural branch, stem and cambium. (TPO/WA/3/17)*

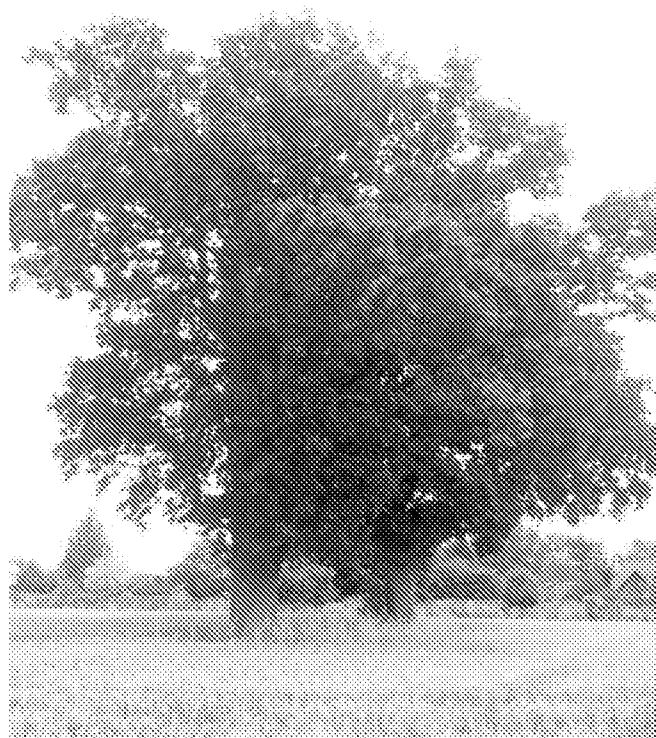
*Photoview 3: Looking east at the 2 Category A (high quality) English oak trees T39, T40. (TPO/WA/1/16)*

| Ref | Species | Height (m) | No. of Stems | Est diam? | Calc. / Actual Stem Dia. (mm) | Crown radii (m) N-E-S-W | Avg. Canopy Height (m) | 1st branch ht (m) | 1st branch dir. | Life Stage | General Observations | Health & vitality | Struct. cond. | Estimated Remaining Contribution (Years) | BS5837 Category | RPA Radius (m) | RPA m² | TPO |
|---|---|---|---|---|---|---|---|---|---|---|---|---|---|---|---|---|---|---|
| T39 | English oak | 16.5 | 1 | - | 1400 | 9.50-8.00-11.00-10.00 | 5.0 | 3 | S | M | Significant tree with no visible defects other than medium diameter historic branch tear outs in the N canopy. Crown is slightly more sparse in foliage in comparison to the neighbouring oak. | Good | Good | 40+ | A2 | 1.7 | 9 | Yes |
| T40 | English oak | 18.0 | 1 | - | 1280 | 13.00-11.00-11.50-9.50 | 5.0 | 4 | S | M | Significant tree with no visible defects, forming a cohesive canopy with the neighbouring oak. | Good | Good | 40+ | A2 | 15.0 | 707 | Yes |

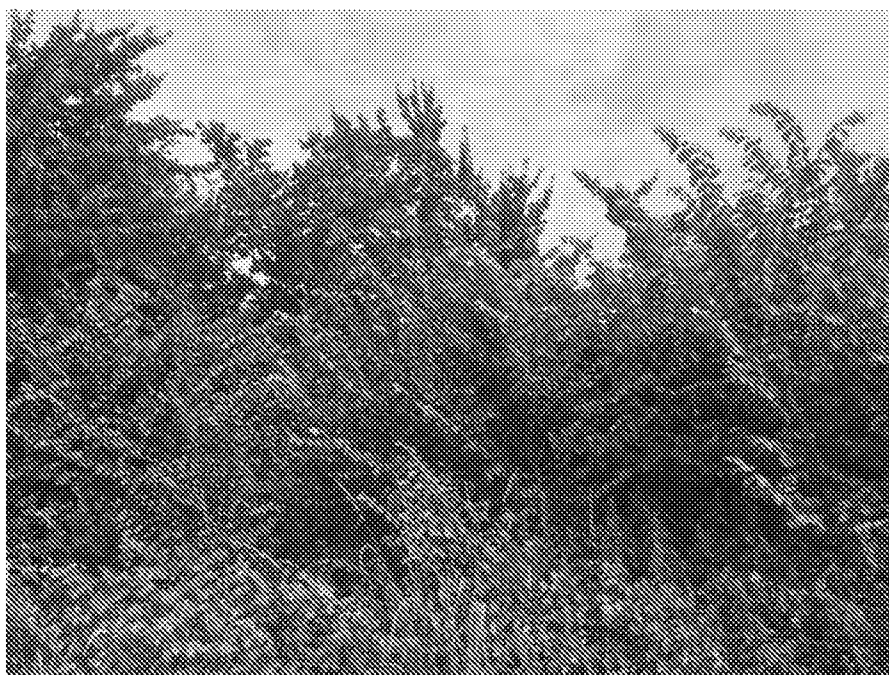
*Photoview 4: Looking east at G23, low quality group requiring removal to facilitate the visibility splay for the site access.*

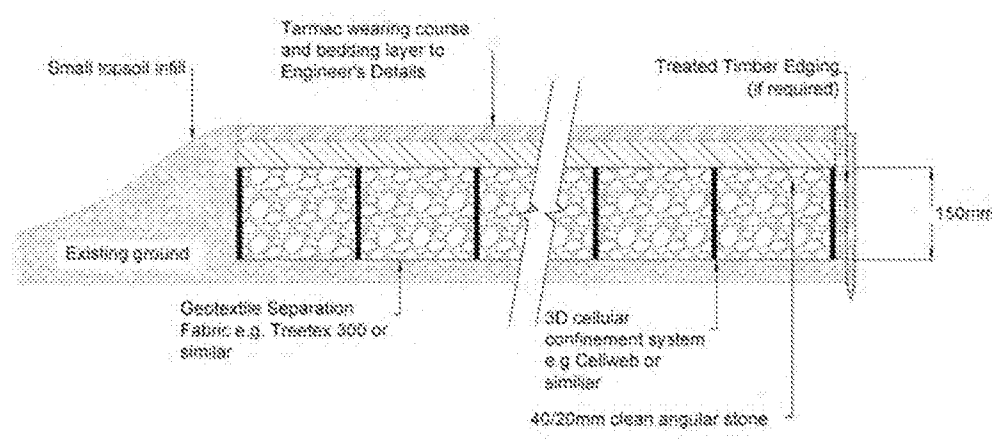
Figure 1: Proposed 'no dig' construction detail for paths within RPAs.

- 10.14 Hard surfacing, in the form of a pedestrian footpath is proposed to be installed within the east portions of the RPA's associated to T28 and in part within the RPA of T38. The alignment of the path in the RPA of T28 been moved further away from the tree since the last iteration of the proposed site layout. Both paths will be of a 'no dig' design that are prepared in response to the soil conditions present and acknowledges the previous land management of the area around T28 and T38. The proposed construction 'no dig' construction detail, including a tarmac wearing course is shown in Figure 1 below. Please note, this section is subject to final approved from the project engineer.

- 10.15 The construction of the footpaths must be undertaken in line with a detailed Arboricultural Method Statement (AMS) in order to control construction activity and eliminate potential impacts. Secondary protective barrier locations are shown on the plan at **APPENDIX 3** which must be used during the construction of the paths. The installation of the paths will be undertaken with an Arboricultural watching brief in place.

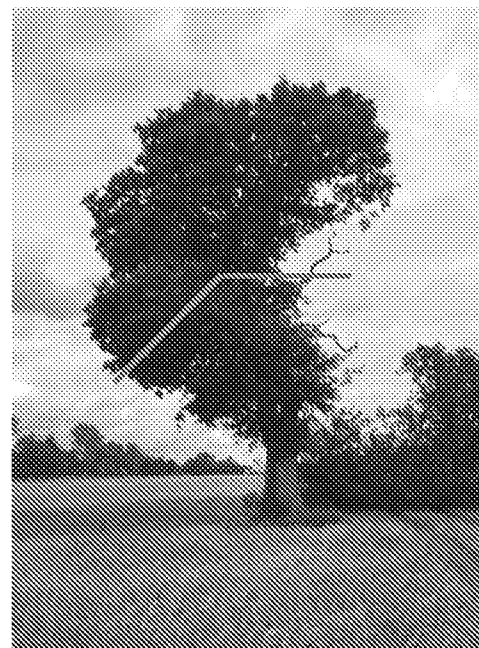
Image 3: View of T28 from the west showing the significant disfiguration to the canopy shape and the extent of the tree works (canopy reduction) required to retain the tree in a safe and appropriate form,
