# ARBORICULTURAL SURVEY, IMPACT ASSESSMENT AND PROTECTION PLAN

RESERVED MATTERS SUBMISSION FOR THE CONSTRUCTION  
OF 175 DWELLINGS AND ASSOCIATED INFRASTRUCTURE

LAND EAST OF TYE LANE,  
WALBERTON, ARUNDEL

LINDEN HOMES SOUTH

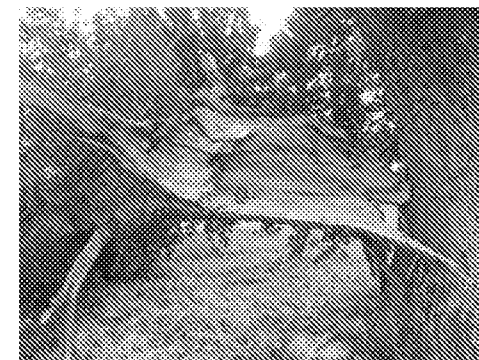
Image 4: Close up of the failed stem on the gourd with mobile phone shown for scale.
