# CLAYS FARM

## Tree Survey Report and Arboricultural Impact Assessment

JSL3904\_770  
Tree Survey and  
Arboricultural Impact  
Assessment  
-  
03 February 2021

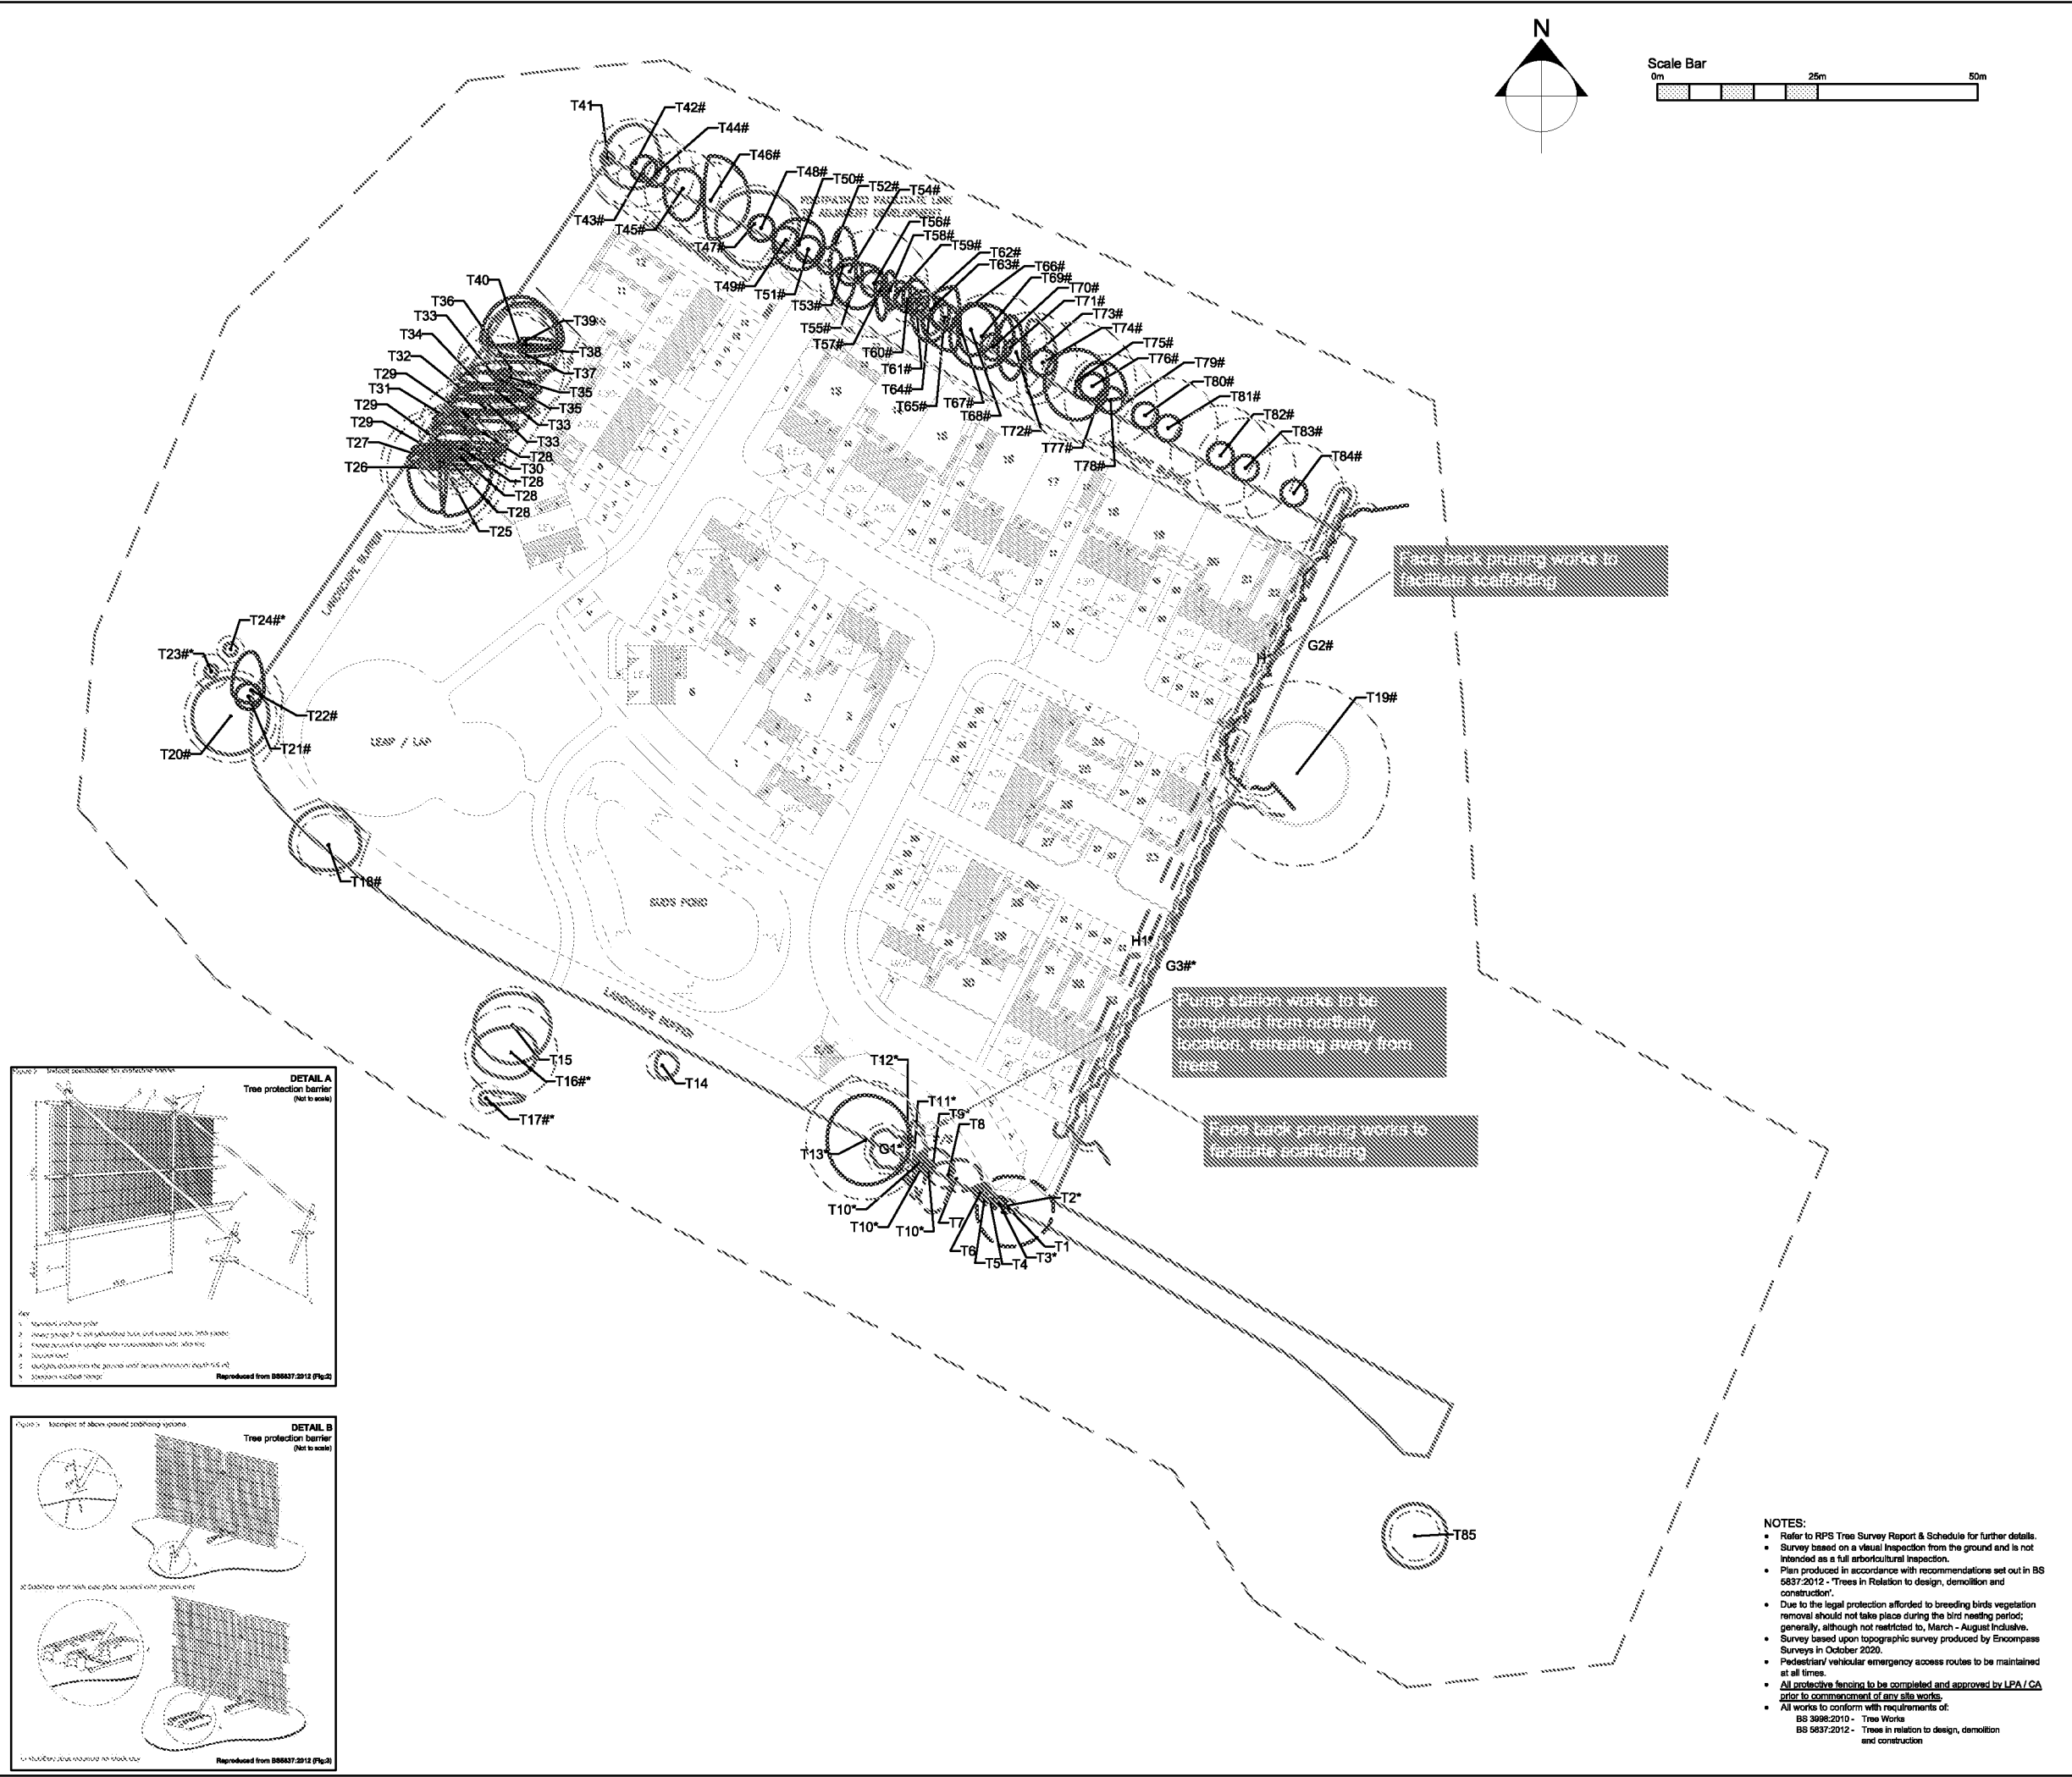
### Tree Protection and Removal Plan JSL3904\_710

- 8.1 A comprehensive tree survey has been completed on the site and its immediate surroundings. The survey was completed in accordance with BS5837:2012.
- 8.2 In order for this development to be realised, T1 to T12 and partial removal of H1 requires removal.
- 8.3 Where the development overlaps with the RPAs of T49 and T56 'no-dig' design principles, in accordance with APN12 will be adopted to protect the roots.
- 8.4 From an arboreal perspective, subject to the satisfactory implementation of the recommendations contained within report, it is considered that the proposed scheme has no arboricultural impacts.
