# Initial Arboricultural Survey

Land North of:  
Stakers Farm  
North End Road  
Yapton

3 May 2017

PJC ref: 4372/17-01

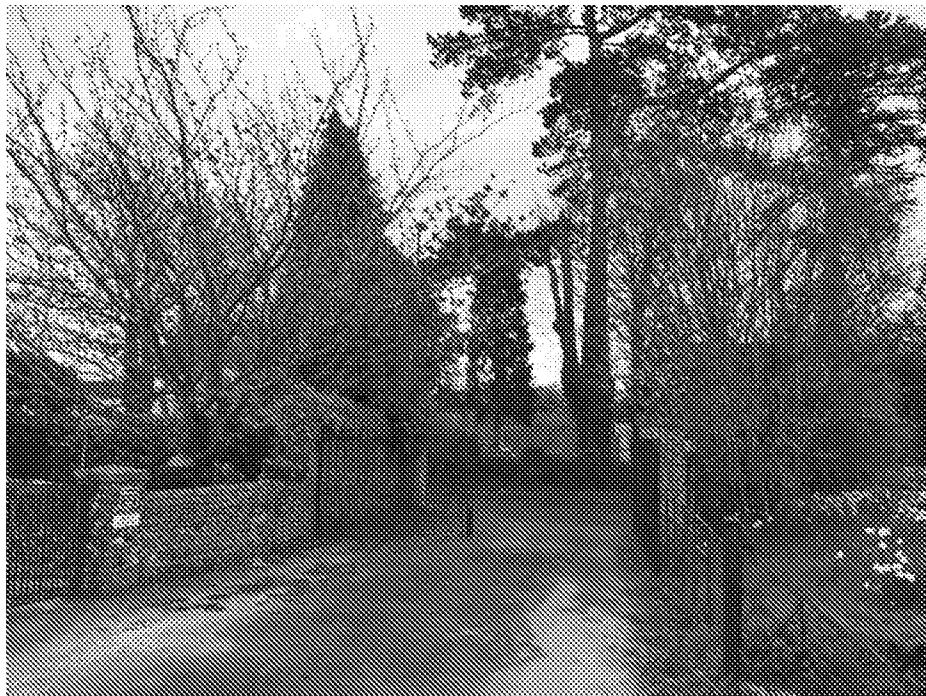
**Photograph 1** – Existing mature trees at main entrance hard standing surfaces within some RPAs.

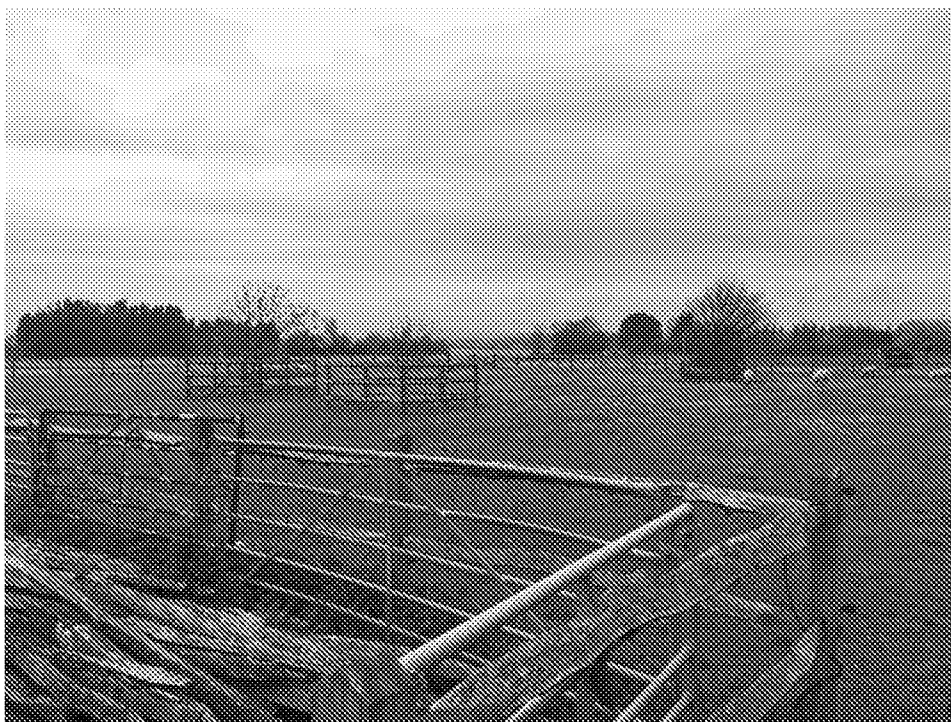
**Photograph 2** – View toward existing paddock showing young trees within.
