**Arboricultural Report**  
**composed of**  
**Arboricultural Impact Assessment**  
**Arboricultural Method Statement**  
**& Tree Protection Plan**

Church Farm House  
Church Lane  
Yapton BN18 0EP

Written by  
Barry Holdsworth MBA, RHS. Dip, MCI Hort, M.Arbor.A, MCMI  
Horticultural Consultant

13th August 2025

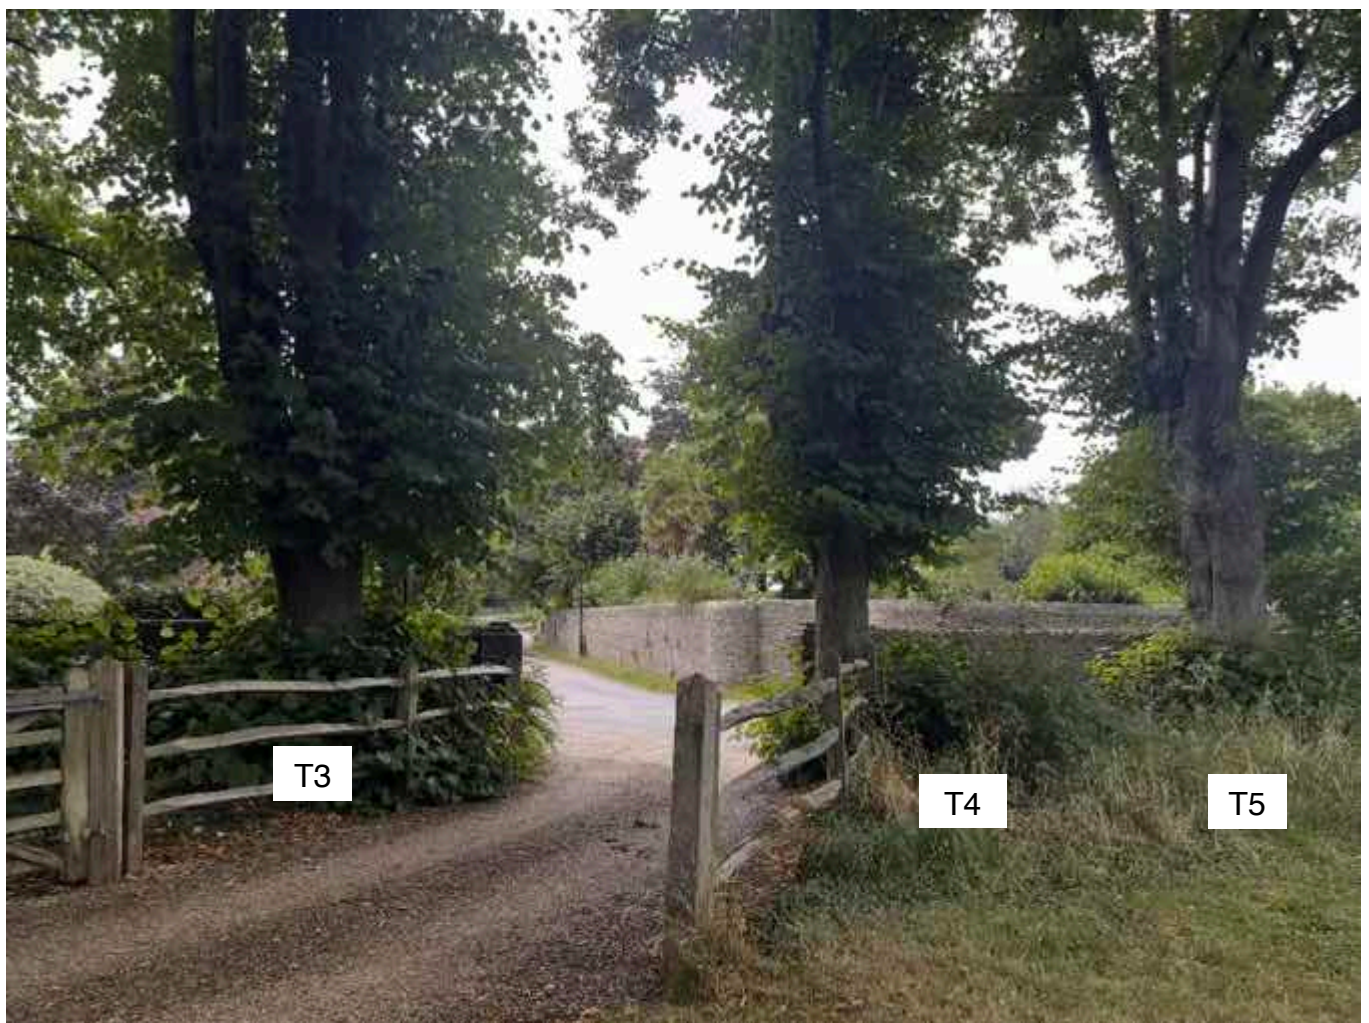
Post and Rail fence to be removed to allow access

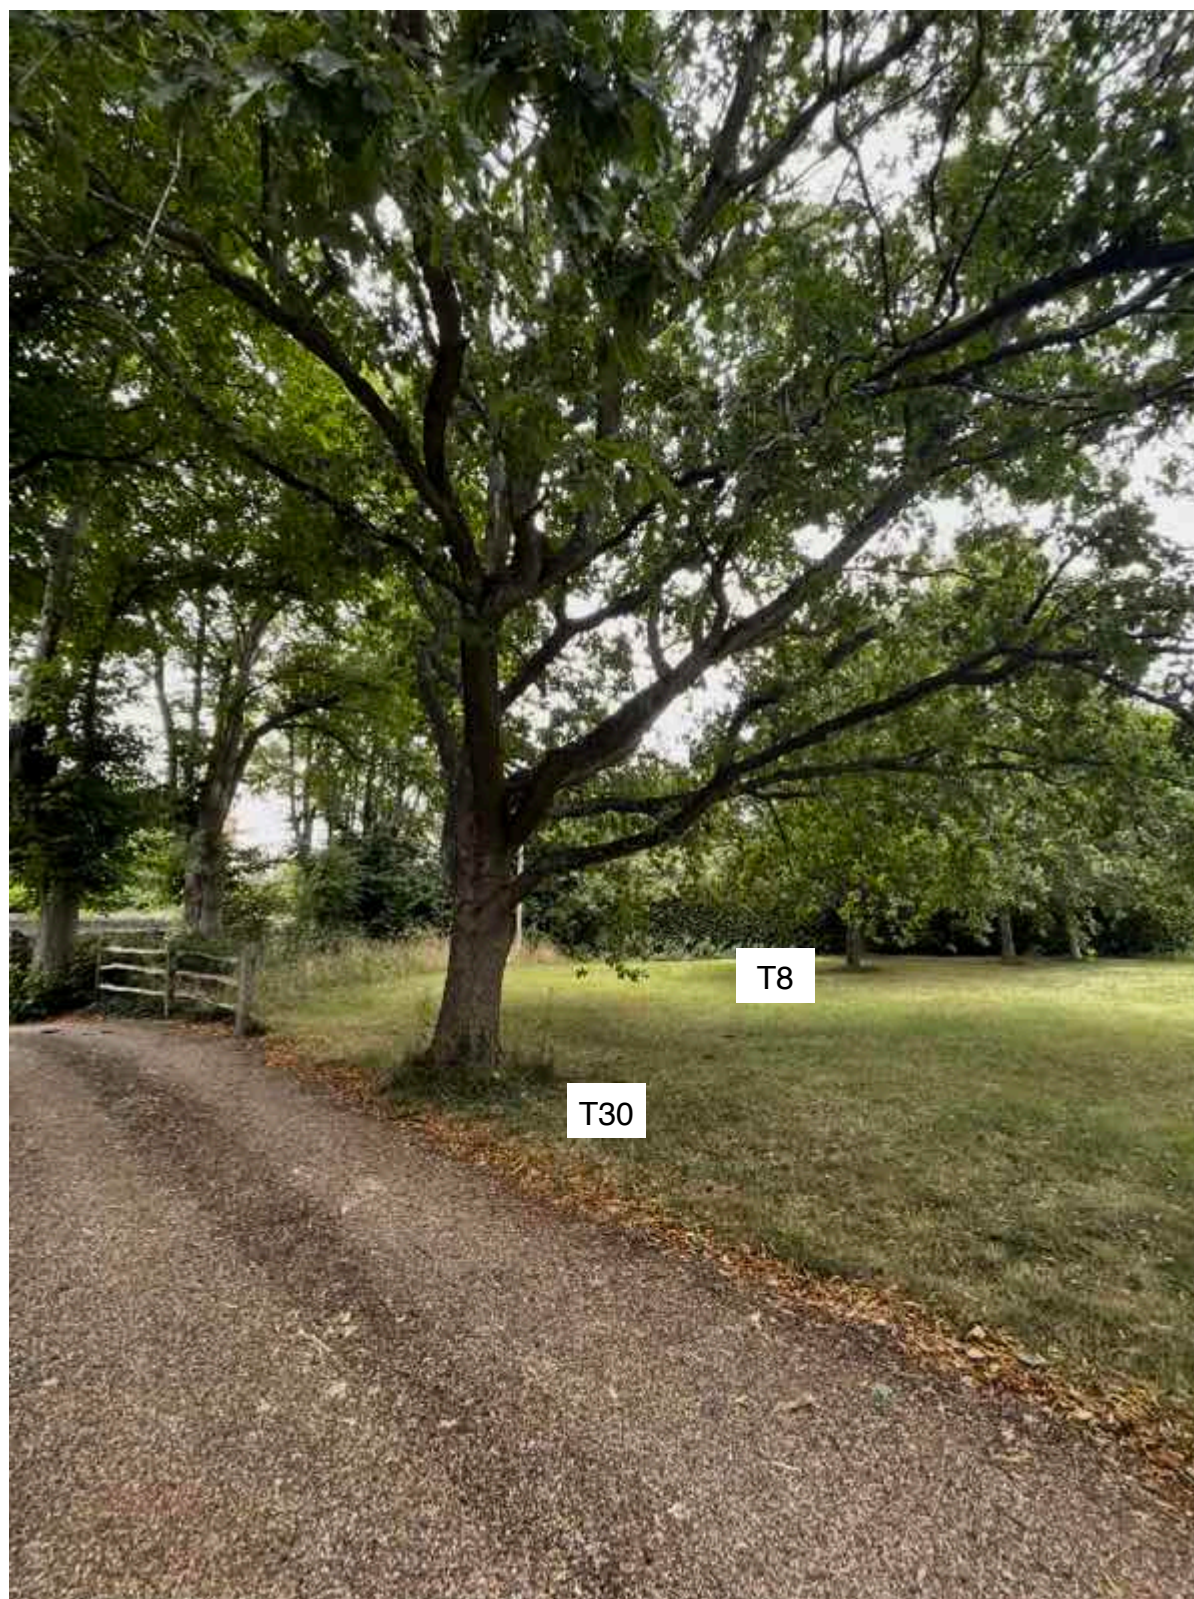
Trees T8 and T30 to be lifted to 4m above ground level

| T8 | Oak<br><i>Quercus robur</i> | 12 | 370 | 11.0Ø | 2mS | SM | Physiological Condition: Good<br>Structural Condition: Good<br>Public Amenity Value: Medium<br>Inspection Limitations: None<br><b>Recommend:</b> Lift tree canopy to 4m AGL for works access | N<br>CL4 | >40<br>B | A2 | 4.44 |

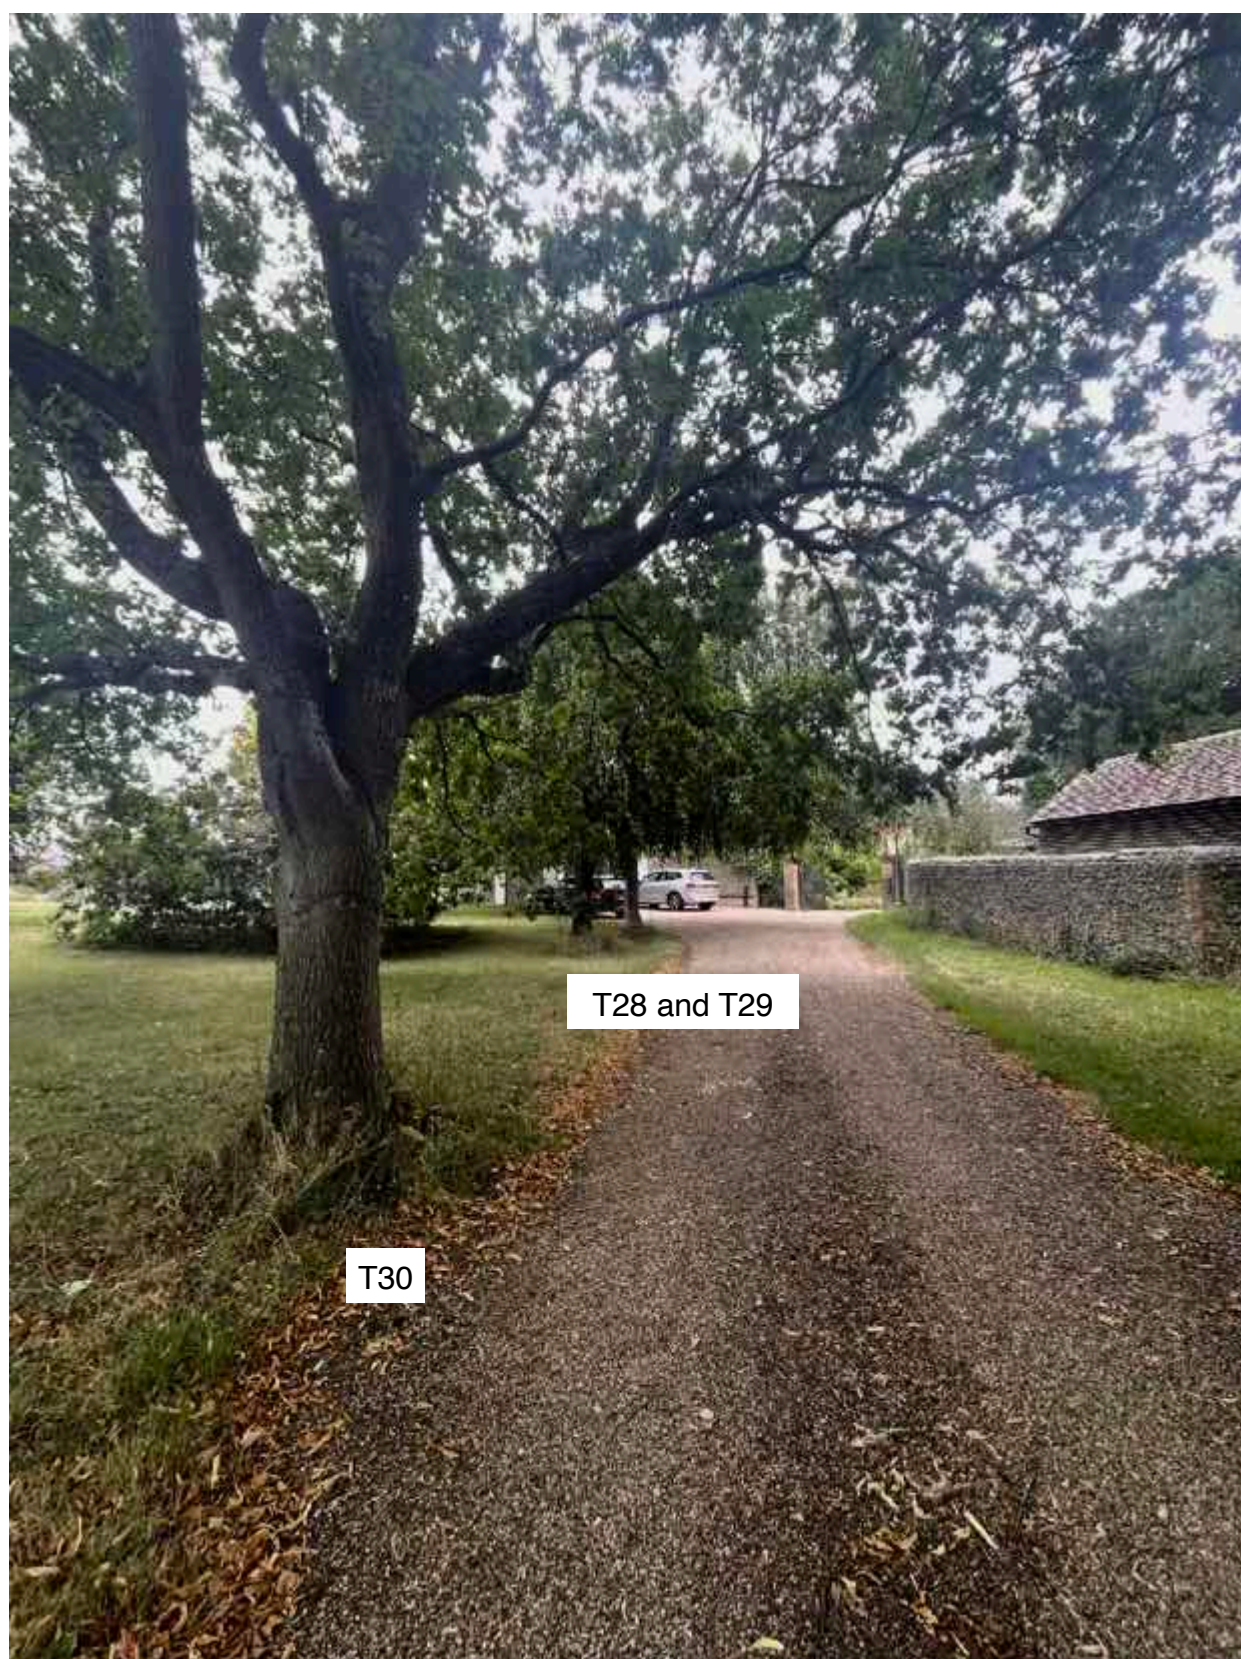
Tree T30 to be lifted to 4m above ground level. Ground protection required over the existing unmetalled drive and the grassland within the site

| <b>T30</b> | Oak<br><i>Quercus robur</i> | 19 | 630 | 12/4/9/8 | 2mN | M | Physiological Condition: Fair<br>Structural Condition: Fair<br>Public Amenity Value: Low<br>Inspection Limitations: None<br>Canopy bias S due too Lime trees along front boundary<br>Previously lifted to 2m.<br><b>Recommend:</b> Lift tree canopy to 4m AGL for works access | N<br>CL4 | >40 | <b>B2</b> | 7.56 |

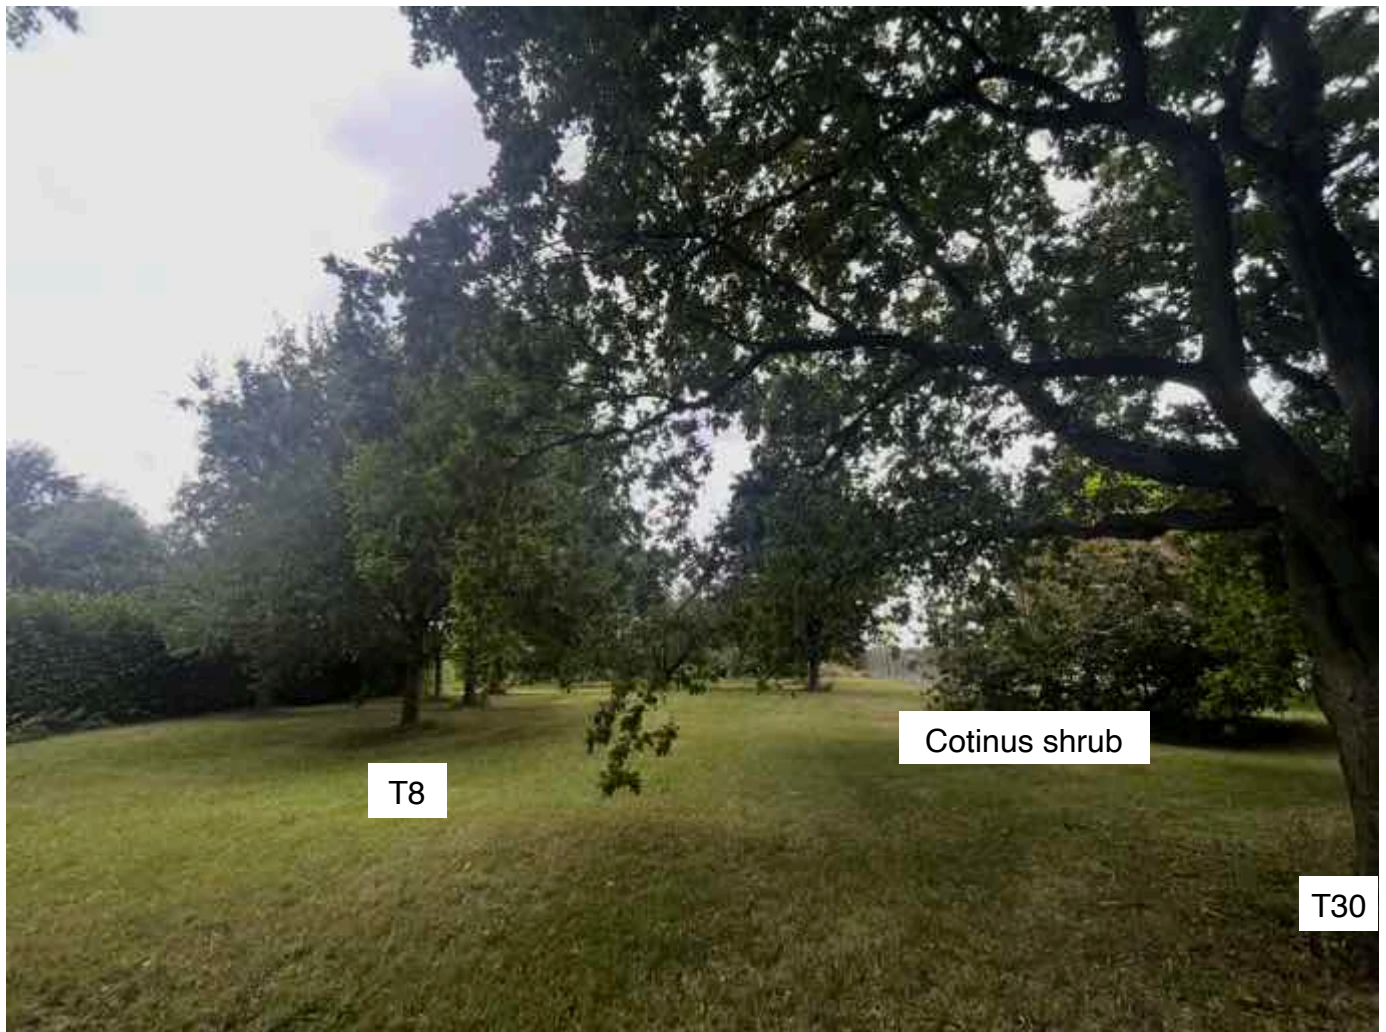
Tree T30 to be lifted to 4m above ground level. Ground protection required over the existing grassland within the site

The Cotinus shrub is to be removed to allow room for the works

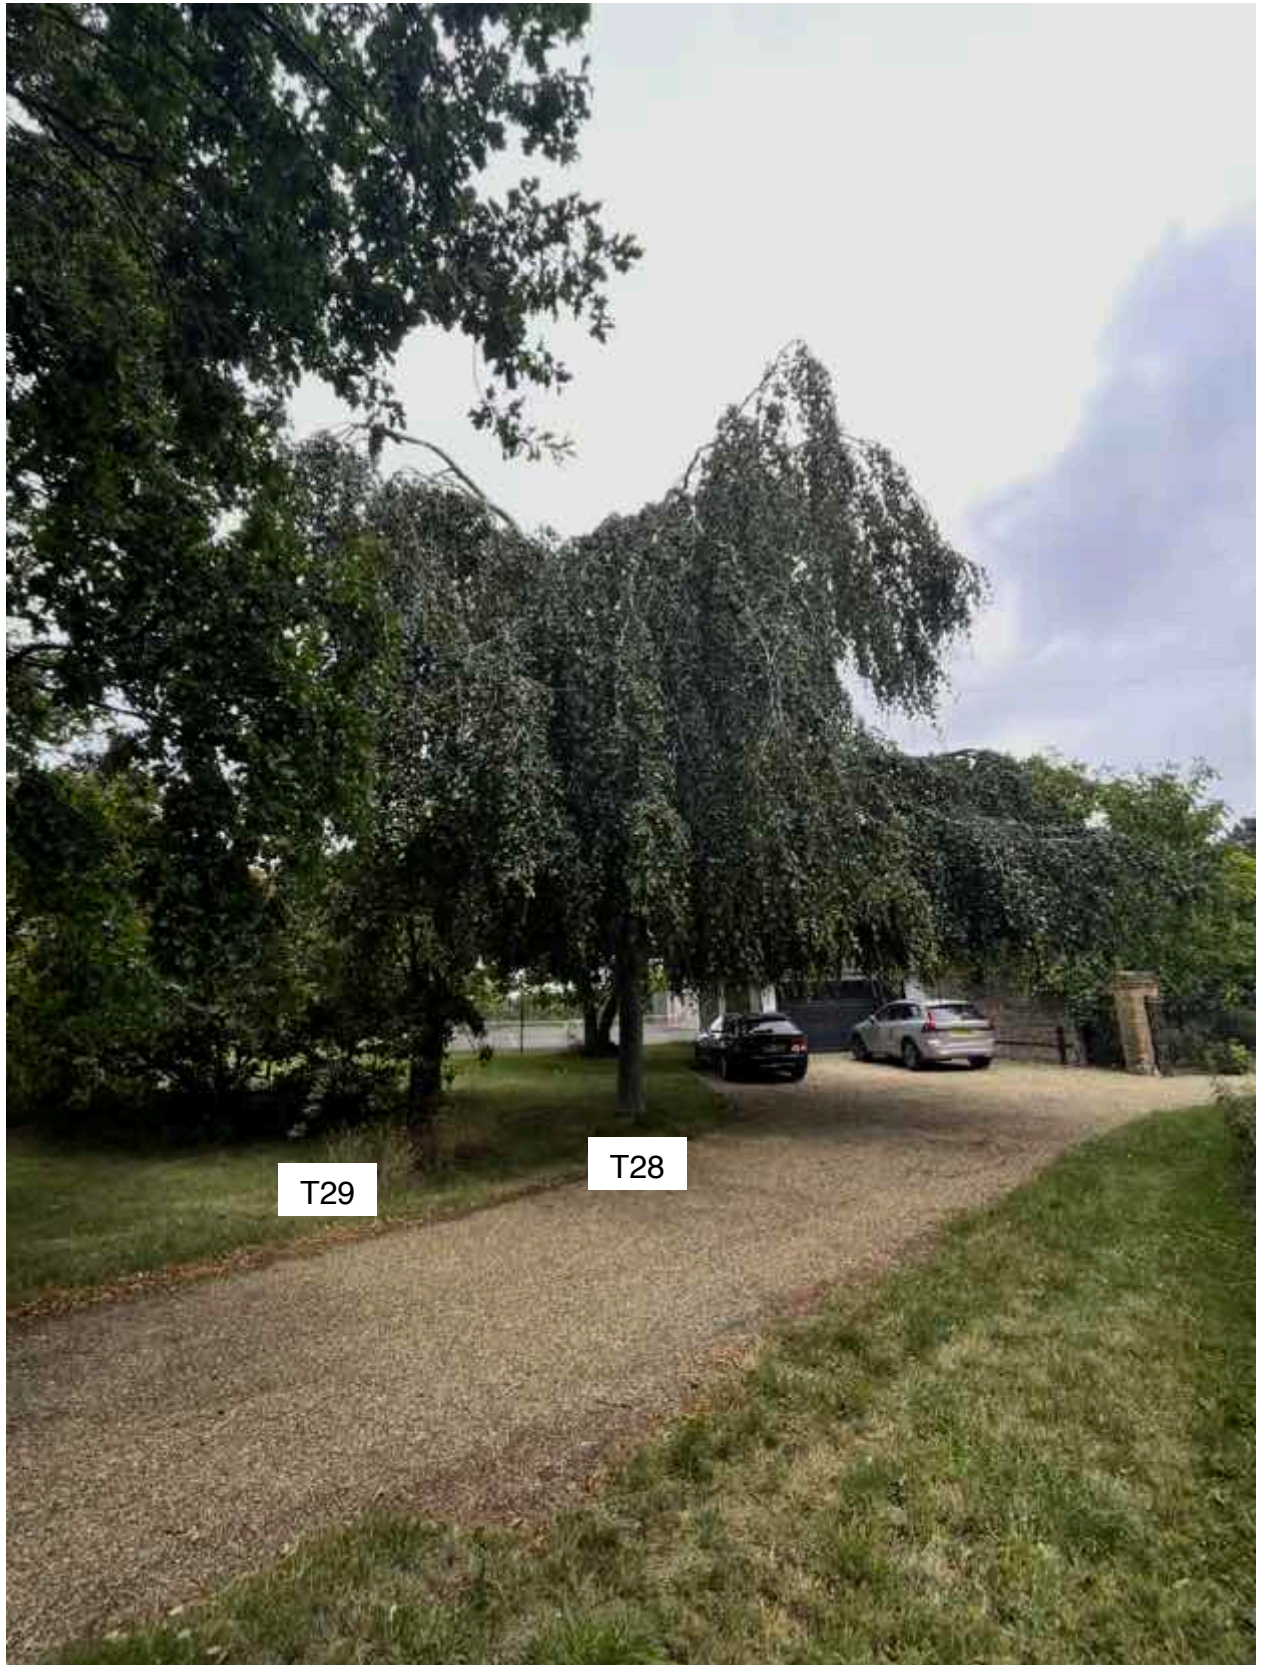
Tree T28 to be lifted to 4m above ground level. Ground protection required over the existing unmetalled drive within the site

| <b>T28</b> | Beech<br><i>Fagus sylvatica</i> 'Pendula' | 16 | 375 | 16.00 | 5mN | EM | Physiological Condition: Good<br>Structural Condition: Good<br>Public Amenity Value: Low<br>Inspection Limitations: None<br><b>Recommend:</b> Lift tree canopy to 4m AGL for works access | N<br>CL4 | >40<br><b>B</b> | <b>A2</b> | 4.5 |

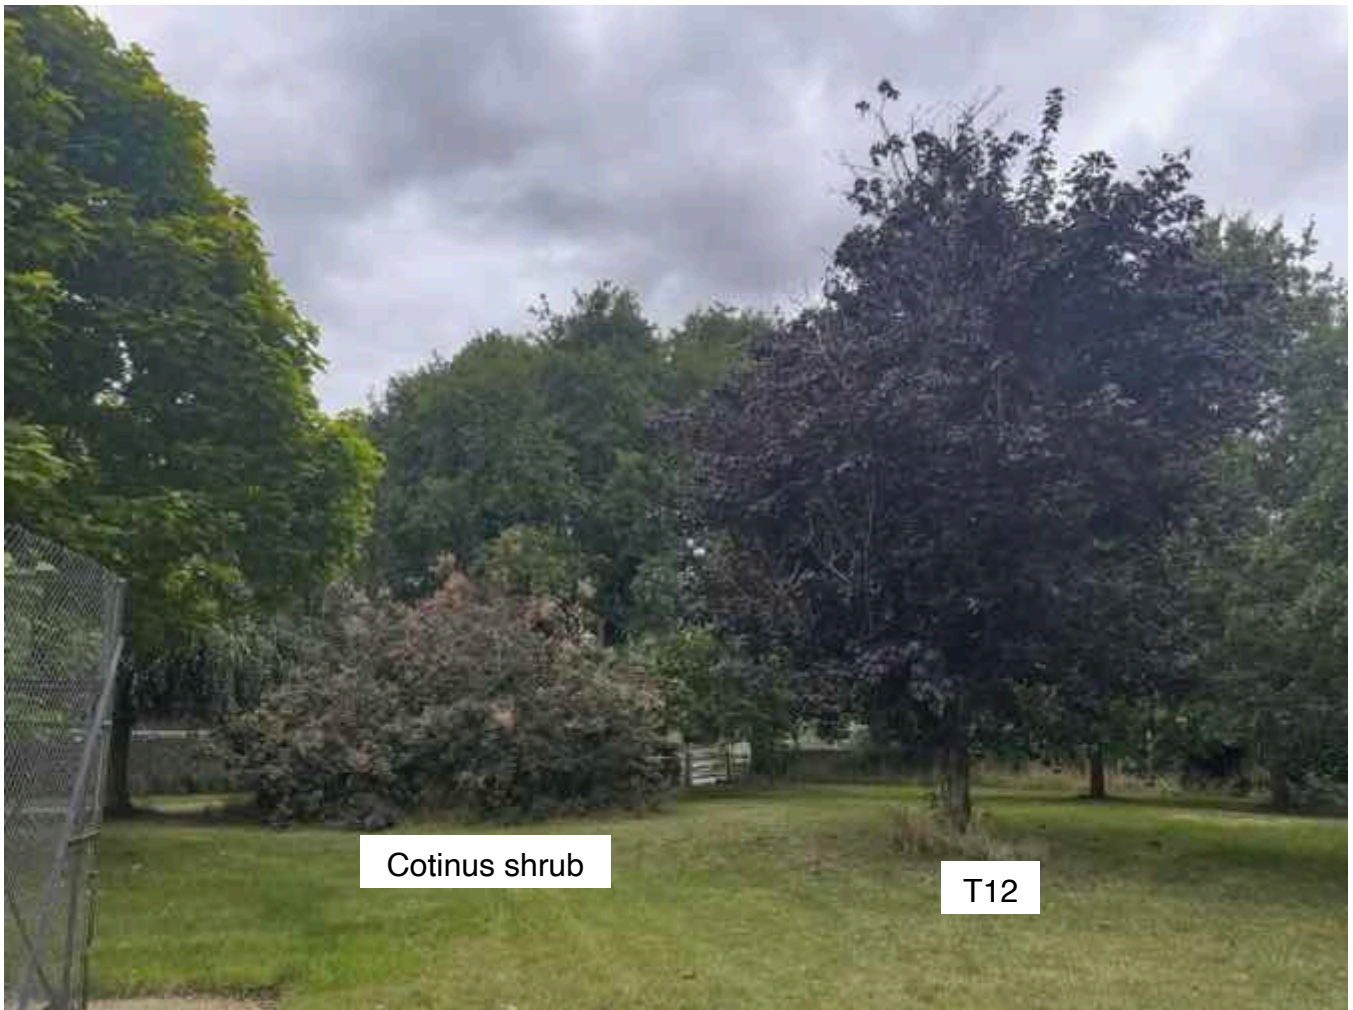
The Cotinus shrub is to be removed to allow room for the works

Ground protection required over the existing grassland within the site

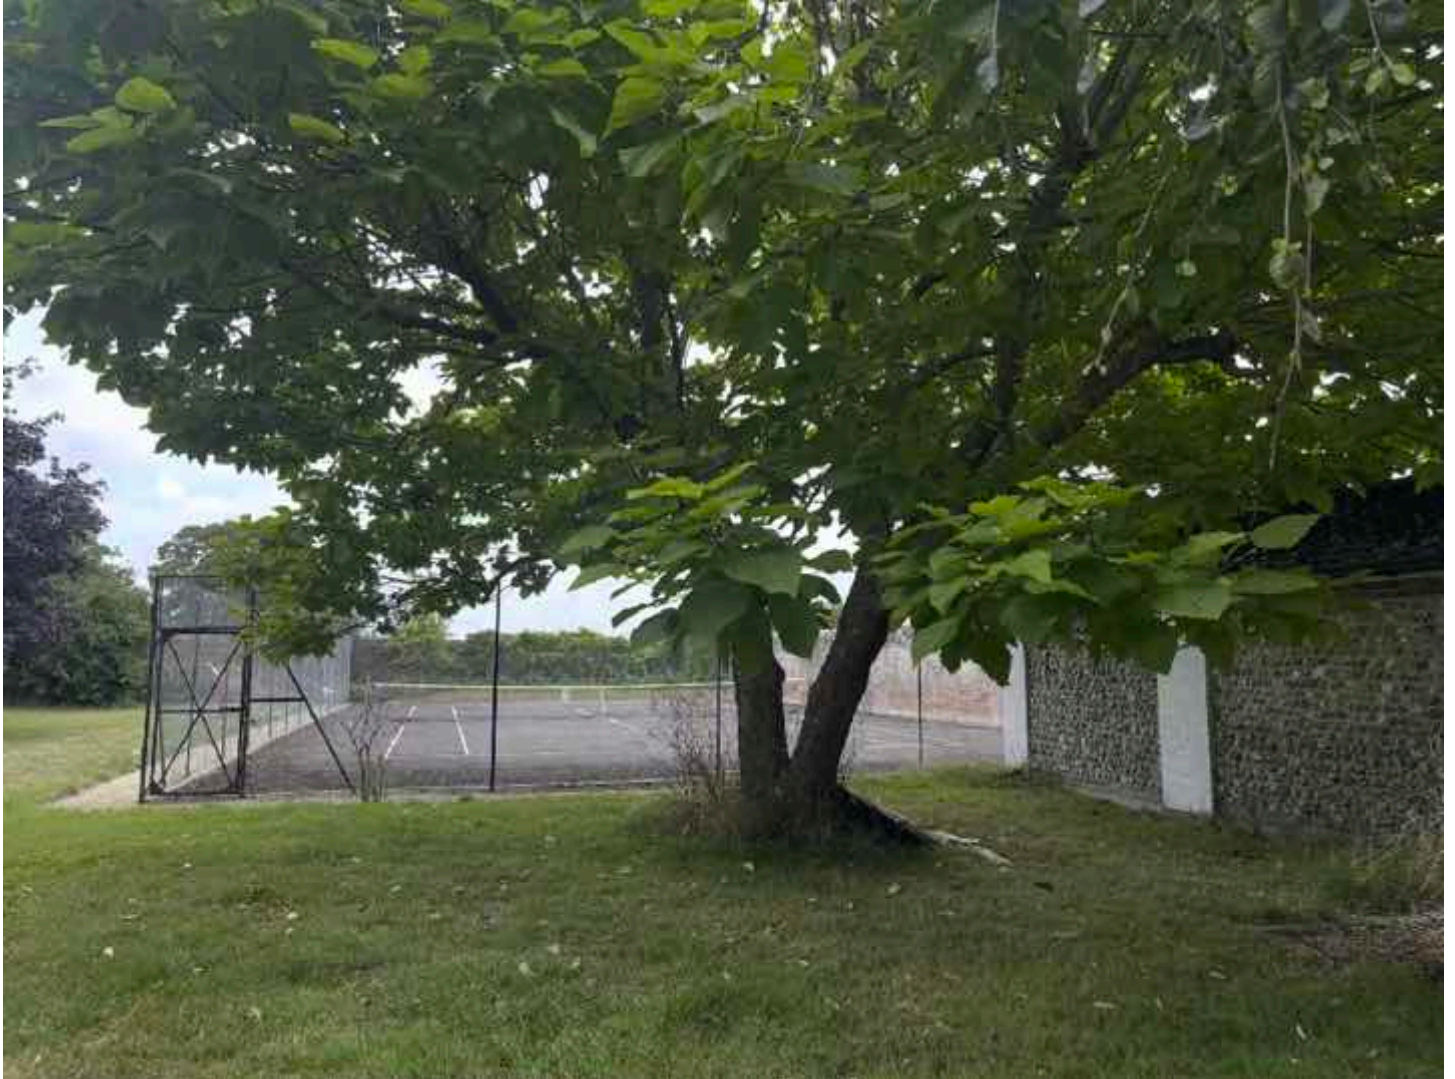
Tree T27 to be lifted to 4 meters above ground level and surrounded by tree fencing and ground protection to ensure the tree remains unharmed during works

| <b>T27</b> | Indian Bean tree<br><i>Catalpa bignonioides</i> | 15 | 485+425 | 7/6/6/5 | 2mS | M | Physiological Condition: Good<br>Structural Condition: Fair<br>Public Amenity Value: Low<br>Inspection Limitations: None<br>Bifurcates @0.25 into two main stems that lean outwards<br><b>Recommend:</b> Lift tree canopy to 4m AGL for works access | N<br>CL4 | >40<br><b>B</b> | <b>B2</b> | 7.74 |

3.14.1. It is advocated that the Local Planning Authority (Tree Officer) should consider approval of the application with the condition that the protective measures stated above in this report are adhered to for the duration of the build and that ground levels remain unaltered within the RPA of the existing trees and that 'No Dig' surfaces, as specified above, are constructed to protect the roots of T27.
