# Lidsey Drainage Impact Assessment

Yew Tree Surgery, North End Road, Yapton

Ref: 14010

Date: October 2025

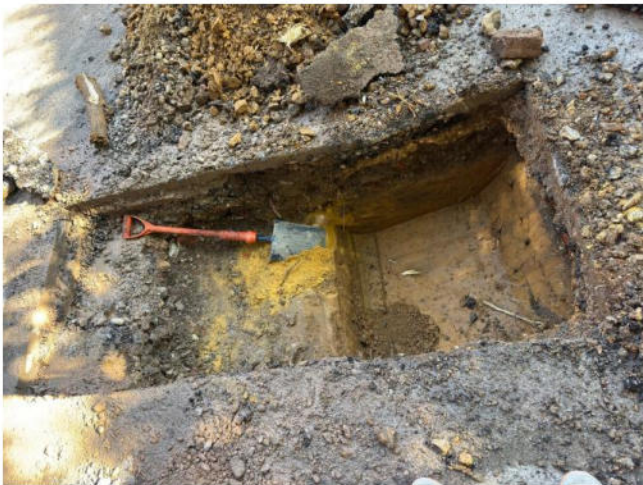
TP01

Depth of tarmac encountered.

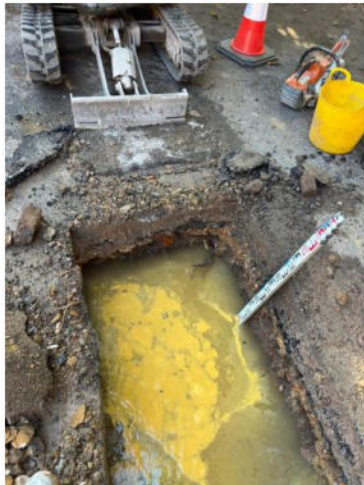
TP01 During the Tests

During the soakaway tests the water failed to achieve a fall from 75% to 25% of the effective depth of the storage volume in the pit. The results obtained from the soakaway tests are summarised below:

The naturally occurring shallow soils encountered beneath the site were found to be sandy Clay. The soakage rates obtained during the investigation were found to be poor. Given the data from the test, it is considered that the use of shallow soakaways is not suitable for this site.

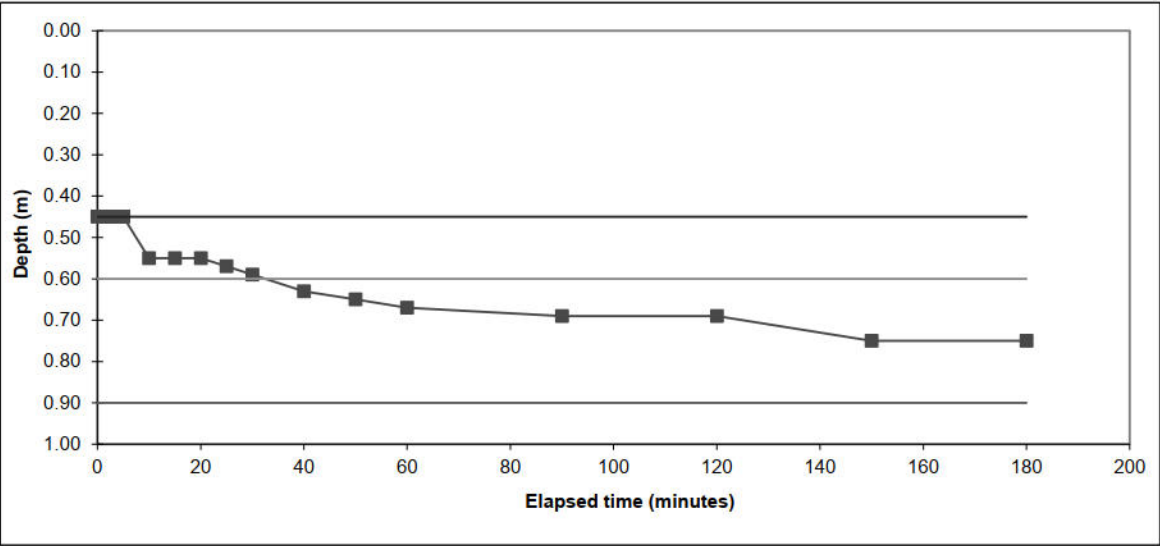
| Soil infiltration rate (m/s): | Test incomplete as 25% effective depth not achieved. Unable to reliably determine soil infiltration rate. |

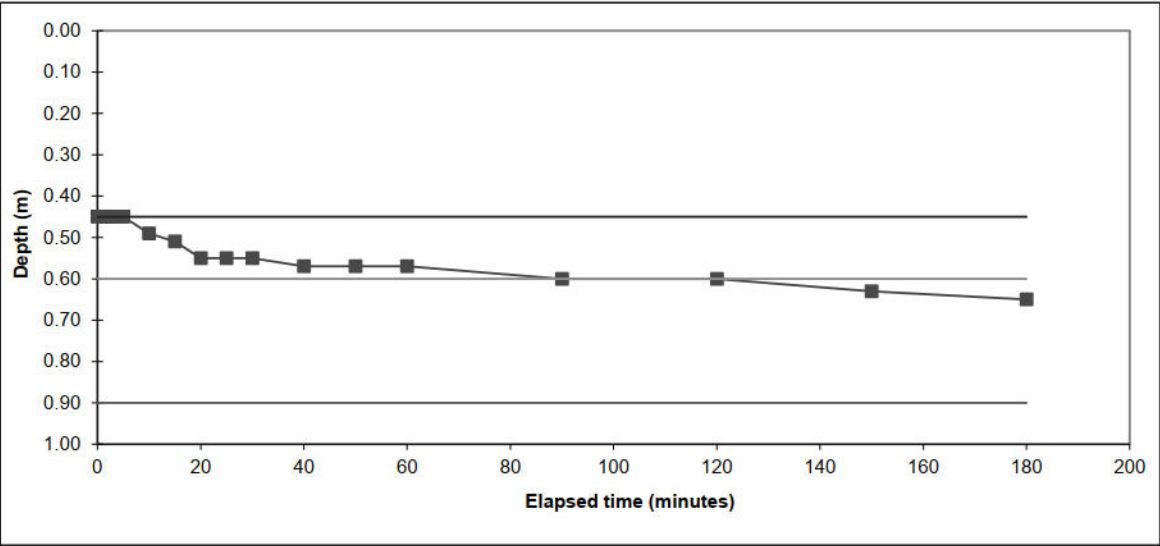
| Soil infiltration rate (m/s): | Test incomplete as 25% effective depth not achieved. Unable to reliably determine soil infiltration rate. |

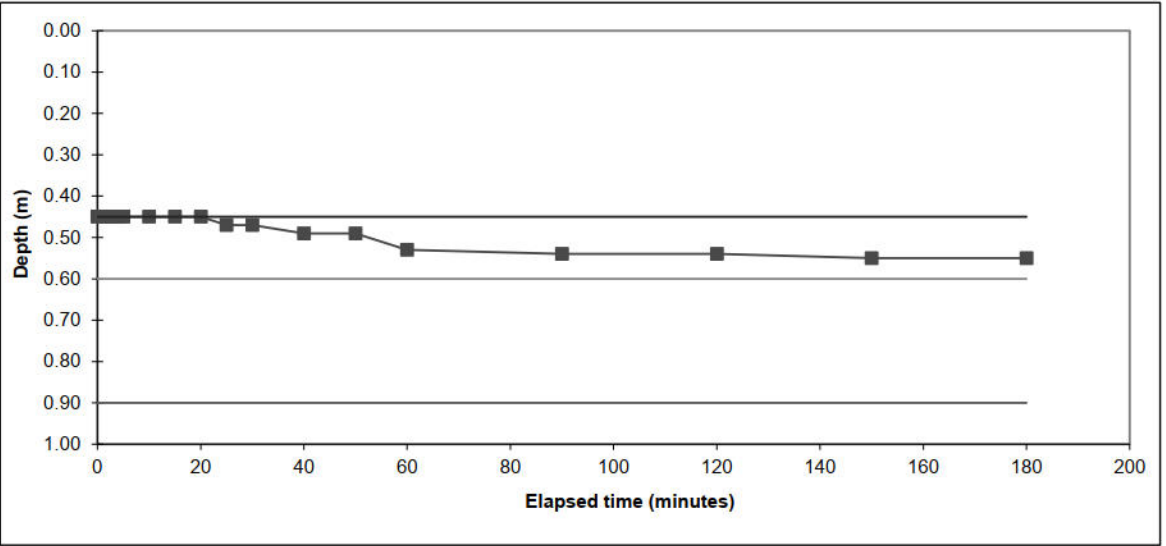
| Soil infiltration rate (m/s): | Test incomplete as 25% effective depth not achieved. Unable to reliably determine soil infiltration rate. |

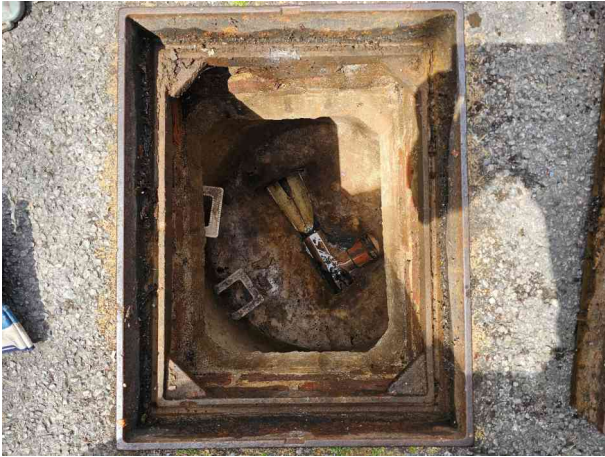
F2

Root ingress was identified within several sections of drainage, with heavy ingress noted within the last two sections of foul drainage to the sewer.  
Joint displacements were also recorded.

| Section | PLR | Grade | Description |
|---|---|---|---|
| 22 | F2X | 5 | Multiple defects |

Consideration should be made to remediate the root ingress and joint displacements, and we recommend the debris is removed by means of high pressure jetting.
