# **Arboricultural Impact Assessment**

Land at Bilsham Road

Yapton

PJC ref: 3867/15/02 Rev 04

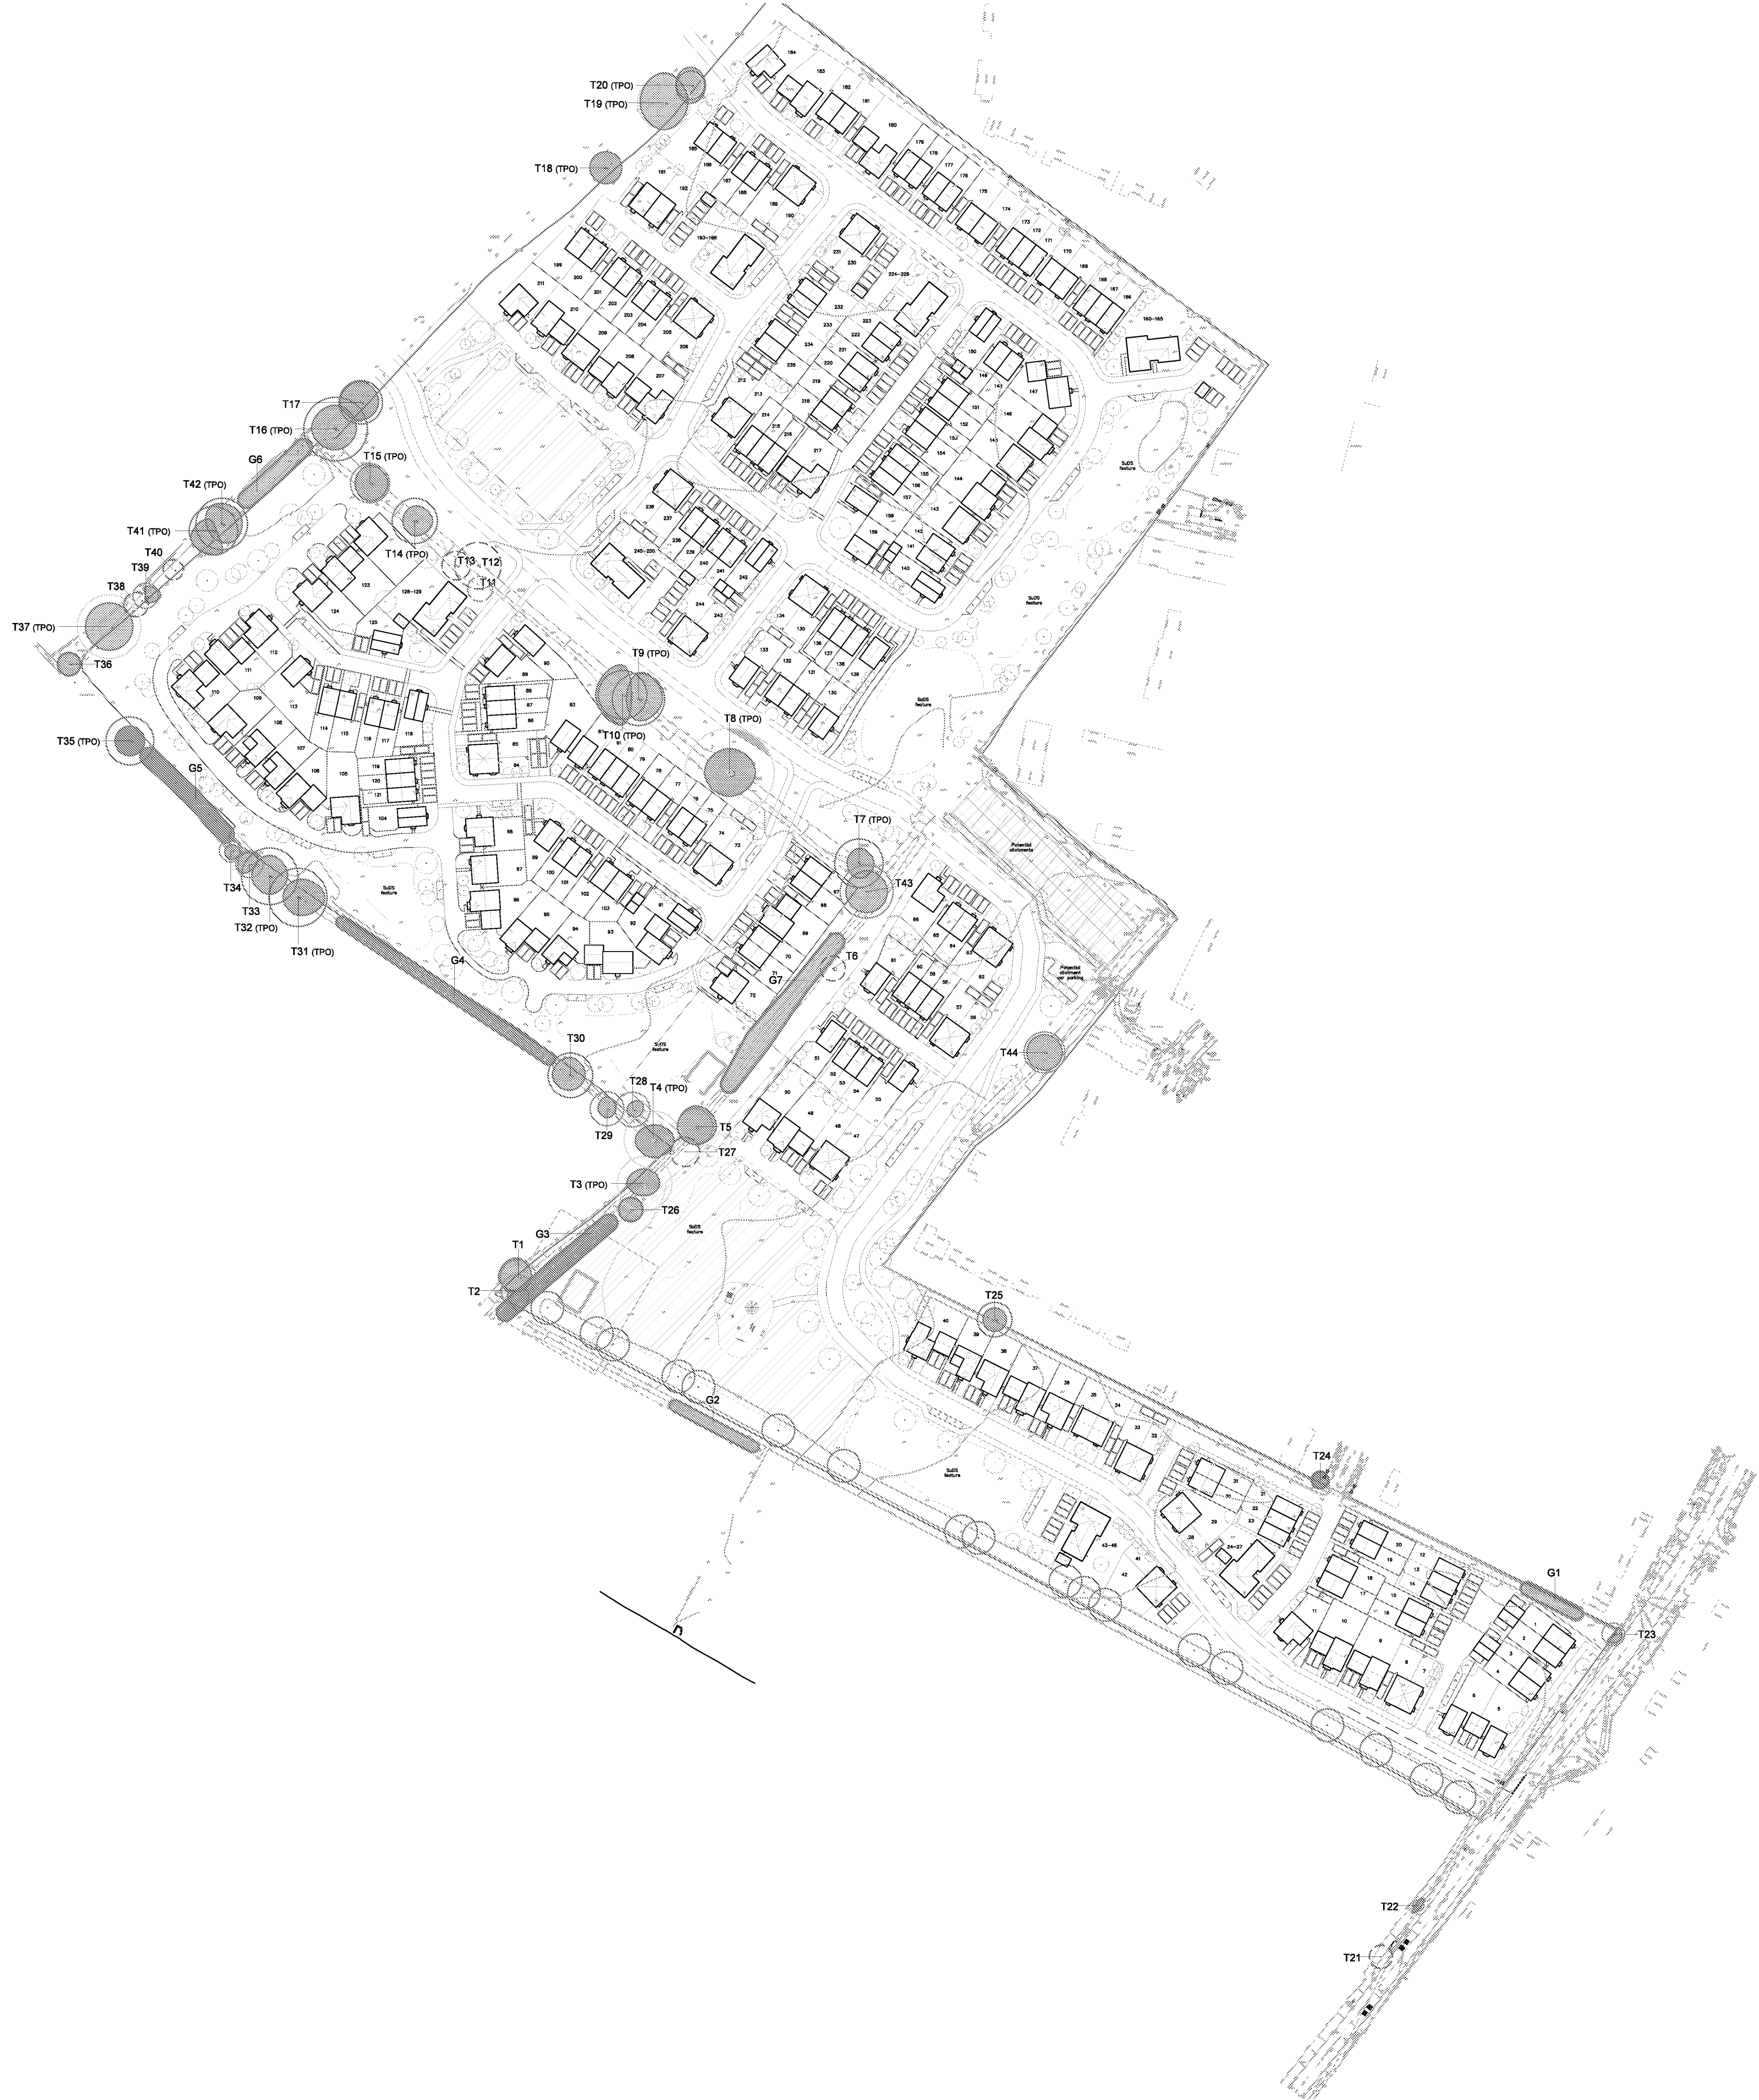
**Drawing title:** Tree Retention Plan

**3.1 Tree removals:** Trees to be removed for the proposed development are shown with dashed outlines on the Tree Retention Plan in Appendix 2 and are shaded to indicate their BS5837 tree category. These comprise one category C tree and seven category U trees.

**3.4 Works within root protection areas:** A new pedestrian footway will encroach the root protection area of oak T8 by 4.3%. This level of encroachment is deemed minor and will have a negligible impact upon the trees physiological and structural condition provided tree protection measures are implemented and sympathetic construction adopted throughout development.
