# **Bat Assessment**

## **Bevin & Bevin Site**

### **Brewery Hill**

### **Arundel**

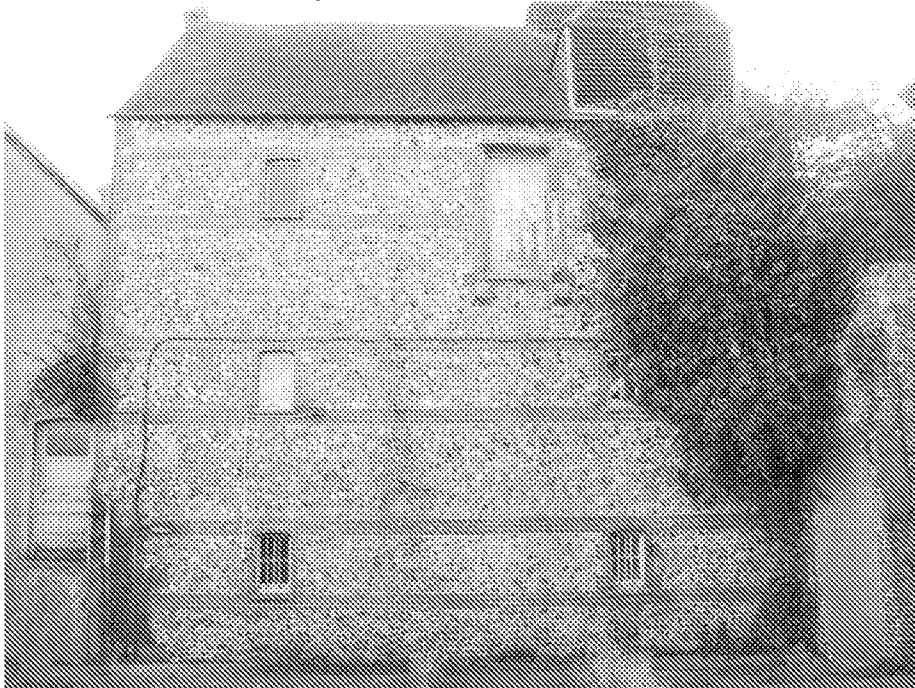
2.2 The main building within the site boundary is a Grade II listed building that has numerous additional buildings and warehouses effectively 'added on'. The main brick and flint three-storey building is shown in Photograph 2.1, from the eastern aspect. The building has a pitched roof clad in traditional clay tiles.

**Photograph 2.1:** View of the main Grade II listed building from the east of the site of Bevin & Bevin Brewery site, Arundel.

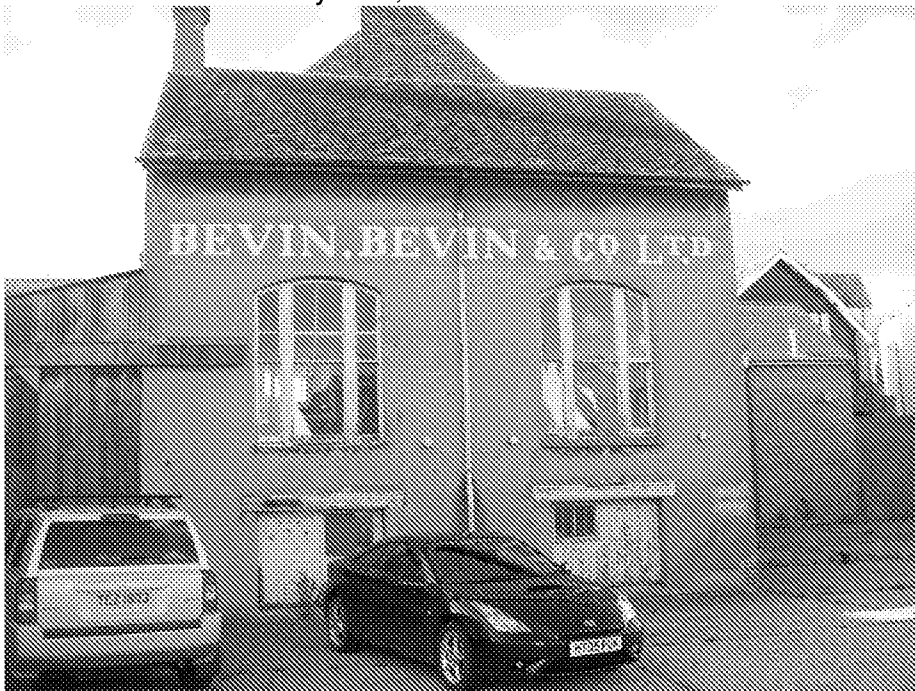
- 2.3 To the south of the Grade II listed building is a two-storey breeze block and concrete add on, with a pitched roof clad in traditional clay tiles. The building is shown in Photograph 2.2

**Photograph 2.2:** View of the building to the south of the Grade II listed building, Bevin & Bevin Brewery Site, Arundel.

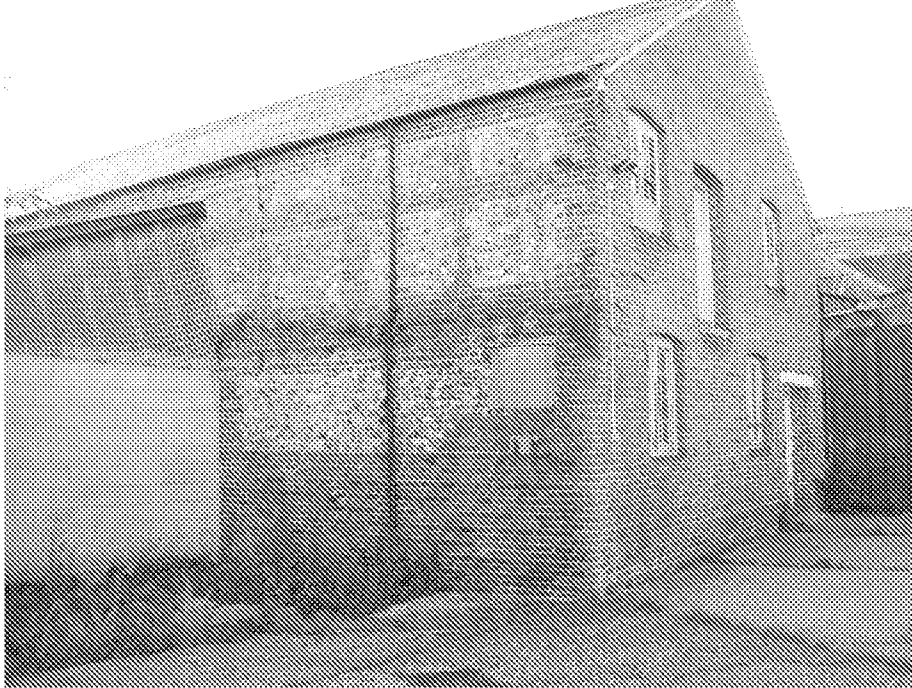
- 2.5 These warehouse extensions connect to a two-storey brick and flint building with a pitched roof covered in slate tiles. This building is shown in Photograph 2.3. A breeze block and corrugated metal add-on is situated to the south of this building.

**Photograph 2.3:** View of the two-storey brick and flint building with a pitched roof covered in Slate tiles to the west of the site, Bevin & Bevin Brewery Arundel.

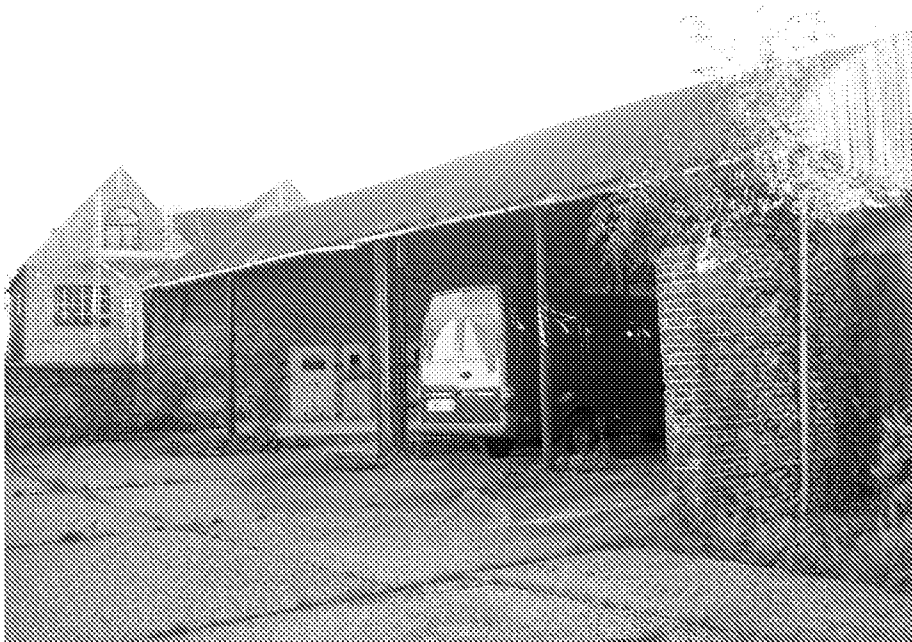
- 2.6 To the south of the site is an open-fronted barn of brick and flint construction with a corrugated metal roof. This building is shown in Photograph 2.4.

**Photograph 2.4:** View of the open fronted barn to the south of the site, Bevin & Bevin Brewery Arundel.

- 4.6 There was no evidence of roosting bats or feeding remains to suggest that the open-fronted barn had been used a night roost.

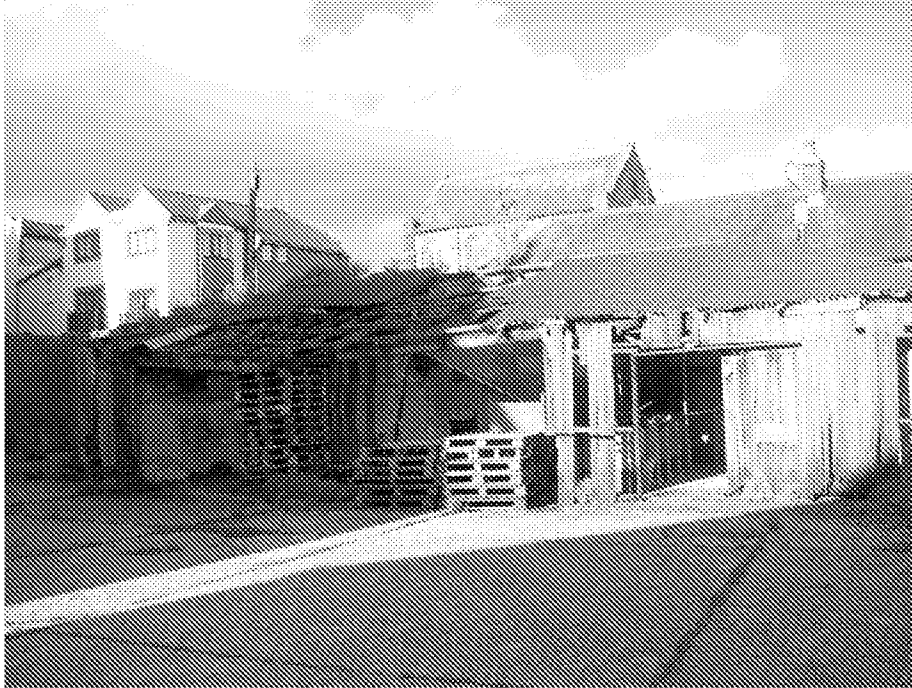
- 2.7 To the east of the site are a number of timber frame dilapidated sheds with corrugated metal roof. These are shown in Photograph 2.5.

**Photograph 2.5:** View of the dilapidated sheds to the east of the site, Bevin & Bevin, Arundel, West Sussex. .

- 4.7 There was no evidence of roosting bats in the dilapidated sheds to the east of the site and the sheds were considered unsuitable for roosting bats.

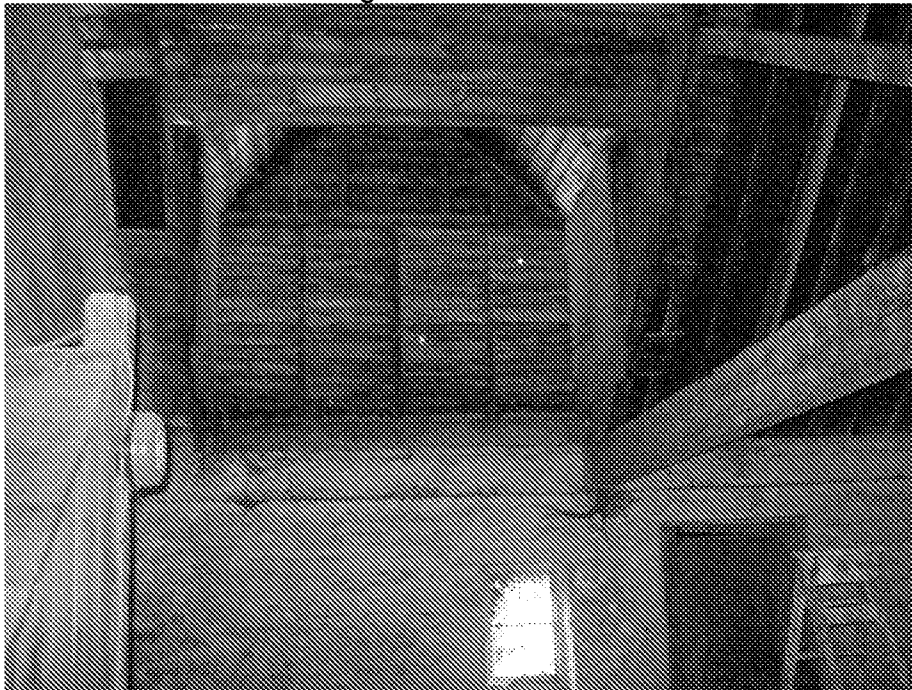
- 4.1 All potential access points and surfaces on the exterior of the Building 1 were surveyed and no evidence of bats was recorded. However, numerous potential bat access points were noted, such as gaps in the soffits and missing roof tiles.
- 4.2 The interior of the building was surveyed for evidence of bats using a high powered cluson torch and endoscope. There was no evidence present on the first two floors but one old Brown Long-eared bat dropping (*Plecotus auritus*) was found in the loft space of the building. Despite an extensive search of the rafters and roof void of the building, as shown in Photograph 4.1, no further evidence of bats was found. The dropping was directly underneath a hole in the roof, as shown in Photograph 4.2, so may have come from an individual flying over the site or investigating the structure.

**Photograph 4.1:** One old bat dropping was found in the interior of the loft space of the Grade II listed building.

- 6.2 No maternity roosts or important roosting areas for bats have been identified present in the buildings. Only one old Brown Long-eared bat dropping was found in the loft space of the Grade II listed building. This is likely to have come from an individual investigating the structure as opposed to roosting, because the building is in a considerable state of disrepair and the loft space is extremely draughty. The dropping was directly a hole in the roof.

- 6.3 As there was limited evidence to suggest that the buildings support roosting bats a Natural England EPS bat licence will not be required and the building can be demolished and/or renovated as planned. However, as bats have seasonal use of buildings, and features are present that could support bats, in particular the traditional roof tiles on the Grade II listed building and on the main warehouse, it is possible that bats could use these features, given that they are present in the local area. Therefore, it is strongly recommended that these tiles should be removed carefully by hand under the supervision of a licensed bat ecologist prior to demolition and/or renovation of the buildings.

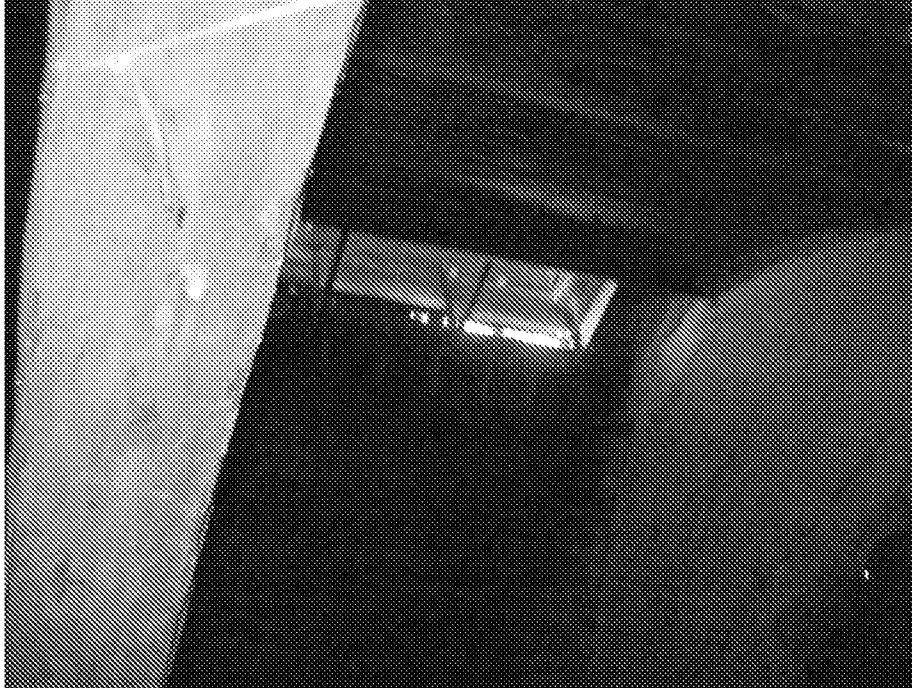
**Photograph 4.2:** One old bat dropping was found underneath the hole in the roof of the Grade II listed building.
