Former Eagle Brewery site,  
Brewery Hill  
Arundel  
West Sussex

Heritage Statement

**August 2013**

FORUM  
Heritage  
Services

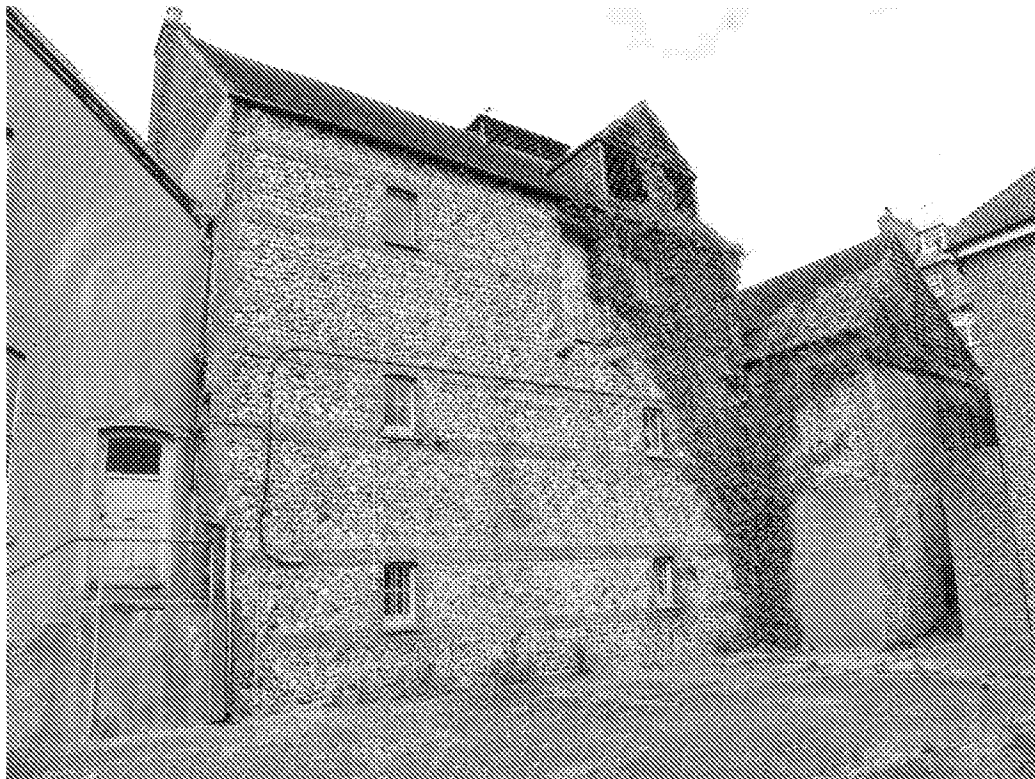
**Figure 3:** East elevation of Building 1

- 5.1 This building is three storeys and rectangular in plan. It is the building described on the list entry for the 'The Brewery', Brewery Hill and is listed at Grade II. The walls comprise roughly coursed cobble, beach or unknapped flints with brick bands (of three courses with alternating stretcher and header courses). Those to the upper floor have some flared headers. Windows have canted brick arches and brick dressings. The brick bands correspond to the head and cill level of the windows at each level. There is limited fenestration, with the east elevation having consistent small single light openings with windows of a fixed frame with glazing bars. There is a door opening with vertical boarded timber door and stone brackets set below the cill. There is a plain unpainted timber lintel above. The roof is pitched to gable ends and has a red/orange clay tile covering. To the east elevation there is a prominent louvered dormer with gable roof. There is a louvered square plan vent to the ridge with pyramidal roof. To the north elevation there are two shuttered openings. The gable to the north is in a Flemish garden wall bond. To the west at second floor are two further windows matching those seen to the east elevation and a further door opening blocked with rendered brickwork with a canted brick arch. There is a projecting brick chimney stack to the south wall with brick corbel and two clay pots.

- 5.2 The internal configuration of the building is generally open plan (with later modern partitions at first floor) with a series of cast iron columns supporting principal roof members. Between ground and first floor there is a notable double floor construction with the regular additional steel columns supporting substantial timber members which support the main floor structure of joists and floorboards. This has been limewashed.

- 5.3 At second floor level, there is an outline of a chimney stack which has been built into the south wall. A line of a former ridge can also be traced in internal finishes where a render system finishes and exposed brickwork (later painted) can be seen above.

- 5.4 The roof comprises three bays defined by principal kingpost trusses of sawn softwood with a single set of back purlins. The roof is underboarded with sawn softwood timbers. The trusses have a centrally placed cast iron column with collar from floor to tie beam.

- 5.8 Given the statutory listing of the building and its recognisable form as an industrial building which although altered and remodelled still retains a number of elements of special interest such as the fenestration, plan form, roof structure, functional openings and substantial floors structure between ground and first floor, this building is of very high significance and its special character must be maintained in any future planned changes to the complex.

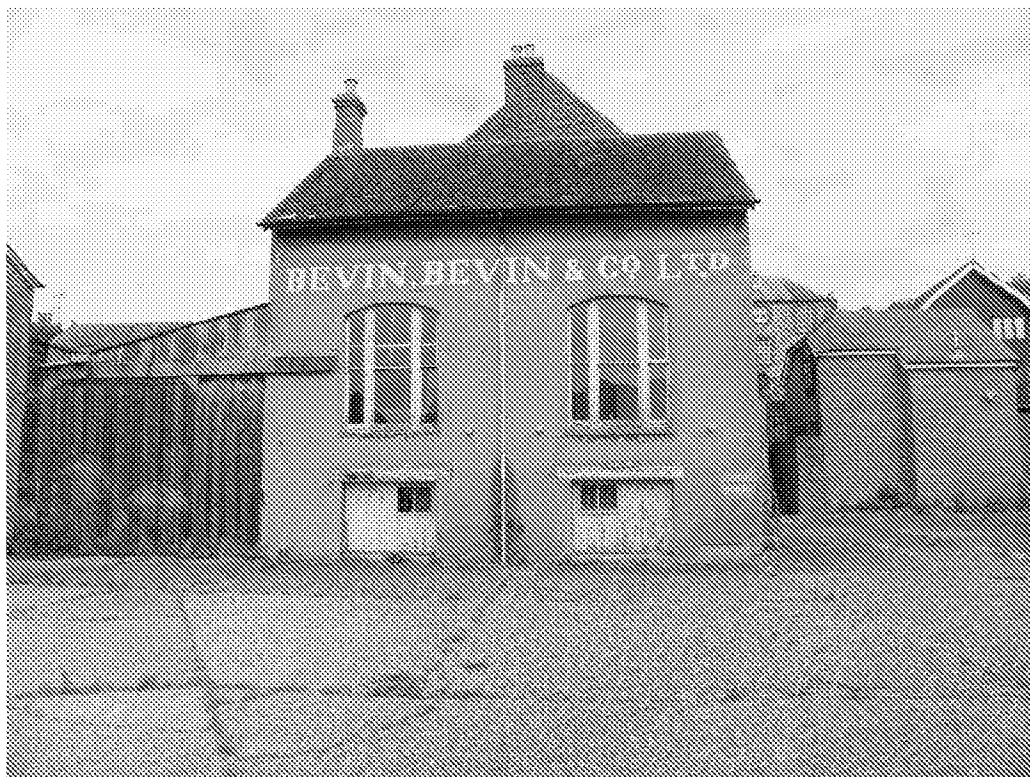
**Figure 4:** South elevation of Building 2

- 5.9 This building is physically connected to Building 1. It would therefore be considered to form part of the listed building despite being described (incorrectly) in the list description as being 'unlistable' (see **Appendix A**). It comprises a two and a half storey rectangular plan with pitched clay tile roof to gables. The walls are rendered with Roman cement incised to mimic ashlar stonework. The principal elevation faces south and is symmetrical with two semi basement openings with timber lintels and timber doors. Above this two arched tripartite timber framed vertical sliding sashes with one central window and two margin lights to each opening. The sashes are unbarred with horns and have exposed timber sash boxes between lights (forming mullions). Above the principal windows there is a large painted sign: **Bevin, Bevin & C<sup>o</sup> L<sup>td</sup>**. There is a further tripartite window matching those to the south elevation and a timber framed vertical sliding sash above this lighting the attic floor. Also to the east elevation, there is the main access reached via a concrete stair. This comprises a panelled door with bead mouldings to the lower panels and some alterations to the upper panels to form two horizontal panels, one of which is glazed. There is a rendered chimney stack with corbel and buff clay pot. to the ridge adjacent to the west elevation.

- 5.10 Internally there is the remnant of what appears to be a painted stone or marble chimney piece of the late 19th century with the mantel shelf removed. To the raised ground floor two chimney breasts are apparent in the plan although the original walls have been lost. To the attic storey the roof comprises three bays divided by king post trusses of sawn softwood timbers. The roof is lined with unpainted softwood boards above the line of the back purlins. The roof construction matches that of Building 1. There is some evidence for the presence of a roof light with the boarding having been cut away to form a rectangular opening. This has now been lined with felt.

- 5.12 Despite the list description describing the building as 'unlisted' it enjoys protection by virtue of its physical connection with the listed building. It is a building of high significance reflecting a clearly defined use with the complex. This office use is reflected in the more architecturally resolved elevations and 'polite' architectural detailing and also the use of an incised render to mimic a more expensive material. The survival of the original windows, an early door, the chimney breast and elements of a former chimney piece along with the principal roof trusses are all significant elements which contribute to the special interest of this building and should be retained.

| Building Number | Summary of significance | Proposed changes | Impact of proposed changes | Mitigation for changes (where necessary) |
|---|---|---|---|---|
| Building 2 | HIGH | Convert to a 3 bedroom house | Potential loss of plan form. | The chimney breasts should be retained in any proposed conversion. Windows should be repaired rather than replaced. |

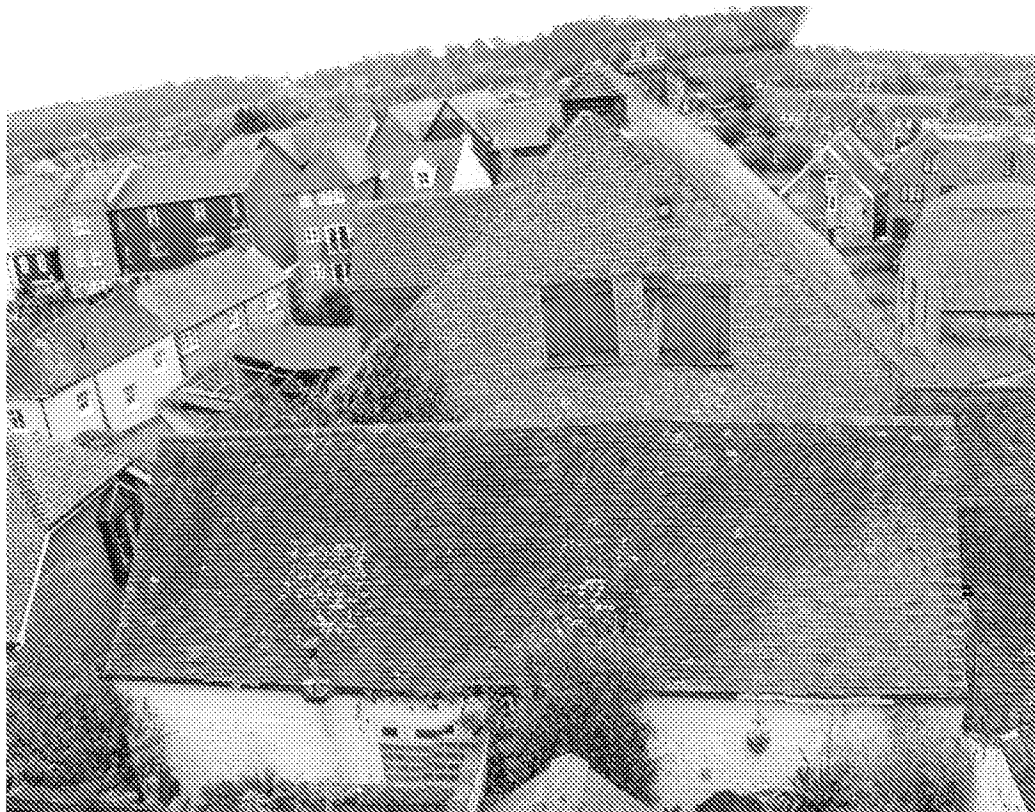
**Figure 5:** The roof of Building 3 (taken from the second floor of 47 Tarrant Street)

- 5.13 Building 3 is constructed of brick (with some flint and some stone) and sits to the north of the site and is physically connected to the Grade II listed Building 1. This physical relationship would provide statutory protection for this part of the site. The long rectangular plan building sits east-west across the site and is two storeys with a gabled steeply pitched roof of orange/red clay tile with decorative tiles in bands. The north wall of the building doubles as the boundary between the site and its neighbours (the Grade II listed Nos. 43-47 Tarrant Street) to the north. The east wall is in at least two phases and has seen some rebuilding to the first floor with the lower section of brickwork in header bond and appearing to date from the 18th century. The north wall has at least two phases with an upper section in later brick suggesting a raising of the eaves line or the entire roof. There are a number of redundant or much altered openings. The main opening to the north has modern glazed bricks to a widened earlier opening.

- 5.16 Whilst previous uses for this part of the complex are not clear, the lower sections probably date from the mid 18th century and therefore are some of the oldest surviving sections of built form on the site. As such the lower sections of this building are of very high significance with the upper sections and roof being of moderate to high significance.

| Building Number | Summary of significance | Proposed changes | Impact of proposed changes | Mitigation for changes (where necessary) |
|---|---|---|---|---|
| | | | | A schedule of repairs and surface finishes should be prepared for the conversion of Building 3 |

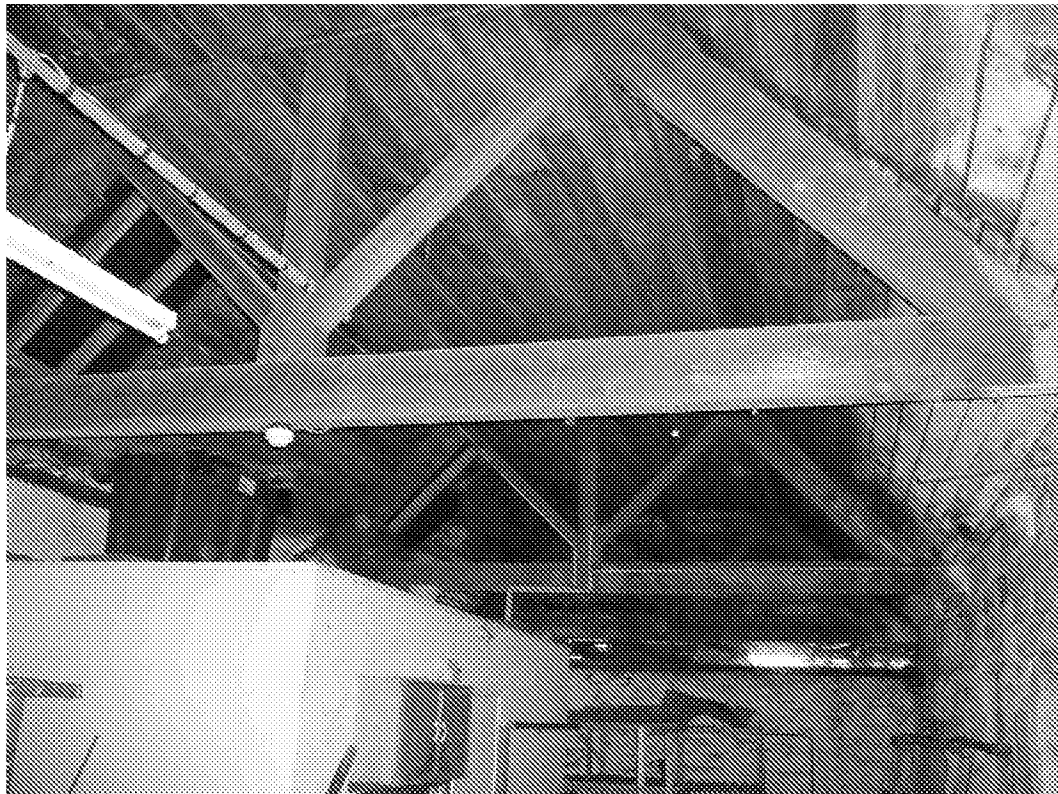
- 5.14 Internally, there is an arched opening between Buildings 1 and 3 at first floor level. The roof is divided into three bays with king post trusses of sawn softwood timbers (Figure 6). The ridge is concealed behind a suspended ceiling of sawn timber boarding at purlin level.

**Figure 6:** Roof to building 3 showing underboarding taken over on a suspended ceiling at purlin level

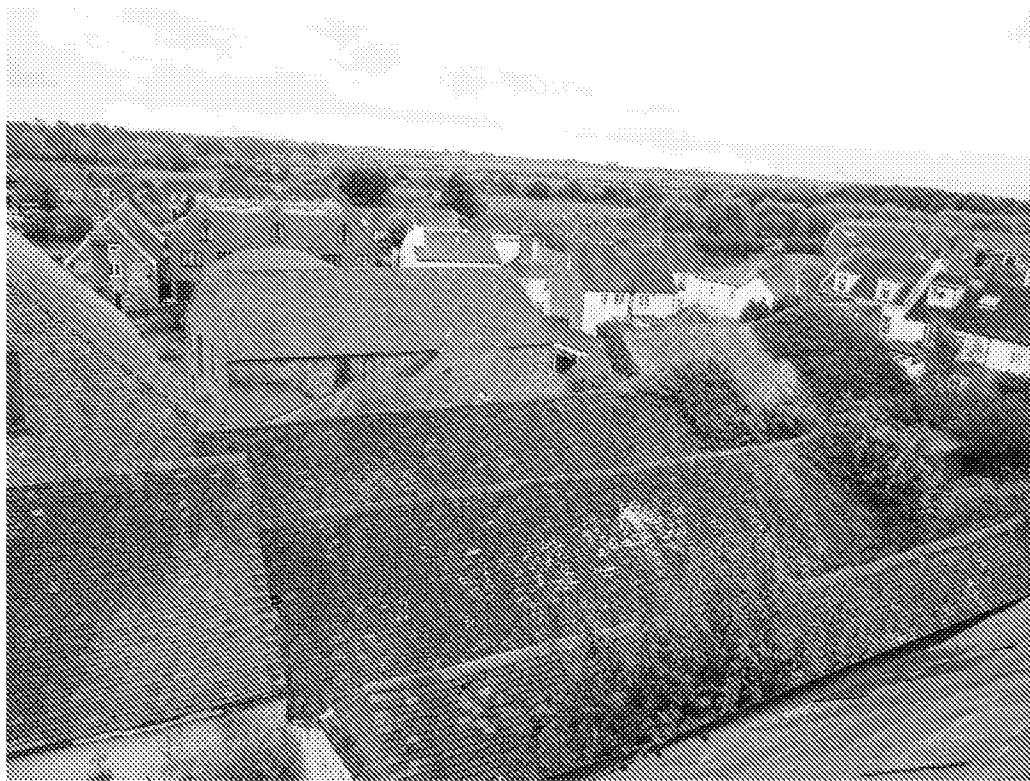
**Figure 7:** Roofs of the three ranges forming Building 4 (taken from 47 Tarrant Street)

- 5.17 This building comprises three open ranges running east-west under clay tile pitch gabled roofs. Each range is equivalent to a two storey structure and walkways and a mezzanine floor to part of the building provide an upper and lower level which is connected at various points to Buildings 1, 3, 5, 6 and 7 at varying levels taking into account the different periods of construction and the topography of the site. The roof is supported on large cast iron columns and comprises a series of principal rafters with king posts and back purlins set to an eaves/wall plate which is supported by the columns set at regular intervals. There is a mezzanine floor and modern timber straight flight stairs connecting this floor to the ground floor. The ground floor has a remnant survival of a stone floor and other areas defined by floor surfaces of worn stonework or clay setts. This continues into the lower ground floor of Building 3 with what appears to be a roadway with gulleys either side of a central stone section. The west wall is brick with a series of louvered brick openings at high level. To the south, a series of brick and flint walls, mostly painted form a part enclosed, part open elevation with adjacent structures 5, 6 and 7.

- 5.19 Despite its apparent shed like structure, this building formed part of the important brewing process and its use is defined in the 1878 conveyancing plan as a 'Tun Room'. The stone and brick floors to sections of the building may reveal more detail of how these buildings were used within the process on the site. The open character, the roof and column structure, the louvered windows and the traditional floor treatments are significant features of this building and should be retained and repaired in any future proposals for reuse. As one of the earlier buildings on the site with a defined use, at least, for part of its life, this building is of high significance on the site.

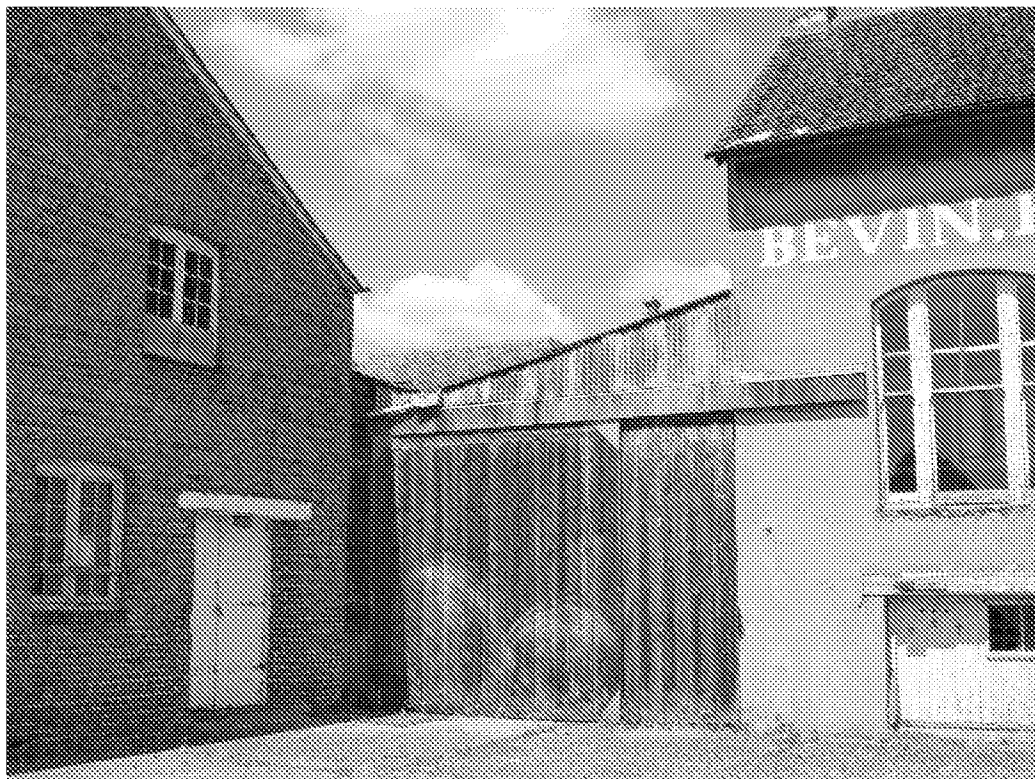
**Figure 8:** Entrance doors and temporary roof of Building 5

- 5.21 This area is shown on the 1897 Ordnance Survey map as open yard. By 1912 it is enclosed. This roof structure may date from the as early as the turn of the last century but it is very crude and in a poor condition and is likely to have been a temporary structure repaired and renewed on a regular basis. It appears to have been a corridor initially allowing access to the Tun Room (Building 4) although this has been partitioned to allow only access to the ground floor of Building 1.

- 5.22 The original use of this area is not immediately apparent and prior to 1897 and possibly up to 1912 it was open yard. The roof structure is crude and in a very poor condition. This building/ area is considered to have very limited significance in relation to the site as a brewery.

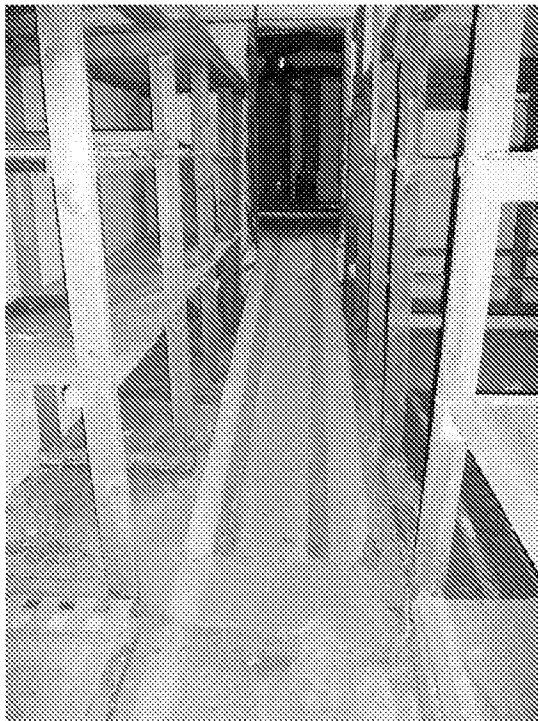
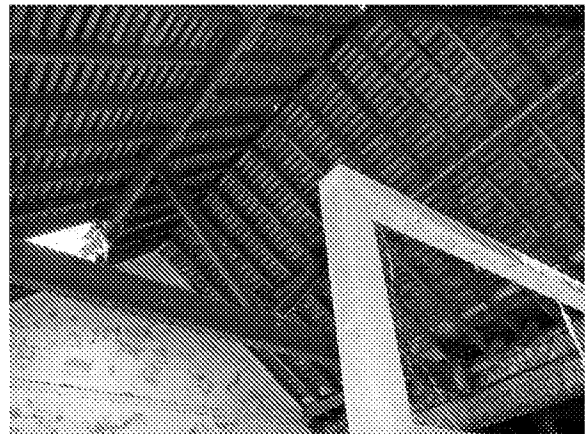
**Figure 9:** (left) Ramp which runs north-south through Building 6 (right) roof to Building 6

- 5.23 This building sits immediately to the south of Building 4 and is open to this building. Walls are a mix of rendered brick and some panels of flintwork. There is a window to the south wall. This is a twelve pane fixed light timber casement window in a timber frame. The glazing bars have ovolo mouldings but this window is probably early 20<sup>th</sup> century in date. It is in a poor condition. The floor is concrete. There is a long ramp up from Building 4 across this space into Building 5. The roof is red/orange clay tiles. The roof has a hip to the east and gable to the west.

- 5.25 This building is an ancillary building to the Building 4 and is a late addition to the Brewery complex. Its use is not clear and it does not contain fabric which clearly defines its former uses. It is crudely constructed and in a very poor condition. The significance of this building is considered to be low.

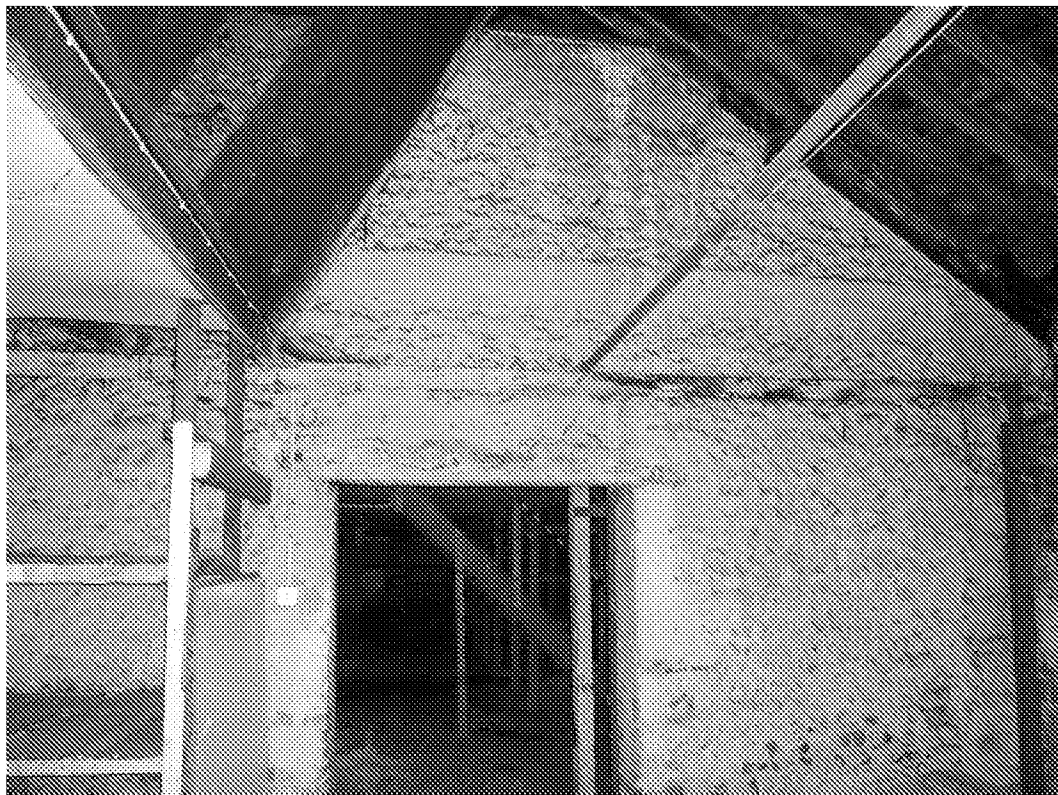
**Figure 10:** Flint with brick banding to walls of Building 7 (looking north towards Building 4)

- 5.28 Whilst its historic use cannot be clearly defined, although it is likely to have been an extension to the Tun room, perhaps to reflect an increase in demand for beer towards the end of the last century. However, the significance of this area lies in the survival of a number of earlier structures which have been adapted and altered to accommodate the present building. This would include the low brick retaining arch to the east wall and the sections of stone walling also to the east elevation. The roof is in a very poor condition and is not considered to be particularly significant to the historic importance of the complex although its presence does form part of the attractive roofscape which characterises these buildings in their wider context. The survival of remnant archaeological features of previous buildings on the site would give the walls in particular the east wall high significance.

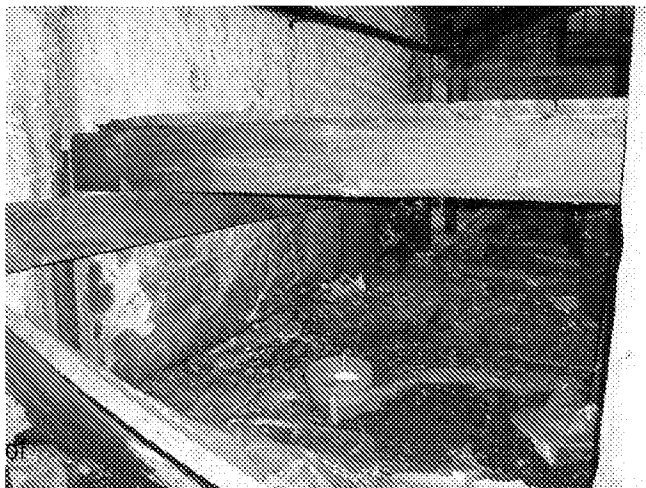
**Figure 11:** Arch to east wall  
Building 7

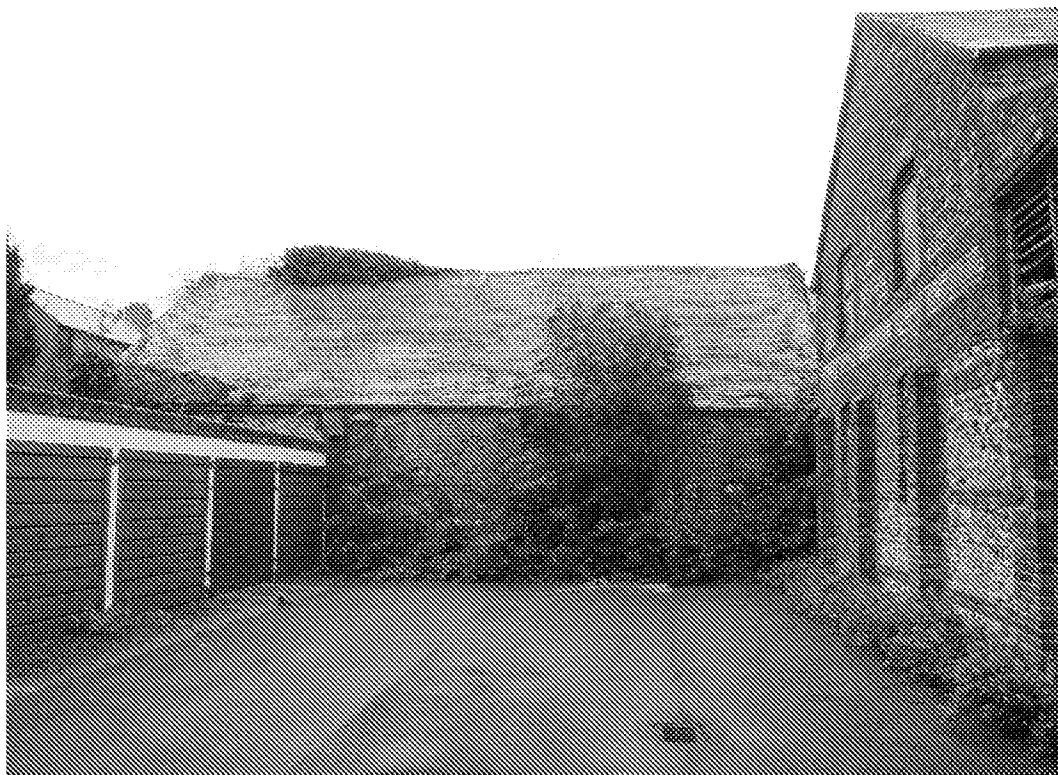
**Figure 12:** South elevation of Building 8

- 5.31 The rebuilding of the brickwork to the south elevation suggests the crude bricking-up of former openings leading to further suggestions that this was a store which was serviced from the yard to the south (although this is not in the ownership of the brewery). There is further evidence in the brickwork to the western end of the south elevation to suggest that the building was originally constructed abutting a structure to the south (which has now been replaced with garaging). Tenements are shown on the 1897 Ordnance Survey map in the place of Building 8.

- 5.32 This building is a late addition to the site and is crudely constructed. However it has some important archaeological fragments of former buildings and structures which have been subsumed into Building 8. The former fireplace and varied brickwork including straight joints and possible former openings all form part of the significance of this building. This building is considered to be of moderate to high significance principally because of the survival of early structures within the walls.

| Building Number | Summary of significance | Proposed changes | Impact of proposed changes | Mitigation for changes (where necessary) |
|---|---|---|---|---|
| Building 8 | MODERATE/HIGH | Part demolition of existing building and conversion to residential use. | Loss of historic fabric<br><br>Loss of structural integrity of surviving walls | Notable archaeological remnants within the built fabric of the walls should be retained and where possible exposed. Where they are to be lost a photographic record should be made.<br><br>A method statement relating to how the existing walls will be consolidated and stabilized should form the subject of a condition of approval. |

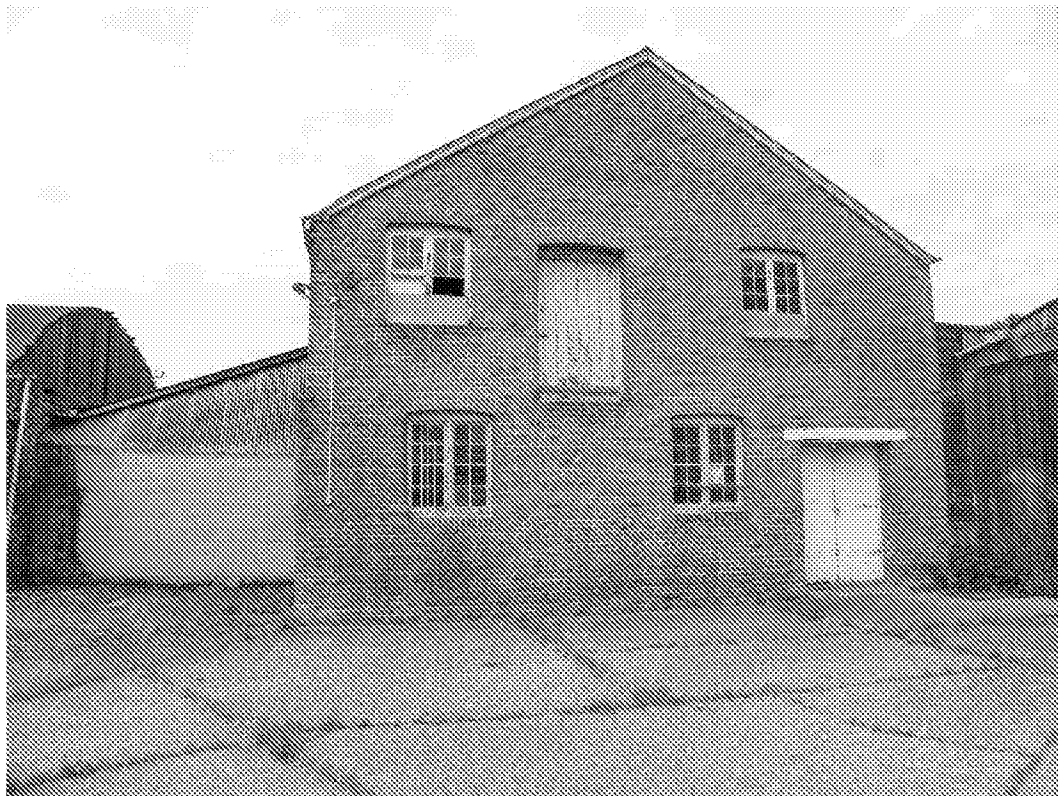
**Figure 13:** East elevation of Building 9

- 5.36 Despite the relatively late date of this building it is in an almost, as built condition and therefore its historic value is more significant than other buildings which have either been heavily altered or created through the presence of other structures. The intact nature of this building and its industrial character contribute to its significance. Of particular note is the west wall of the building which appears to comprise at least three building phases and may have started as a boundary wall which has been built upon. The presence of varied band widths of flint and some use of stone all contribute to the significance of this part of the building as an archaeological record of change on the site. This should be considered with buildings 10 and 11 which share this boundary as their western walls. This building is of moderate to high significance.

- 5.37 It should be noted that there is a very significant floor to eaves crack in the south wall of this building which will require investigation, stitching and probably underpinning.

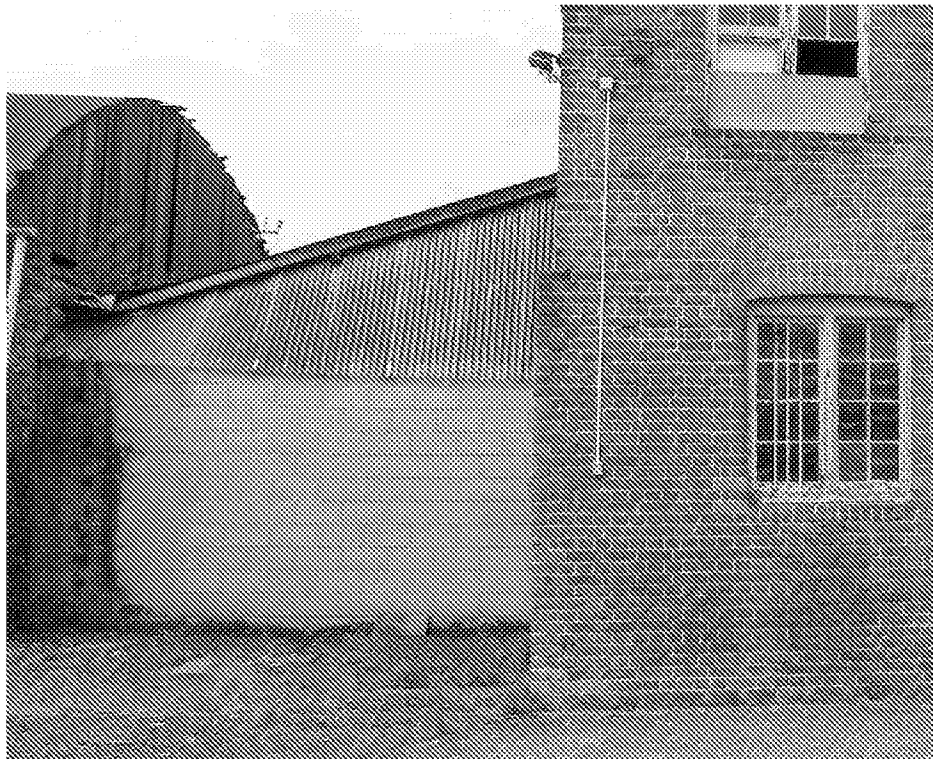
**Figure 14:** West elevation of Building 10

- 5.40 The west wall of this building which is shared with the adjacent buildings; 9 and 11 is of high significance as it is an archaeological record of change on the site which has been complex to this part of the site. The roof is of low significance.

| Building Number | Summary of significance | Proposed changes | Impact of proposed changes | Mitigation for changes (where necessary) |
|---|---|---|---|---|
| Building 10 | LOW | Demolition | This will be an enhancement to the site | The west wall should be consolidated and carefully protected during works of demolition on the site. A method statement relating to stabilising and capping of existing walls should form the subject of a condition of approval. |

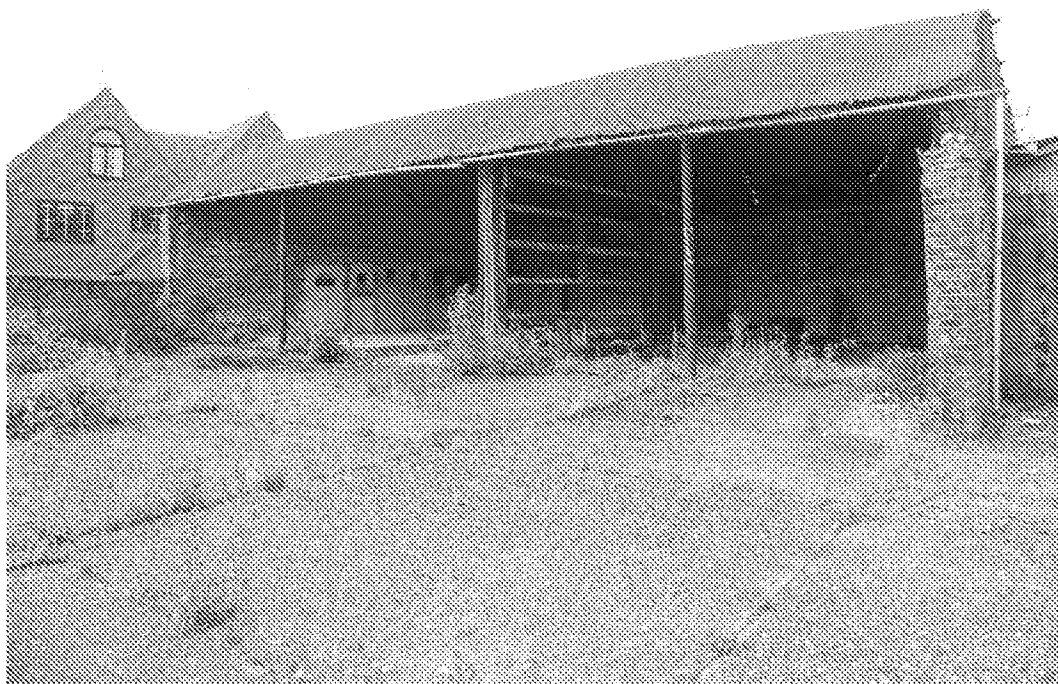
**Figure 15:** East and south elevation of Building 11

- 5.43 This building appears to have largely replaced earlier structures on the site and so evidence for earlier built form appears limited. The use is ancillary to the site and although it has some significance as demonstrating the changing character and nature of the scale of production in the brewery, it is a structure which in itself is of limited architectural or historic interest and is functionally industrial in character. It is of low to moderate significance.

| Building Number | Summary of significance | Proposed changes | Impact of proposed changes | Mitigation for changes (where necessary) |
|---|---|---|---|---|
| Building 11 | MODERATE to HIGH | Demolition and replacement with new buildings – 2 x 3 bed houses | Potential impact upon the stability of the existing walls to Building 11 (which form the boundary to the site) | <p>A method statement should form part of a condition of approval relating to the proposed method of demolition and stabilization of the existing boundary walls.</p> <p>The proposed houses are intended to reflect the industrial aesthetic of the site and make reference to the curving roof structure which presently forms a distinctive element of the roofscape of this part of the Arundel Conservation Area.</p> |

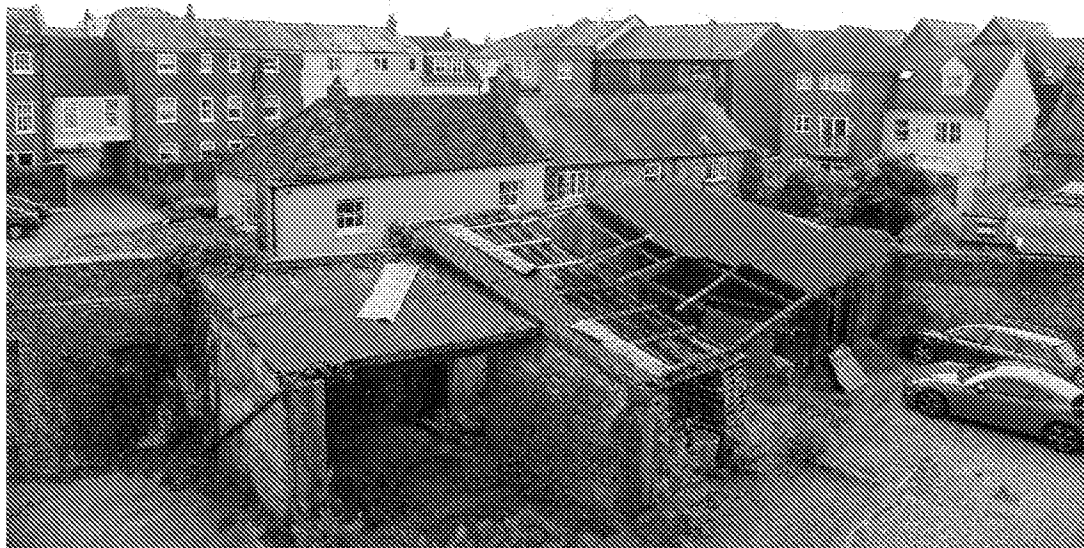
**Figure 16:** West and north elevation of Building 12

- 5.44 This building lies to the east of the site and its east wall forms part of the boundary wall to the site. It is a small rectangular plan single storey building with a pent roof. The building is semi-derelict and partially collapsed in places. There are some sections of brickwork in an English bond with flared headers. These form partitions to a series of open and closed bays. The roof comprises corrugated metal sheeting and is missing in places.

- 5.46 Whilst it is possible that small sections of this building could form part of earlier buildings, their condition and context and integrity have been severely compromised so as to make them almost unreadable and of limited value. This building is therefore of low significance.

| Building Number | Summary of significance | Proposed changes | Impact of proposed changes | Mitigation for changes (where necessary) |
|---|---|---|---|---|
| Building 12 | LOW | Demolition and replacement with new buildings | Changing the character of Brewery Lane | <p>The proposed development is intended to perform four tasks:</p> <ol style="list-style-type: none"> <li>1. Provide some enclosure to the site and in particular frame the listed building</li> <li>2. Mask, in part the unrelieved blank façade of a neighbouring property which presently has an adverse impact on the setting of a Grade II listed building</li> <li>3. Provide additional parking for the site whilst also providing additional accommodation</li> <li>4. Reinstating a physical presence to Brewery Hill where once the main brewery building stood, whilst at the same time maintaining the now established cottage scale of the lane.</li> </ol> |

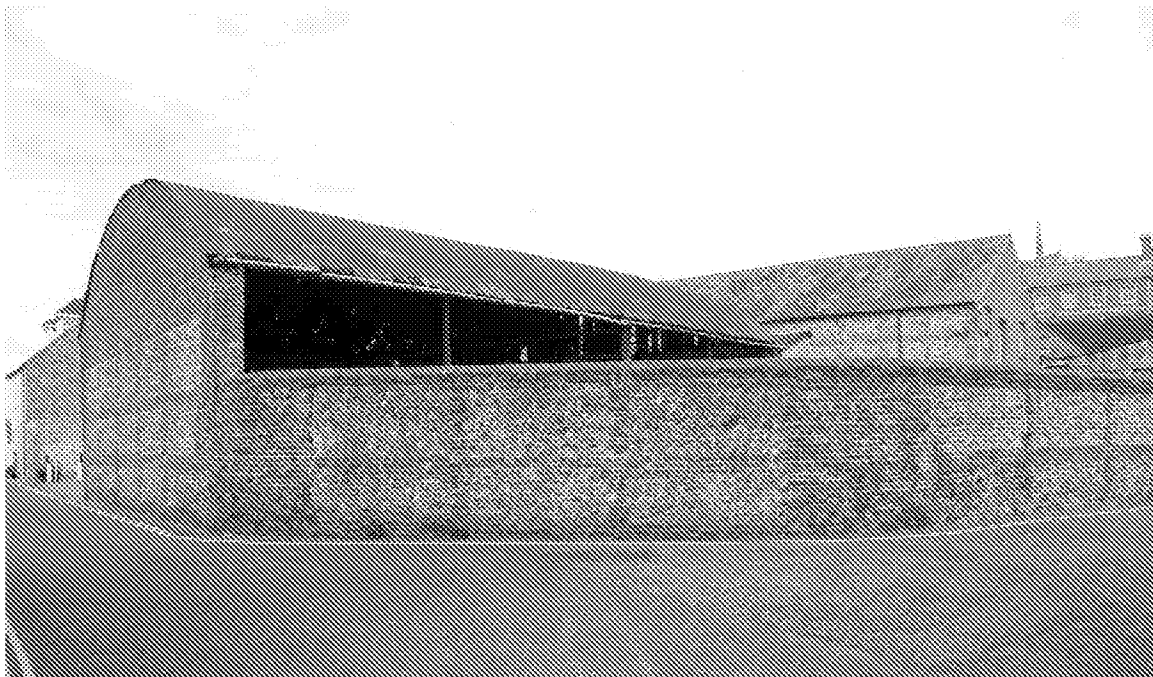
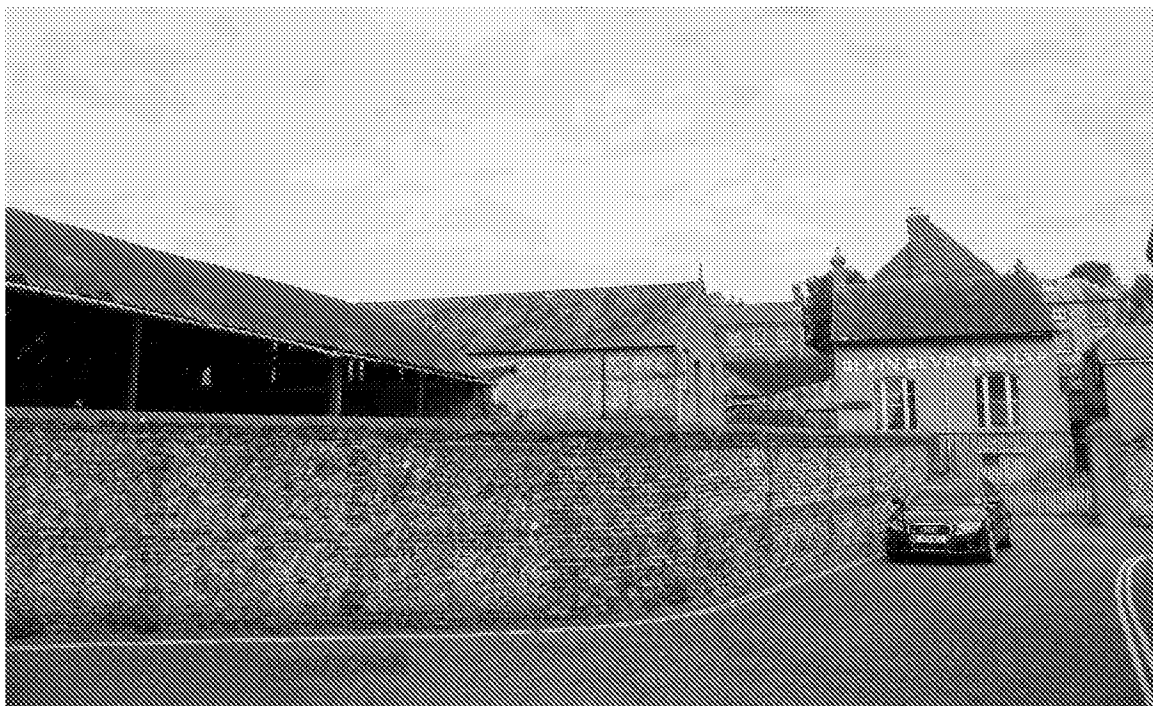
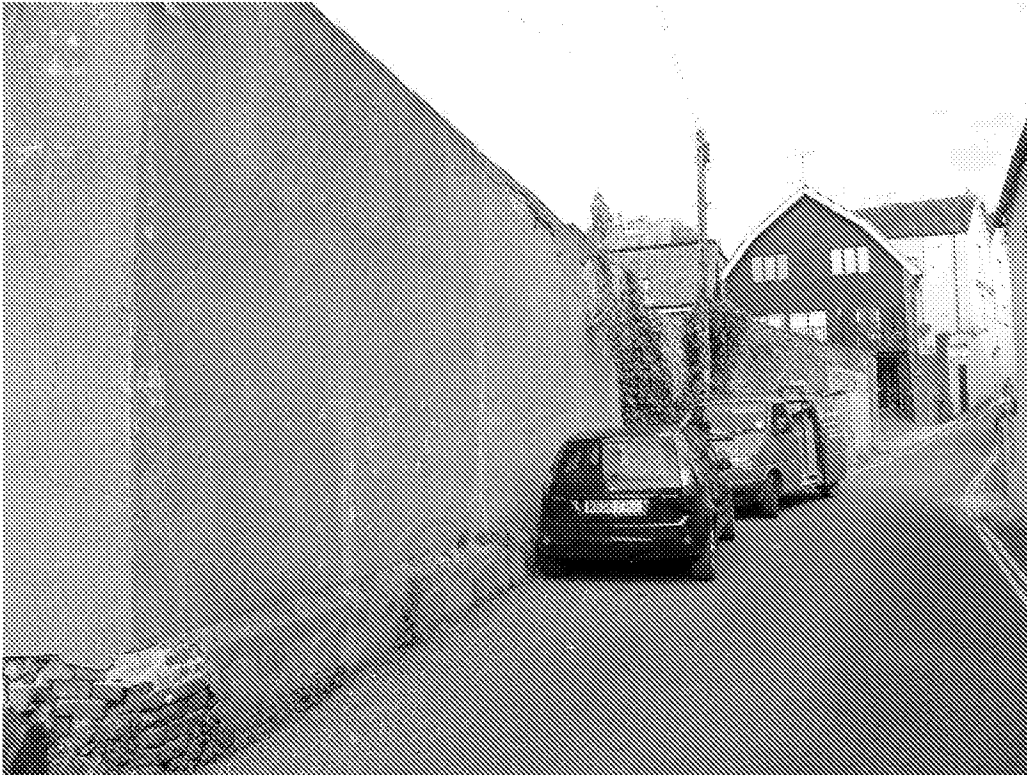
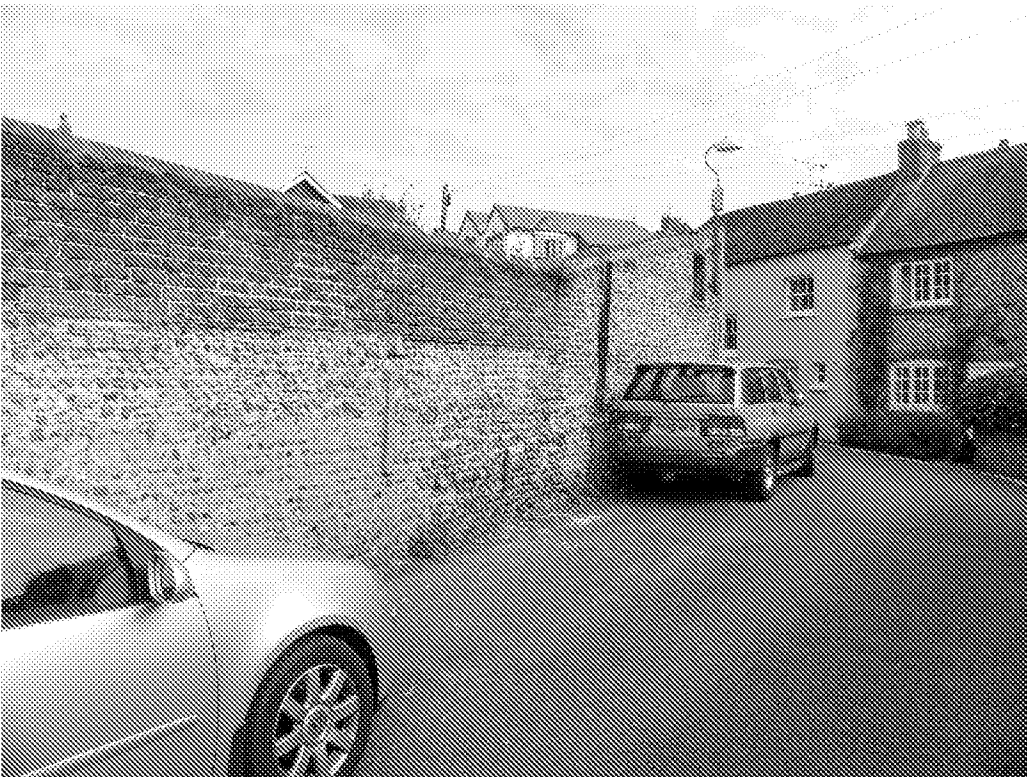
**Figure 17a and b:** Sections of boundary wall –south (above) and south-east boundary (below) - collectively described as Building 13

**Figure 17c and 15d:** Boundary walls (Building 13) south-eastern to east of entrance (above) and eastern boundary of the site (below)

- 5.49 Whilst some of these sections of boundary wall may not be considered to be particularly historic, they do form a very important part of the setting of the site and the listed building and make a very positive contribution towards the character and appearance of the Arundel Conservation Area. There is also the potential for the survival of earlier structures of significance to the site embedded within the walls particularly to the north-east corner of the site. These walls are therefore of high significance.

| Building Number | Summary of significance | Proposed changes | Impact of proposed changes | Mitigation for changes (where necessary) |
|---|---|---|---|---|
| Building 13<br>(sections of boundary wall) | HIGH | Repair and consolidation and some rebuilding where deemed necessary for health and safety reasons (to be agreed with the Local Authority) | Over-repair and/or mis-specification of repairs | Condition the preparation of a schedule of works for repairs to the boundary walls to be approved prior to works taking place. |
