A  
LISTED BUILDING ASSESSMENT  
for  
**CARLETON HOUSE**  
**15 Maltravers Street**  
**Arundel**

Prepared for  
Mr and Mrs A BATTY

NOVEMBER 2016

Prepared  
by  
**FRED ALDSWORTH BA FSA MCIfA IHBC**  
Archaeologist and Heritage Consultant  
124 Whyke Road, Chichester, West Sussex PO19 8JG  
Tel. 01243 782904 e-mail [aldsworthfred@hotmail.com](mailto:aldsworthfred@hotmail.com)

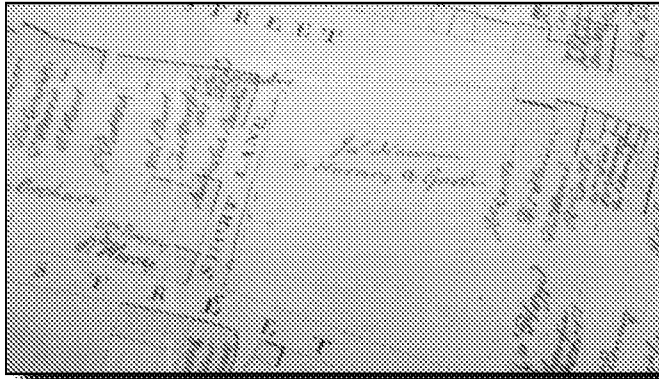
*Extract from the 1785 plan, with a detail showing the plot now partially occupied by Carleton House.*

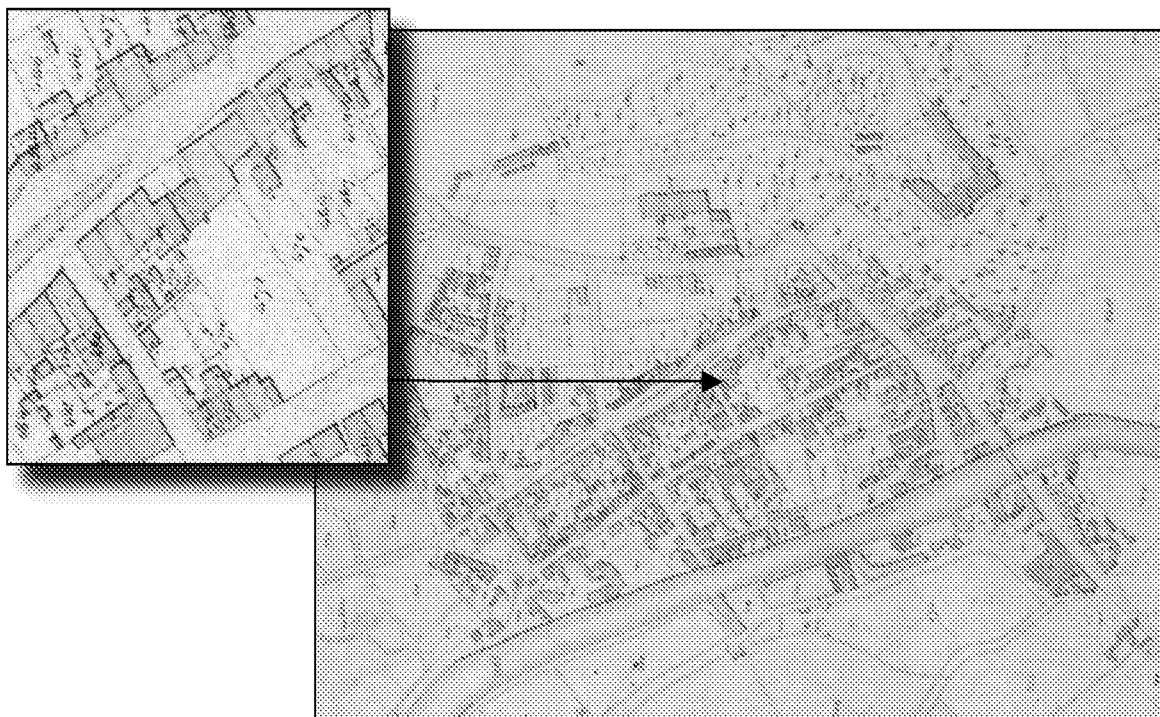
*The Arundel Tithe Map and an extract showing the property now known as Carleton House – Plot 471.*

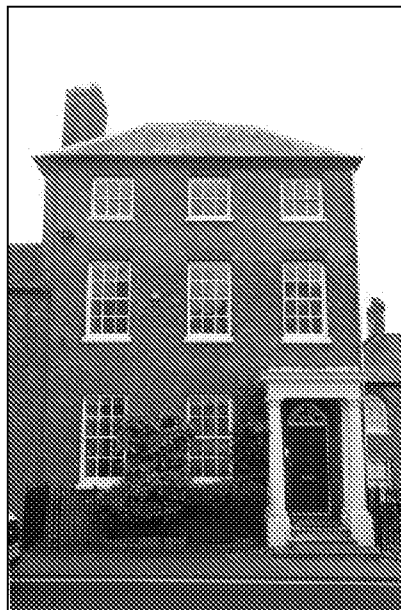
There are the heads of two former window openings at ground level, which lit the lower ground floor level; two tall window openings at ground floor level; three tall window openings at first floor level; and three smaller windows at second floor level. All the window openings have near flat, prefabricated heads formed of gauged, or rubbed, bricks. There are no string course picking out the floor levels but there is a dentilled eaves course.

*The north elevation of Carleton House.*

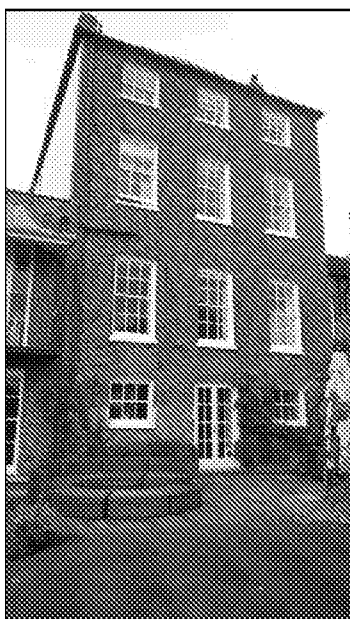
The *south elevation* is of four storeys and of brickwork, similar to that on the north elevation, but without the employment of gauged, or rubbed, bricks in the window heads, which are in a shallow, segmental form and constructed of stretcher bricks on end.

Originally there was no direct access to the garden at the lower ground floor level, which was lit by three relatively small windows, but that in the centre was converted to a door opening at a later (Phase 5) date. There are then three tall windows at ground and at first floor levels and three small ones at second floor level. There are no string courses picking out the floor levels but the original dentilled eaves course survives at the top.

*The south elevation of Carleton House.*

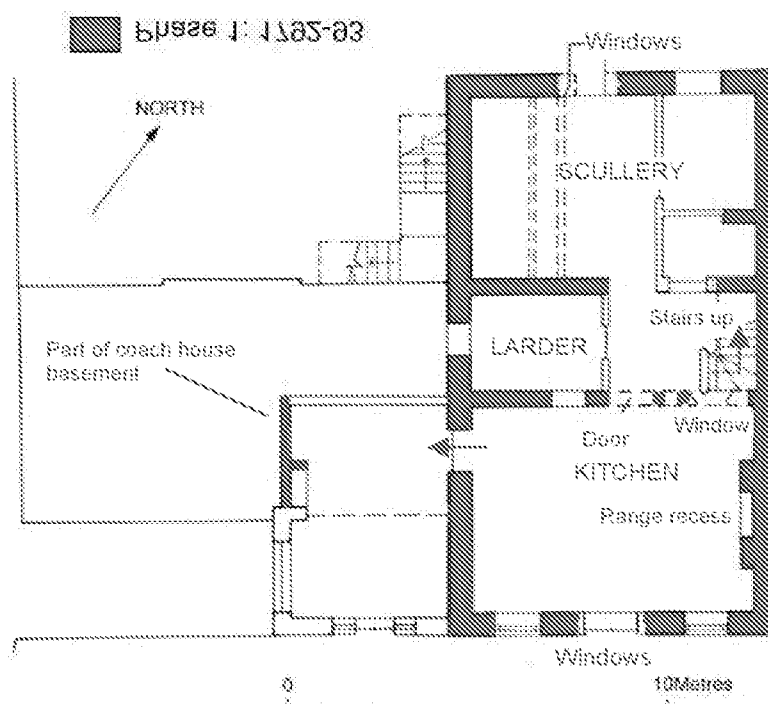
It probably had a kitchen on the south side, served by a cooking range in the recess on the east side; a scullery on the north side and, perhaps, a larder between them. The stairs were lit by an internal window gaining light from the kitchen. There was also an access through to the basement of the coach house from the kitchen.

*Lower ground floor plan, showing the possible arrangement of the original house. Scale 1:200.*

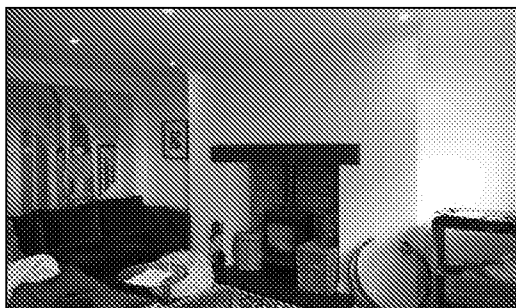
*The recess on the east side of the lower ground floor (above) and an example of a typical combination cooking range of the type that may have existed here (right).*

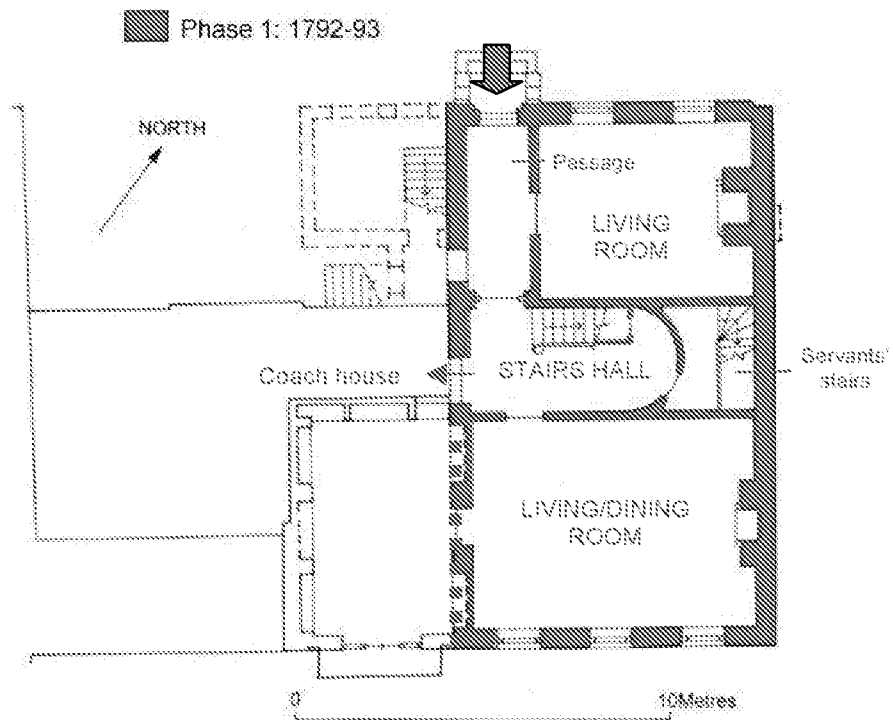
There was no direct access to the garden from this level and it is assumed that access could only be achieved through the coach house via a door opening in the west wall of the stairs hall.

*Ground floor plan, showing the possible arrangement of the original house. Scale 1:200.*

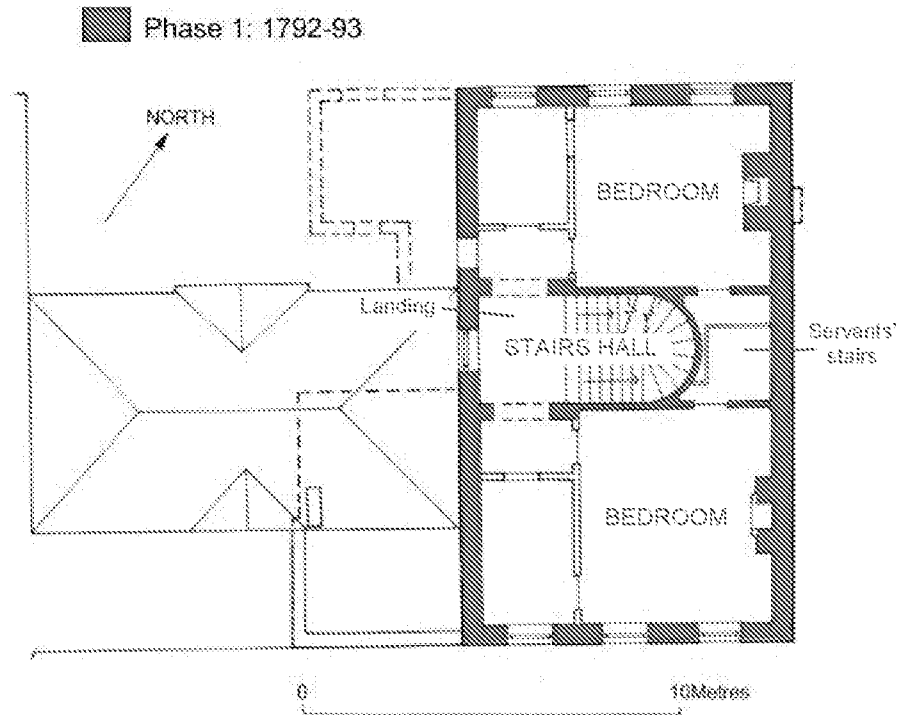
The remainder of the existing partitions at this level appear to be later (Phase 4) insertions, two of them with even later (Phase 5) blocked door openings, and it is difficult to be certain about the original arrangement, but it is likely to have included a lobby for each bedroom off the main landing.

*First floor plan, showing the possible arrangement of the original house. Scale 1:200.*

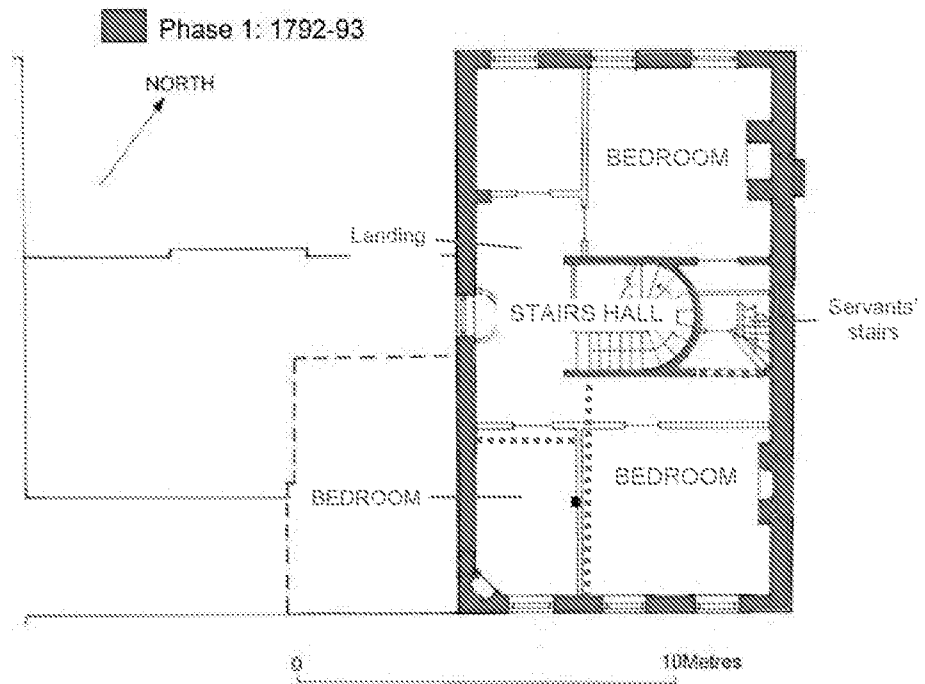
The servants' back stairs were probably behind, to the east of, the main staircase.

*Second floor plan, showing the possible arrangement of the original house. Scale 1:200.*

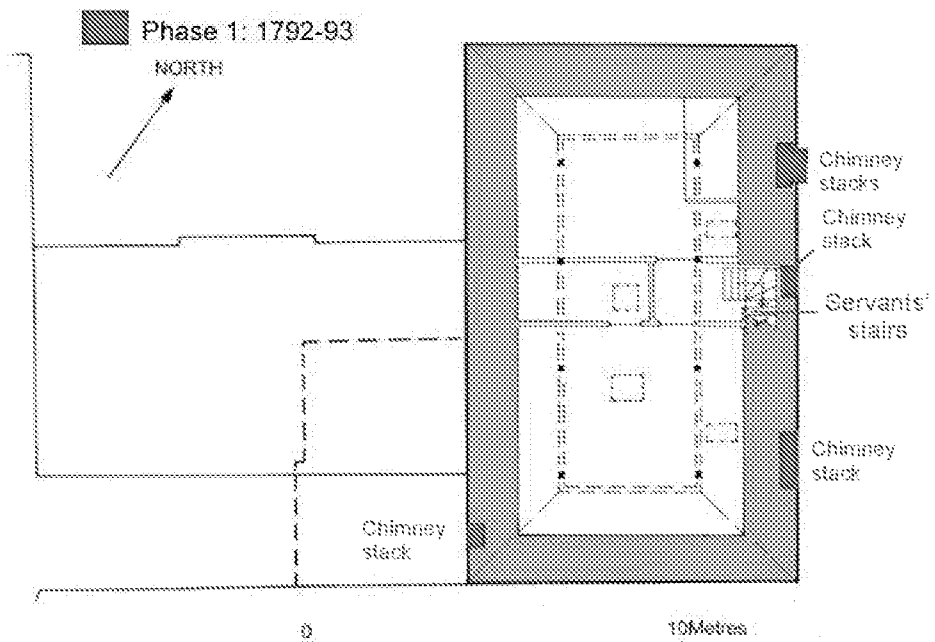
The existing windows in the east side and in the flat roof are also recent additions.

*Third, or attic, floor plan, showing the possible arrangement of the original house. Scale 1:200.*

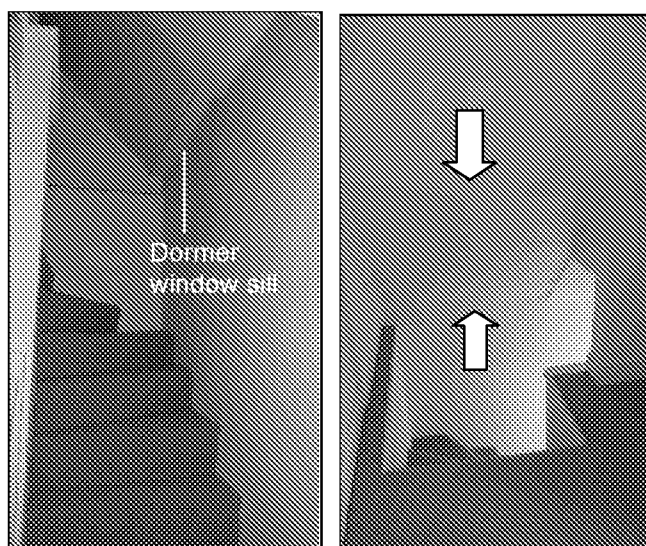
*The evidence for the former dormer window, showing the sill (right) and the extent of the planked-up opening (far right).*

There are eight posts within the attic space supporting the framing for the flat roof and the tops of the rafters

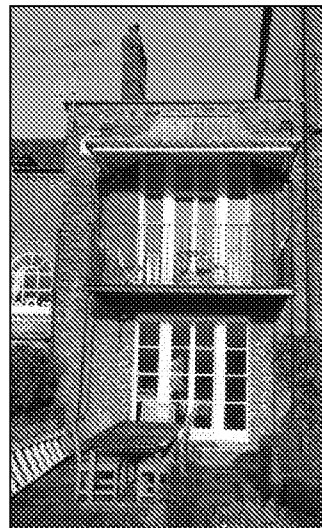
The south wall was totally rebuilt at lower ground floor level, to replace the wall of the covered yard, and partially rebuilt at ground level at a later (Phase 5) date. However, at ground level it seems to be partially in its original form, with red bricks and some blue headers laid in a lime-based mortar in Flemish bond rising to the coping of a parapet wall in front of a flat roof.

On the west side is one chimney stack added at this time to serve both a fireplace in the basement boiler room and another in the ground floor dining room.

A balcony with an ornate, Georgian-style roof, was added at ground floor level at the later (Phase 5) date.

*The south elevation of the Phase 2 extension.*

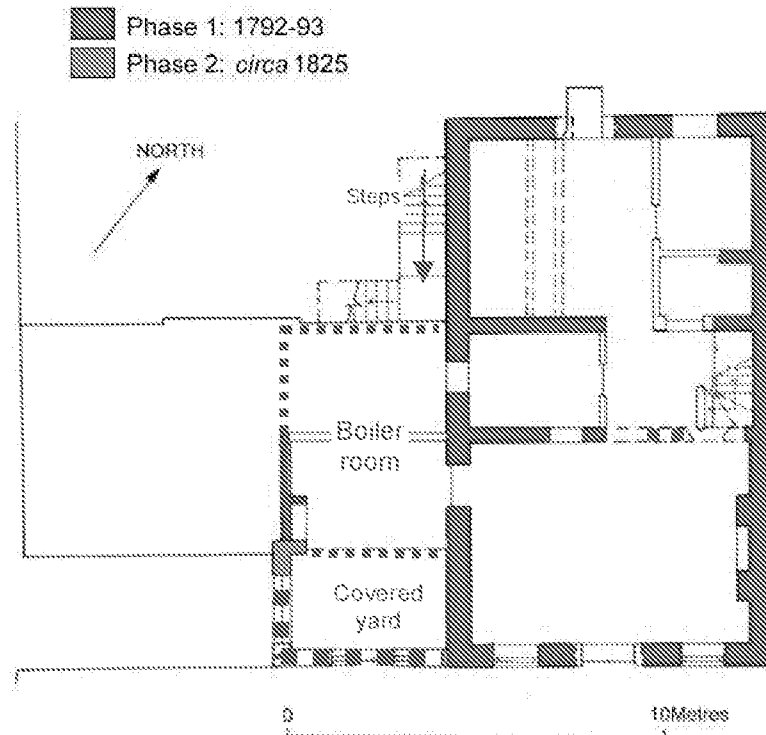
The extended space created beneath and to the south of the coach house accommodated a covered yard and a boiler room, accessed down external steps and in part now part of the adjoining dwelling, both of which were shown on the as existing plan produced in 1998 (see Appendix 1).

*Lower ground floor plan, showing the Phase 2 addition (dark blue).  
Scale 1:200.*

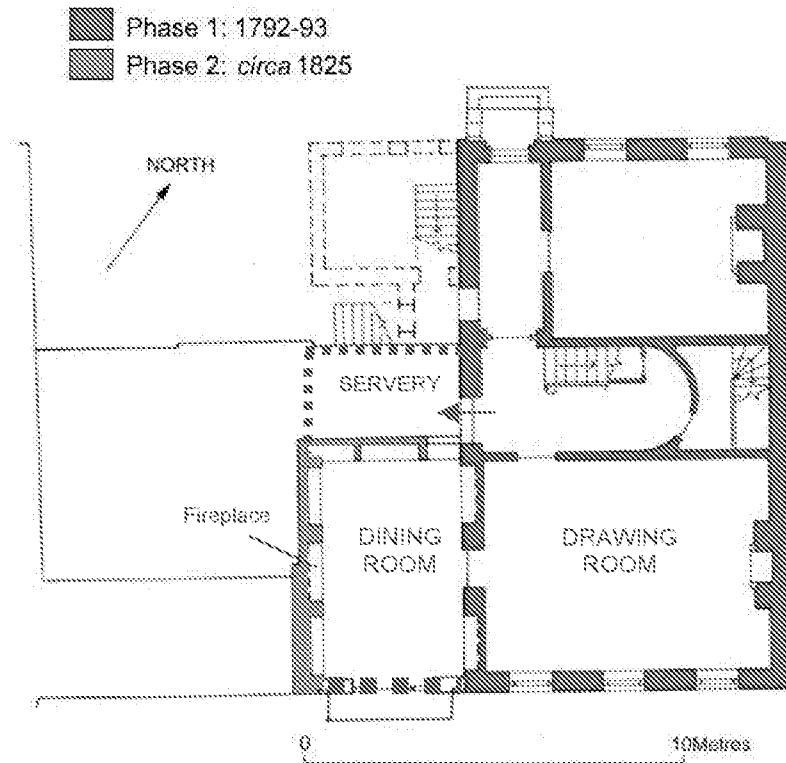
A former servery now forms part of the adjoining dwelling in the former coach house.

*Ground floor plan, showing the Phase 2 addition (dark blue).  
Scale 1:200.*

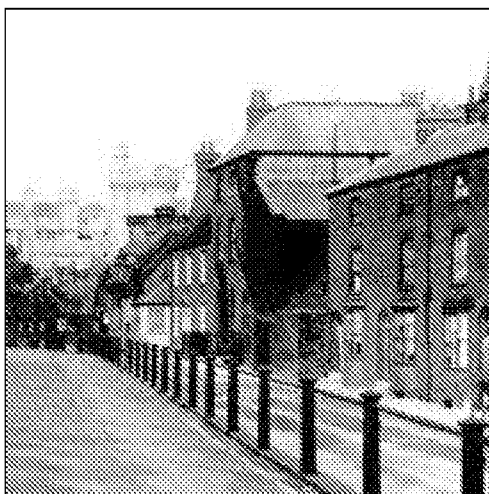
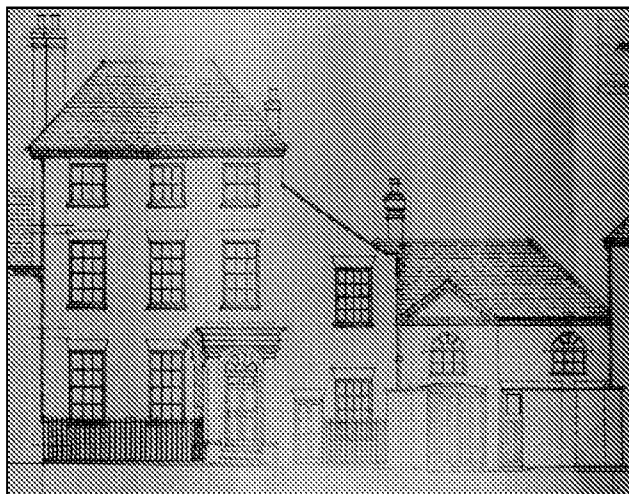
The addition was depicted on the photograph taken in 1906 and on the as existing drawings accompanying the planning application submitted in 1998, at which times there was a walled yard in front of the coach house containing a small shed in the north-west corner (see Appendix 1).

*Extracts from the photograph taken in 1906, from the west (above left)  
and from the as existing drawing submitted in 1998 (above right).*

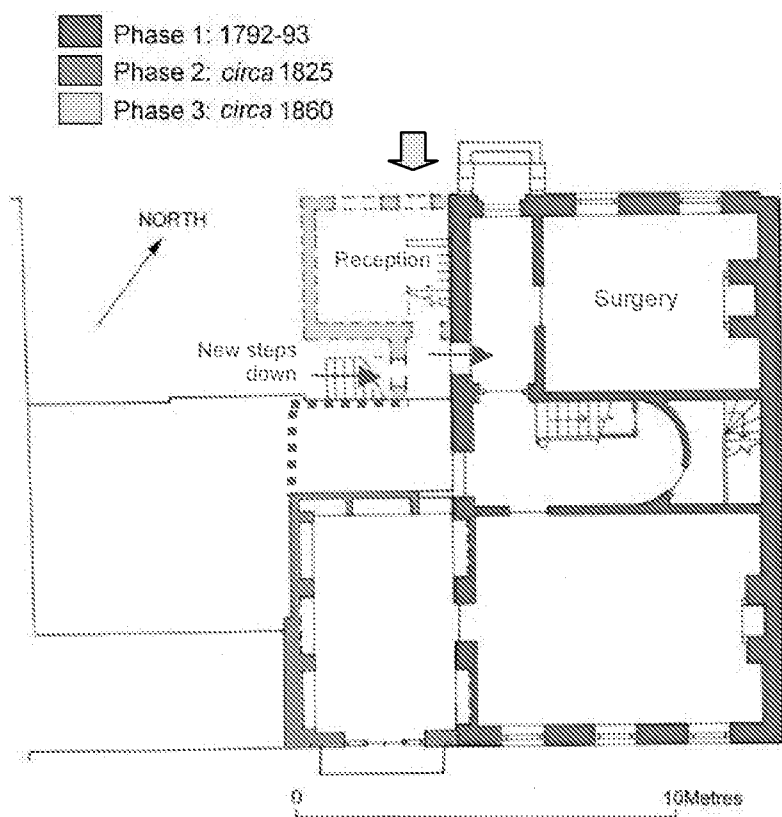
The additional door on the north front suggests that the newly-created extension may have had a separate functional use, and had a door leading through to the entrance passage of the main part of the house (see Overview).

*Ground floor plan, showing the Phase 3 addition (light blue).  
Scale 1:200.*

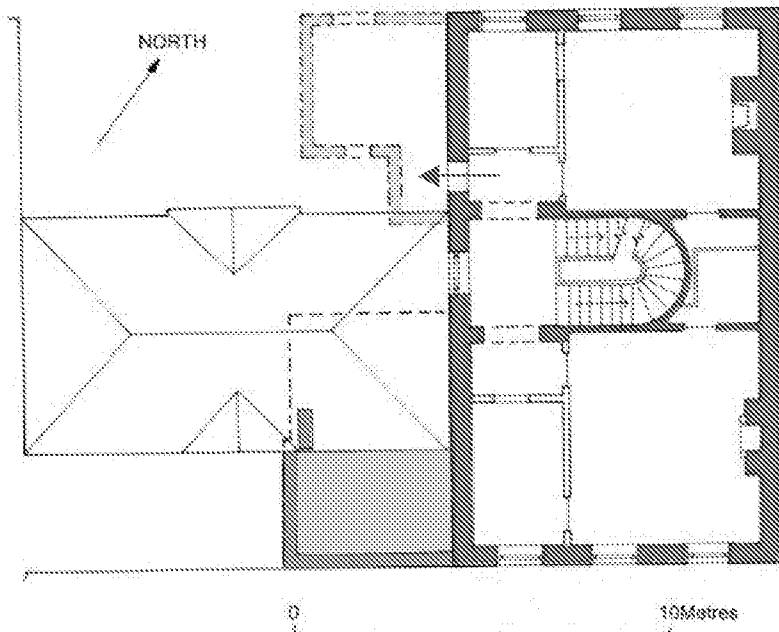
*First floor plan, showing the Phase 3 addition (light blue).  
Scale 1:200.*

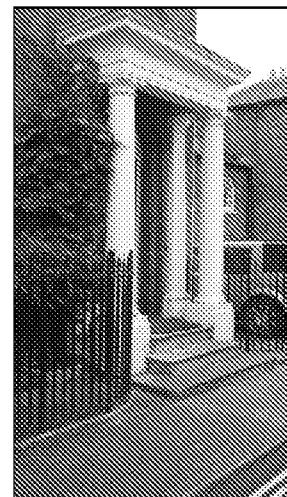
This provides a covered access, up three stone steps, to the main door and is formed of engaged square and two free-standing stone columns supporting an ornate cornice and flat roof.

*The porch, from the north-west.*

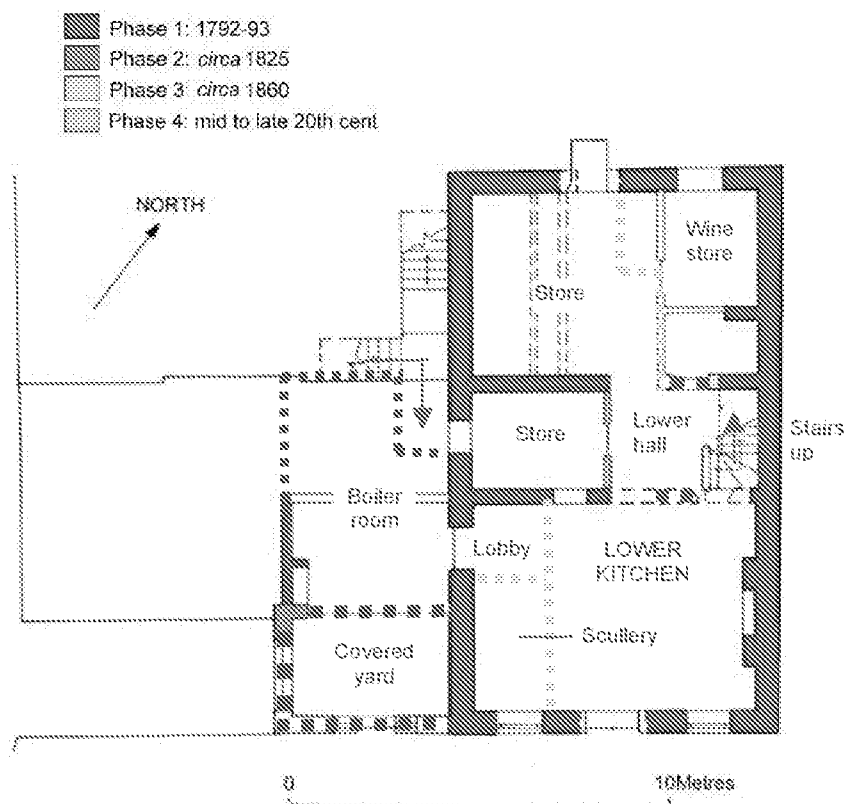
Access to the remainder of the house was by the former servants' staircase on the east side.

*Lower ground floor plan, showing the room uses in 1998 (green).  
Scale 1:200.*

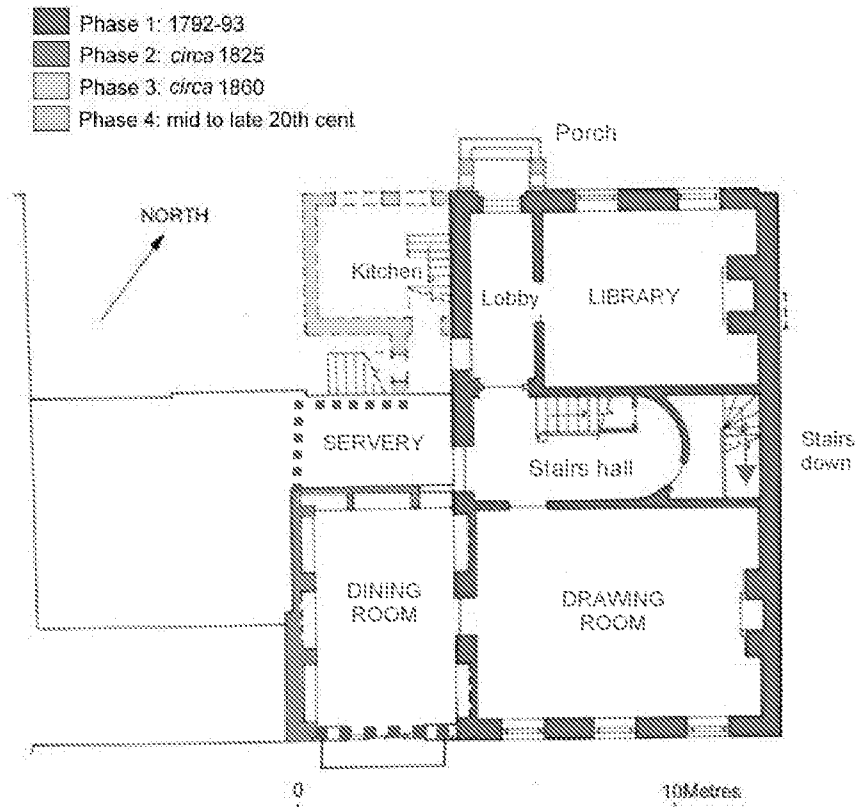
The large room on the north front was now a library and the large room to the rear was now a drawing room. Behind the stairs hall, the stairs down to the lower ground level were still in use, but the former servants' staircase up to the higher levels, which are presumed to have existed in this space up to second floor level, had been removed.

*Ground floor plan, showing the room uses in 1998 (green).  
 Scale 1:200.*

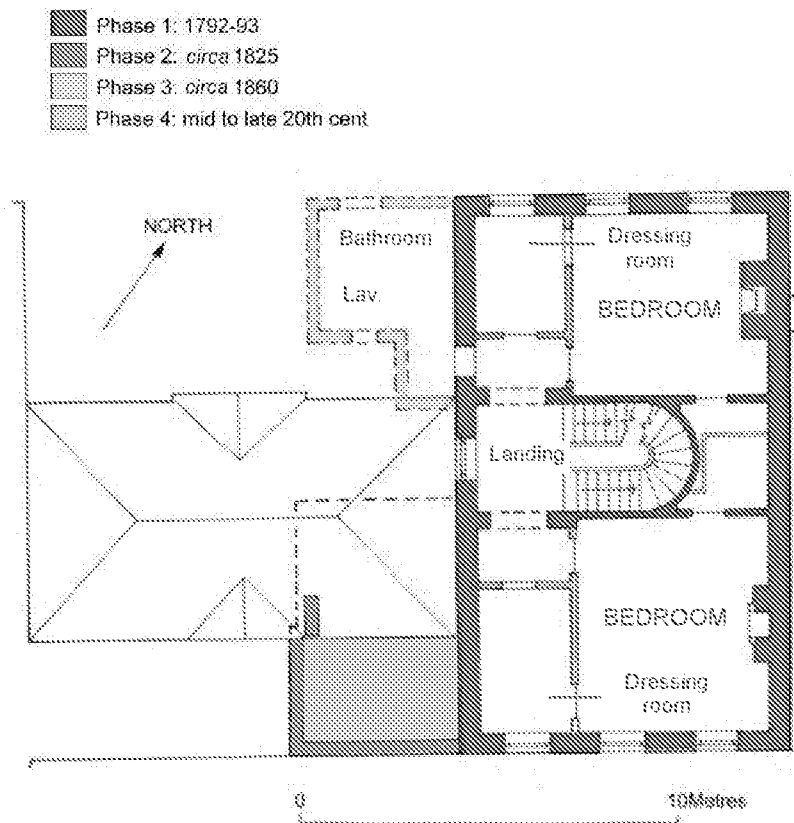
The space behind the main staircase, which had probably contained the servants' stairs, had by now been converted as cupboards.

*First floor plan, showing the room uses in 1998 (green).  
 Scale 1:200.*

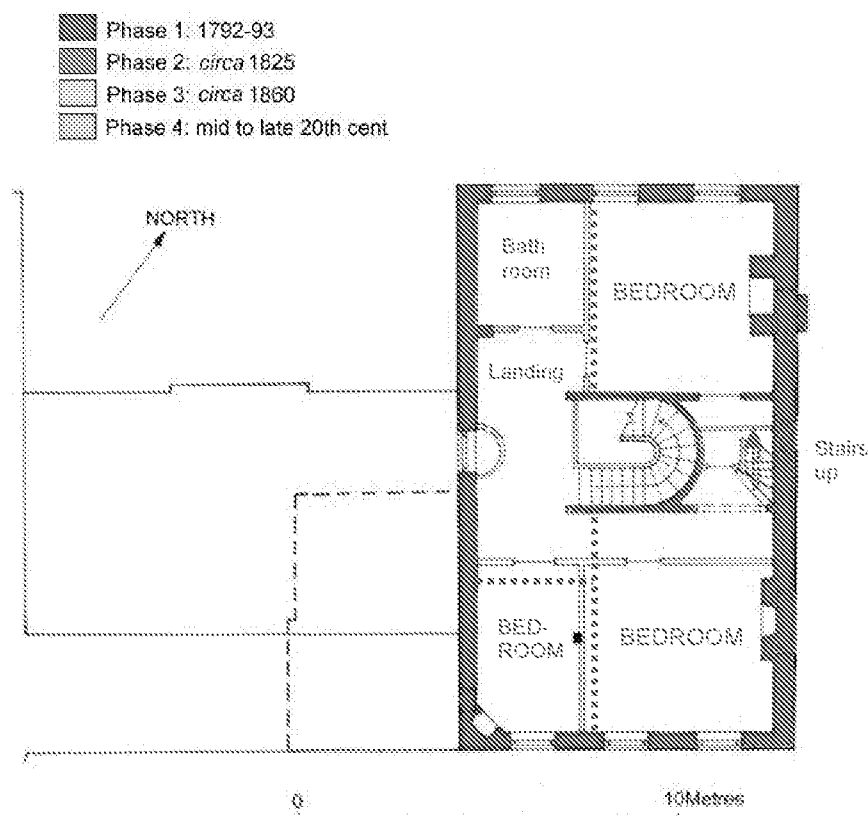
Behind the main staircase, in the space probably originally occupied by the servants' stairs, only the flight up to the third, or attic, level was still in use.

*Second floor plan, showing the room uses in 1998 (green).  
Scale 1:200.*

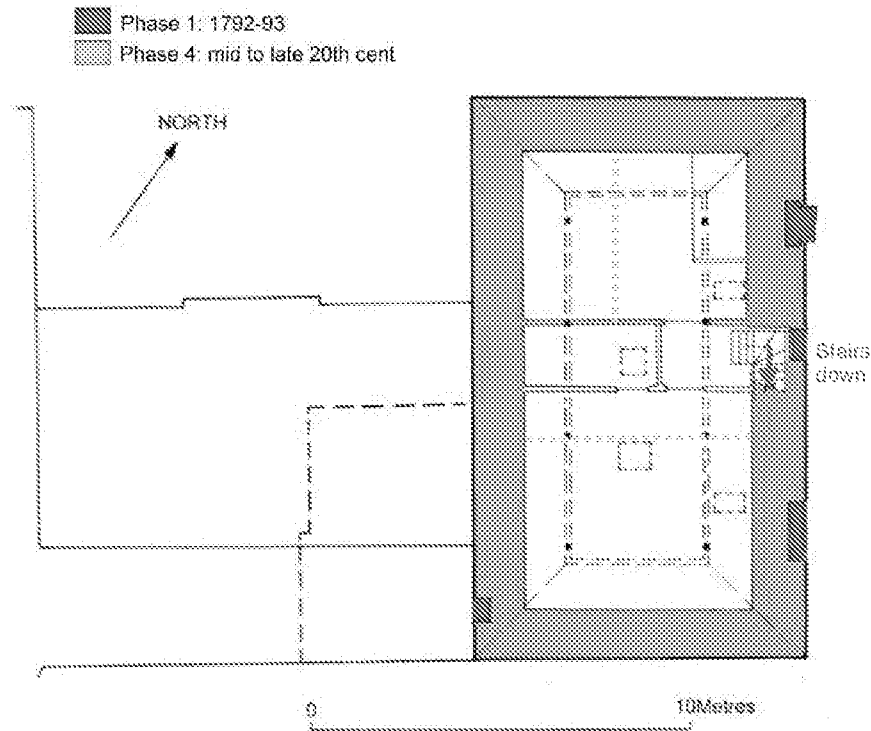
For the purposes of the Assessment a date of mid- to late-twentieth century is proposed for these works.

*Third, or attic, floor plan, showing the partitioned spaces in 1998 (green).  
Scale 1:200.*

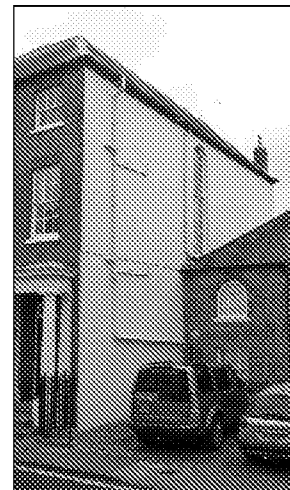
Following the demolition of the two-storey extension on the north-west side of the house, the *west elevation* was rendered; scribed with lines to simulate ashlar-work; and painted, leaving the original round-headed window and original dentilled-eaves course.

*The west wall of Carleton House, from the north-west.*

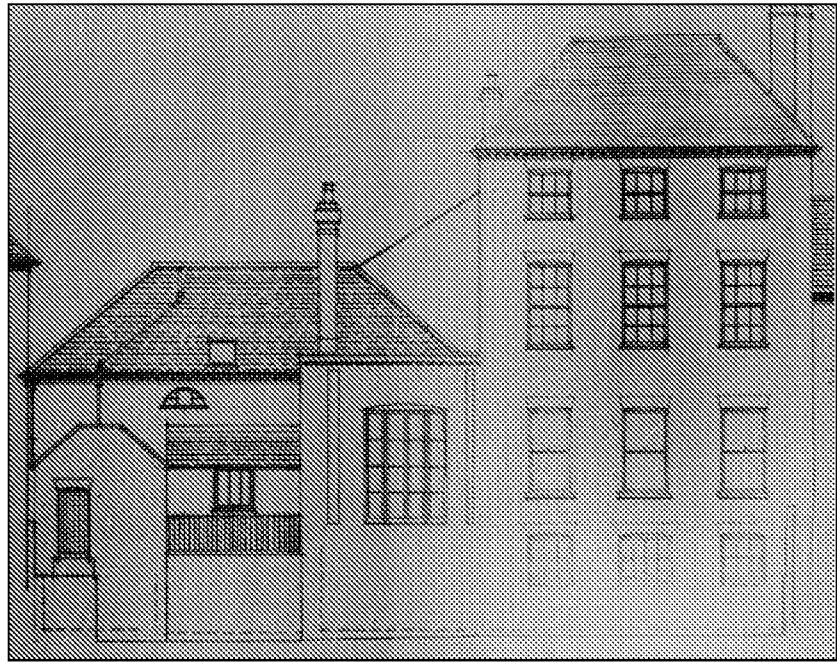
*The 1998 as existing drawing of the south elevation of Carleton House and the coach house.*

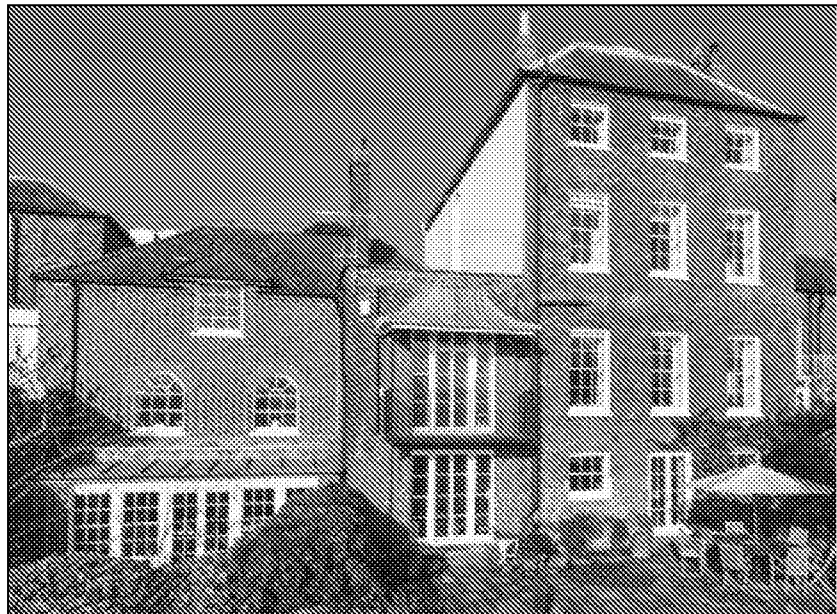
*The existing south elevation of Carleton House and the former coach house.*

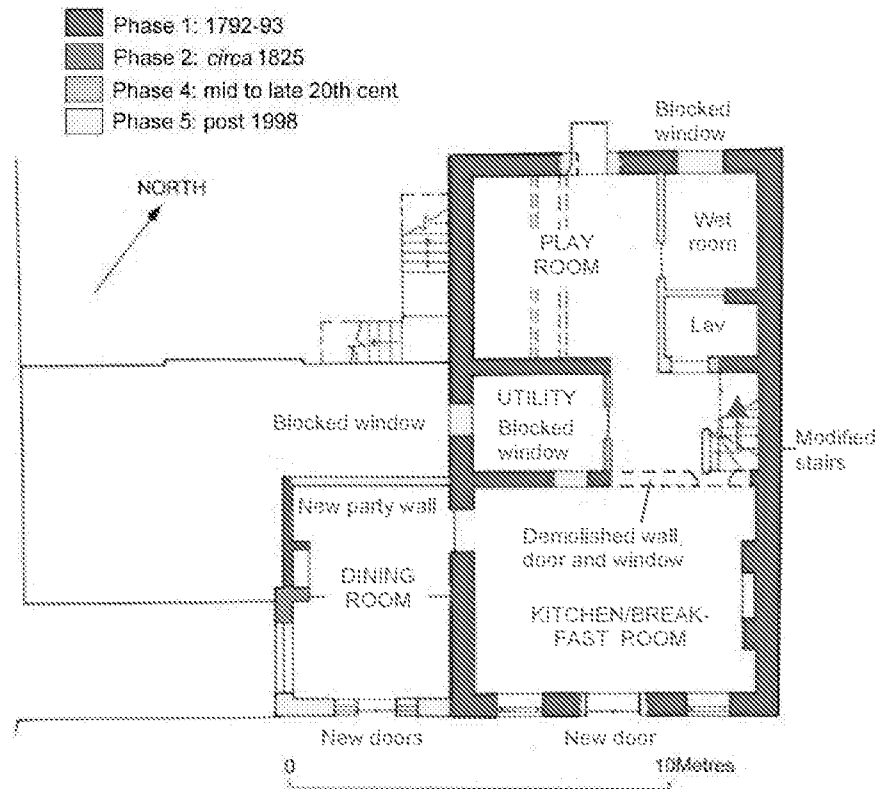
*Lower ground floor plan, showing the uses of spaces prior to the recent sale of the house (yellow and grey). Scale 1:200.*

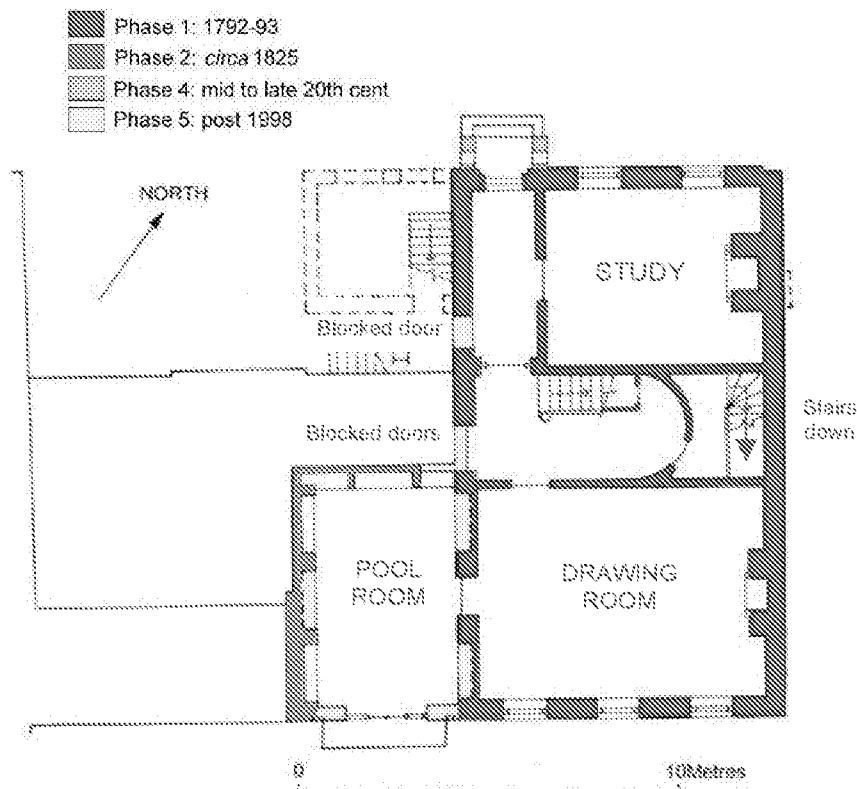
*Ground floor plan, showing the uses of spaces prior to the recent sale of the house (yellow and grey). Scale 1:200.*

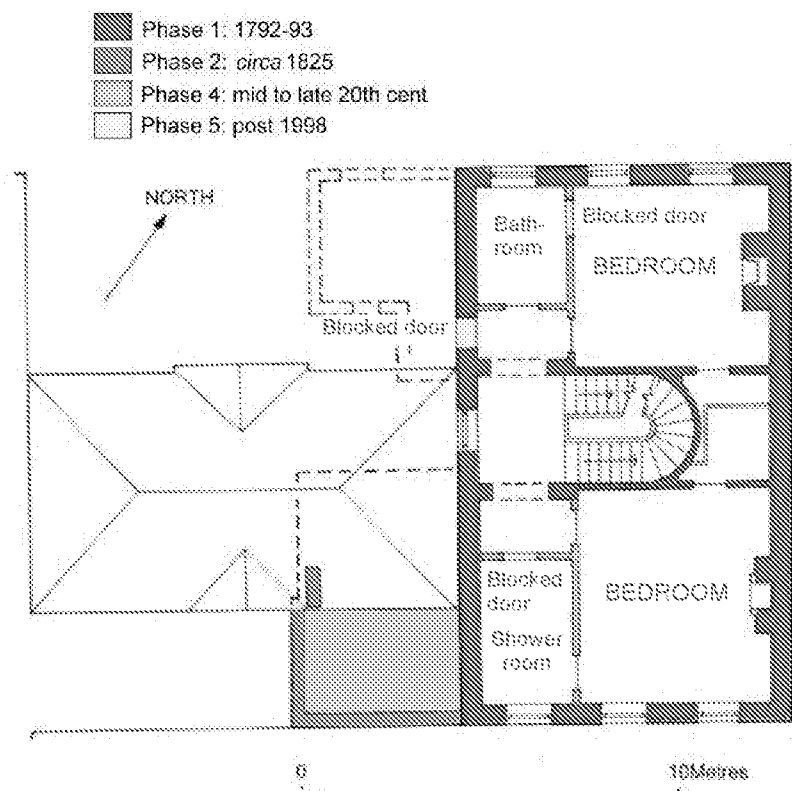
*First floor plan, showing the uses of spaces prior to the recent sale of the house (yellow and grey). Scale 1:200.*

Most of the existing stud partitions, probably, with plasterboard finishes, were inserted in their present positions shortly after 1998 as replacements for a different arrangement of spaces that existed at that time (see Appendix 1).

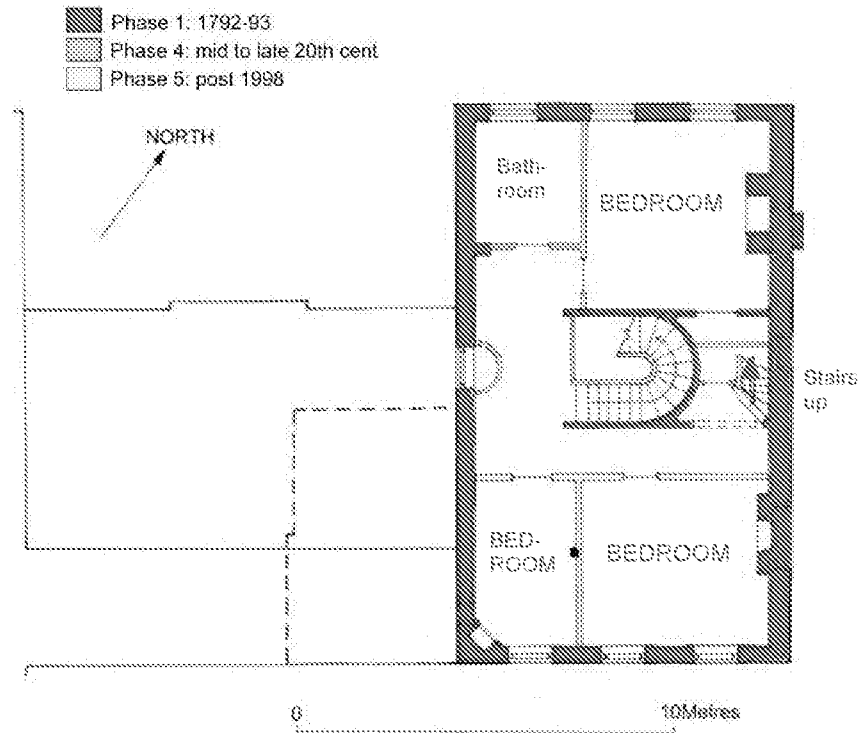
*Second floor plan, showing the uses of spaces prior to the recent sale of the house (yellow and grey). Scale 1:200.*

The existing stud partitions, probably with plasterboard finishes, were mostly inserted in their present positions shortly after 1998 as replacements for a different arrangement of spaces that existed at that time (see Appendix 1).

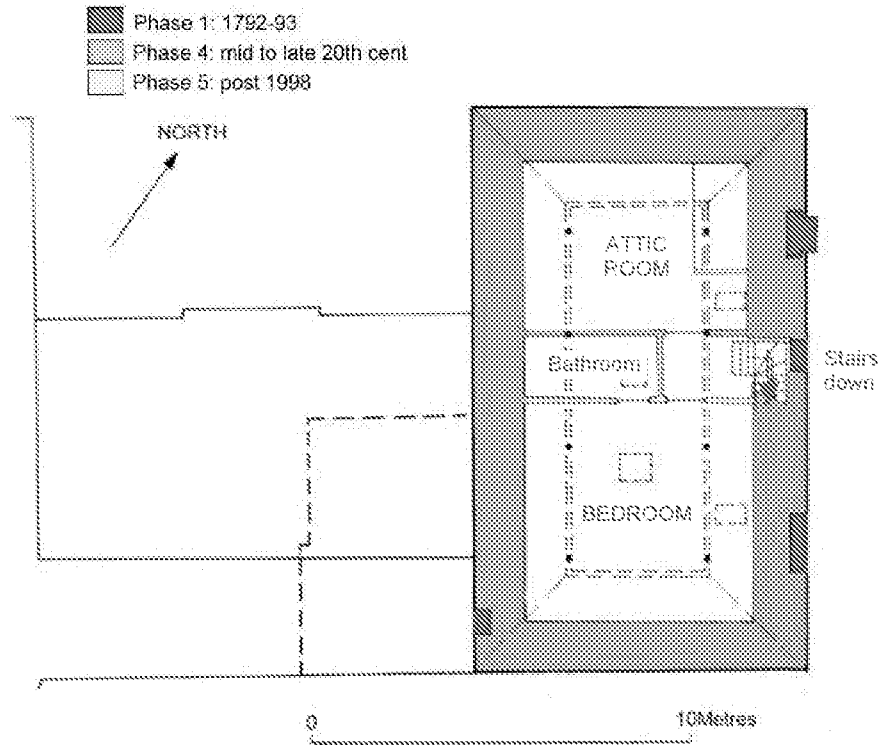
*Third, or attic, floor plan, showing the uses of spaces prior to the recent sale of the house (yellow and grey). Scale 1:200.*

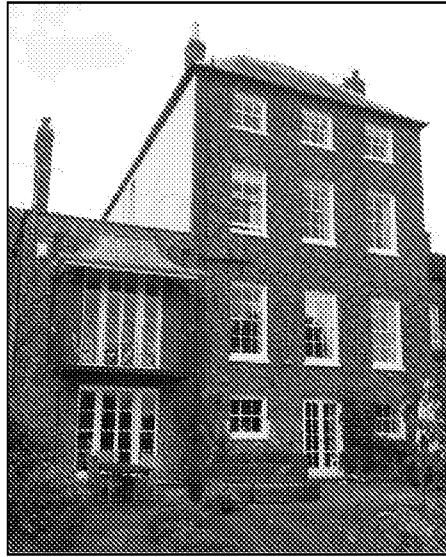
The *south elevation* is partially as built in the 1790s; extended in about 1825; and then altered shortly after 1998, at which time the two doors were inserted at lower ground level and the doors, balcony and canopy were added at ground floor level.

The windows in the original part of the house are all wooden hung sashes with either six or twelve panes in slender glazing bars, whilst the glazed doors, some with tall flanking windows, are all of wood.

*The south elevation of Carleton House.*

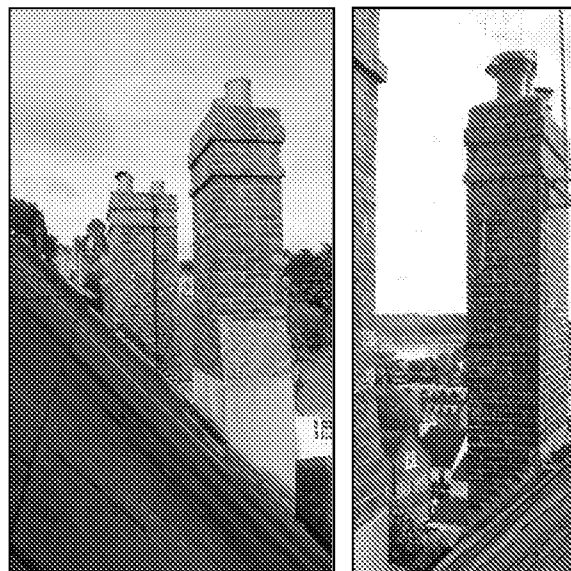
They are all of brick and presumably date to the late eighteenth century but possibly with some later repairs.

*Two of the chimney stacks on the east side, looking north (right) and the larger one looking south (far right).*

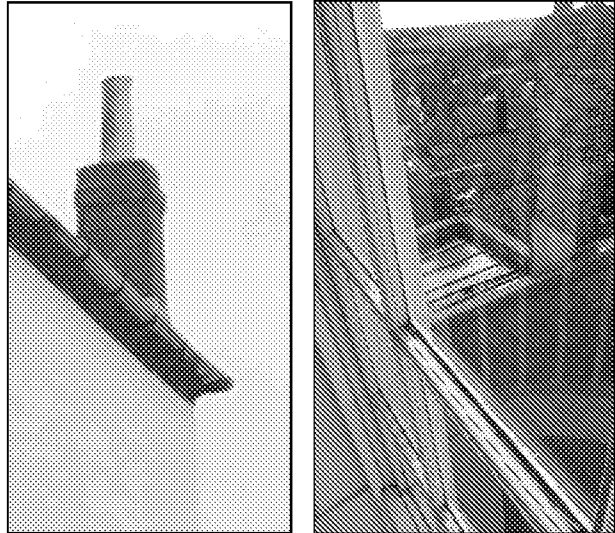
The roof over the later (Phase 2) extension is flat and leaded behind a brick parapet wall. It has one chimney stack with two flues, previously serving the lower ground level boiler house and the first floor ornate, dining room added in *circa* 1825.

*The small chimney stack near the south-west corner of the original house (right) and the flat roof and chimney stack on the later extension (far right).*

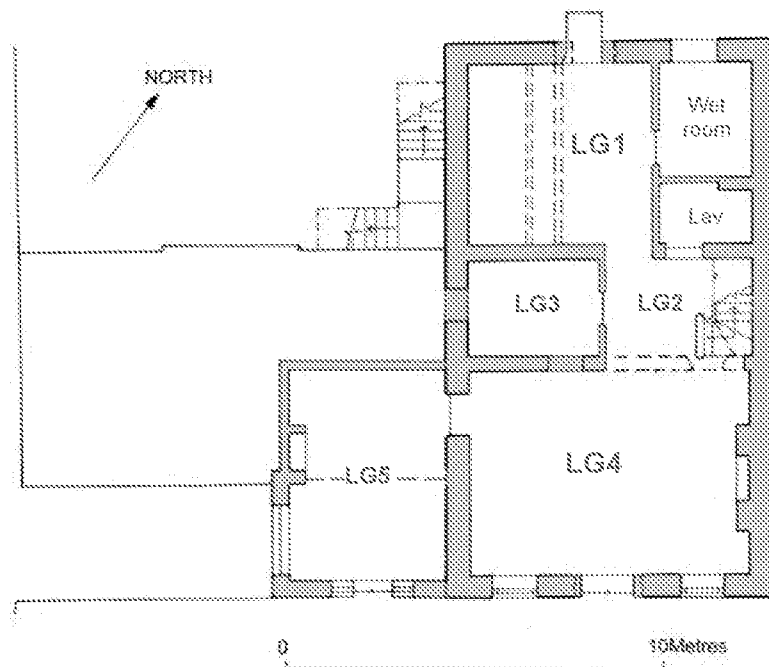
*Lower ground floor plan, showing the room numbering used in the text. Scale 1:200.*

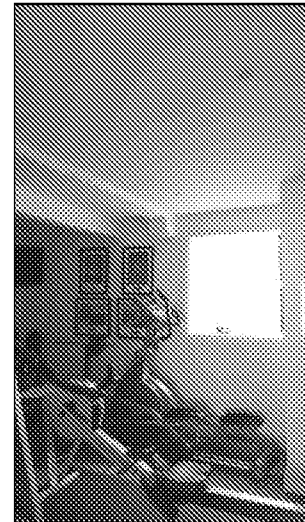
Only one of the light wells is now in use and the space has been subdivided since 1998 to provide a home gym, a wet room and a lavatory. It has an exposed floor beam, supported on a corbel at its north end, in the ceiling.

*The gym, looking north-west.*

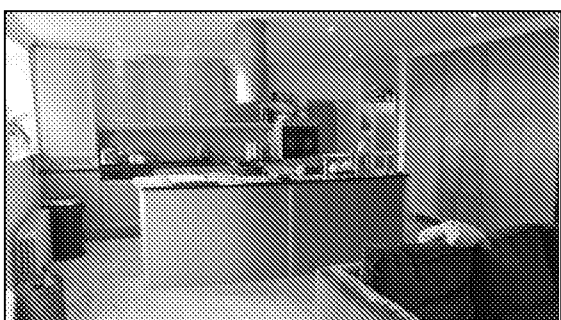
Shortly after 1998 one of the windows on the south side was altered to form an external door to the garden and the partitions at the west end were removed to form a larger space, now used as a kitchen/breakfast room. It has a modern moulded cornice and a wooden floor.

*The kitchen/breakfast room, looking west (above left) and looking north-east at the recess which may originally have contained a cooking range (above right).*

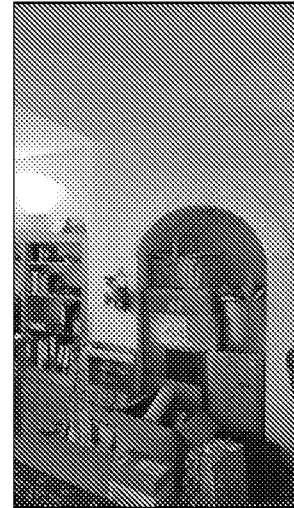
The existing space was created shortly after 1998, by the insertion of a dividing wall separating the south end of the former boiler house from the north end, which was retained as part of the separate dwelling, and the construction of a new south wall incorporating glazed doors. The room has the remains of a fireplace on the west side and a ceiling at two levels.

*The office, looking south-west.*

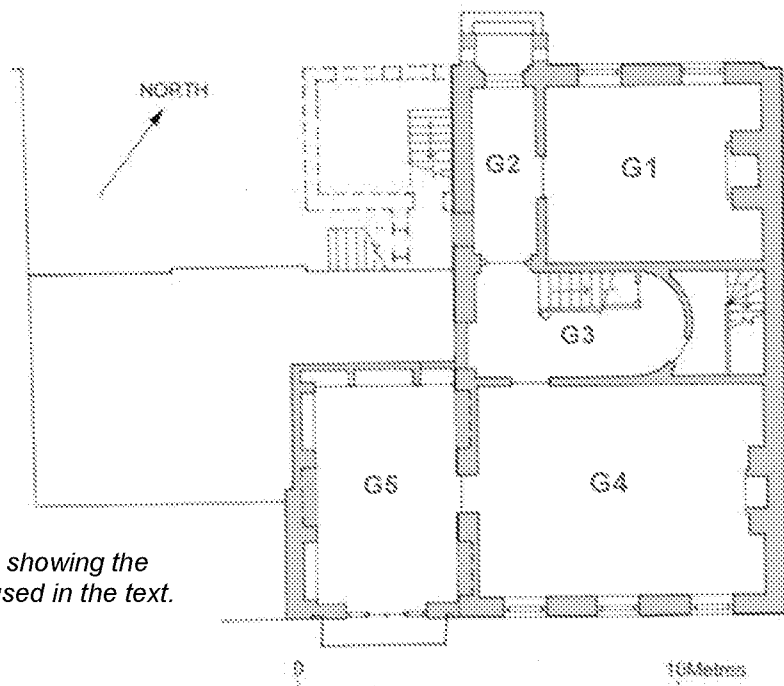
*Ground floor plan, showing the room numbering used in the text.  
Scale 1:200.*

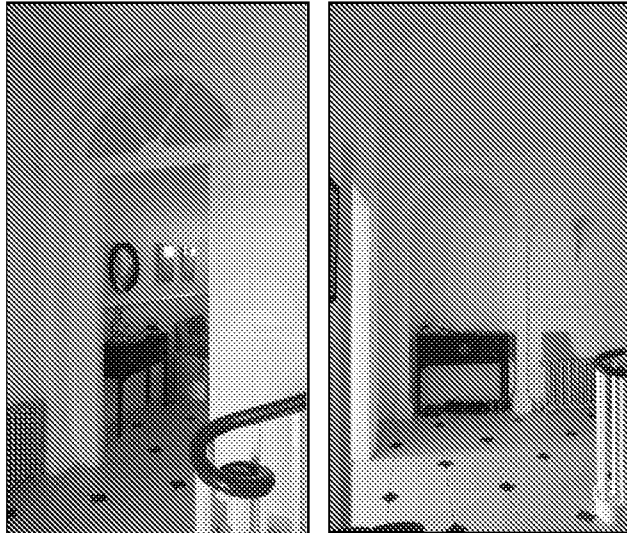
The main, cantilevered spiral staircase has plain spindles and a wooden handrail. Behind the staircase is the space formerly occupied by the servants' stairs, which now has stairs which lead only down to the lower ground floor level.

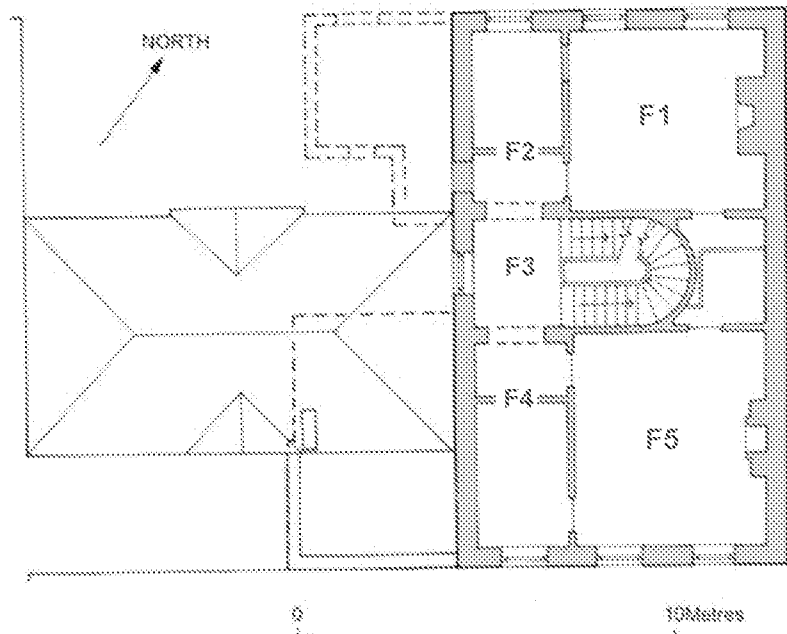
This is described as five compartments (F1-F5).

*First floor plan, showing the room numbering used in the text.  
Scale 1:200.*

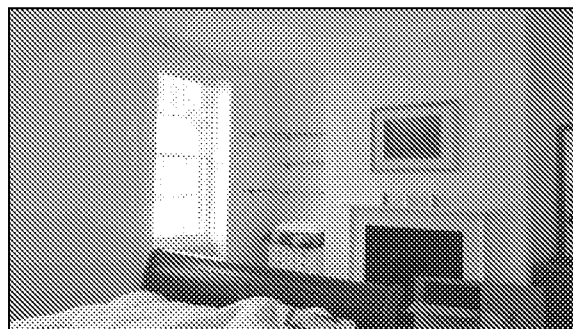
It is accessed from an adjoining lobby (F2) and is lit by two windows, set in panelled reveals, on the north side. The walls on the west side, which in 1998 formed a lobby and an en-suite dressing room (F2), are all twentieth century stud partitions - the door to the en-suite dressing room having been blocked since 1998.

It has a moulded cornice; moulded skirting boards; and moulded architraves to the door and windows. It has a plain wooden chimneypiece with metal insert, which may be an original feature.

*The bedroom, looking north-east (above) and  
the chimneypiece (right).*
