A  
LISTED BUILDING ASSESSMENT  
for  
**CARLETON HOUSE**  
**15 Maltravers Street**  
**Arundel**

Prepared for  
Mr and Mrs A BATTY

NOVEMBER 2016

Prepared  
by  
**FRED ALDSWORTH BA FSA MCIfA IHBC**  
Archaeologist and Heritage Consultant  
124 Whyke Road, Chichester, West Sussex PO19 8JG  
Tel. 01243 782904 e-mail [aldsworthfred@hotmail.com](mailto:aldsworthfred@hotmail.com)

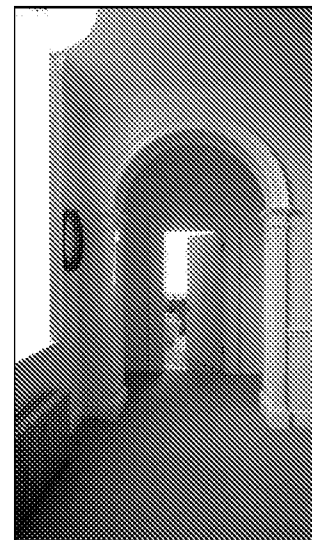
The walls, which in 1998 formed a lobby and an en-suite dressing room, are all twentieth century stud partitions, the door to the adjoining bedroom (F1) room having been blocked since 1998. There was a door opening on the west side of the lobby, which was inserted at a later (Phase 3) date to provide access to the addition, which in 1998 contained a bathroom and a lavatory. This was sealed when the addition was demolished shortly after 1998.

The lobby, which has a moulded cornice and skirting boards, is accessed from the stairs hall (F3) through a semi circular-headed opening with panelled reveals. The doors and architraves to the bathroom and bedroom are of twentieth century date and the bathroom has relatively modern fixtures.

*The lobby and bathroom, from the south.*

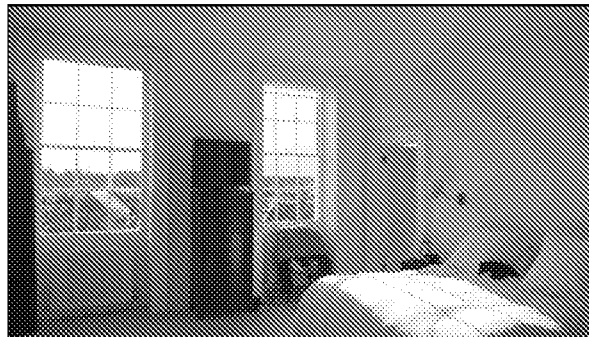
The walls on its west side, which in 1998 formed a lobby and an en-suite dressing room, are all twentieth century stud partitions, the door from the lobby to the former changing room, now an en-suite bathroom to the bedroom (F5), having been blocked since 1998.

It has a moulded cornice; moulded skirting boards; and moulded architraves to the doors and windows. The marble chimneypiece may be a later insertion.

*The bedroom, looking south-west (above) and the chimneypiece (right).*

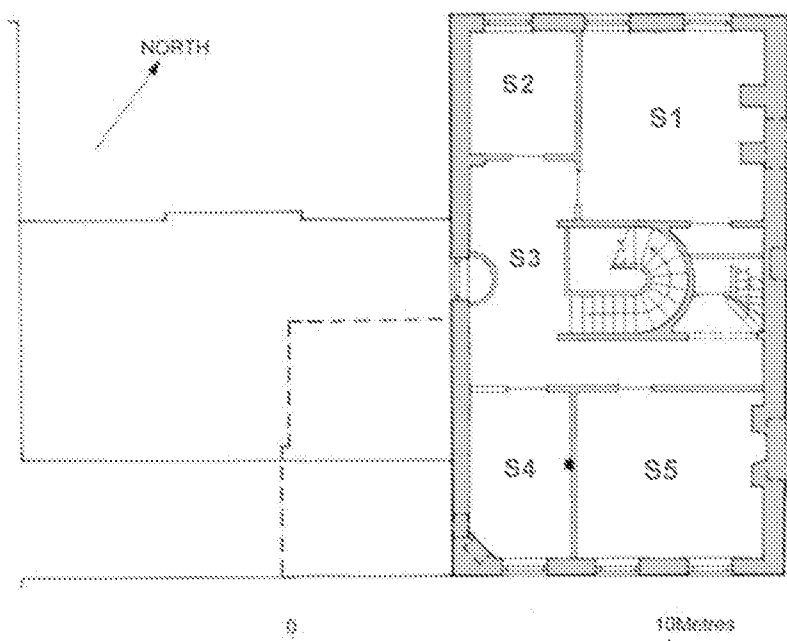
*Second floor plan, showing the room numbering used in the text.  
Scale 1:200.*

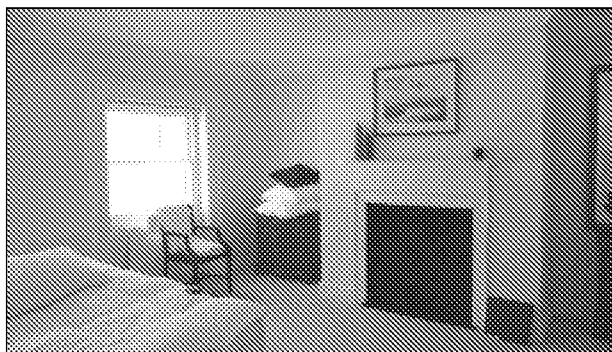
It has a moulded cornice; a central ceiling roundel; moulded skirting boards; and moulded architraves to the door and windows. The plain wooden chimneypiece with iron and brick inserts may be an original feature.

The walls on the west side, which in 1998 formed a family bathroom (S2) and access from the landing (S3), are twentieth century stud partitions probably dating to after 1998.

*The bedroom, looking north-east.*

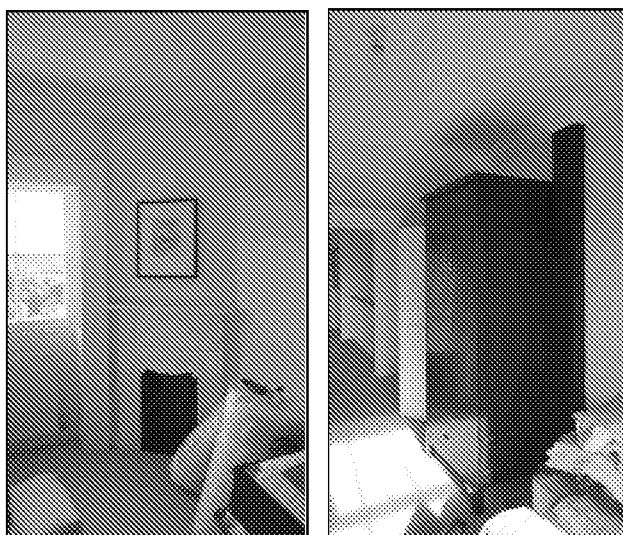
The room has a moulded cornice; a central ceiling roundel; moulded skirting boards; and moulded architraves to the door and window.

*The small bedroom, looking south-west (right) and looking north (far right).*

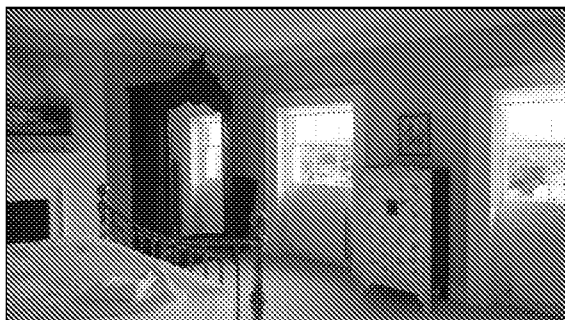
The walls on the north and west sides are twentieth century stud partitions inserted shortly after 1998.

It has a moulded cornice; moulded skirting boards; and moulded architraves to the door and windows. The plain wooden chimneypiece with iron and brick inserts may be an original feature.

*The bedroom, looking south-west (above) and the chimneypiece (right).*

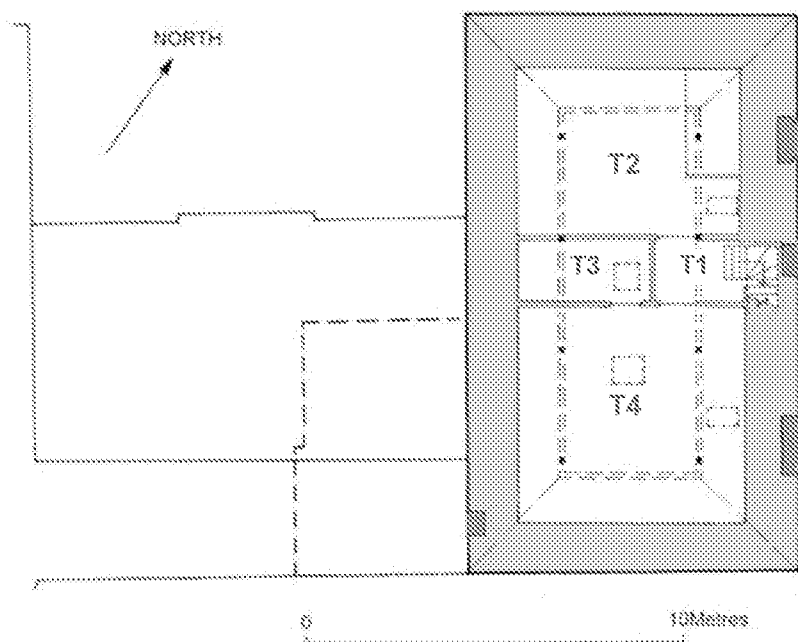
*Third, or attic floor plan, showing the room numbering used in the text.  
Scale 1:200.*

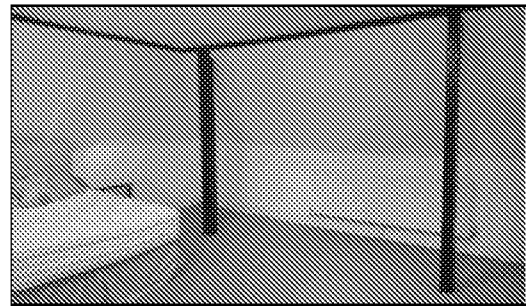
It is lit by a window in the sloping roof on the east side and by a roof-light.

It contains four upright posts supporting the purlins forming the outline of the flat roof element.

*The bedroom, looking south-east (left) and looking south-west (above).*
