FORD ROAD, ARUNDEL  
NATIONAL GRID PROPERTY  
HOLDINGS

R1820/20/5043

SUPPLEMENTARY SITE  
INVESTIGATION FACTUAL  
REPORT

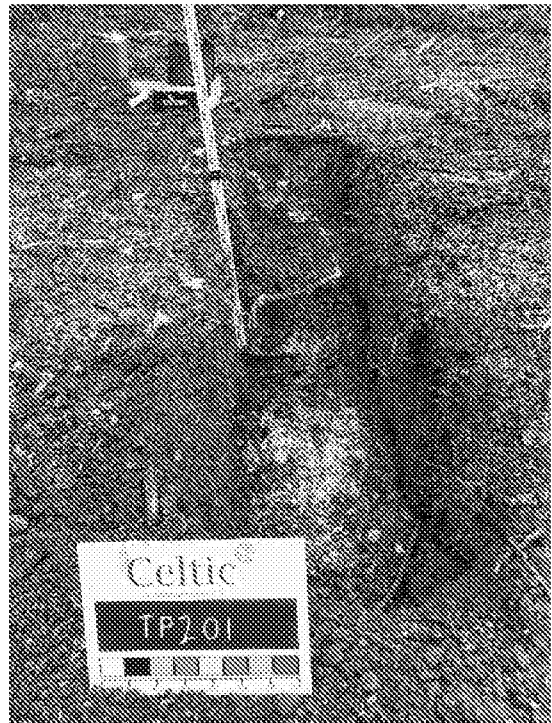
Plate 23 Trial Pit TP201

| Samples & In Situ Testing | | | Depth (m) | Level (m AOD) | Legend | Stratum Description | |
|---|---|---|---|---|---|---|---|
| | | | | | White weathered reworked chalk with coarse gravel of flint. Concrete slab of former gasholder base found at 0.6m depth (0.3m thick). Made Ground. Stable sides, no water, no visual/olfactory contamination (MG) | | |

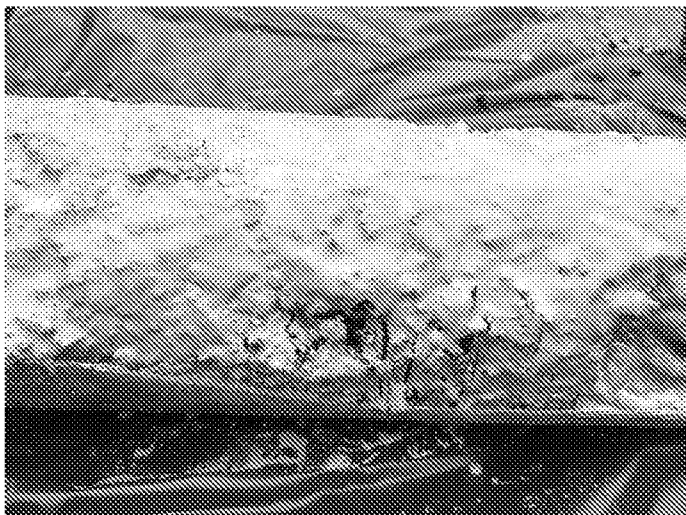
Plate 46 Borehole BH202 Cored material exhibiting NAPL staining within chalk

| Well | Water Strikes | Samples & In Situ Testing | | | Depth (m) | Level (m AOD) | Legend | Stratum Description | | |
|---|---|---|---|---|---|---|---|---|---|---|
| | | | | | 7.20 | -3.61 | | White clay and CHALK with flint bands. Tar staining between 7.2 m to 9 m. (CHALK - Natural) | 8 | |
