# Heritage Statement

Arundel Town Hall, Arundel

Ref: 455947

In 2019 the Arundel Town Council approached Savills (UK) Ltd to update the quinquennial survey and to comment on persistent water leaks coming from the main roof.

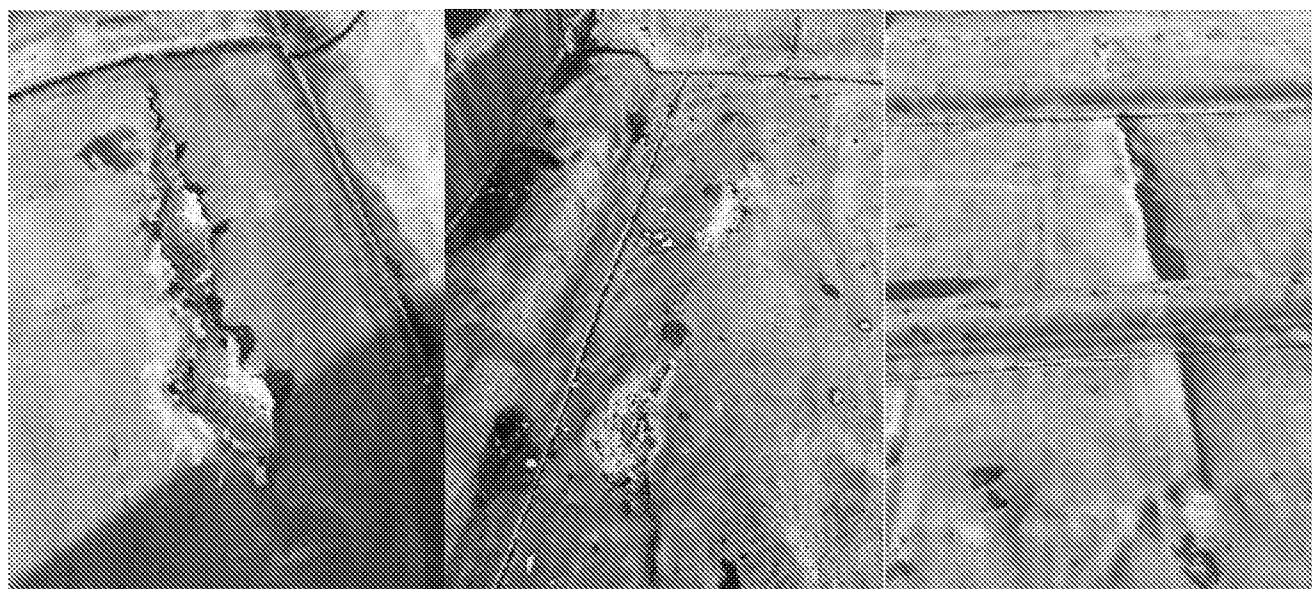
*Splits in lead sheet*

*The brown spots are chemical erosion*

*Thermal movement creases*

Investigation concluded that the splits and discolouration in the lead is due to underside lead corrosion. This is caused by interstitial condensation forming to the underside of the lead due to a lack of ventilation. This causes carbonation (layers of white powder) to build up, thinning the lead by chemical attack to the point it pulls itself apart. The use of a woven geotextile membrane below the lead over the plywood substrate combined with incorrect fixing of the lead has brought forward the damage. The poor fixing stops the natural thermal movement of the lead causing the tears, ridges and creases seen.

The existing codes 5 & 6 lead are not heavy enough for the exposed location and there are a number of locations where the drips and laps are below minimum.

Unfortunately due to the fundamental design flaws and extent of the damage isolated repairs will be ineffective and replacement with new heavier code 8 lead and increased ventilation detailing is required. The opportunity will also be taken to form small inspection hatches to the ceiling below in discrete locations. Whilst not thought to be fibrous plaster the Association of British Theatre Technicians guide 20 on the survey and inspection of ceilings is still relevant.

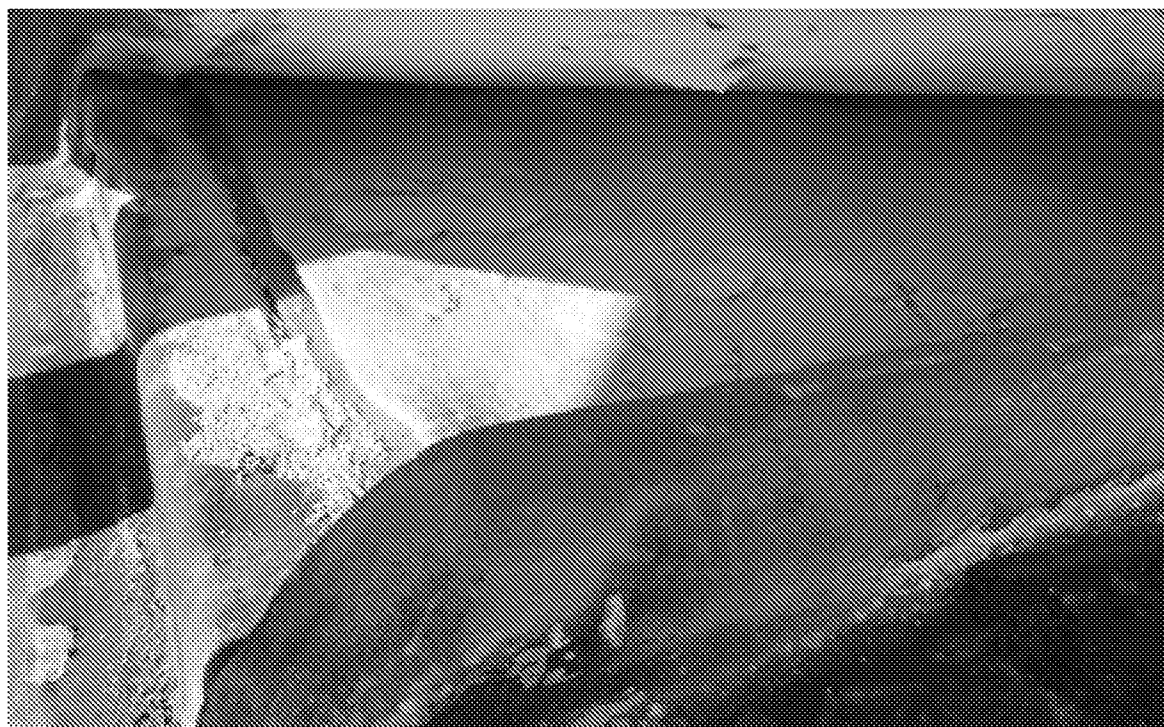
- 2.4.4 Substrate: The main roof is plywood with a geotextile underlay. It is not best practice to combine these two materials. When lifted the underside lead corrosion can clearly be seen as layers and layers of compacted white powder and in areas with little or no step the membrane has soaked up moisture.

**Image – Photo - Arundel Town Hall – Underside Lead Corrosion & geotextile underlay**

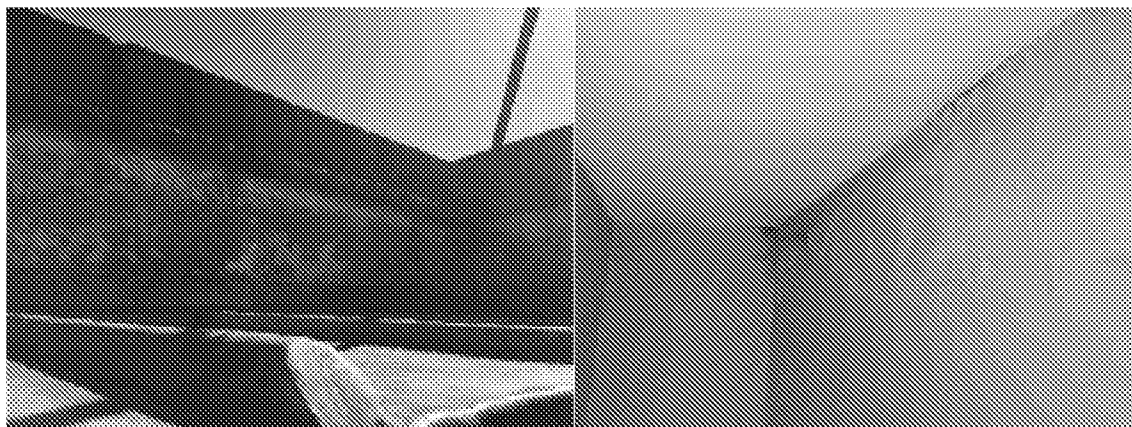
Cement render has been applied to the internal face of the external walls above the roof access stairs causing damp problems within the stairwell internally.

Image – Photos - Arundel Town Hall – Cement Render and internal damp

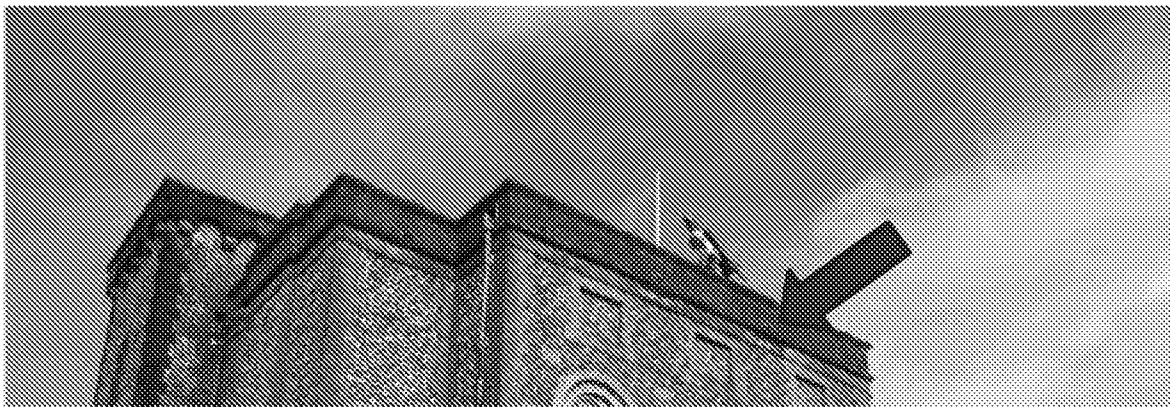
Externally, at high level to the south elevation two steel anchor plates can be seen which serve to provide lateral restraint to the wall and would be tied to principal roof beams. Above the projecting string course are four air bricks that date back to the mid 1990's when major works of repair were undertaken to deal with an extensive outbreak of dry rot. There are additional air bricks on other elevations to provide some additional ventilation to the space below.

**Image – Photo - Arundel Town Hall – Vents at high level through parapets & black anchor plates.**
