## **PHASE I AND II GEO-ENVIRONMENTAL ASSESSMENT**

**14 FITZALAN ROAD, ARUNDEL  
WEST SUSSEX, BN18 9JS**

**REC REFERENCE: 1CO102284P2R0**

**DATE: OCTOBER 2016**

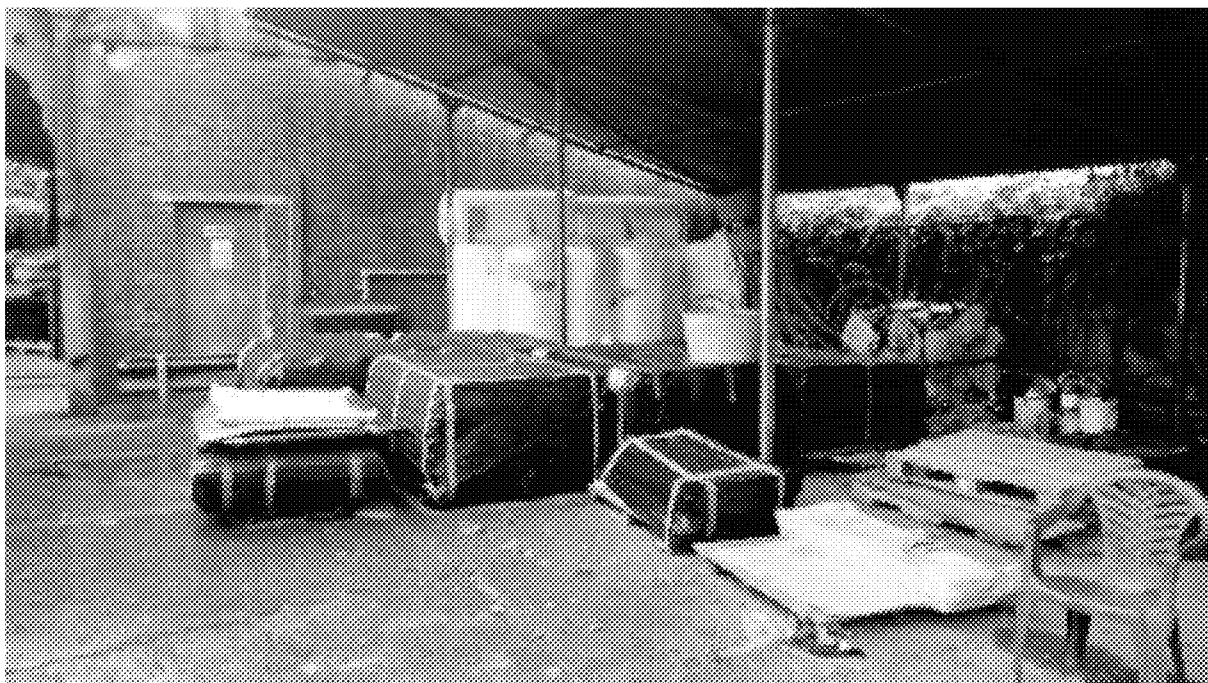
**Photograph 2: Storage of products on site.**

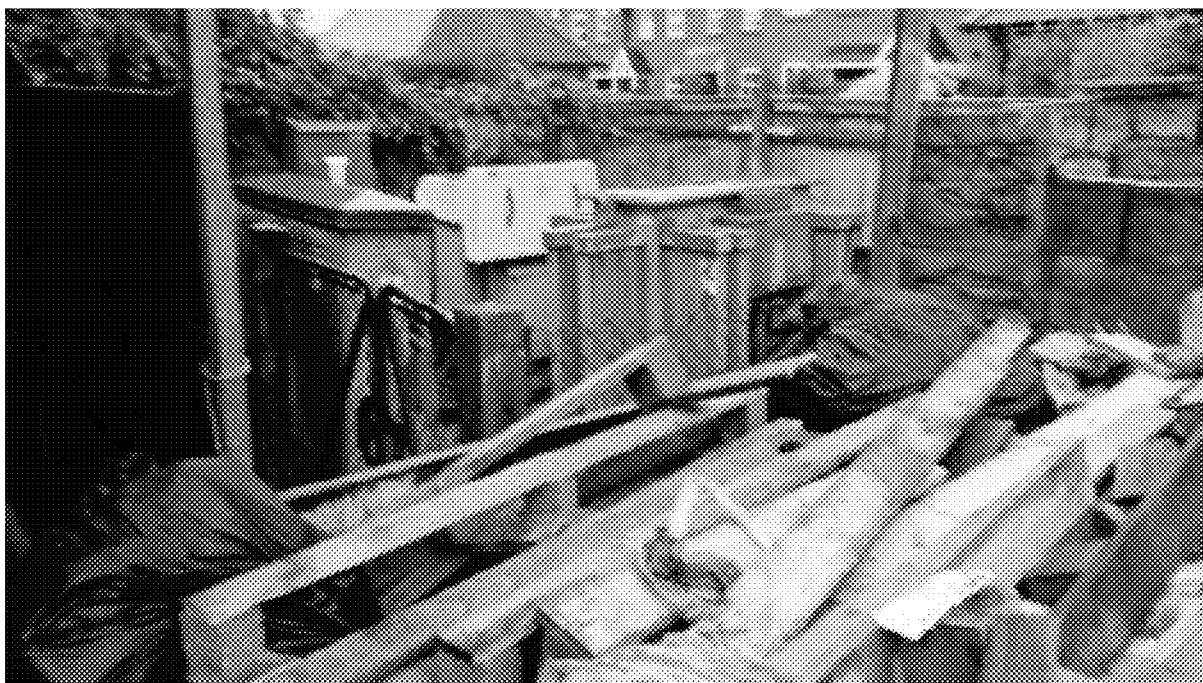
An electricity substation with transformers was noted on the northwest corner of the site. The condition was visually inspected and deemed to be satisfactory. As the substation is owned and operated by UKPN, responsibility for any contamination, if present, should reside with them.

**Photograph 3: Electricity Substation.**

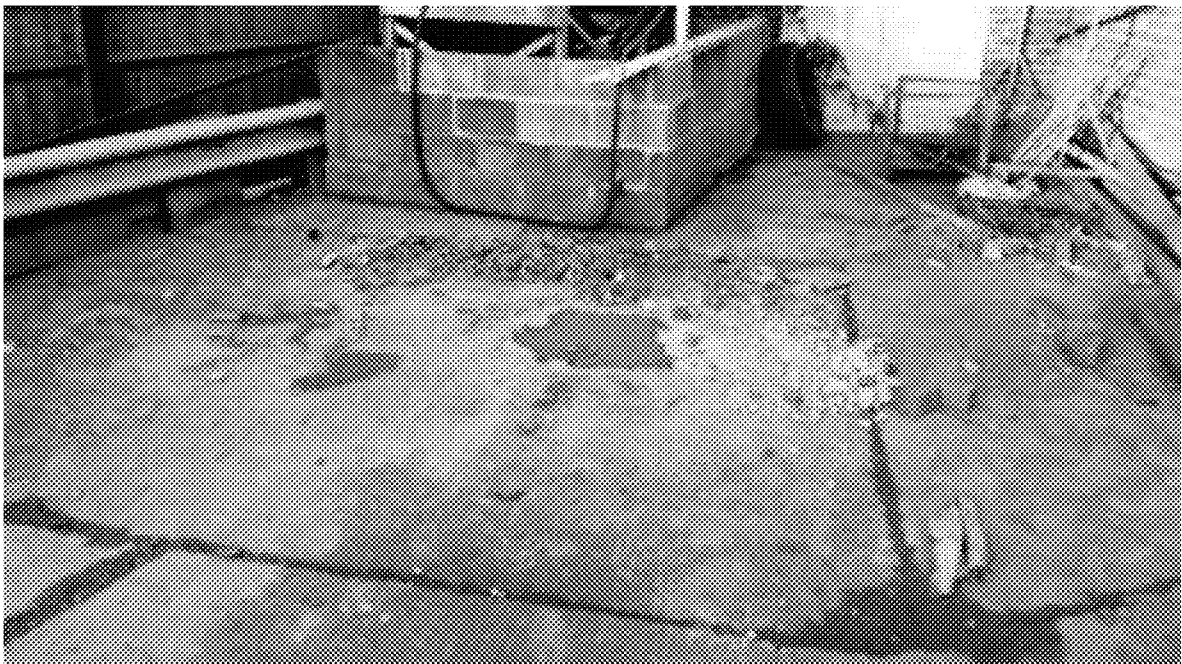
During the site walkover, a raised diesel storage tank with a 1m high bund wall was noted on the northeast corner of the site. The tank appeared to be in good condition, with no significant spillages noted within the area. No other visual evidence of Underground Storage Tanks (USTs) or further Above Ground Storage Tanks (ASTs) were observed.

**Photograph 6: Exploratory Hole Location Adjacent to Existing Diesel Fuel Tank**
