**Project Name**  
Arundel C Of E Primary School, Jarvis Road, Arundel BN18 9HT

**Project Date**  
18/06/2020

### Project Summary

The survey was carried out to ascertain condition and connectivity to gain information for a new connection.

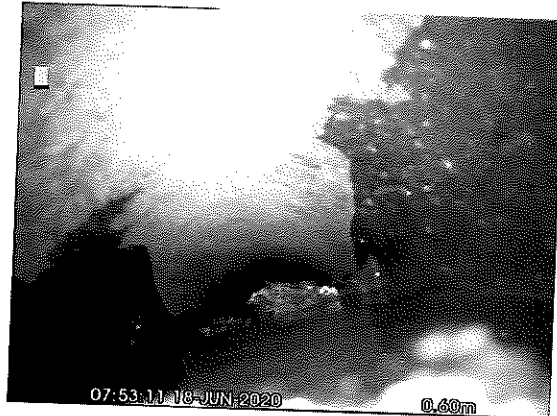
| Comments: | The pipework is holding water and debris/silt | | | | |

SMH1X\_81a92dec-fd09-4178-bb3d-9612c6e23625\_20200623  
\_225427\_362.jpg, 00:00:14, 0.60 m  
Water level, 20% of the vertical dimension

Surface Water System - To attend site with a Jet Vac Combination Unit to clean and clear the pipework.

| Recommendations: | To carry out a combination of High Pressure Water Jetting and Vacuum to restore flow | | | | |

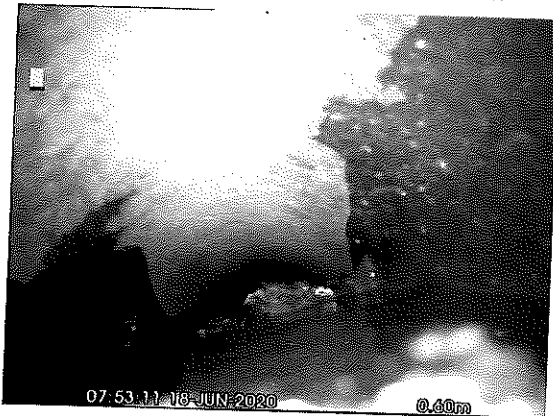
The surface Water system has a high build up of silt. Debris and water level. A combination of High-Pressure Water Jetting and Vacuum is required to restore and maintain flow.

| S02 DES | Settled deposits, fine, 20% cross-sectional area loss, start | |

SMH1X\_5eb04566-2251-48c5-8f42-4562f90994b\_20200623  
\_225453\_109.jpg, 00:00:14, 0.60 m  
Settled deposits, fine, 20% cross-sectional area loss, start

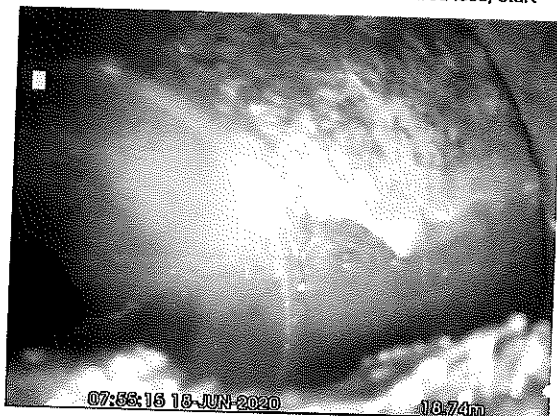
SMH1X\_79e4a593-19bf-4761-9334-b9146c200d5e\_20200623  
\_225850\_862.jpg, 00:02:17, 18.74 m  
Line deviates left
