# HB Archaeology & Conservation Ltd

30-32 HIGH STREET, ARUNDEL  
WEST SUSSEX, BN18 9AB

## HERITAGE STATEMENT & IMPACT ASSESSMENT

Prepared by Maggie Henderson  
With contributions from Diccon Hart, Val Hart and  
Philippa Whitehill

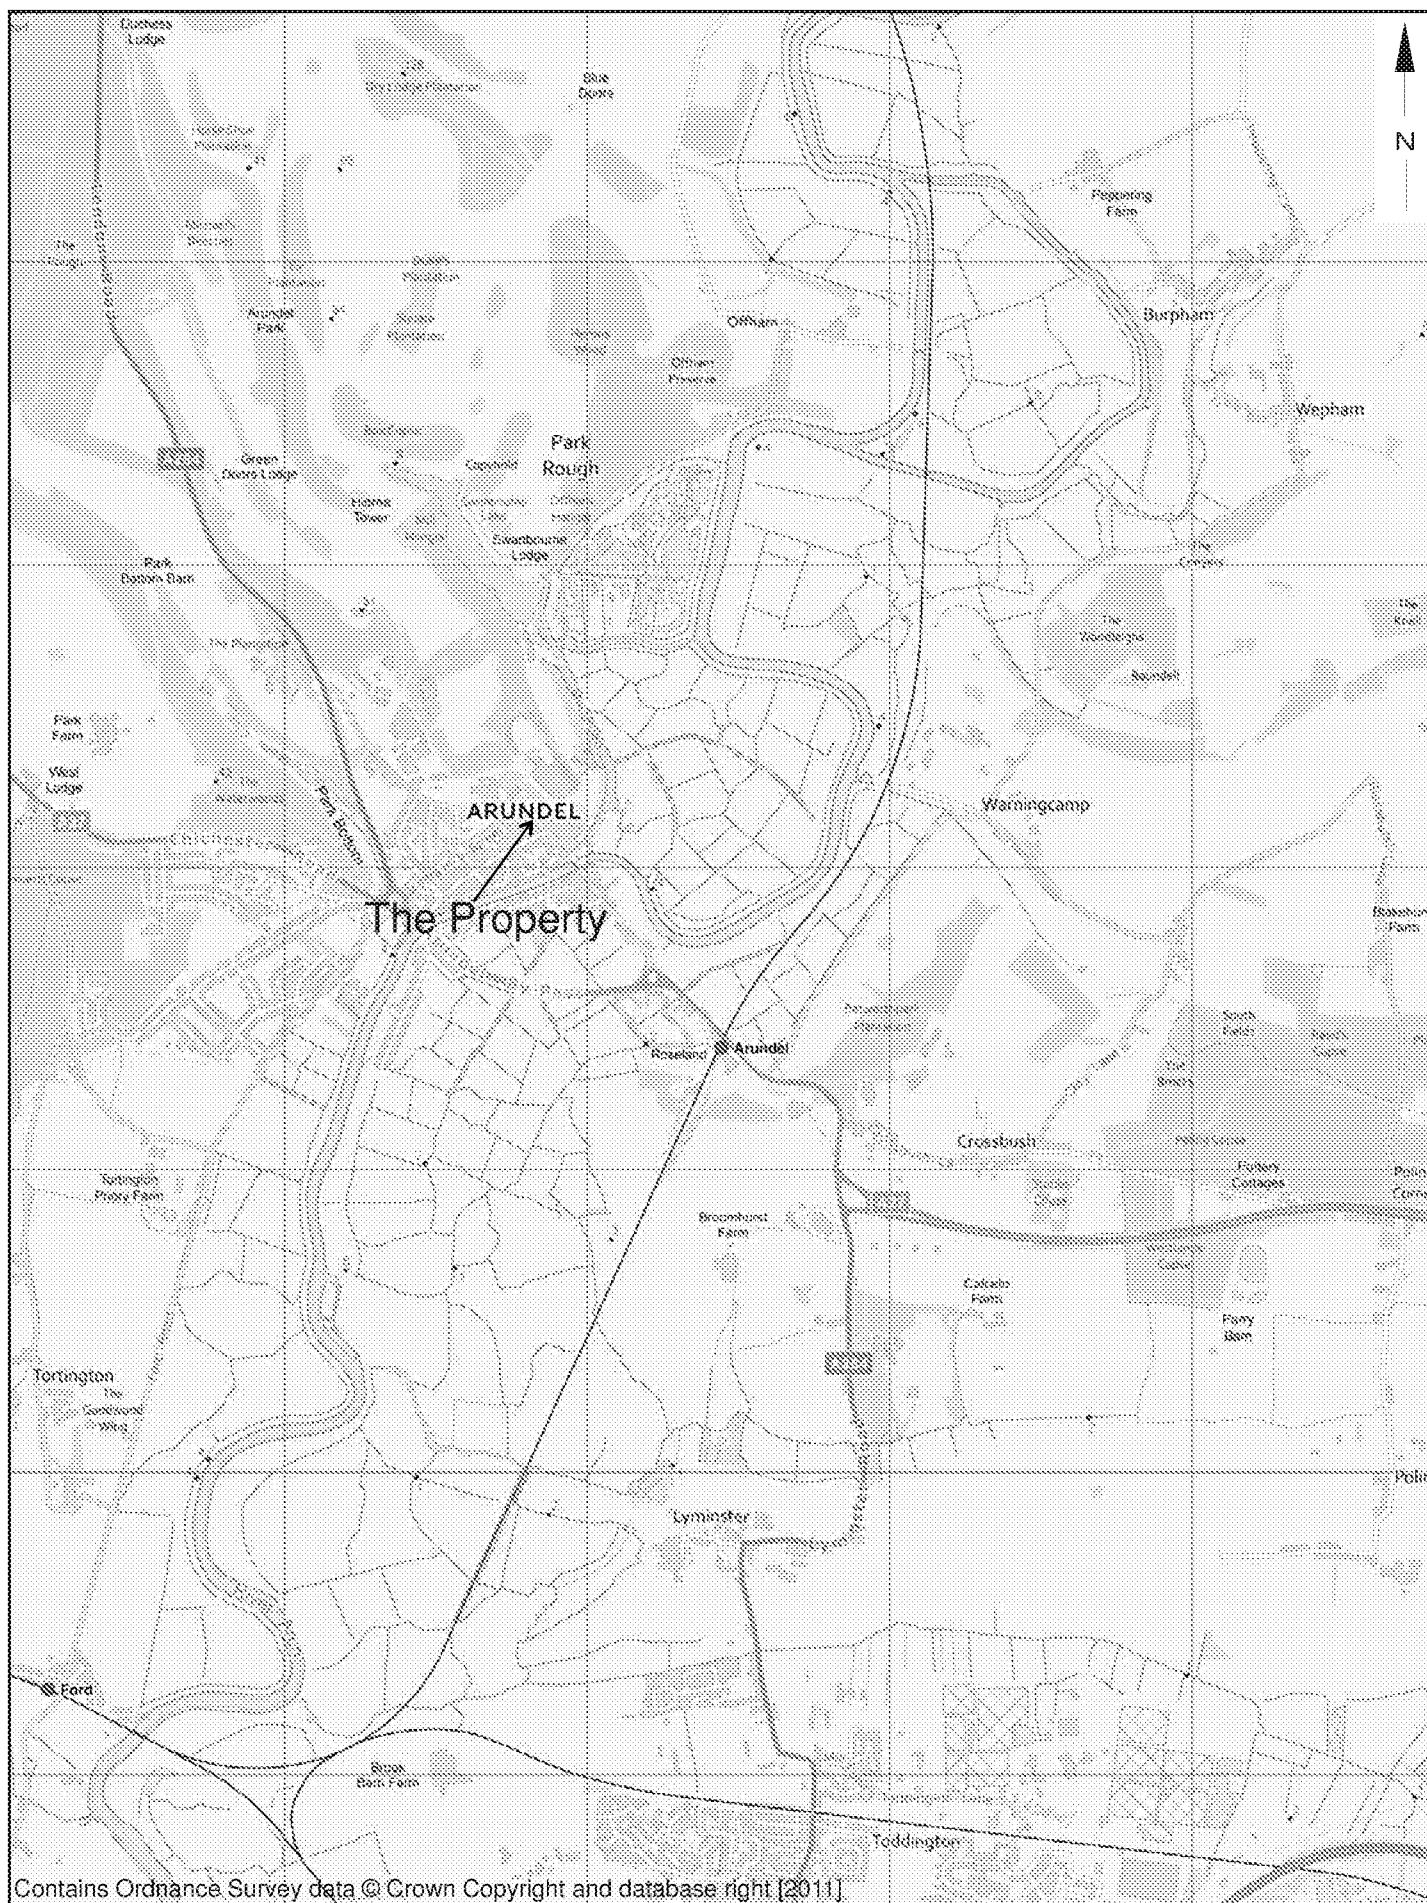
| © HB Archaeology & Conservation Ltd | | 30 High Street, Arundel, West Sussex, BN18 9AB | Fig. 1 |

| Project Ref: 2019393 | March 2019 | Property Location (TQ 01851 07151) | |

- 3.1.1 The property is situated to the east side of Arundel High Street just outside the walls that define the boundary to Arundel Castle (Figure 1). Numbers 30 – 32 all excepting the northwestern part of what had been a single street front property. The property is the northernmost structure on the east side of the street, those adjacent demolished during the 19th century to create the Arundel Castle Walls.

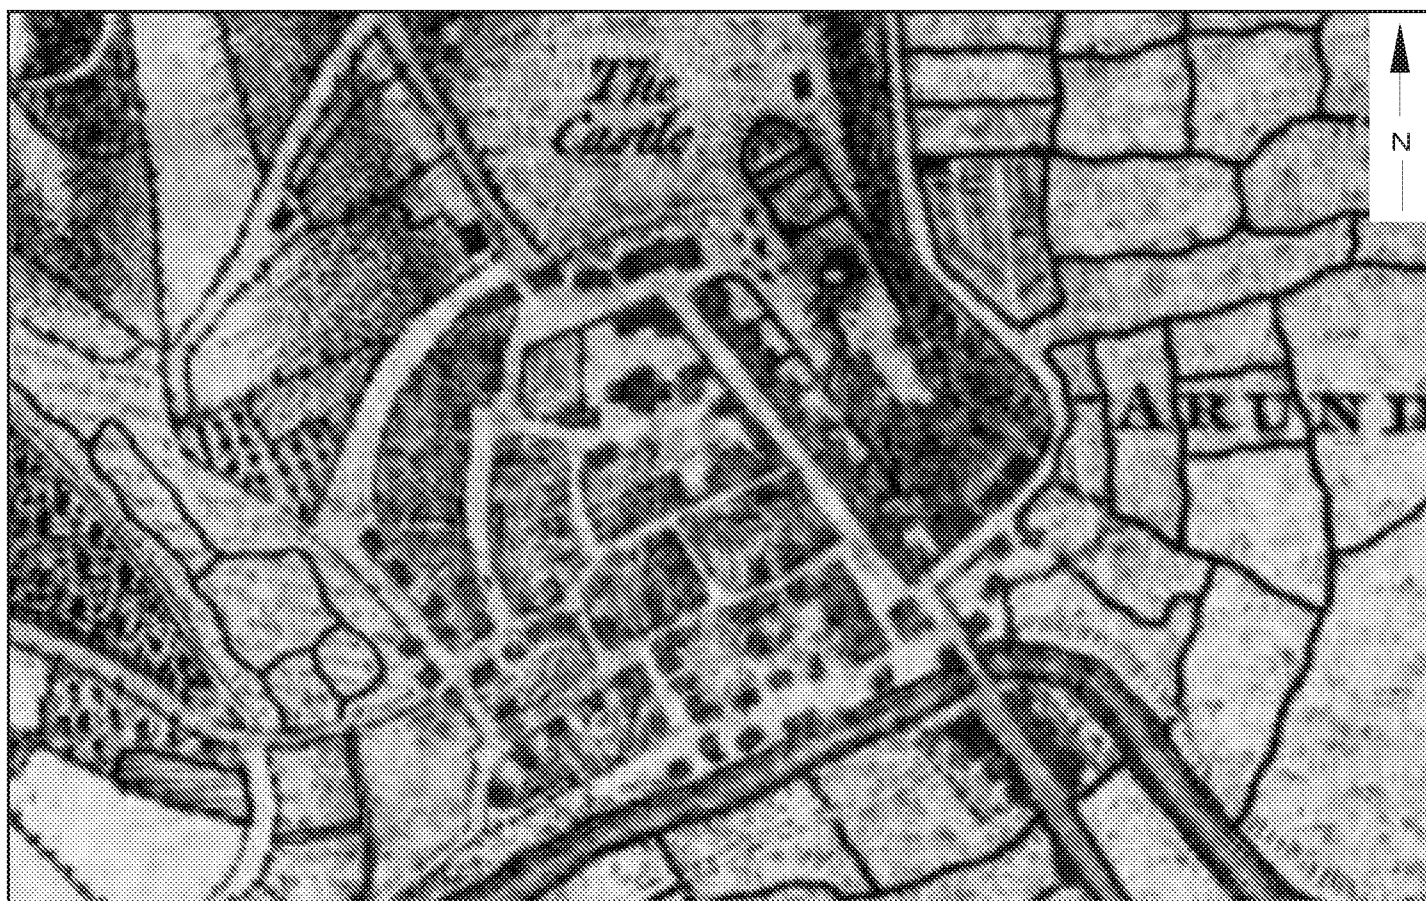
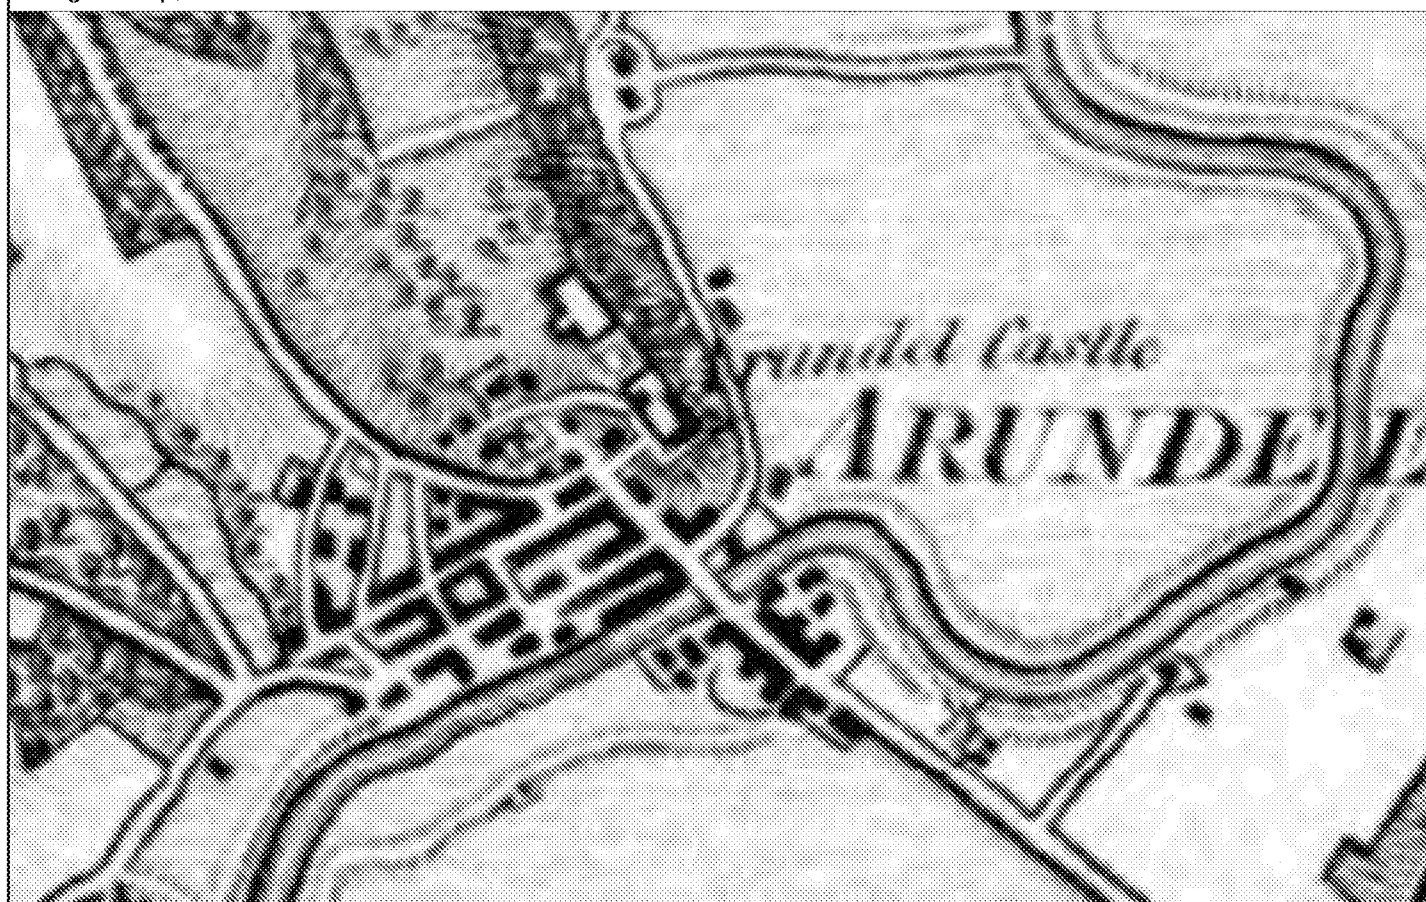
| © HB Archaeology & Conservation Ltd | | 30 High Street, Arundel, West Sussex, BN18 9AB | Fig. 2 |

Yeakell and Gardner Survey 1778-83

Mudge's Map, 1813

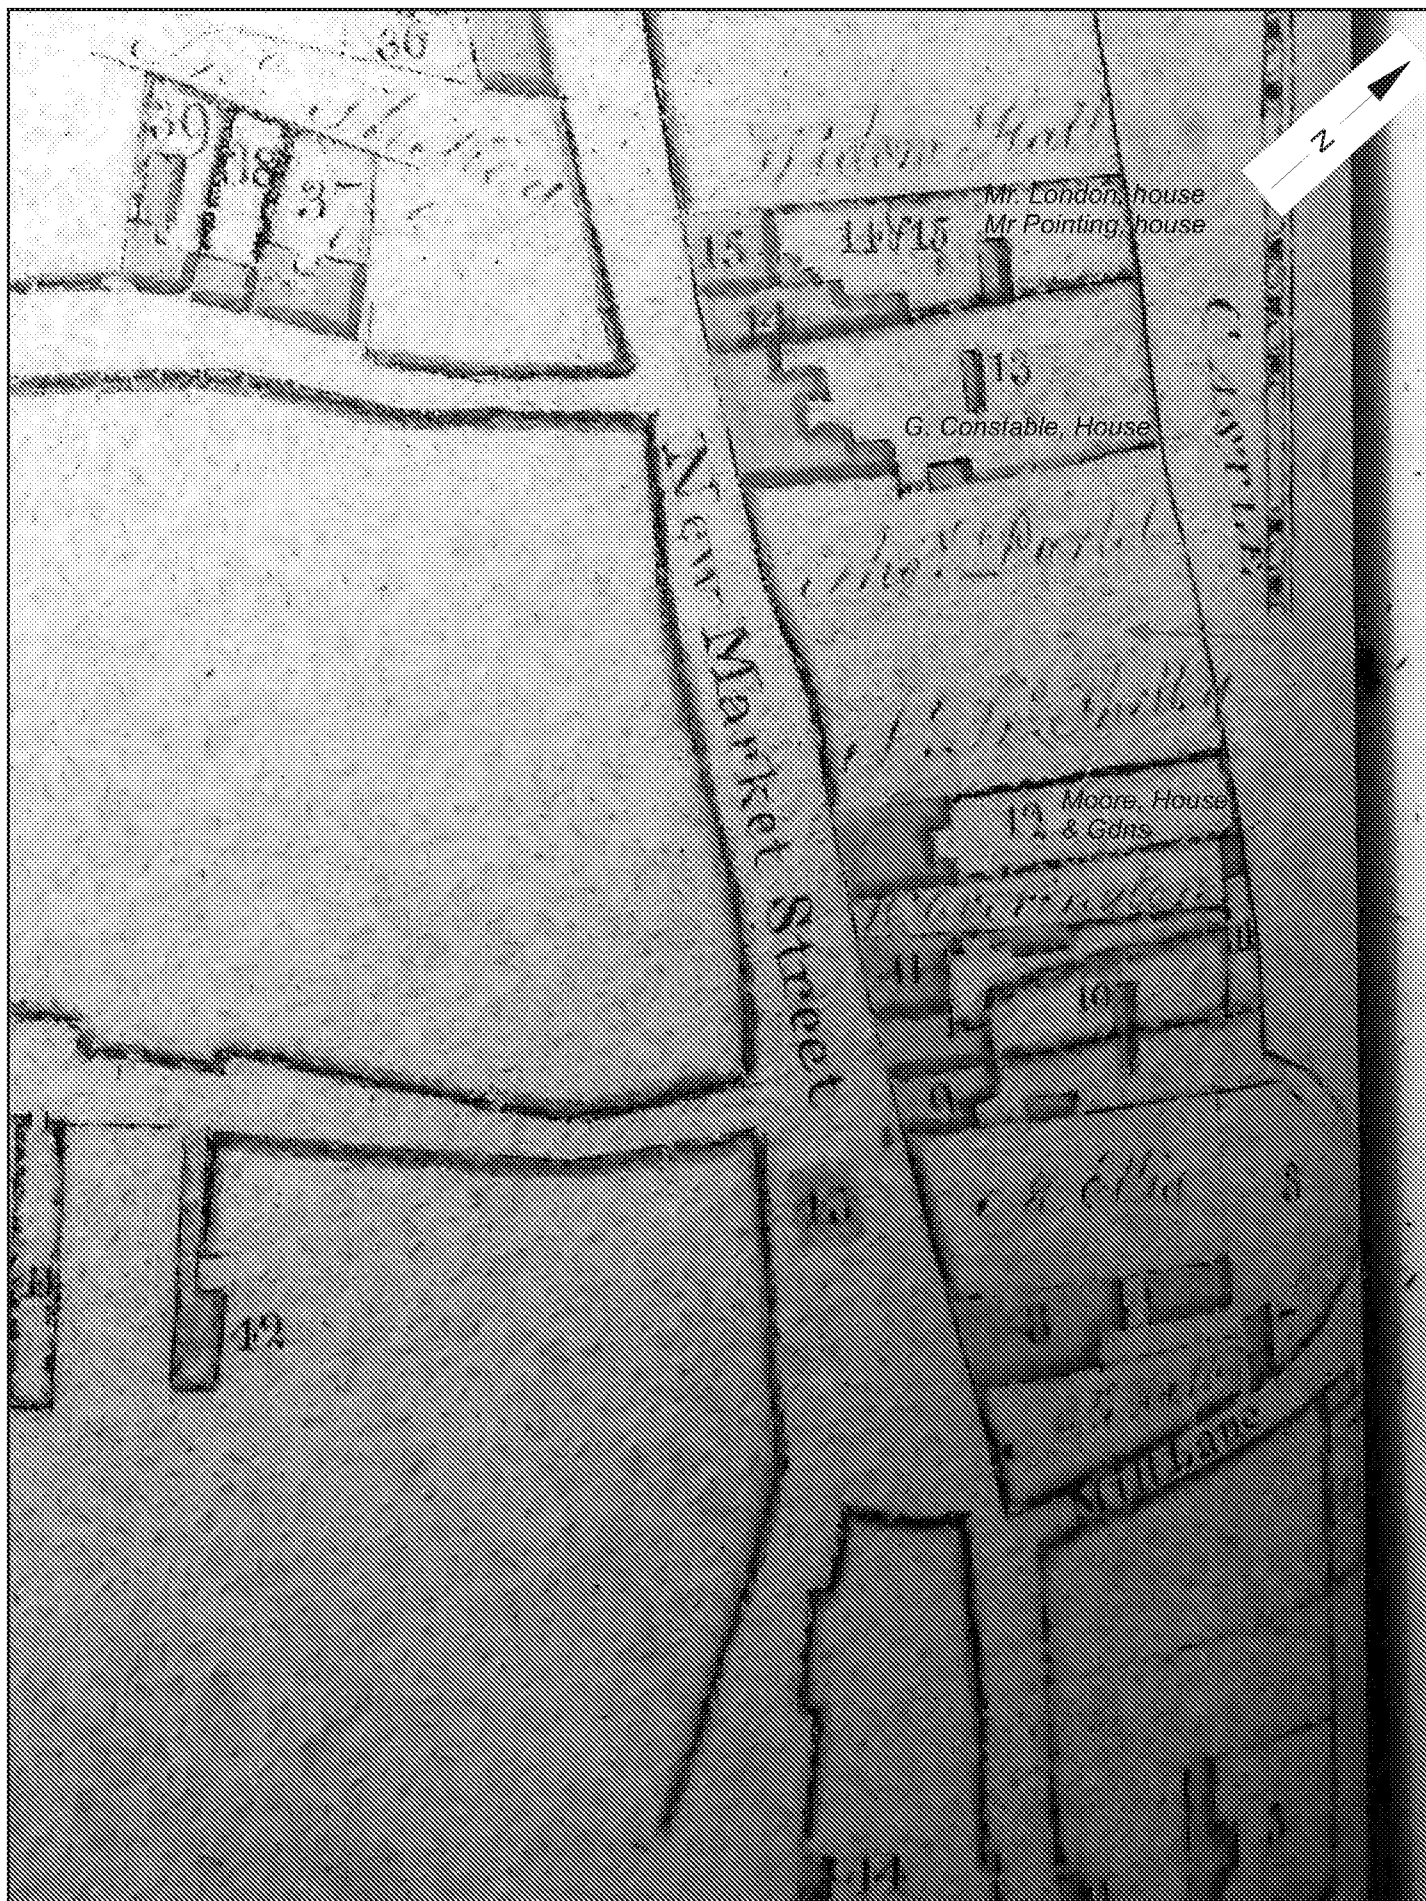
| © HB Archaeology & Conservation Ltd | 30 High Street, Arundel, West Sussex, BN18 9AB | Fig. 3 |

| Drawn by: mh | 1778 Plan, The Duke of Norfolk's Estate | |

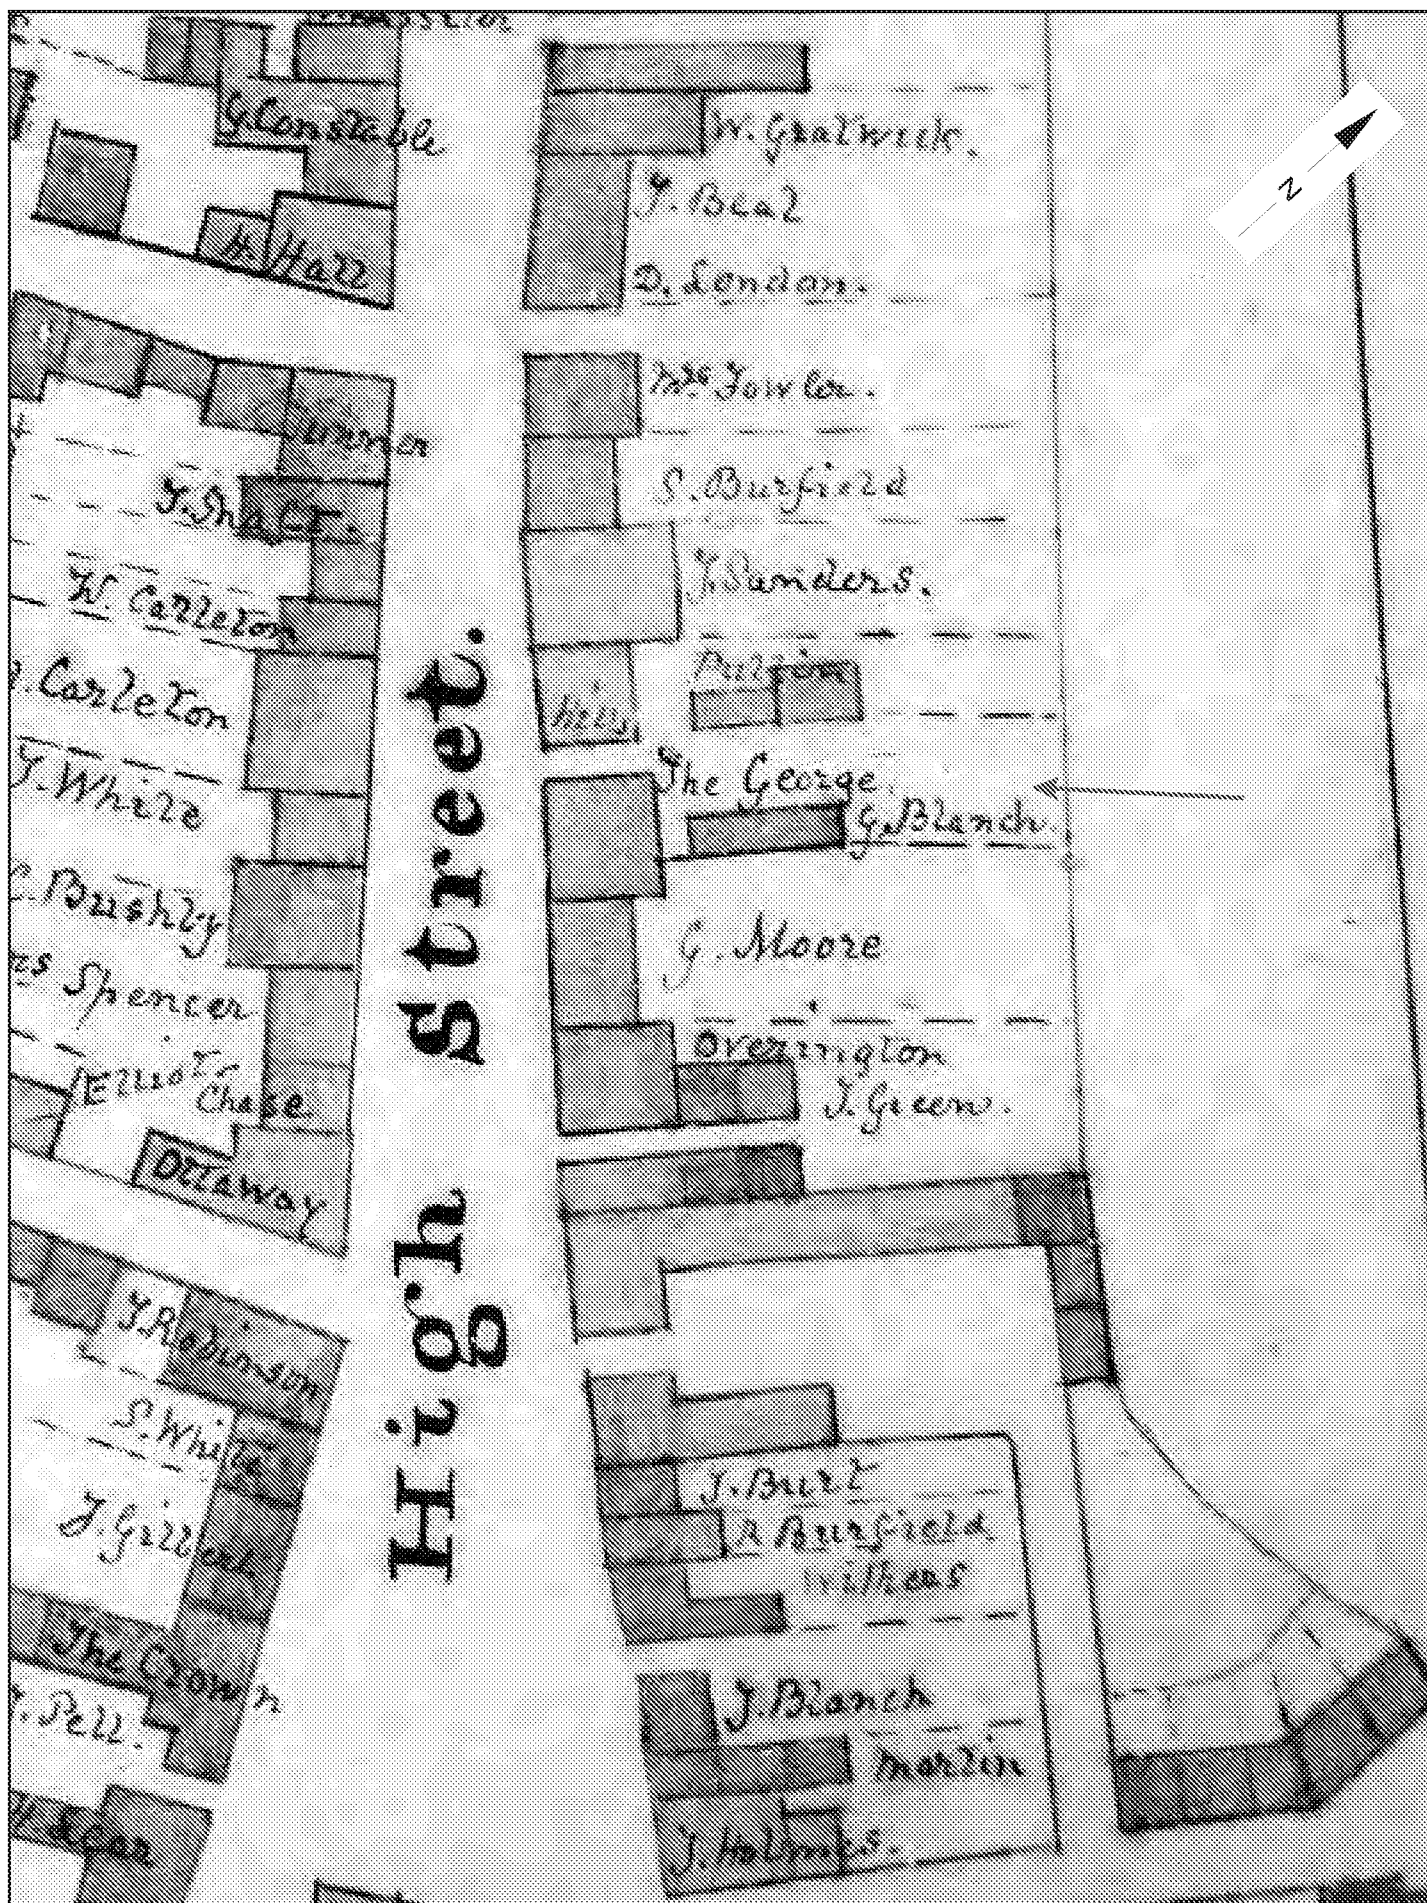
Fig. 4

1785 Town Plan

connection to the other ranges, the stair turret's northeast wall would terminate, leaving it open to the elements: as such, if the gap on the plan represents a gap in the building in 1785, that gap must have existed at ground floor level only, indicative of another passage or an open-fronted area below the first floor rooms, a feature not uncommon within stables or commercial properties at that time. Indeed, it is tempting to suggest that the ground floor part of the building had succumbed to the alterations recorded during the siege of Arundel in 1643, whereby *"all the windows broken with the great guns and the soldiers making stables of all the shops and lower rooms.."* (Stanford, C. S. 1910:116).

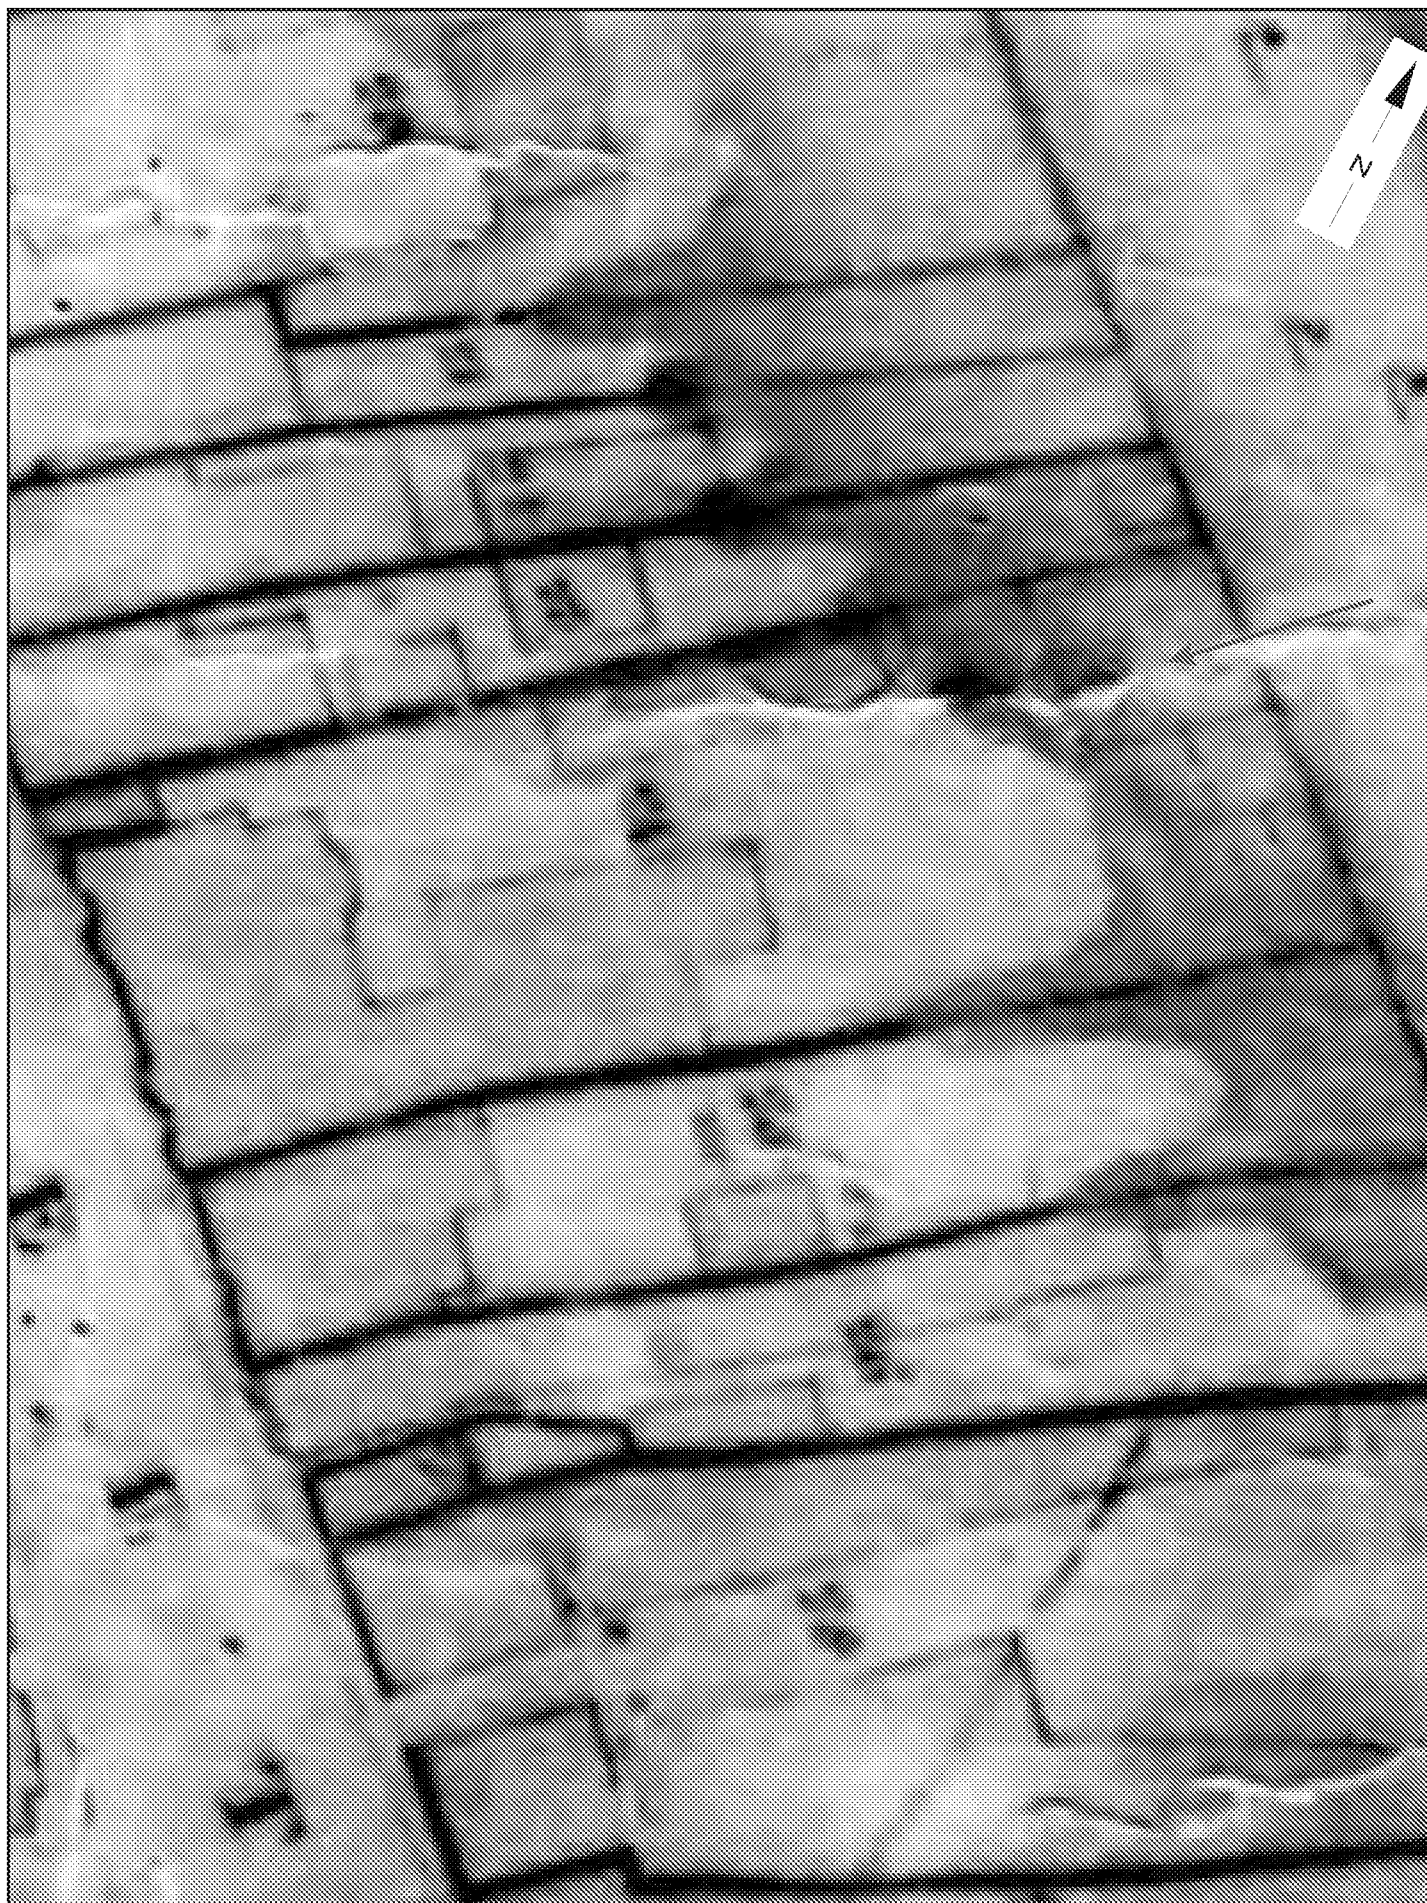
| © HB Archaeology & Conservation Ltd | 30 High Street, Arundel, West Sussex, BN18 9AB | Fig. 5 |

| Drawn by: mh | 1788 Plan prepared for the Duke of Norfolk by Tho. White | |

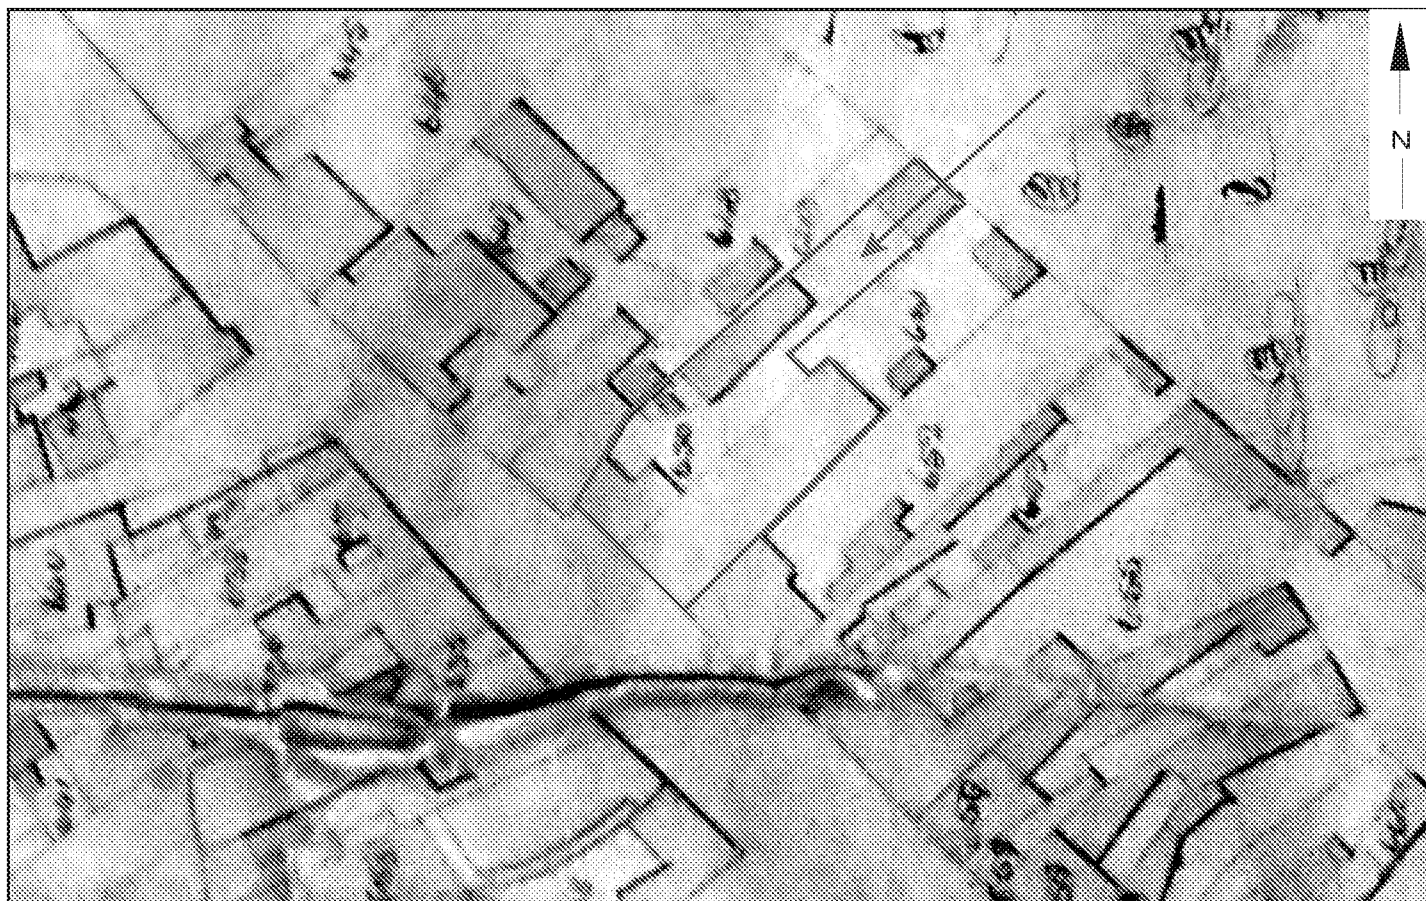
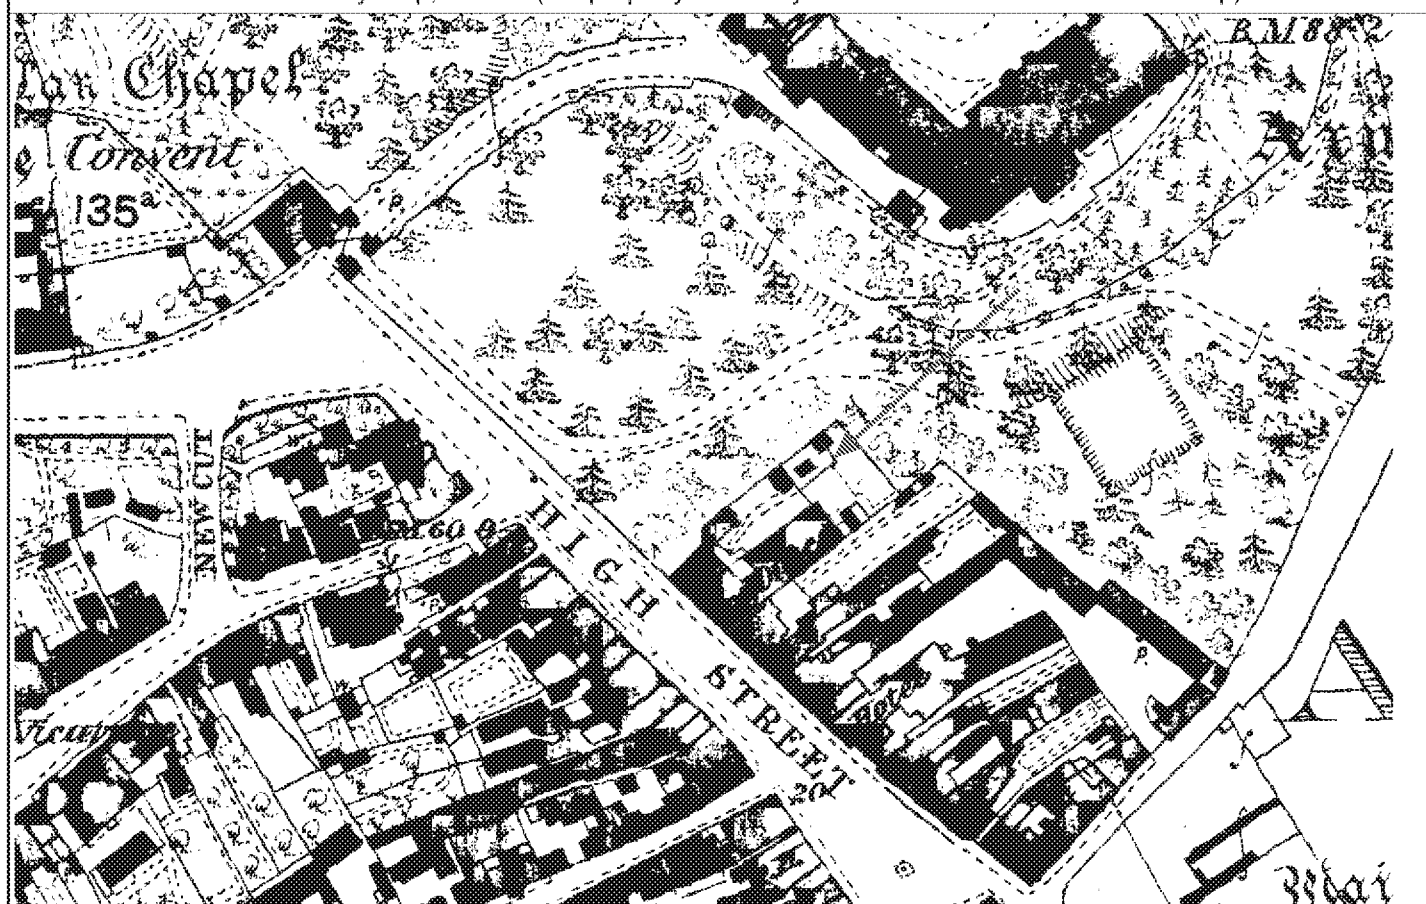
| © HB Archaeology & Conservation Ltd | | 30 High Street, Arundel, West Sussex, BN18 9AB | Fig. 6 |

Tithe Map Extract, 1841 (plot 650, the former George Hotel)

First Edition Ordnance Survey Map, 1874-5 (the property boundary shown is derived from the tithe map)

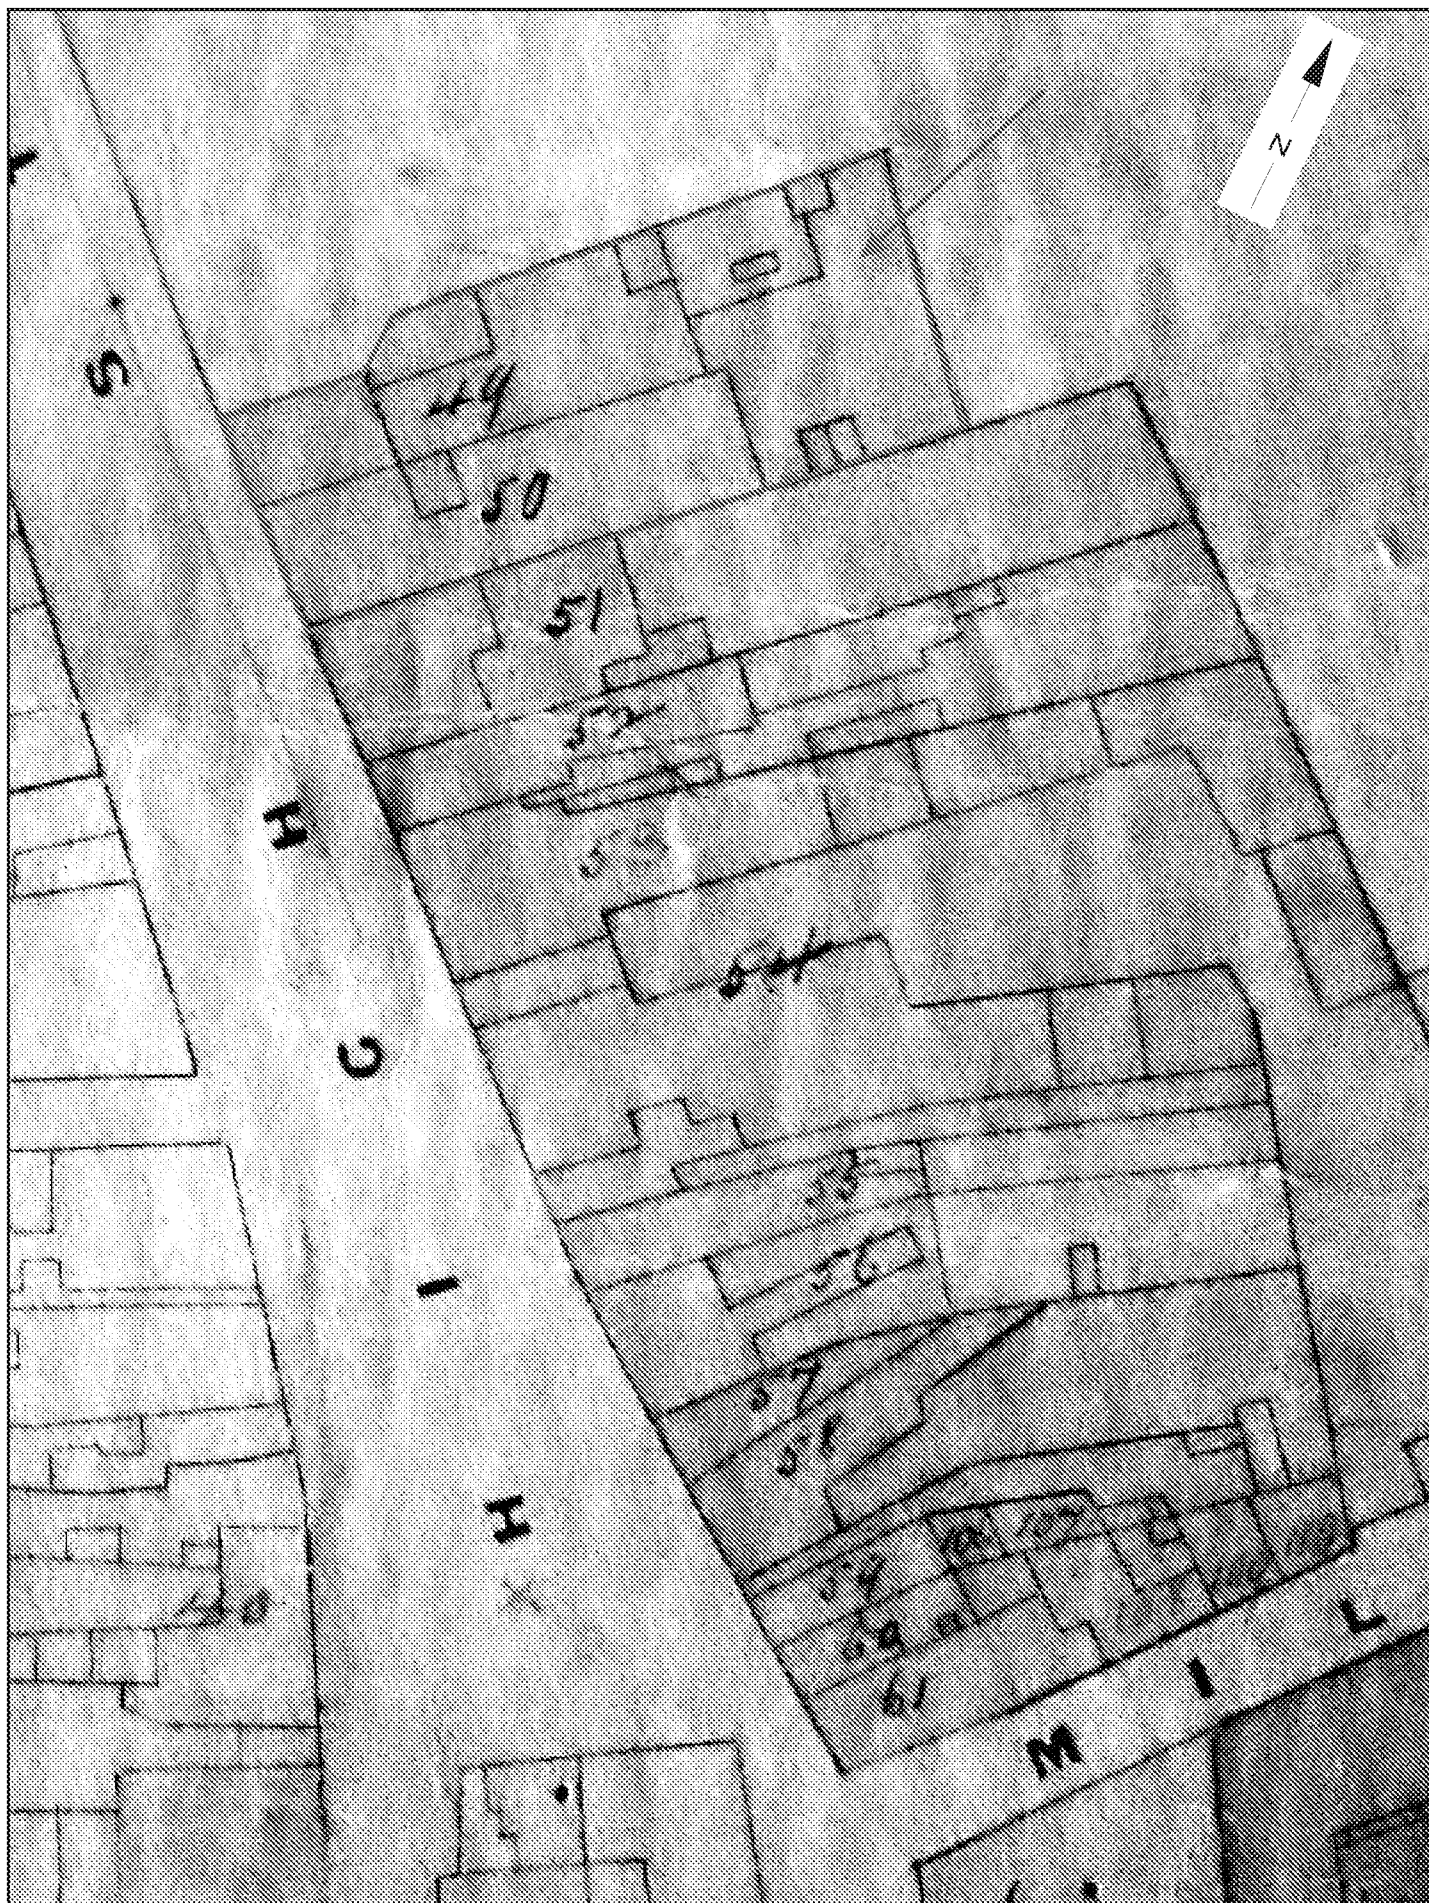
| © HB Archaeology & Conservation Ltd | | 30 High Street, Arundel, West Sussex, BN18 9AB | Fig. 7 |

| Project Ref: 2019393 | March 2019 | Map dating from 1870-80 | |

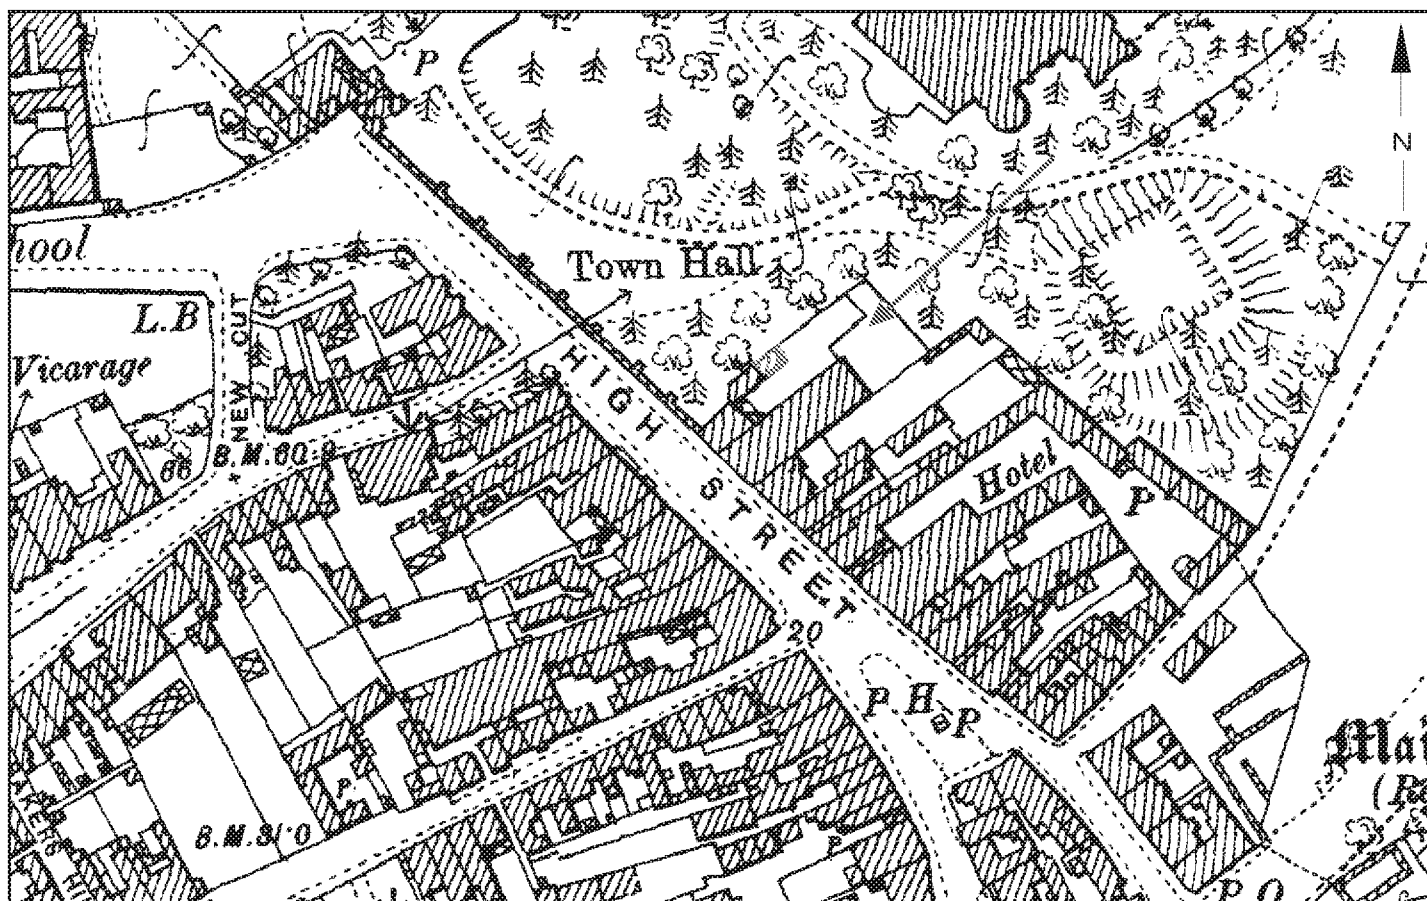
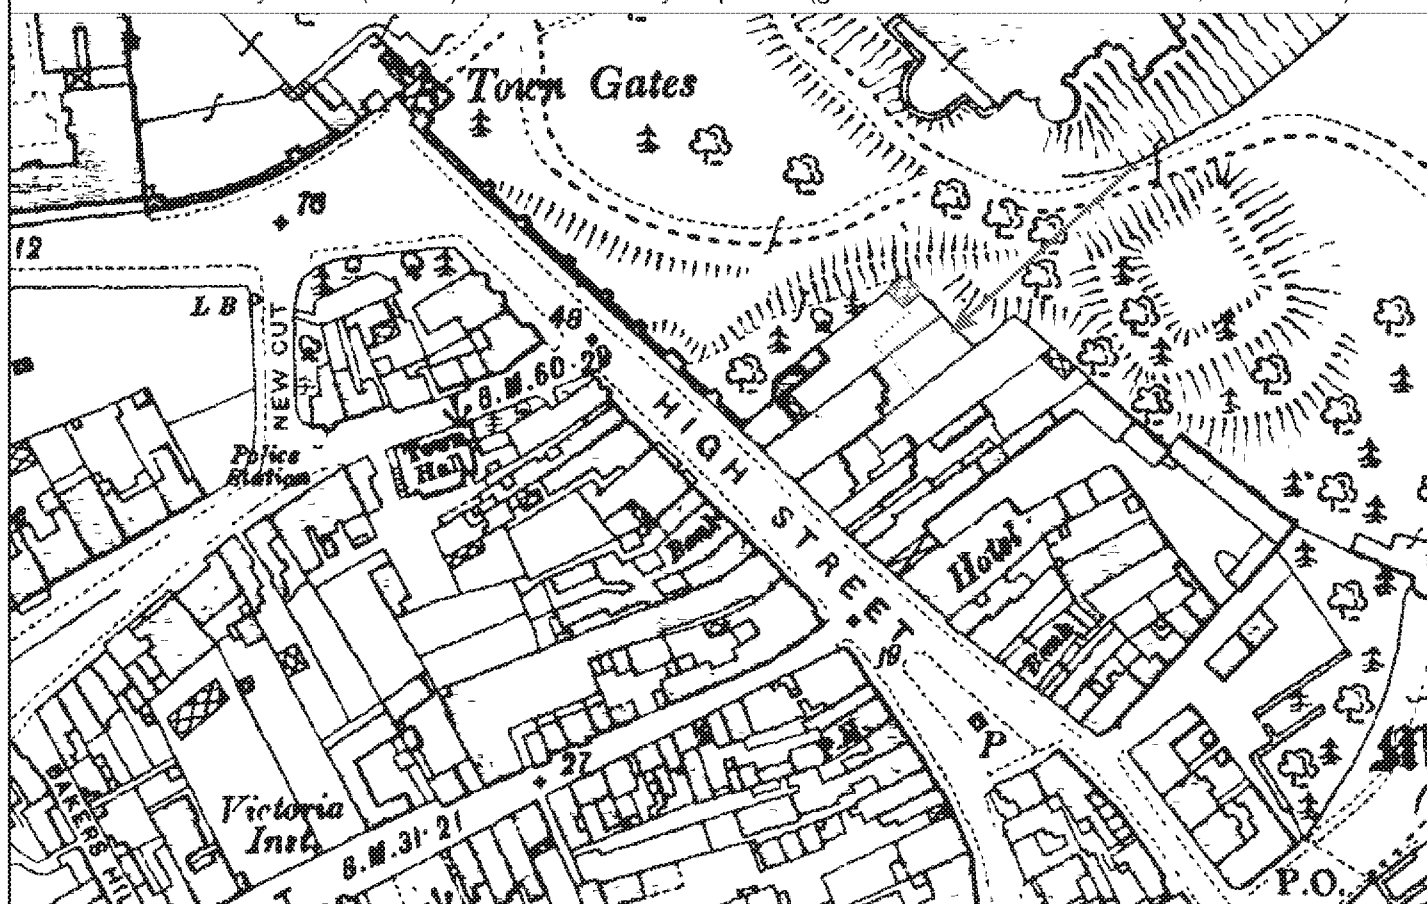
| © HB Archaeology & Conservation Ltd | | 30 High Street, Arundel, West Sussex, BN18 9AB | Fig. 8 |

First Revision County Series (1:2500) Ordnance Survey Map 1896 (blue shaded structure added by this date)

2nd Revision County Series (1:2500) Ordnance Survey Map 1910 (green dashed - removed/alterd, blue added)

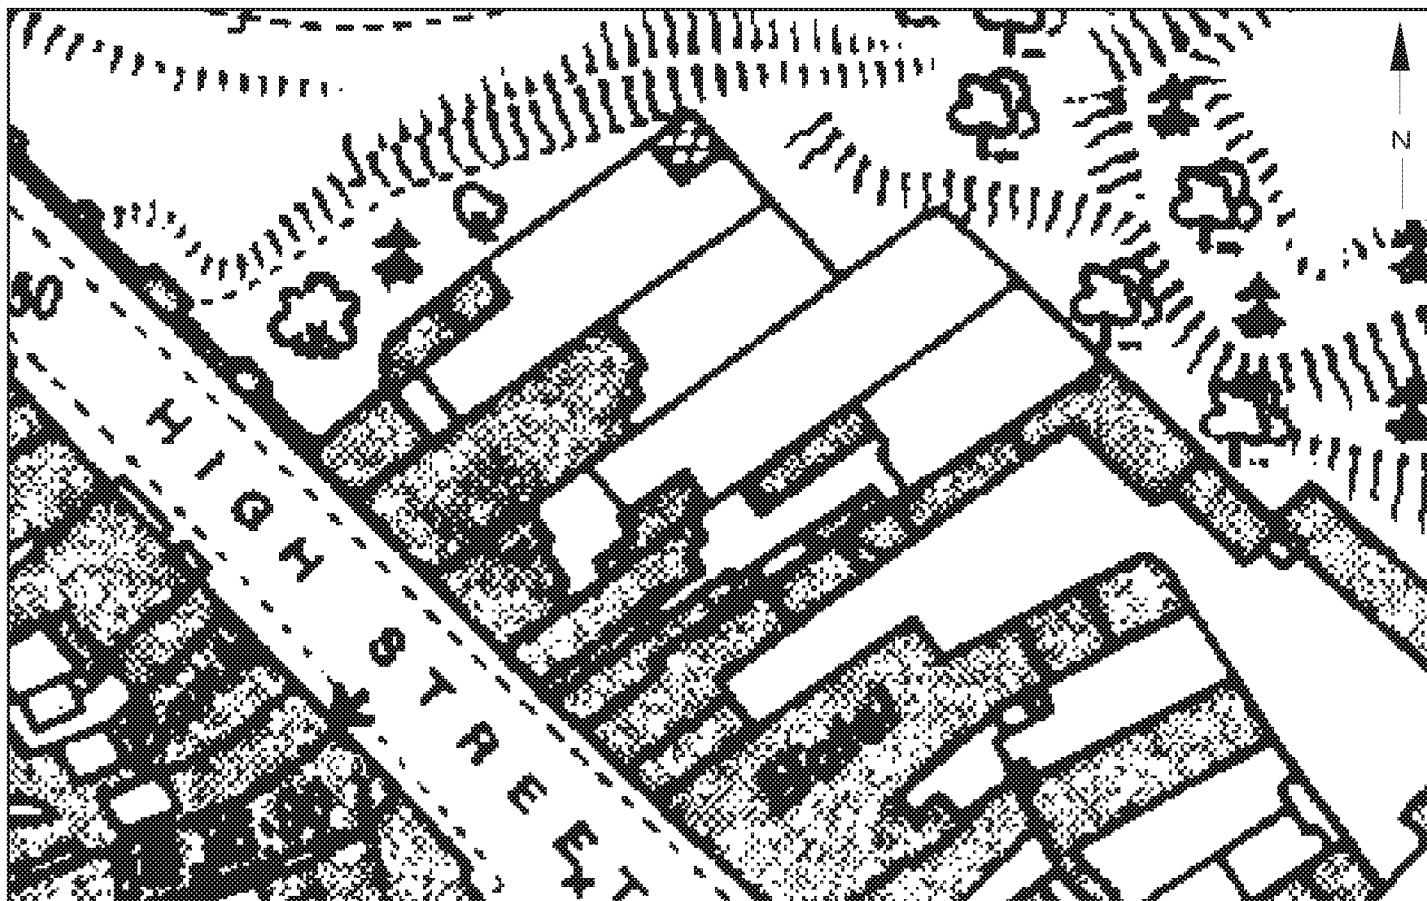
| © HB Archaeology & Conservation Ltd | | 30 High Street, Arundel, West Sussex, BN18 9AB | Fig. 9 |

3rd Revision County Series (1:2500) Ordnance Survey Map 1937
