# HB Archaeology & Conservation Ltd

30-32 HIGH STREET, ARUNDEL  
WEST SUSSEX, BN18 9AB

## HERITAGE STATEMENT & IMPACT ASSESSMENT

Prepared by Maggie Henderson  
With contributions from Diccon Hart, Val Hart and  
Philippa Whitehill

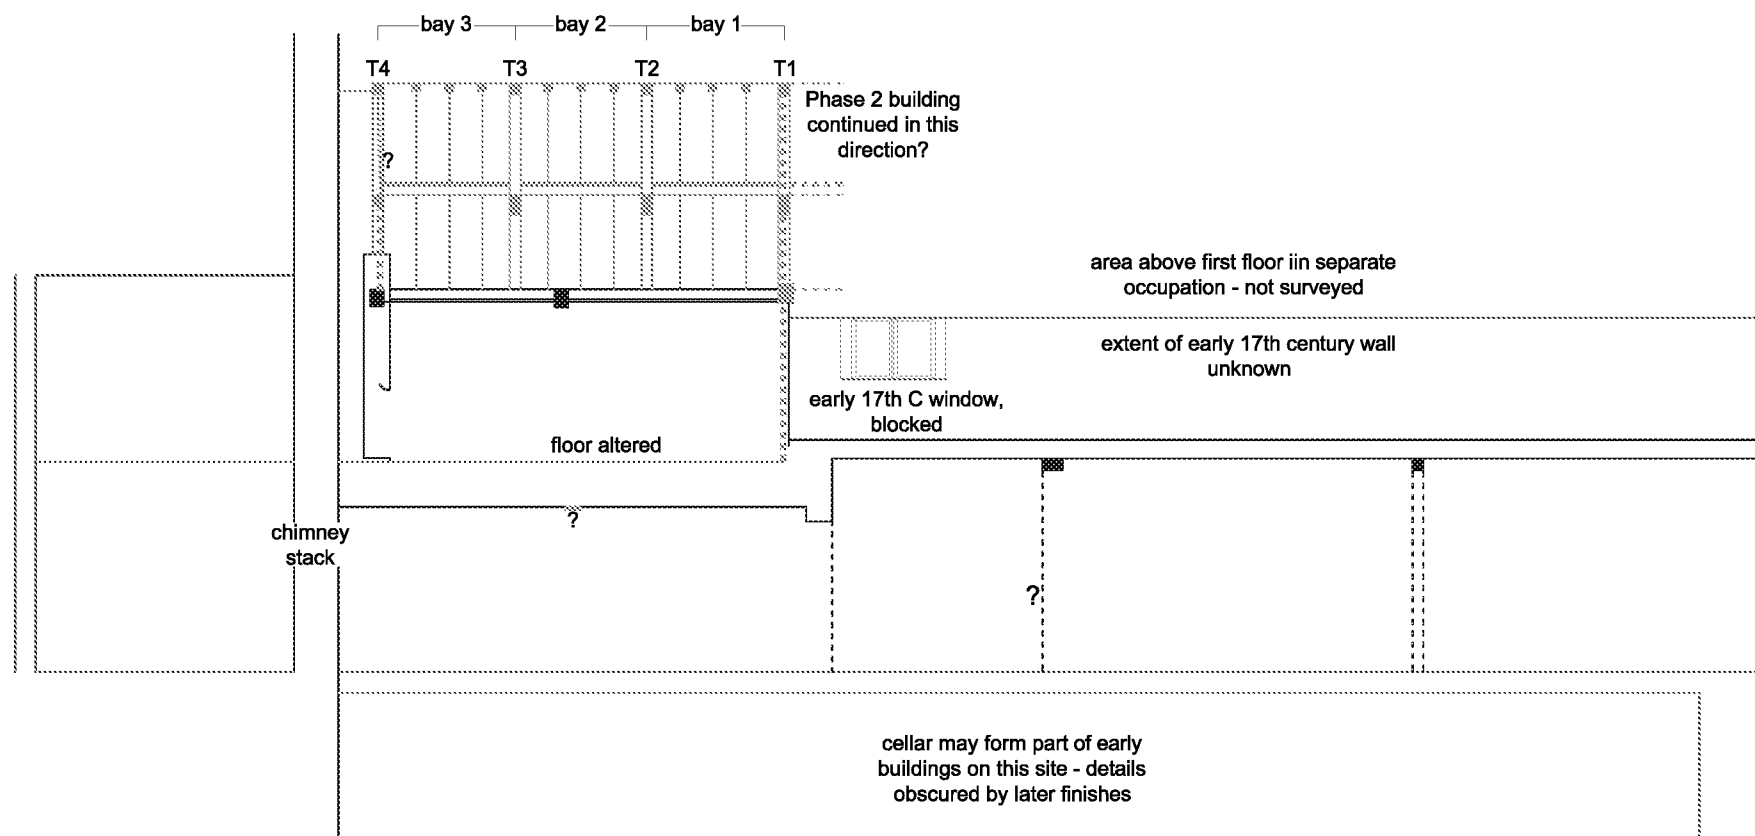
Section through the southeastern side of the property

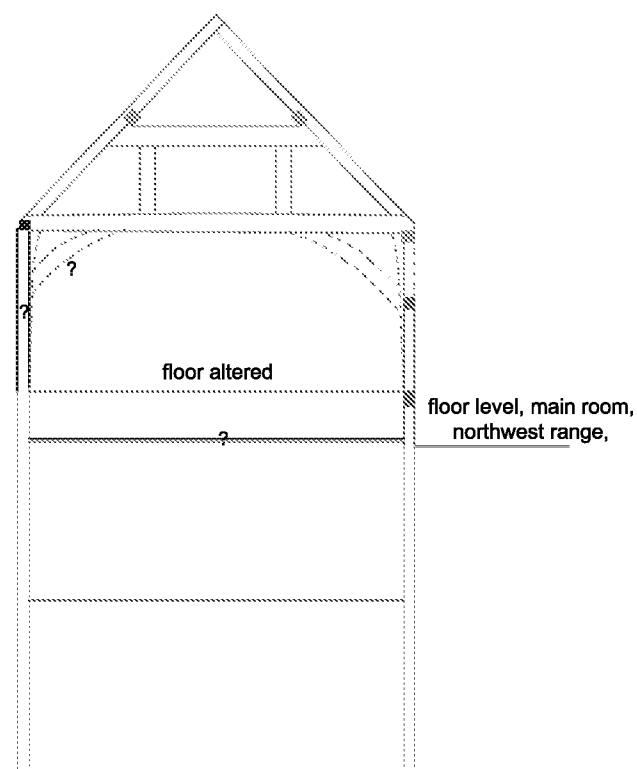
The T1 truss,  
northeast facing

- 7.4.2 If the T1 truss had been part of a timber framed building in its current location, the evidence would suggest that the roof was contemporary, while the other alterations, the rebuilding of the southeast wall in masonry (to replace the timber frame evidenced by the truss), and the insertion of the ceilings, had been the result of a subsequent phase of activity undertaken no earlier than the turn of the 18th century. While complex, such a sequence of events is not unknown, and in this instance would have entailed retaining a late 17th century roof, inserting a series of mortises on the inner face of the T1 tie-beam, rebuilding the timber framed wall on the southeast elevation in masonry, and inserting the new ceiling.

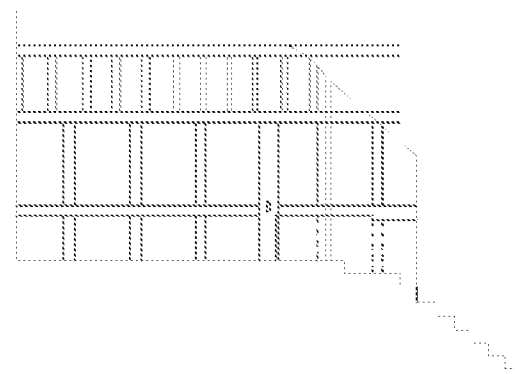
Phase 1 remains trapped by the northwest extension  
and the subsequent alterations to the southeast range

- 7.3.4 It is perhaps more probable that the bracket or cleat carrying the girder had been fixed to the principal post at a later date as part of another programme of alteration, as such, caution is recommended in interpreting the girder as part of the phase 1 building. Indeed, the work may have been undertaken in conjunction with the second clear phase of construction that involved the re-use of the earlier timber wall (Figure 11).

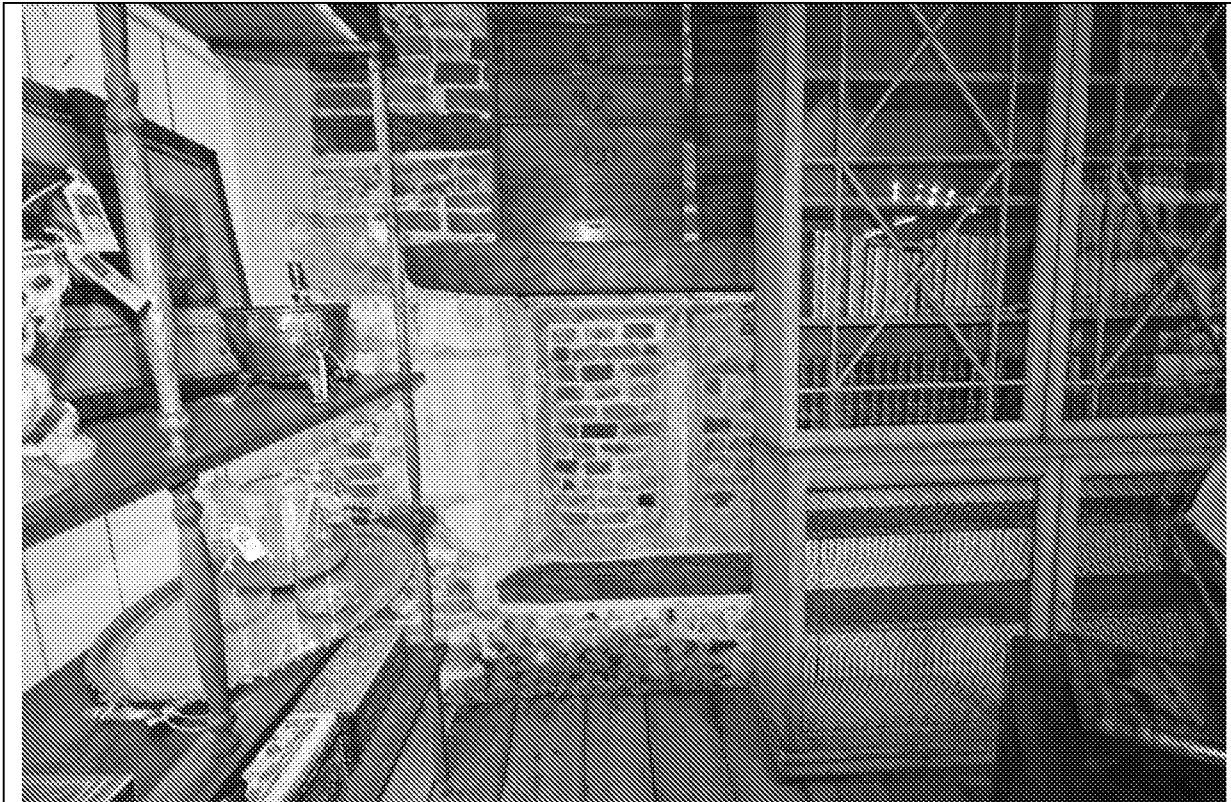
Plate 1: Early 17th century window

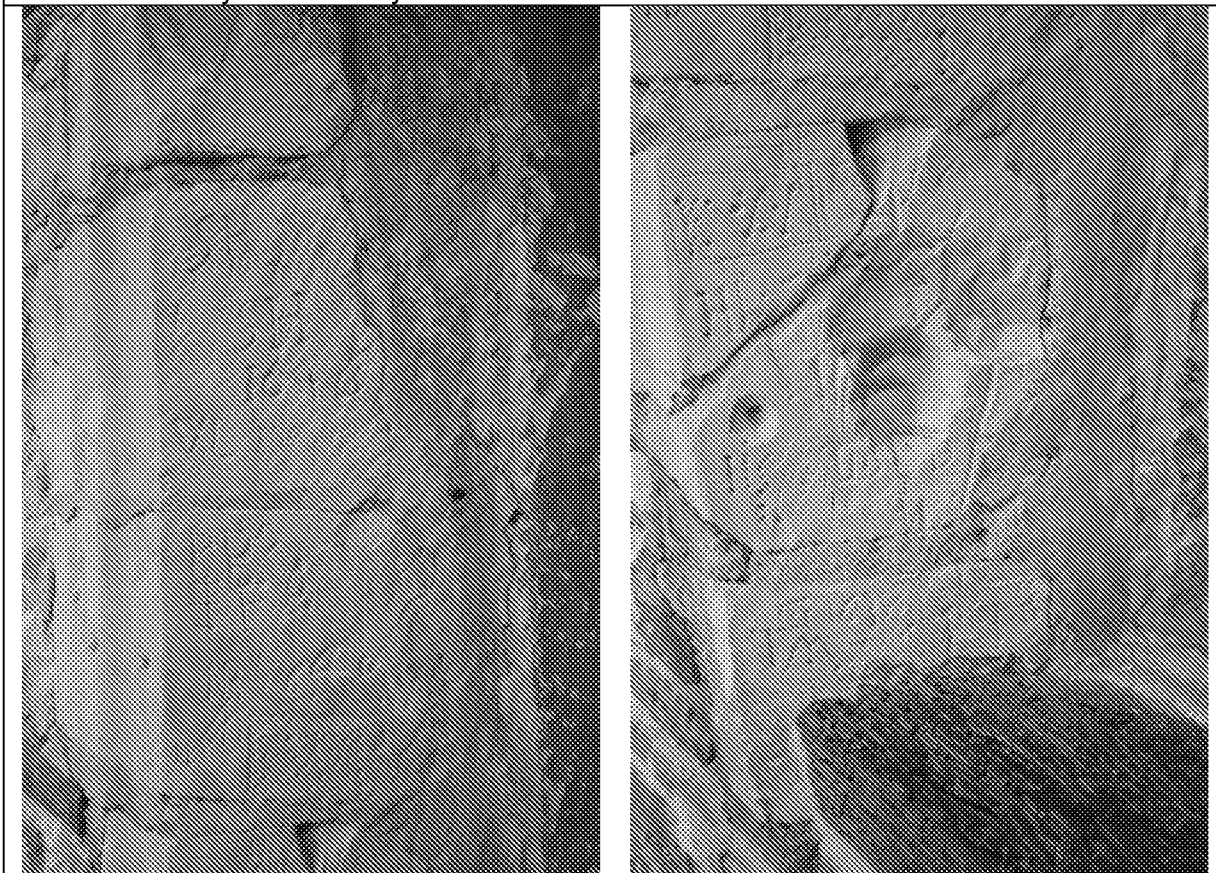
Plate 2: Detail of the early to mid 17th century graffiti

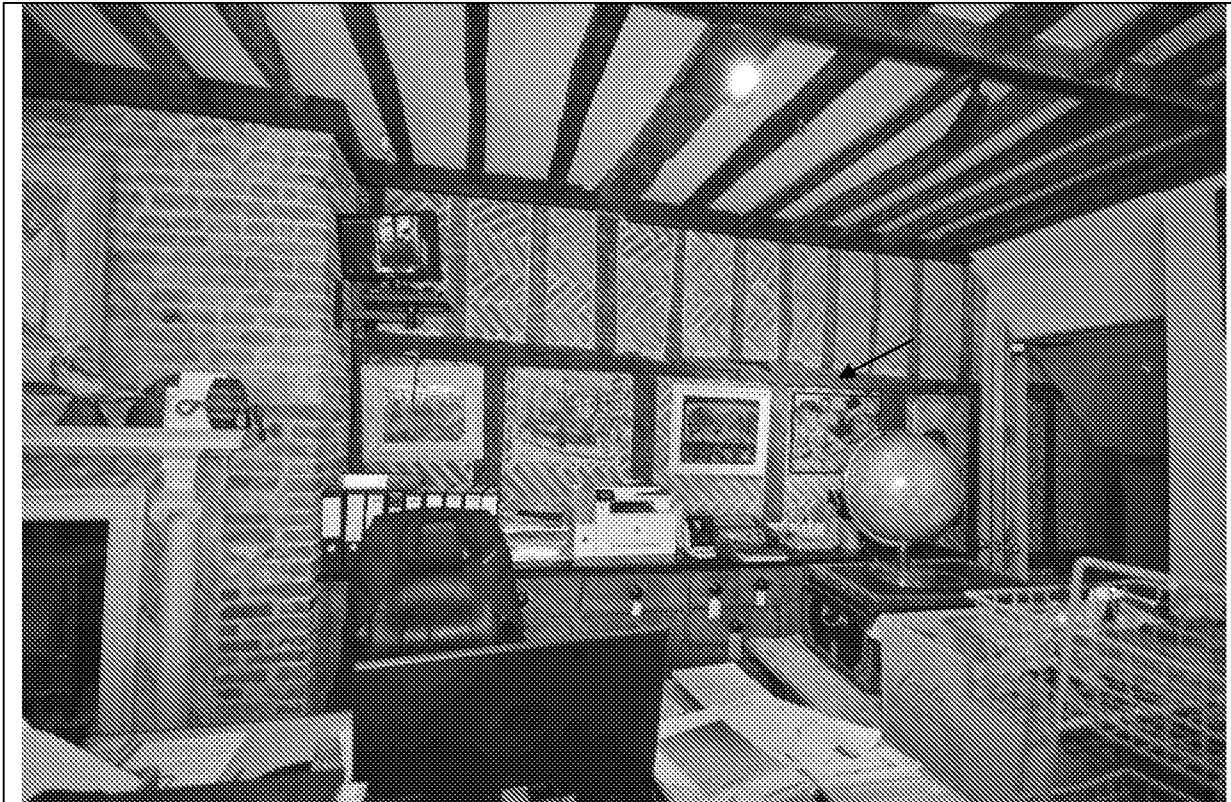
Plate 3: The early 17th century wall (wall-plate indicated by arrow)

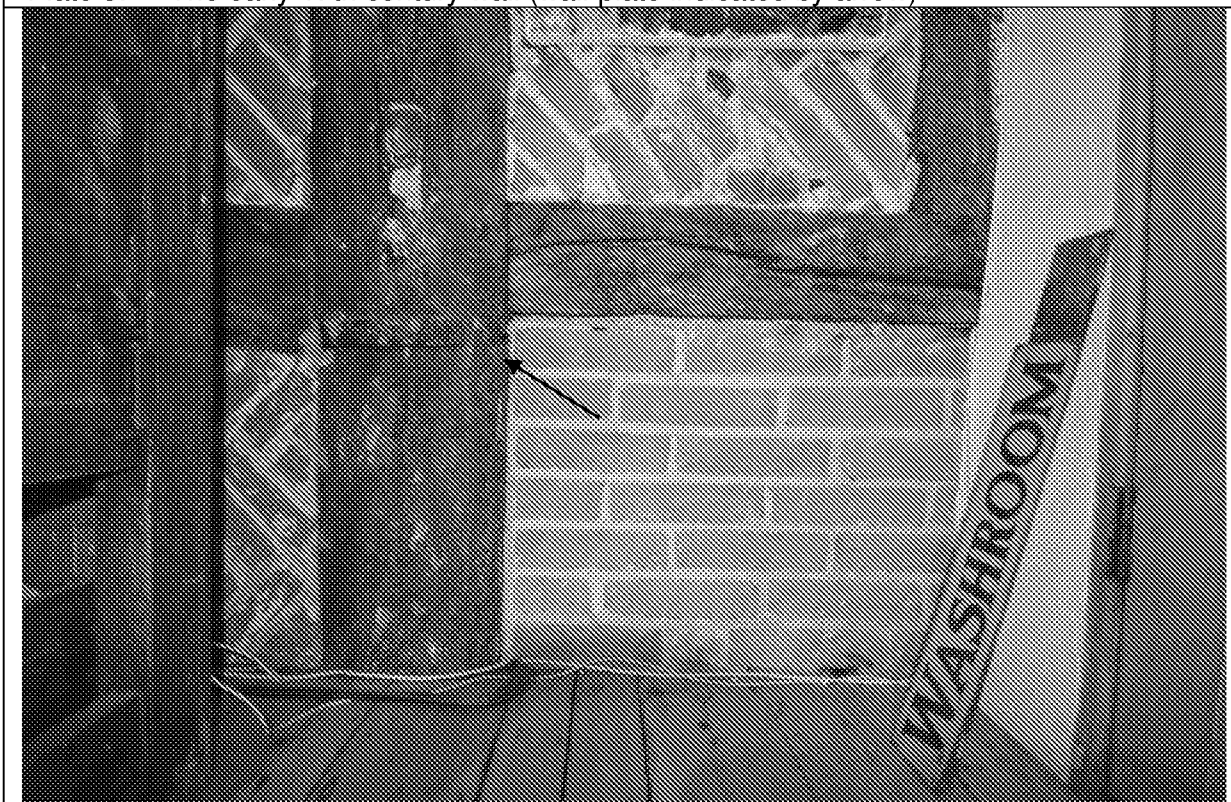
Plate 4: Detail of chamfered opening and redundant mortise (mason's mitre indicated by arrow)

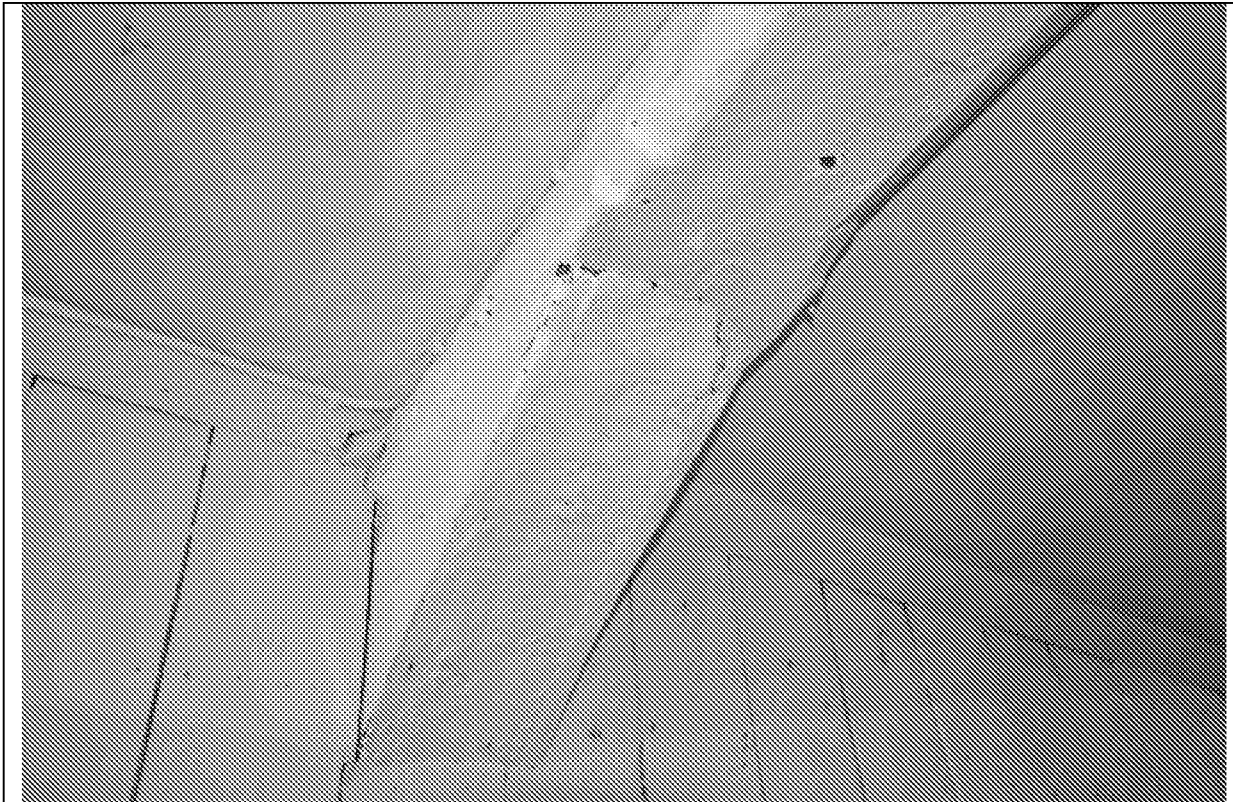
Plate 5: Phase 1 or 2 girder in the ceiling of the rear gallery

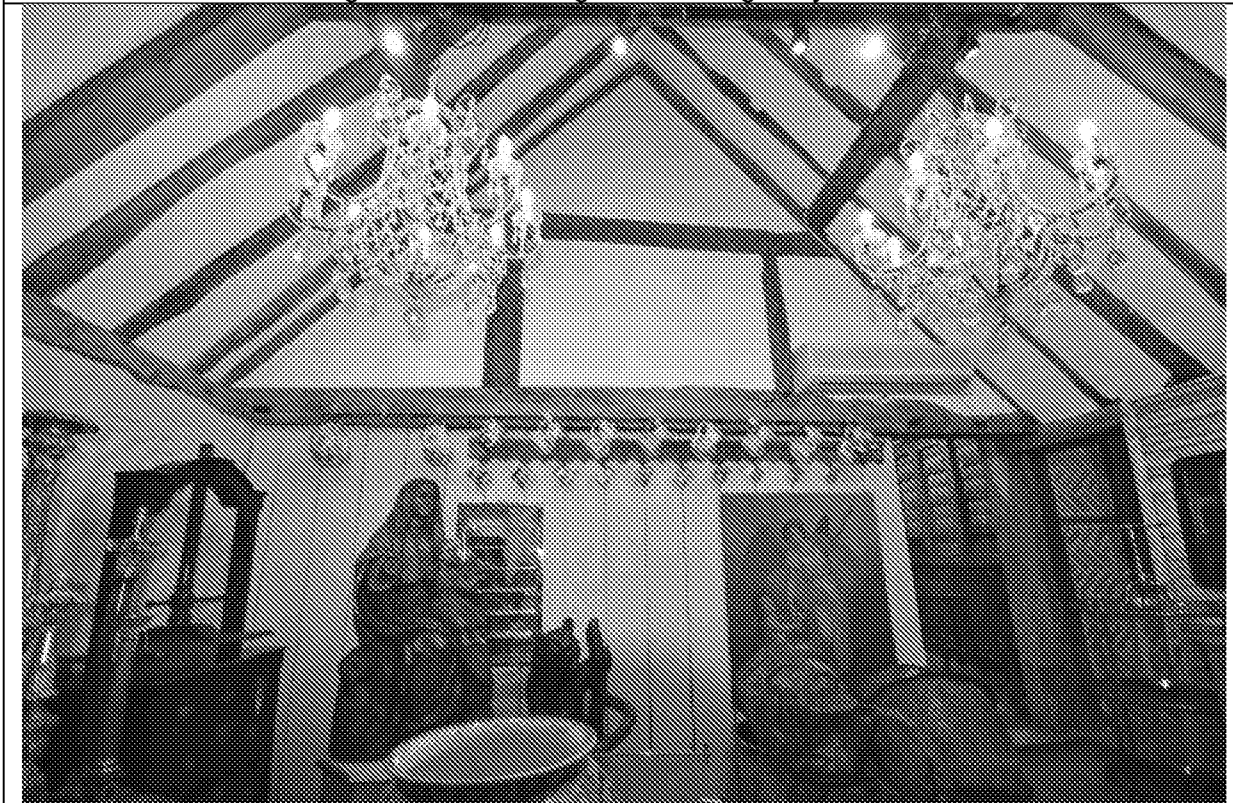
Plate 6: Gallery 3, with phase 2 roof structure and T1 queen post truss

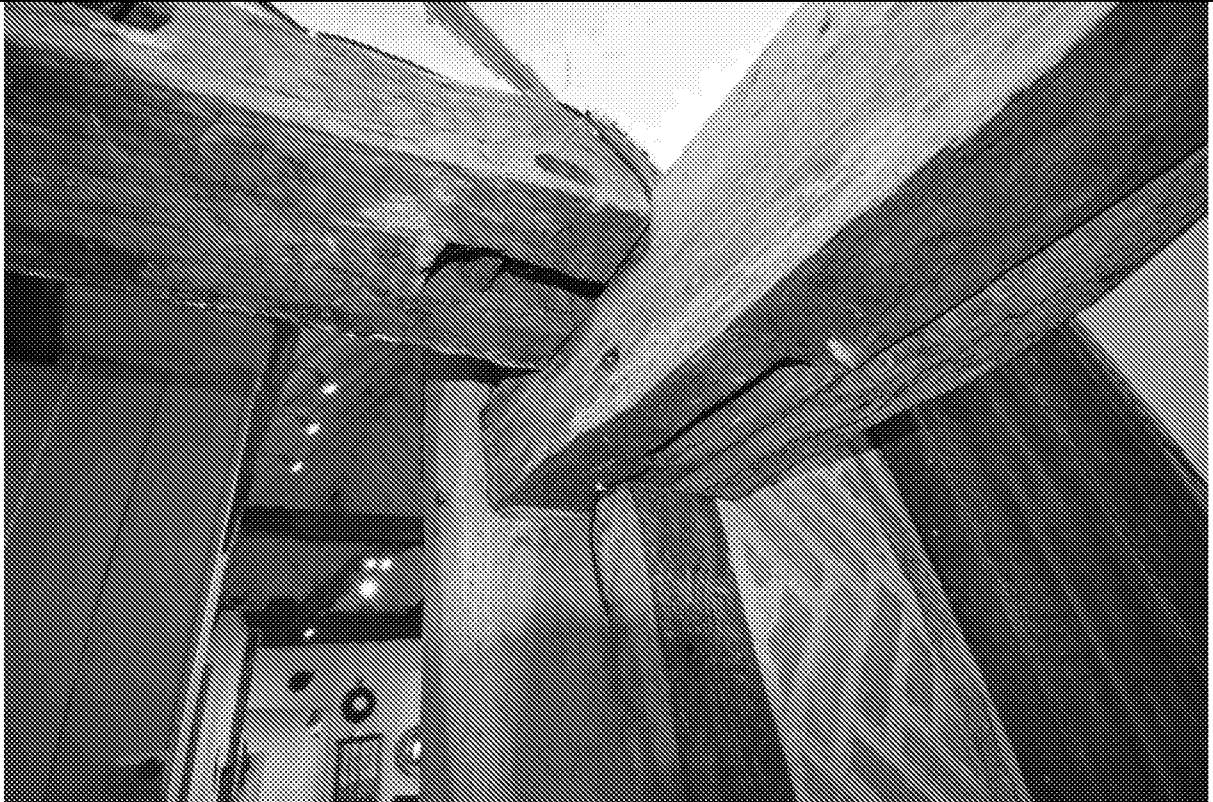
Plate 7: Mortise for principal post with a jowled head linking the T1 truss tie-beam to the wall plate

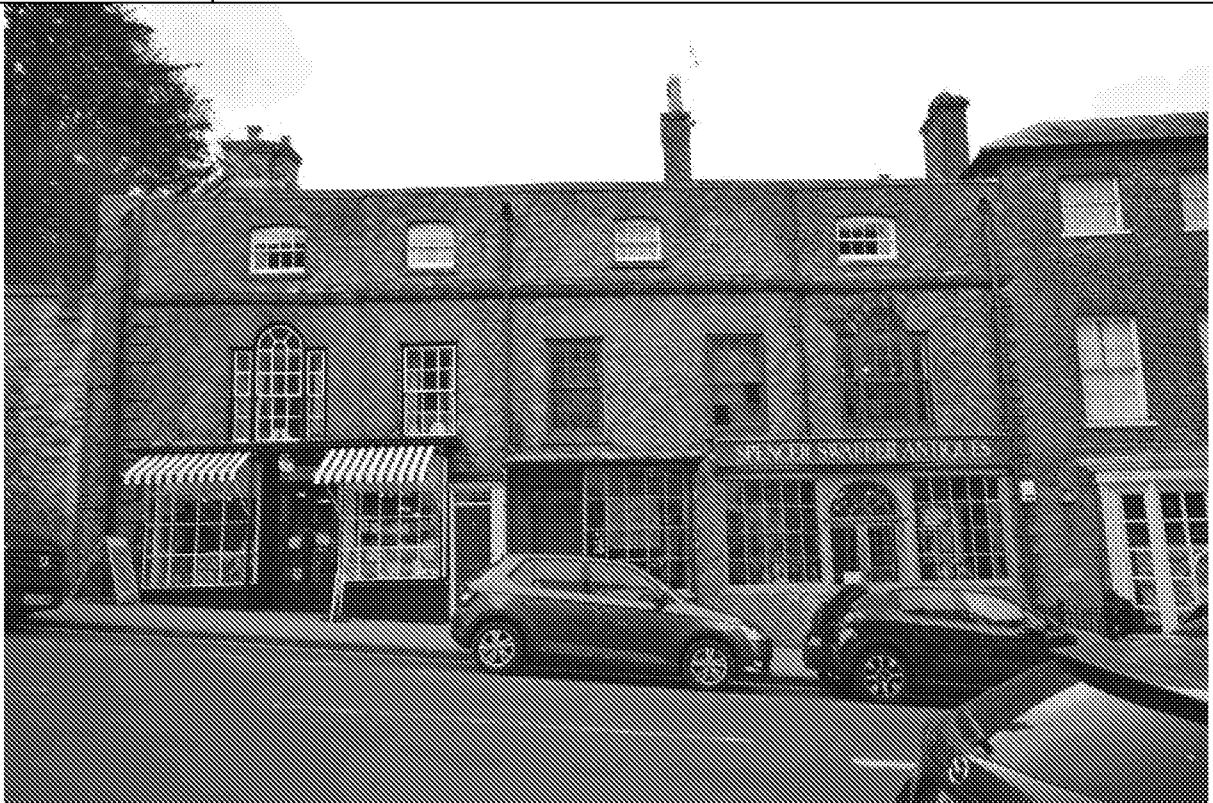
Plate 8: Mid 18th century frontage with late 18th and early 19th century shop fronts inserted

- 7.4.11 The attic rooms have smaller sash windows (with evidence of alteration) and the roof is concealed by a parapet (Plate 8). The parapet lacks a continuation of the rusticated quoins extant at the corner of the building, perhaps indicating that it was a later addition or alteration. Additional embellishments are extant in a moulded string above the first floor windows that stops short of rusticated quoins, both moulding and the fact that the string does not continue to the end of the elevation are details commensurate with early to mid 18th century work.

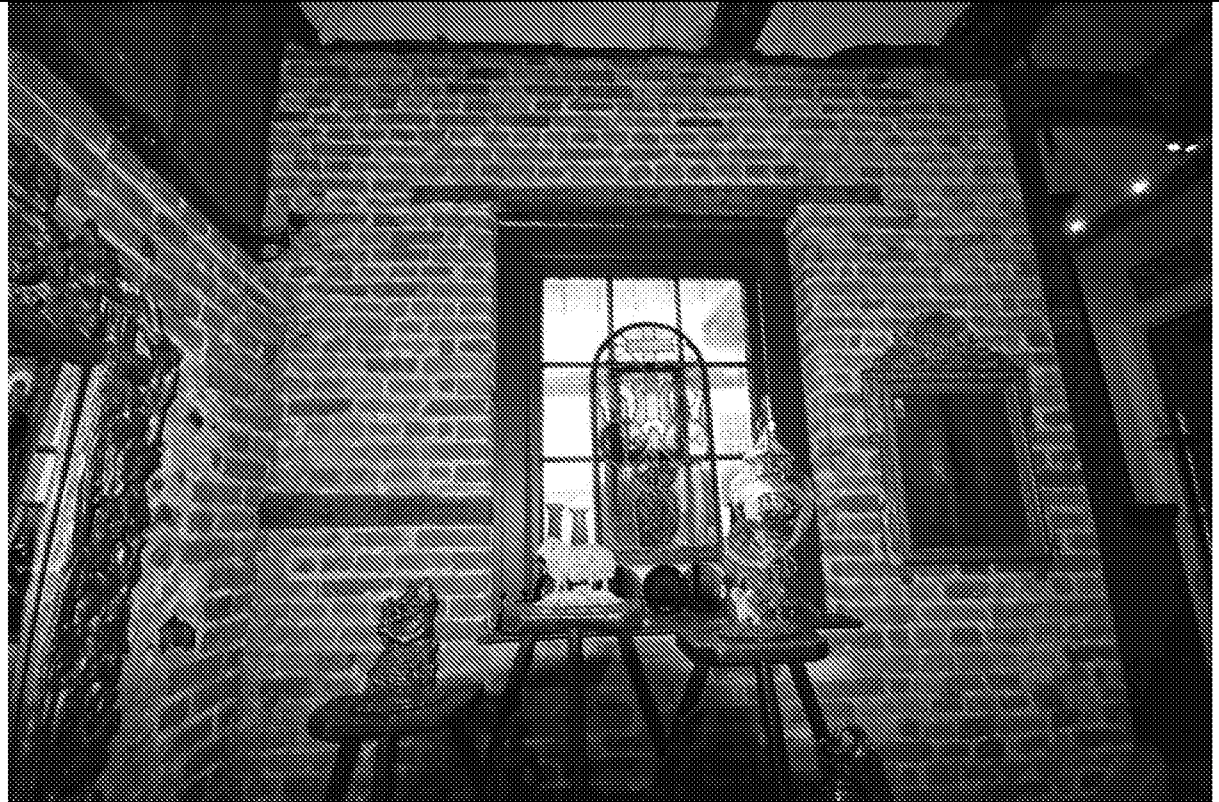
Plate 9: Northeast elevation of the stair turret with queen closers finishing the wall to accommodate a return and the corridor

- 7.4.19 The staircase, with its turned balusters and elegant ramped handrail is also of mid 18th century origin, situated within a purpose-built stair turret complete with a large window in the rear elevation. It is important to note that while the staircase is of 18th century origin, it is not quite intact, indicating subsequent modifications, possibly carried out as part of the conversion to separate commercial and domestic premises. Indeed the masonry wall to the northwest side of the stair turret abuts the rear elevation, and the roof has been replaced indicating later programmes of alteration (Plate 9).

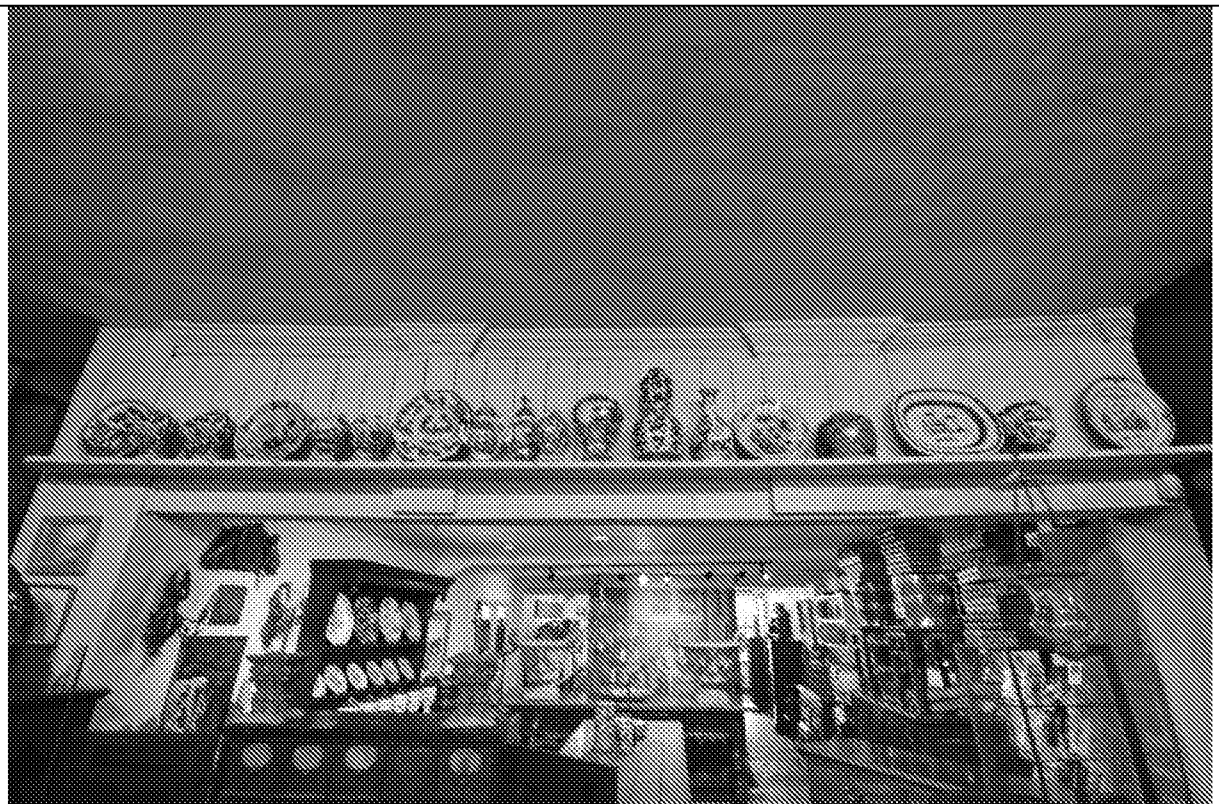
Plate 10: Moulded cornice and pilasters of late 18th century origin

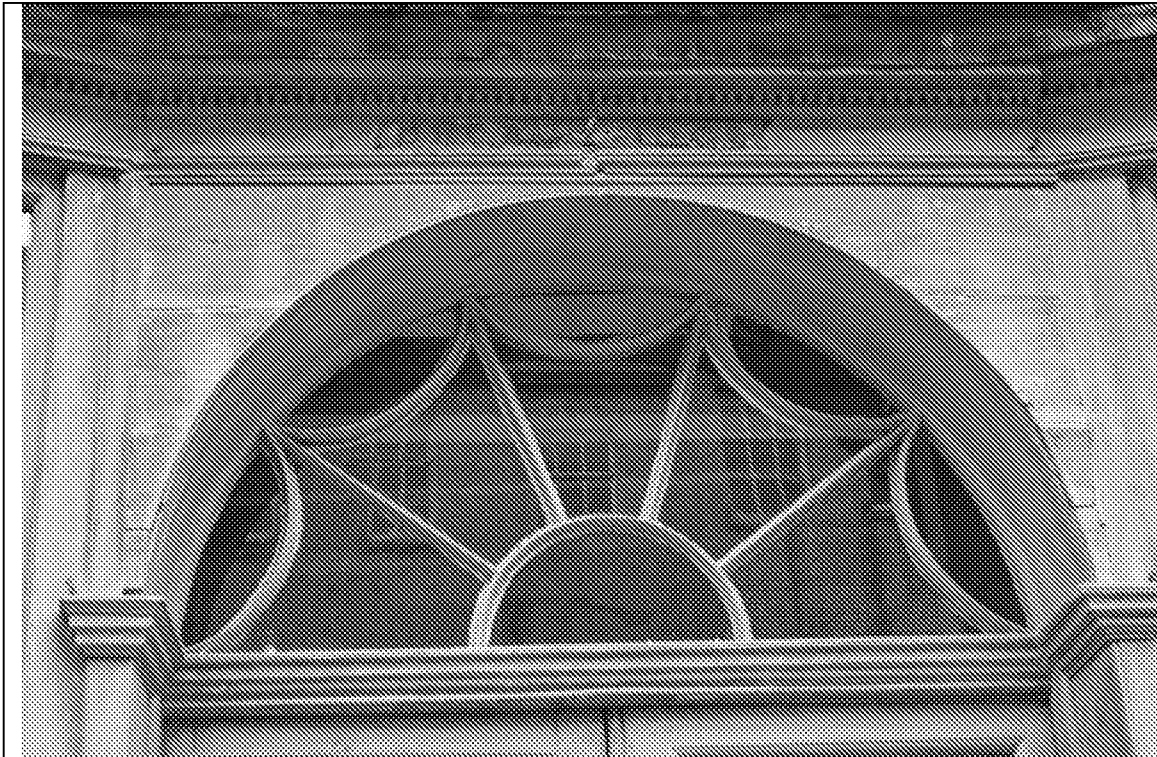
Plate 11: Lettering just visible above the fanlight of the late 18th century shop front

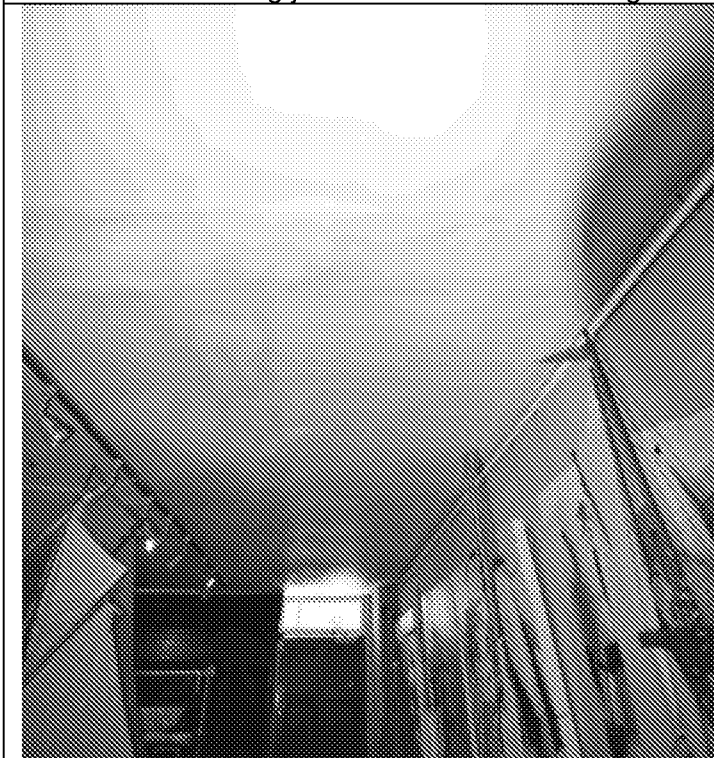
Plate 12: Scars in the ceiling indicating the former location of the corridor partition for the northwest domestic entrance

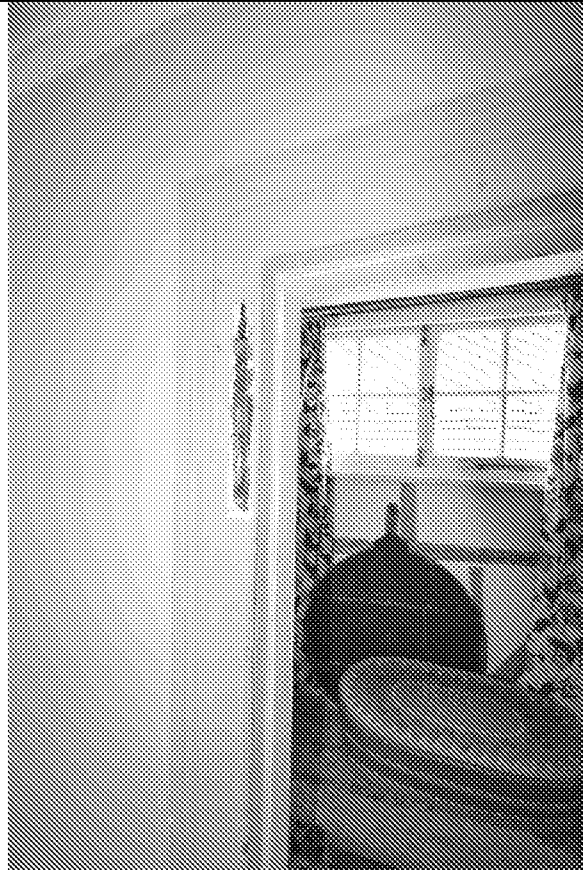
Plate 13: Georgian doorcase and scar for H-hinge in gallery 2, first floor of the late 18th century northwest extension

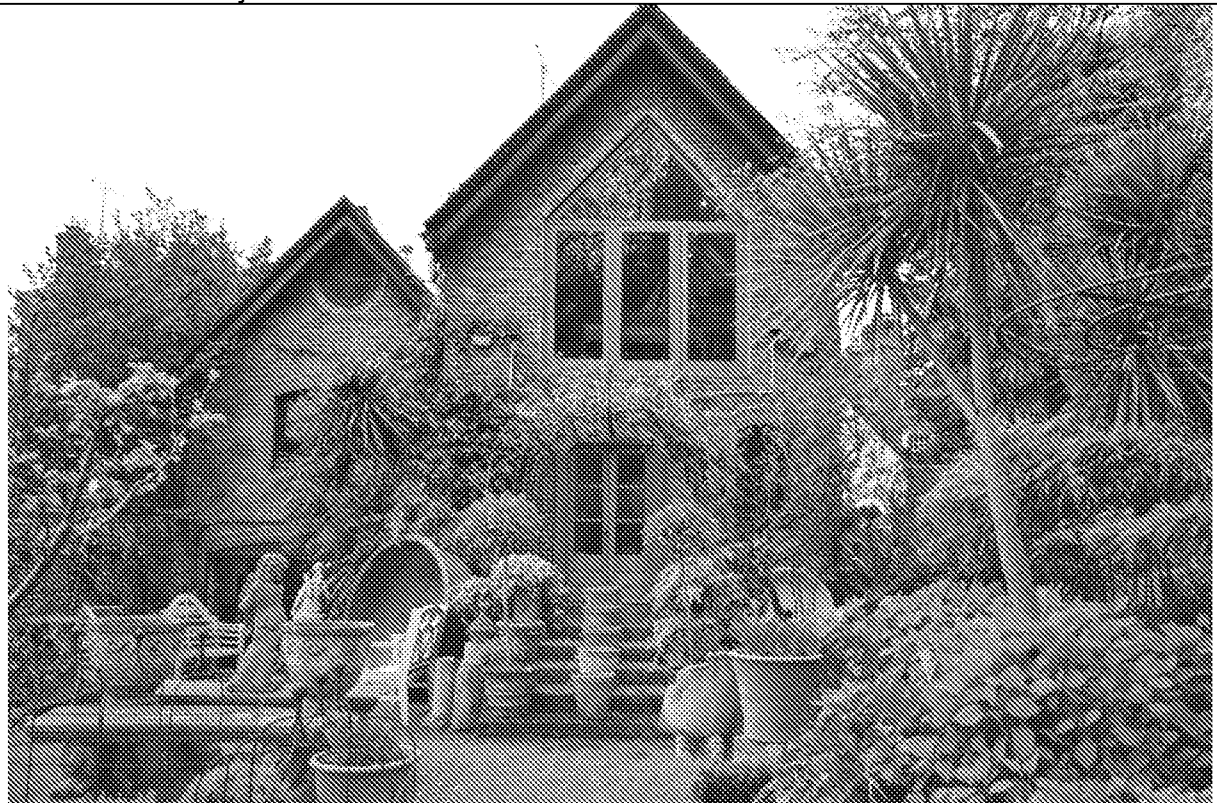
Plate 14: The Edwardian ends of the rear wings, with later windows inserted

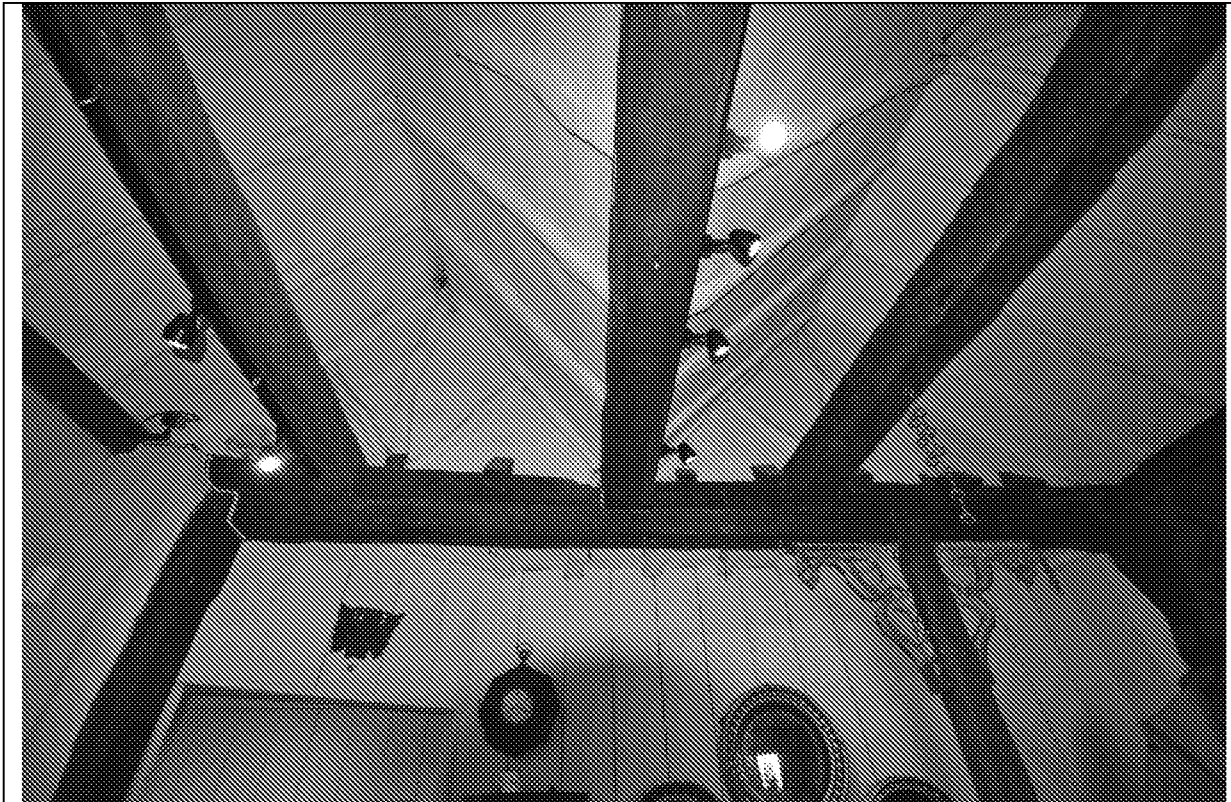
Plate 15: Replaced roof with rusticated timbers on the first floor corridor

- 7.6.8 Within the rear return to the main range at first floor level, the ceiling heights are markedly high, while those over the first floor corridor and stair turret include a high degree of rusticated timber (Plate 15). The alterations are indicative of work undertaken in the early to mid 20th century, as repairs and replacements, yet also in the fashion of the time, intended to 'enhance' the historic appearance of the building. The application of waney edged timbers, strap-work to walls, and the removal of under-drawn ceilings, as outlined above, became a feature of the late 19th and early decades of the 20th century.

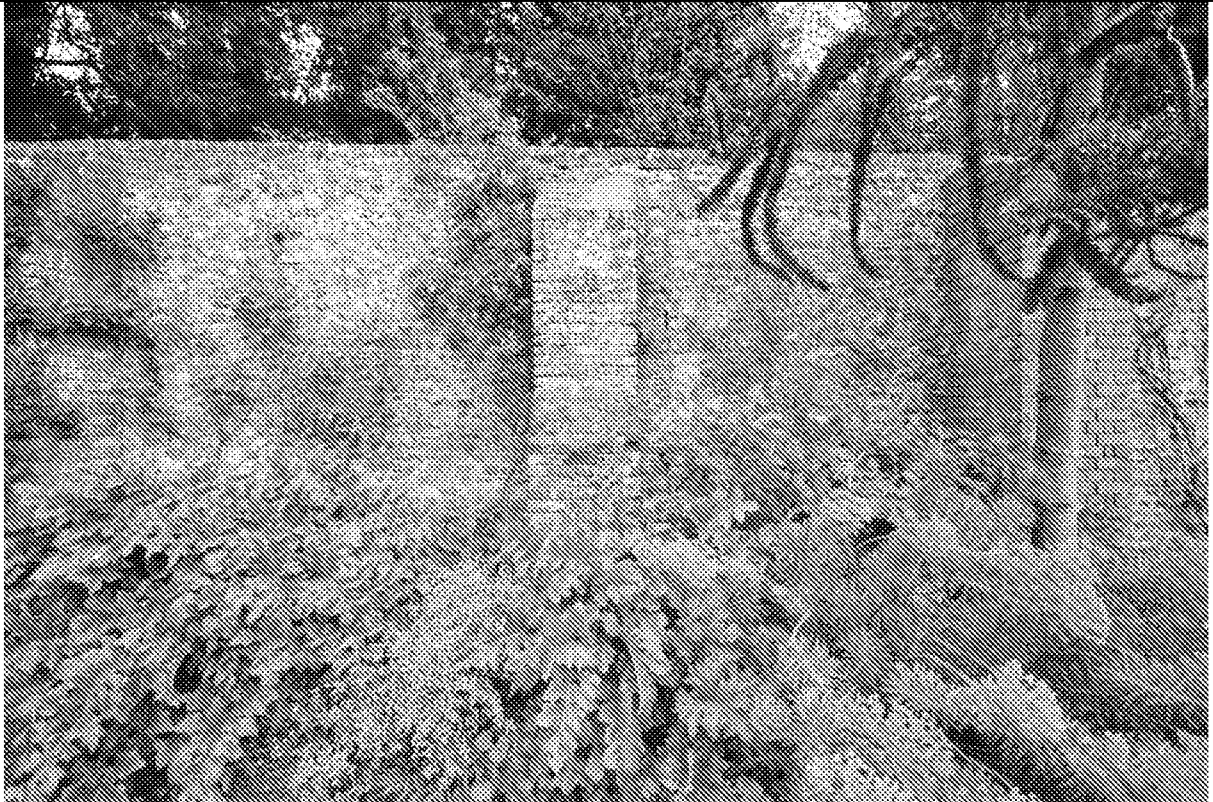
Plate 19: Bungaroosh of the northeast boundary wall

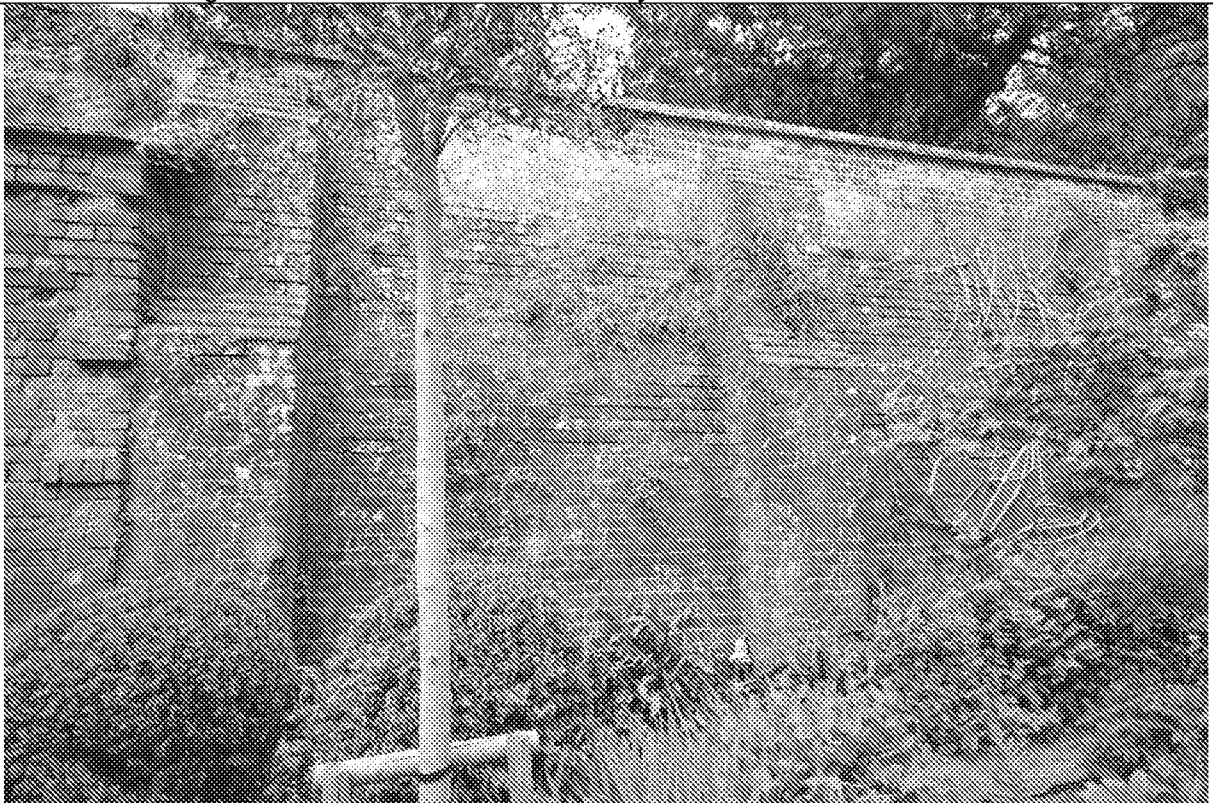
Plate 20: Brickwork of the northwest wall, built over the remains of an earlier structure (just visible)

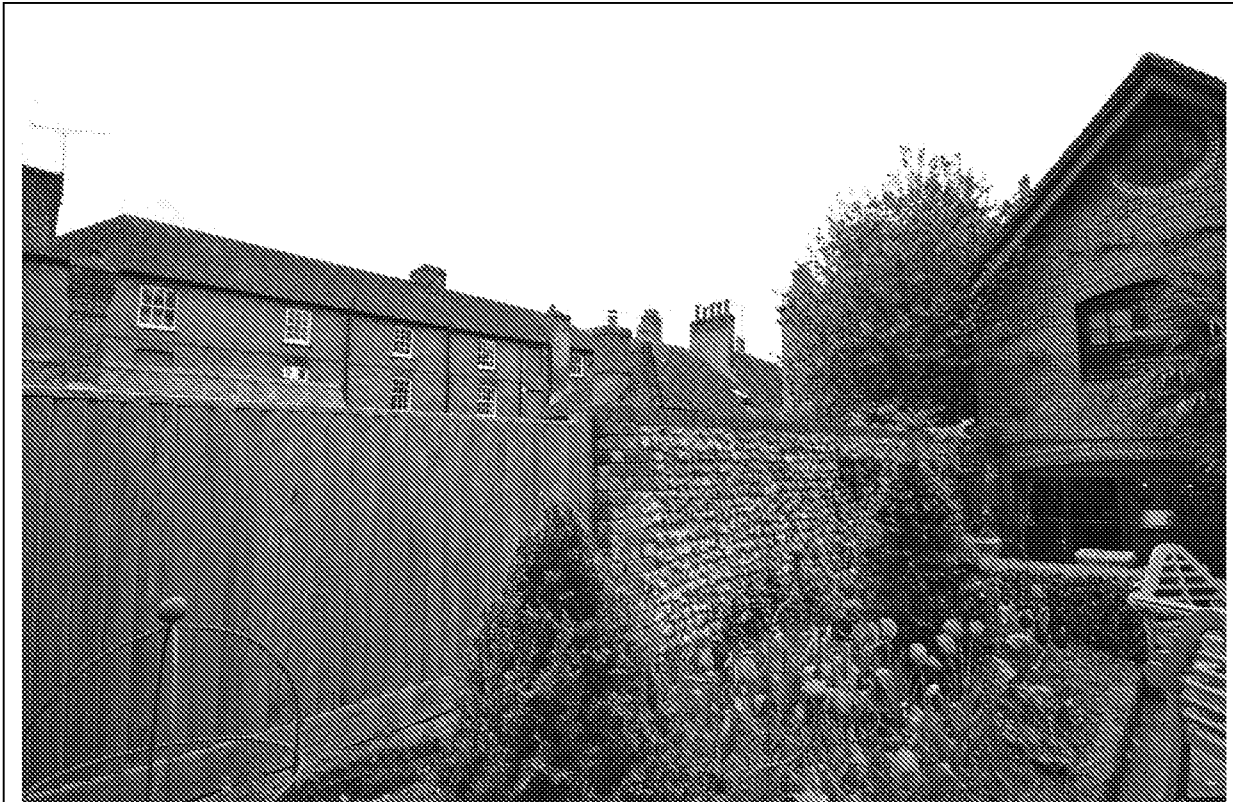
Plate 21: Lower height of the property boundary and temporary boards in the southwest side of the grounds

- 7.8.6 The southeastern boundary wall is notably lower than the others, in flint nodules brought to course with brick quoins and trim. A boarded area is extant (Plate 21): the boards were added as a result of storm-related damage in recent years: the section of wall will be reinstated in due course as part of the long term management of the property.

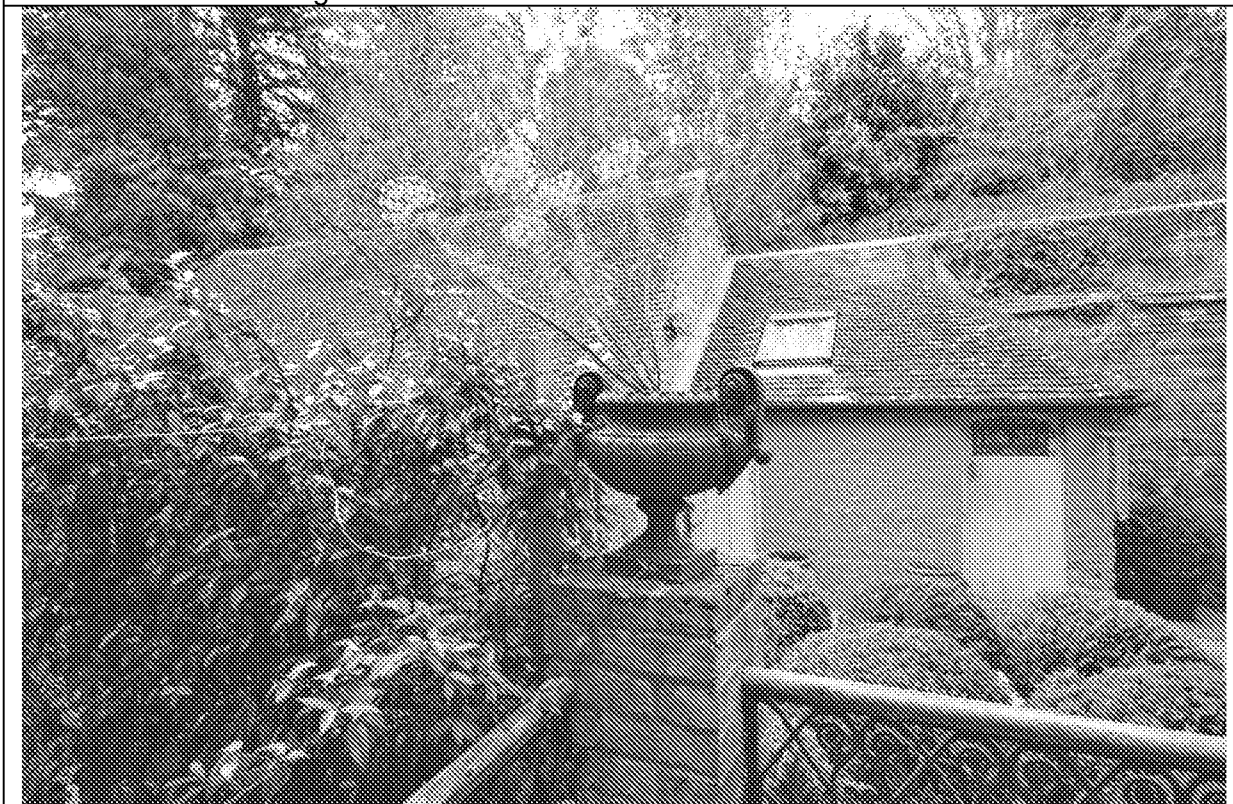
Plate 22: Varied roof-slopes of the two remaining ancillary buildings

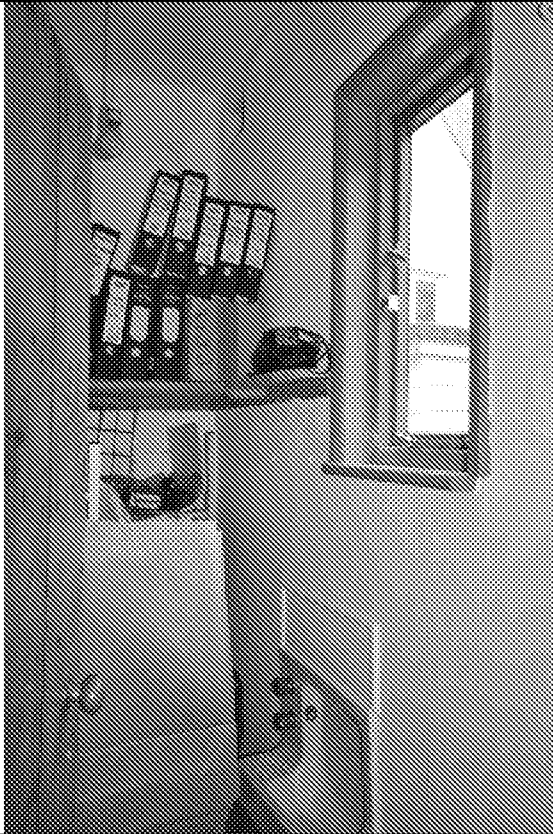
Plate 23: Store (former WC) with modern partitions, fittings and window

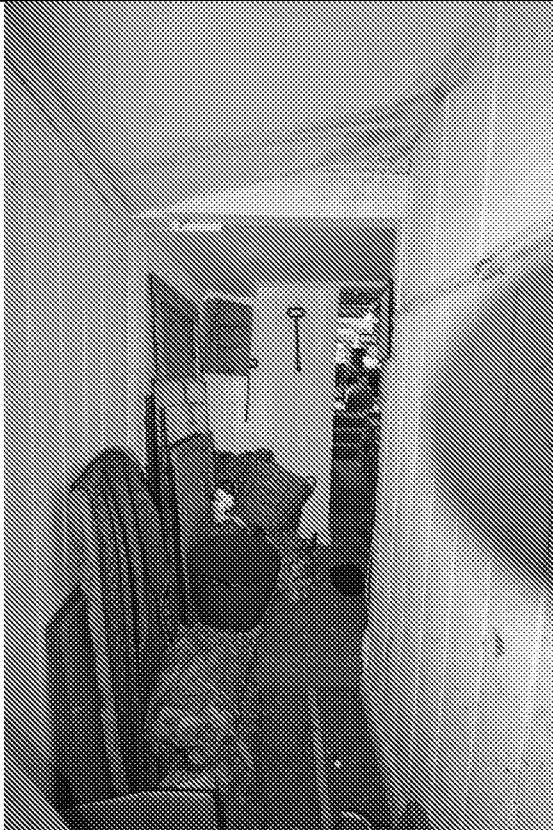
Plate 24: View from the narrow passage behind the staircase to the former light-well and the inserted store/WC enclosure. Note the varied short flights of steps used to link the separate areas
