**Land at Nyton Nurseries**  
**Westergate**  
**Arboricultural Impact Assessment**  
**& Method Statement**

**Our Ref:** JSL2869\_771

JSL2869\_711-713

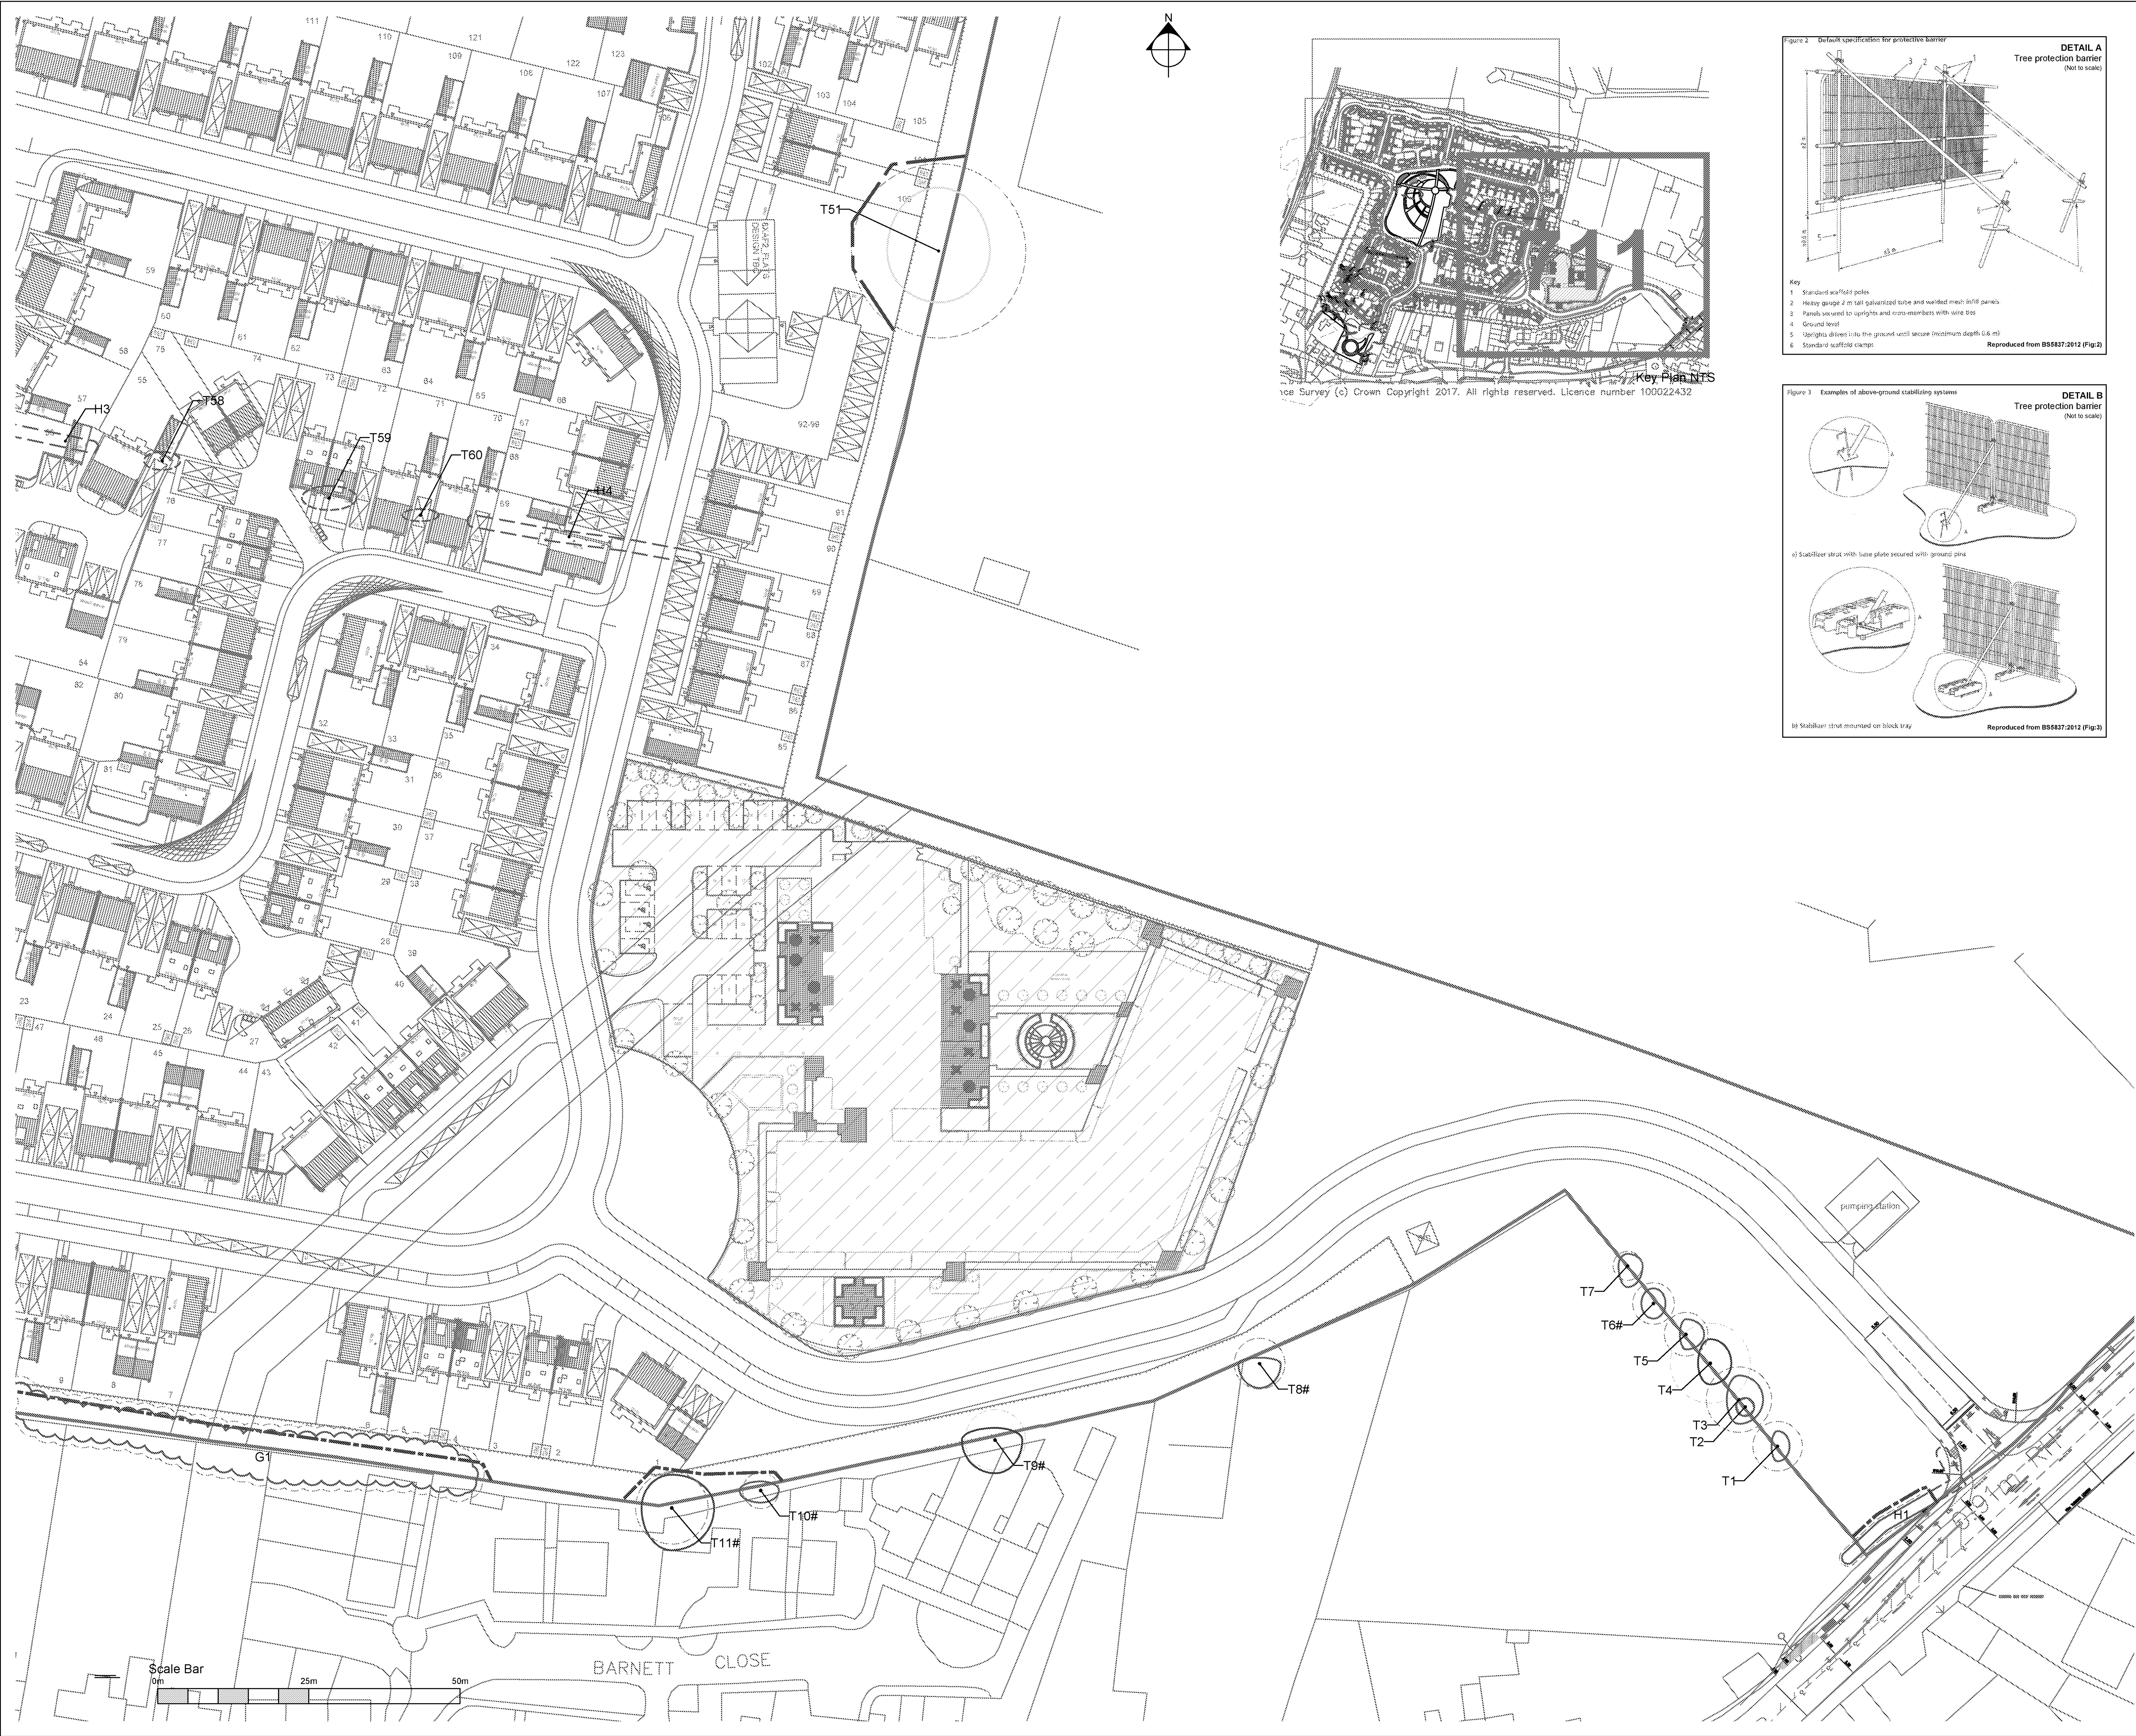
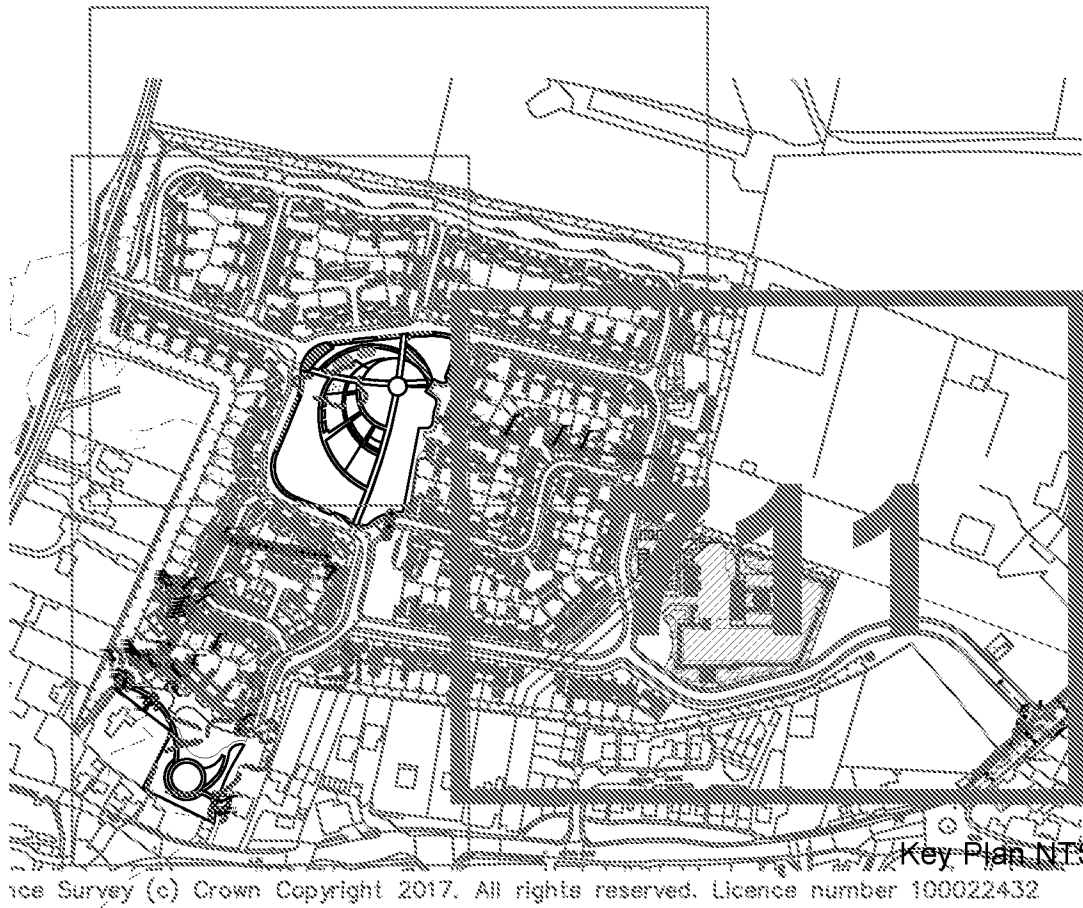
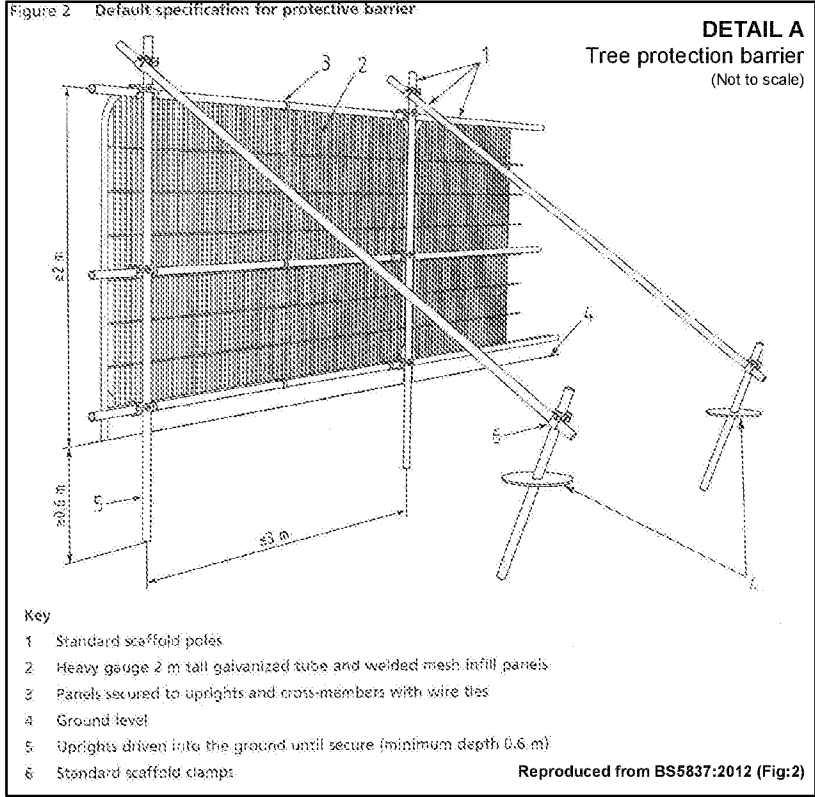
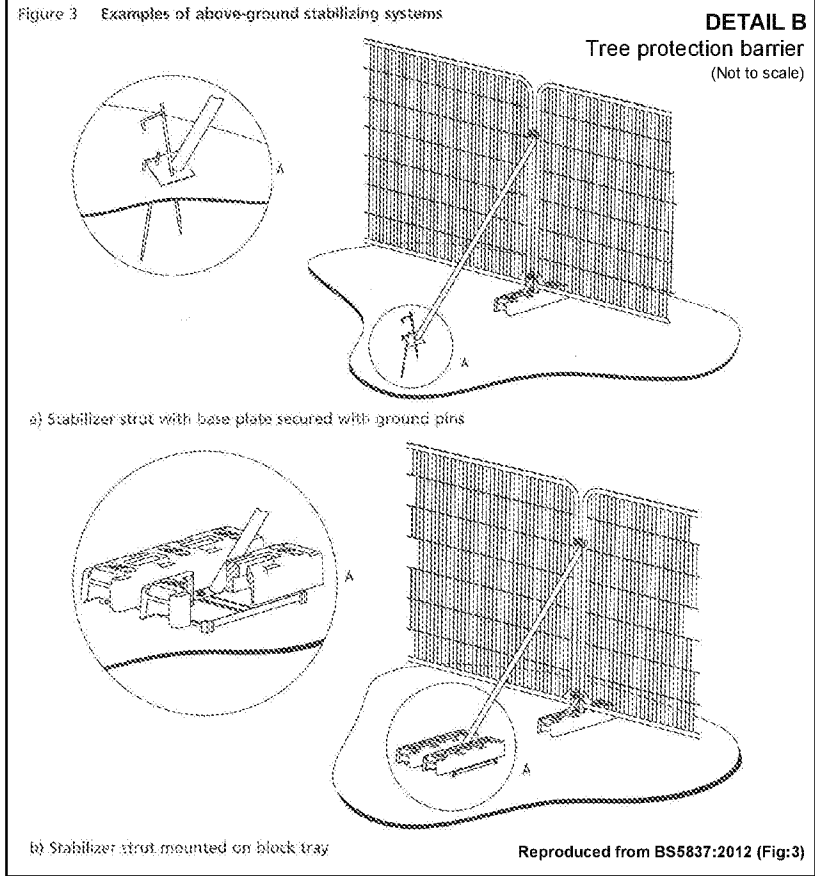
| Drawing Number <b>711</b> | | Rev <b>A</b> |

- Excavation to be completed by hand, any required root pruning to be in accordance with BS 3998. Pruning of roots over 25mm<sup>2</sup> to be monitored by arboriculturalist, with ongoing monitoring of trees condition by an arboriculturalist being recommended.

- 4.14 The proposed footpath within the LEAP area central to the site is to bisect the outer RPAs of T49 and T50 as shown in the Tree Protection & Removal Plans JSL2869\_711-713. Where it is within the RPAs of T49 & T50, the footpath is to be of a 'no-dig' specification in accordance with APN12<sup>4</sup>, using a load bearing, cellular confinement system such as cell-web ® or a similar and equivalent system and finished with a permeable wearing course. No excavation is to occur at all. The minimum amount of protective fencing required for access to carry out the works may be temporarily removed and replaced following completion or at the end of the working day if the construction is to be left overnight. No wheeled or tracked machinery is to enter the RPA during installation of the path. See Appendix 6 for no-dig surfacing construction detail and Appendix 7 for installation methodology.

- 4.15 Where it is within the RPA of T50, the proposed private road at the rear of the proposed residential dwellings to the west of T50 is to be constructed using a 'no-dig' specification in accordance with APN12<sup>4</sup> utilising a load bearing, cellular confinement system such as cell-web ® or a similar and equivalent system and finished with a permeable wearing course in the locations shown. No excavation is to occur at all. Ground protection is to be removed in stages as cell-web is added, in a retreating manner away from T50. See Appendix 6 for no-dig surfacing construction detail and Appendix 7 for installation methodology.
- 4.16 Alternatively, should site constraints allow, the road could be re-aligned so that it does not fall within the RPA of T50. In this instance Temporary Protective Fencing is to be re-aligned to encompass the entire RPA.

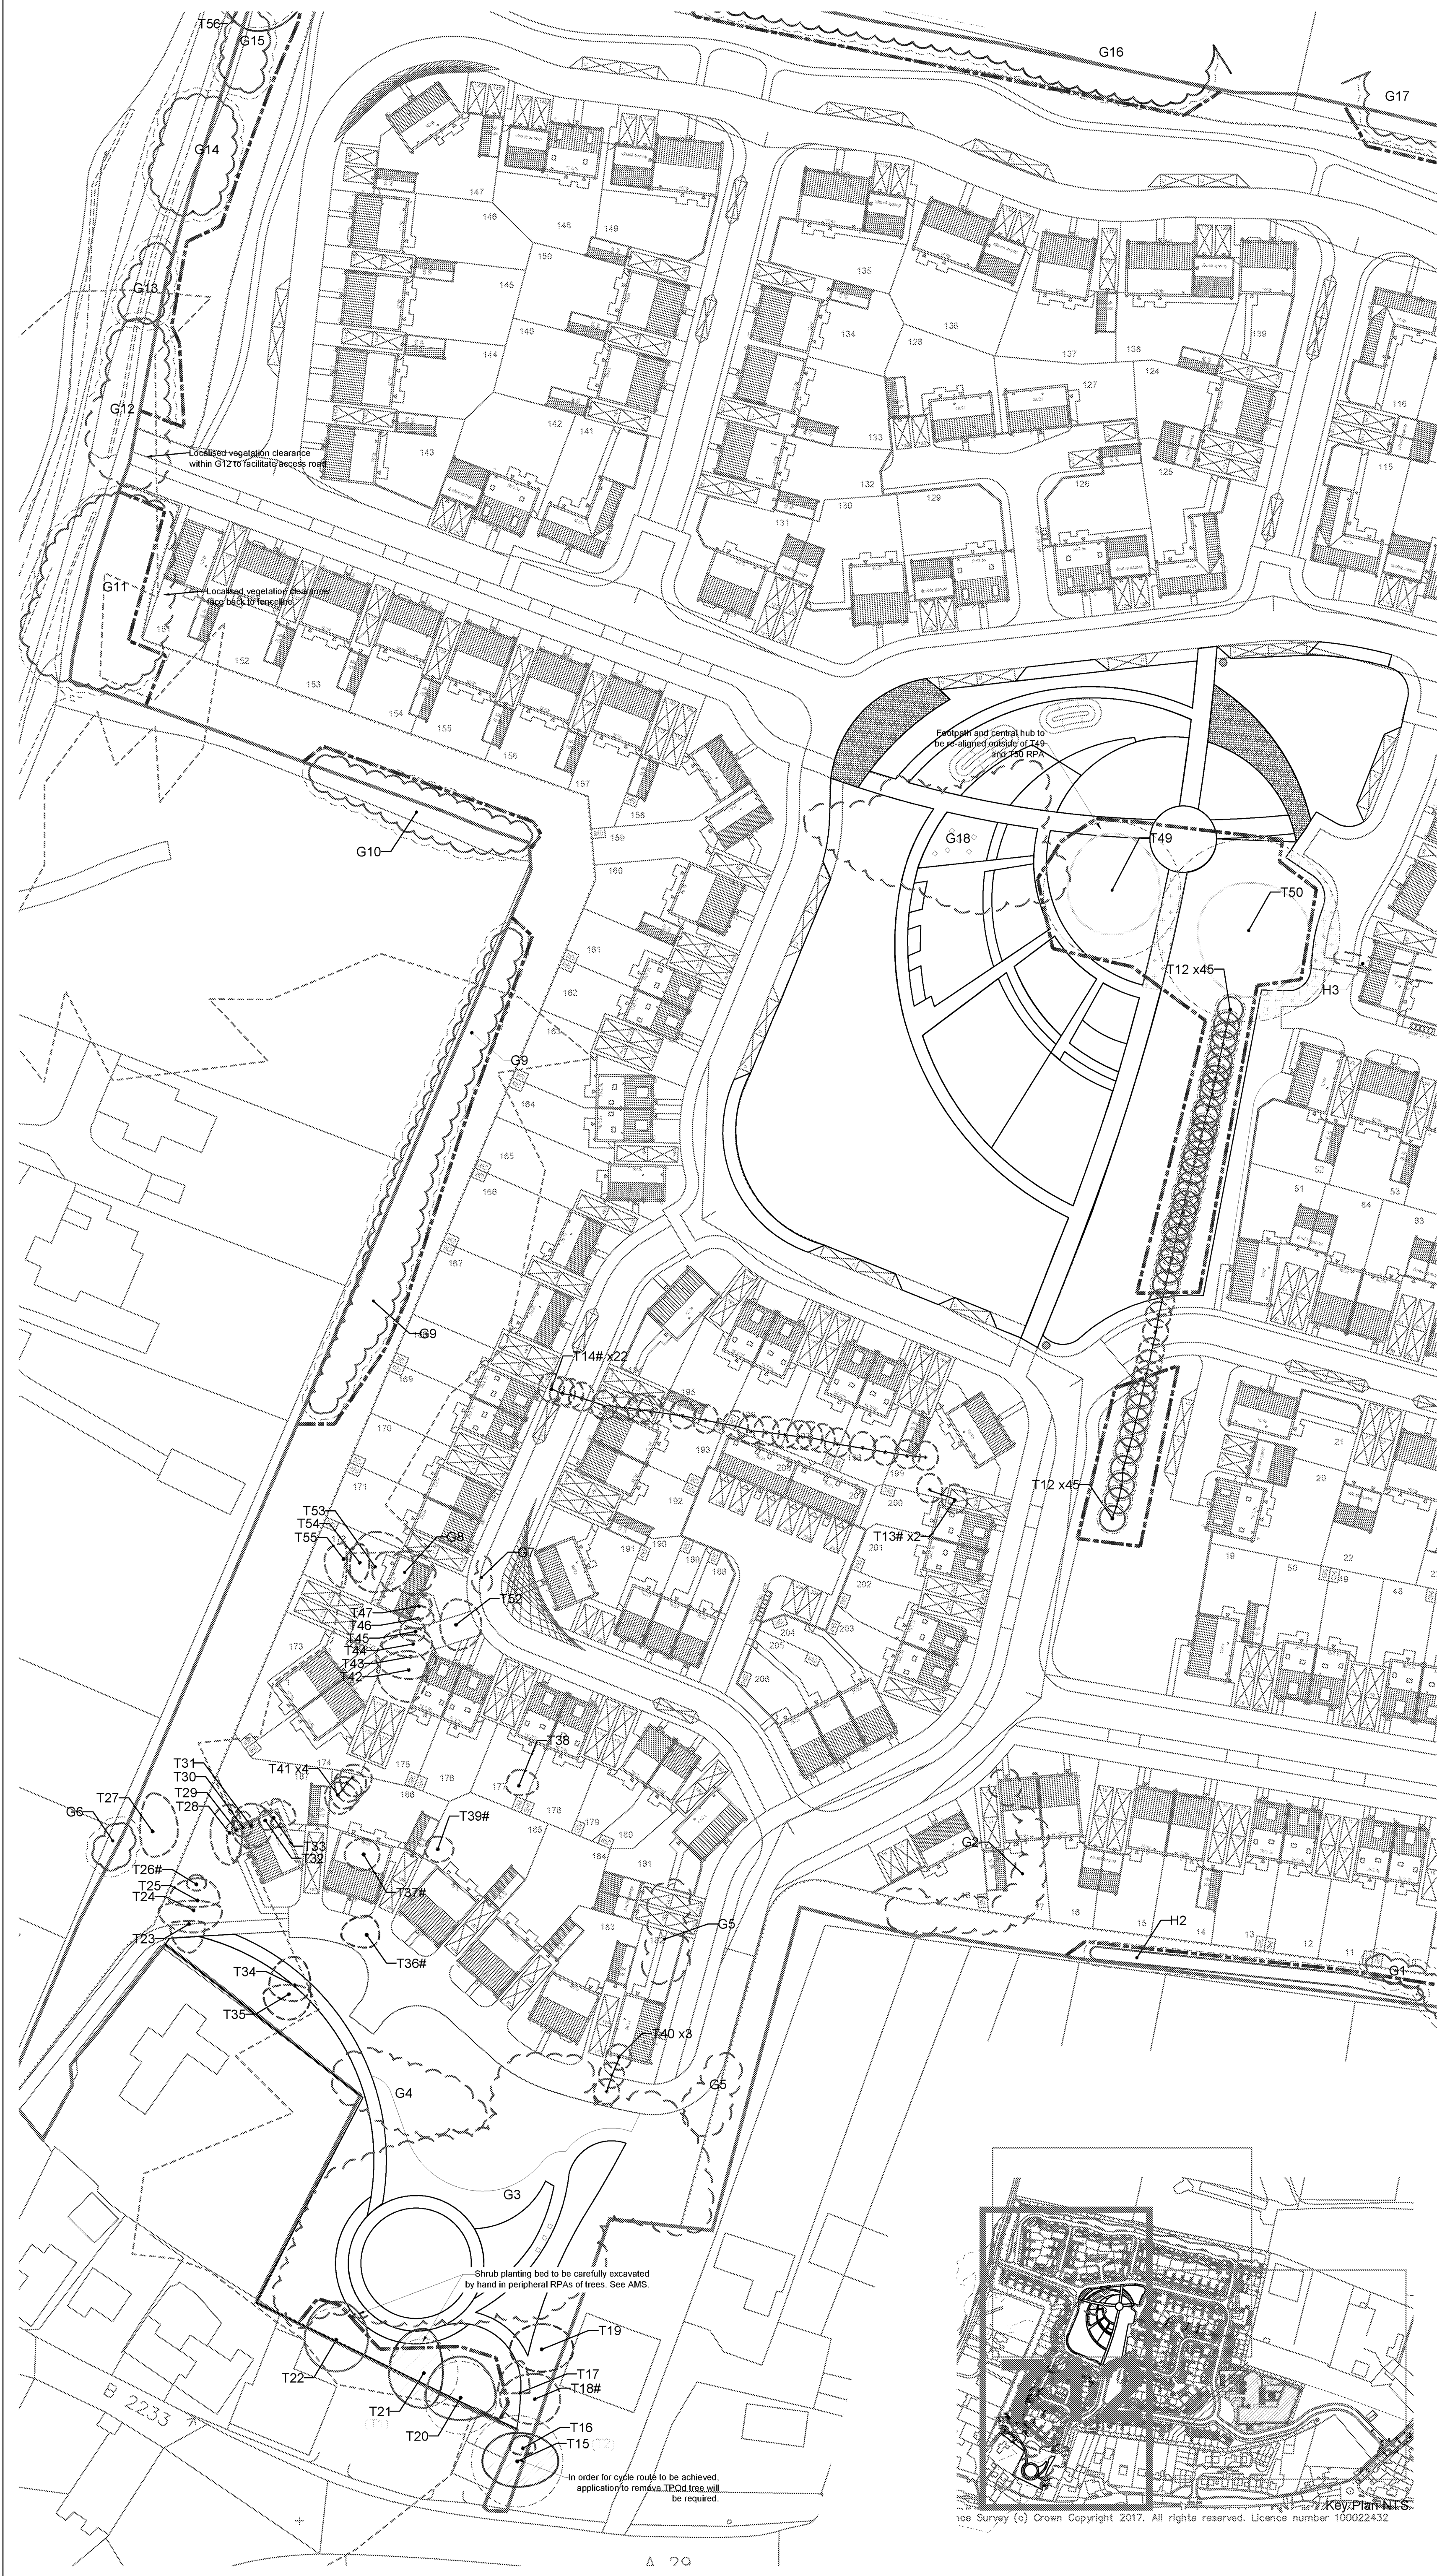
Excavation to be completed by hand, any required root pruning to be in accordance with BS 3998. Pruning of roots over 25mmØ to be monitored by arboriculturalist, with ongoing monitoring of trees condition by an arboriculturalist being recommended.

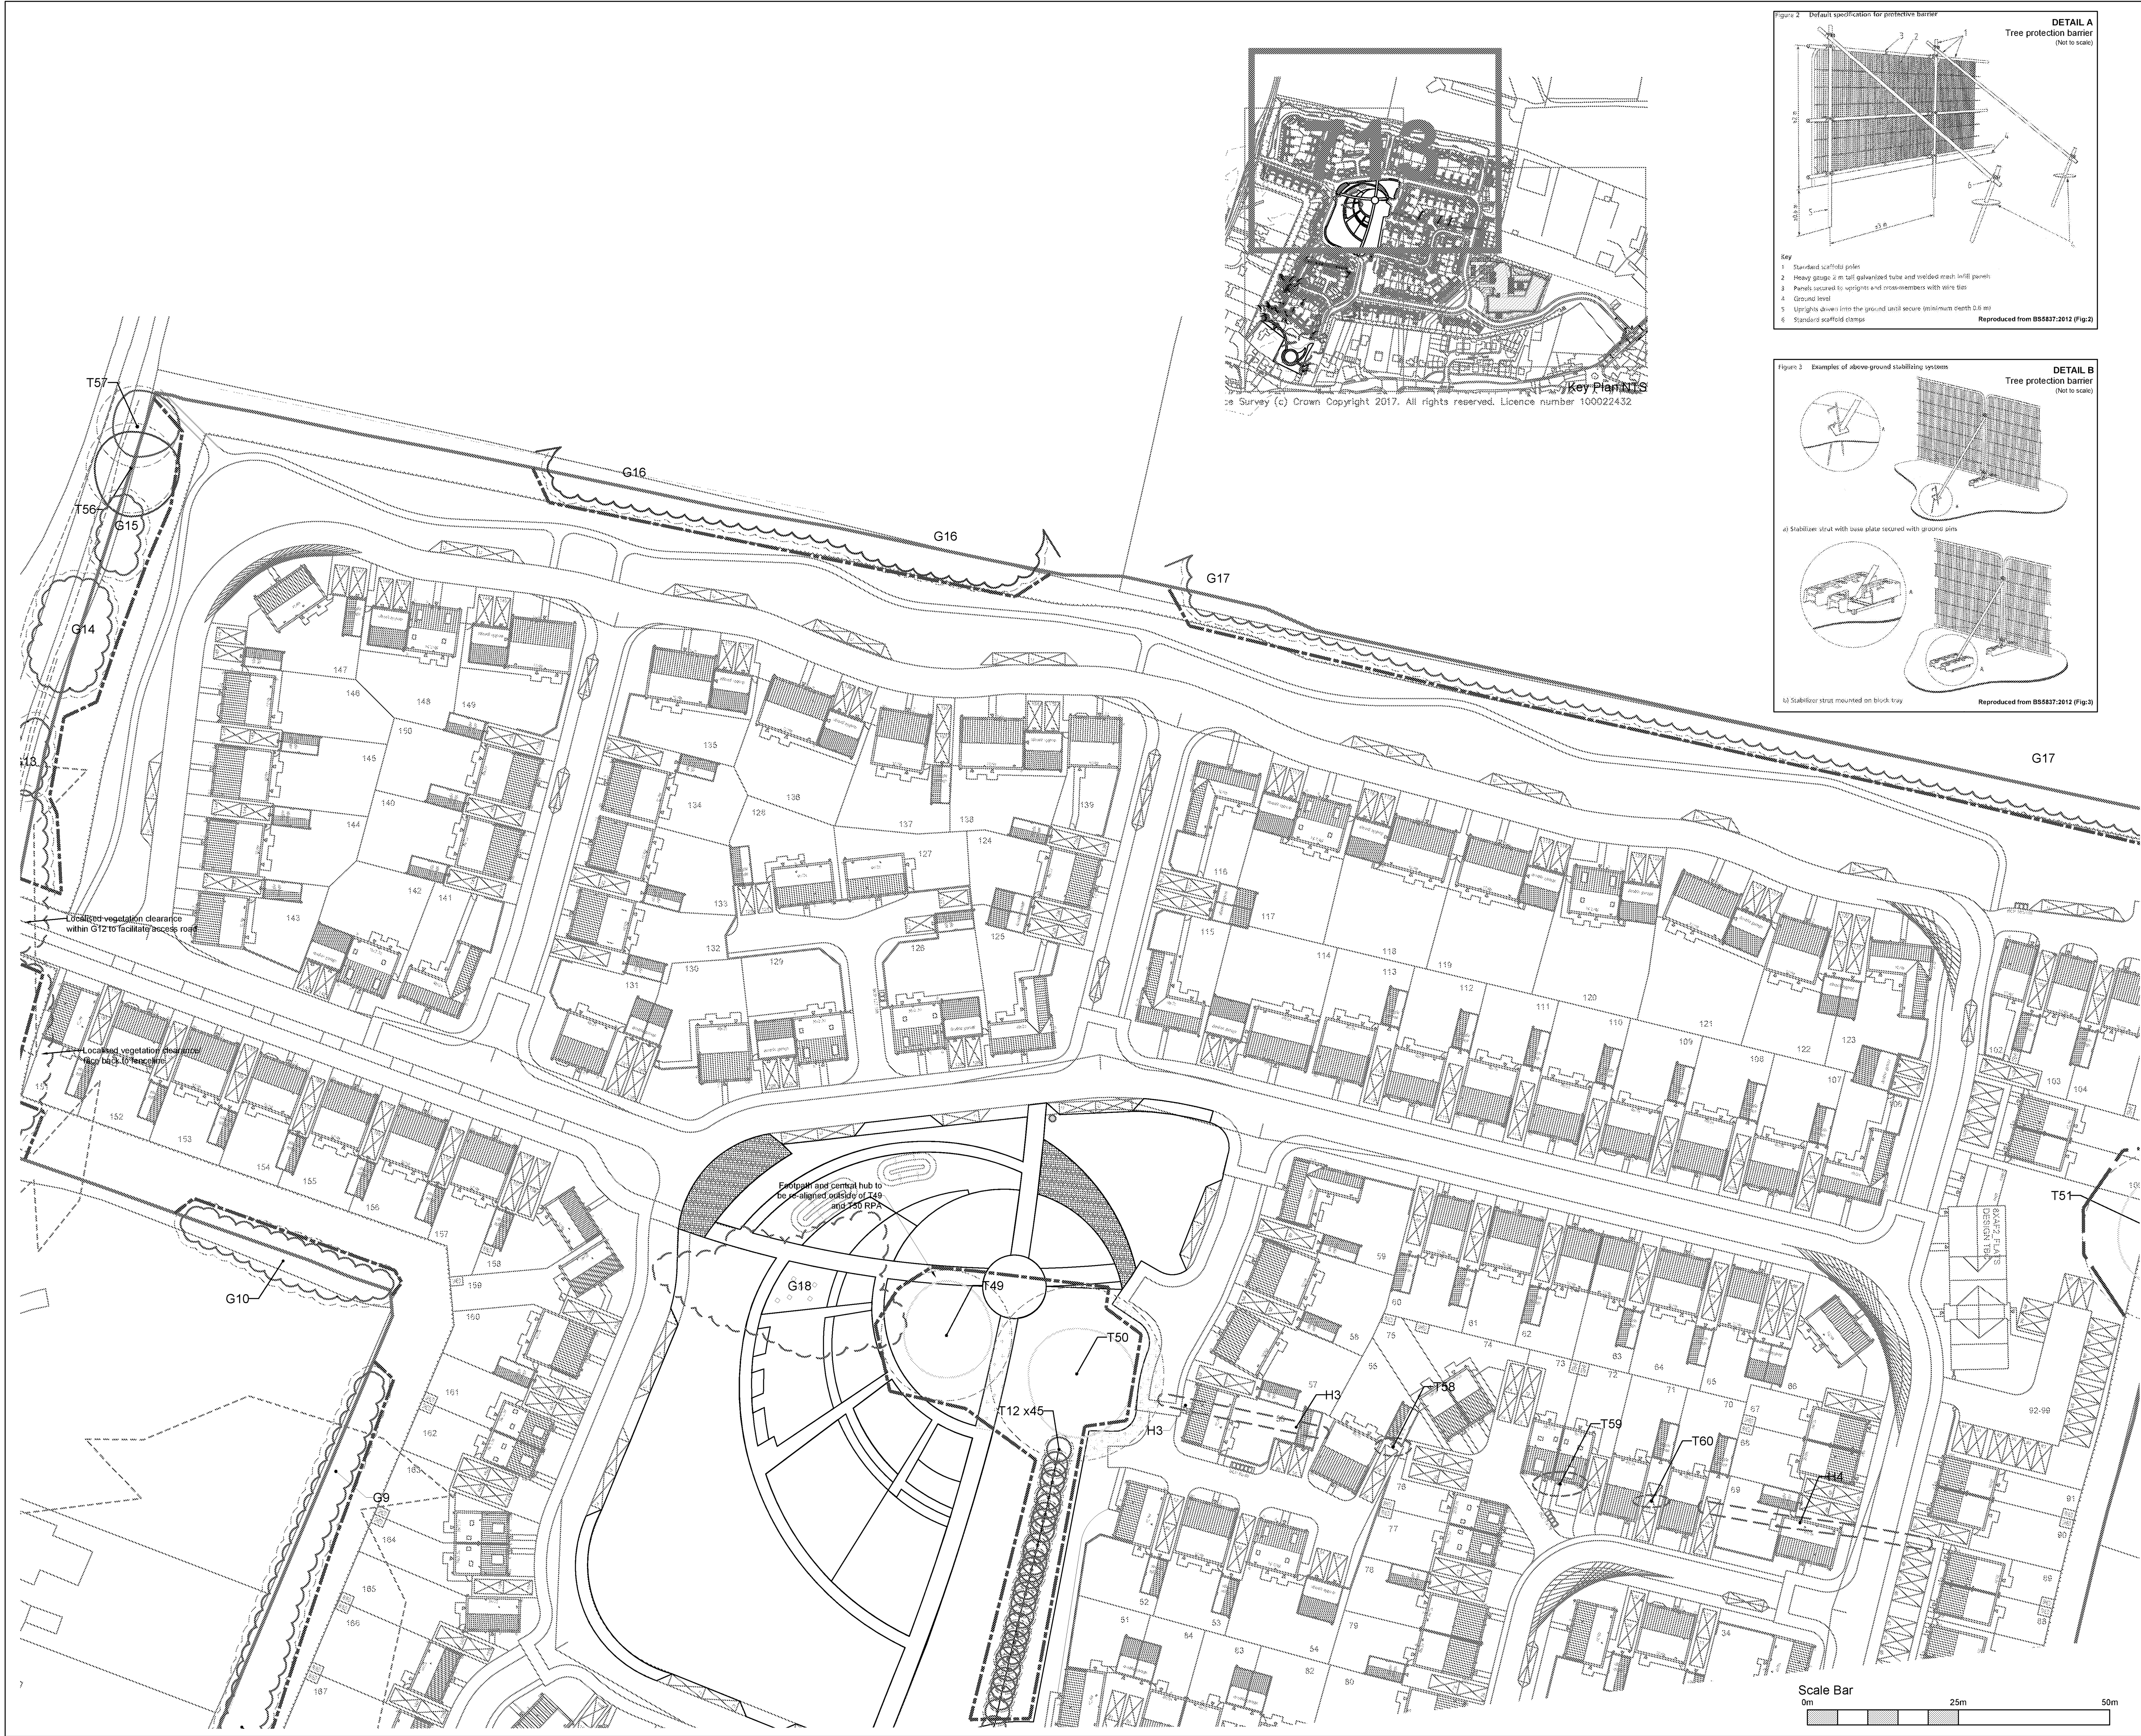
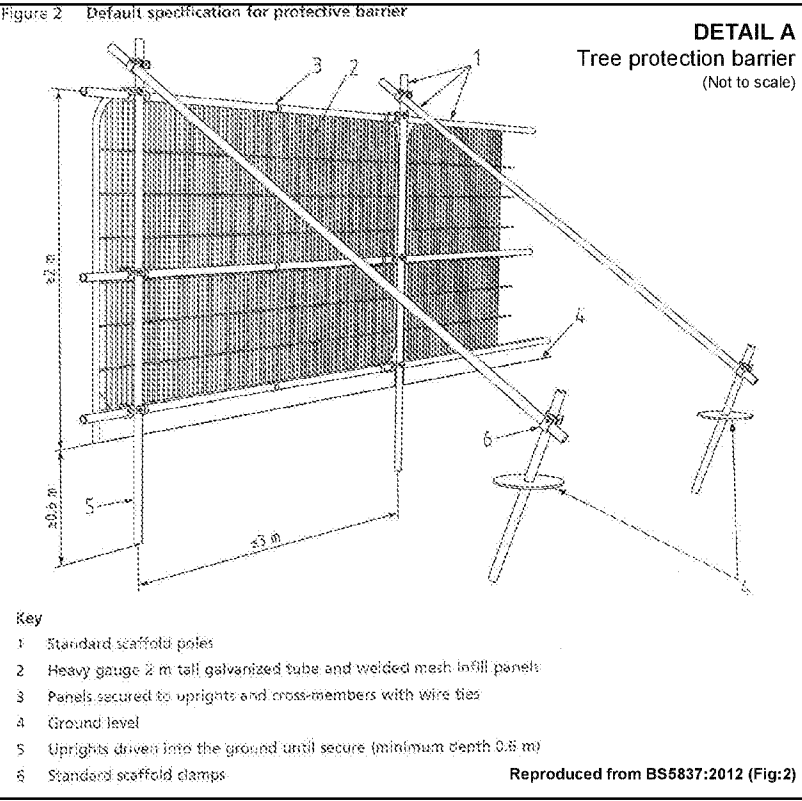
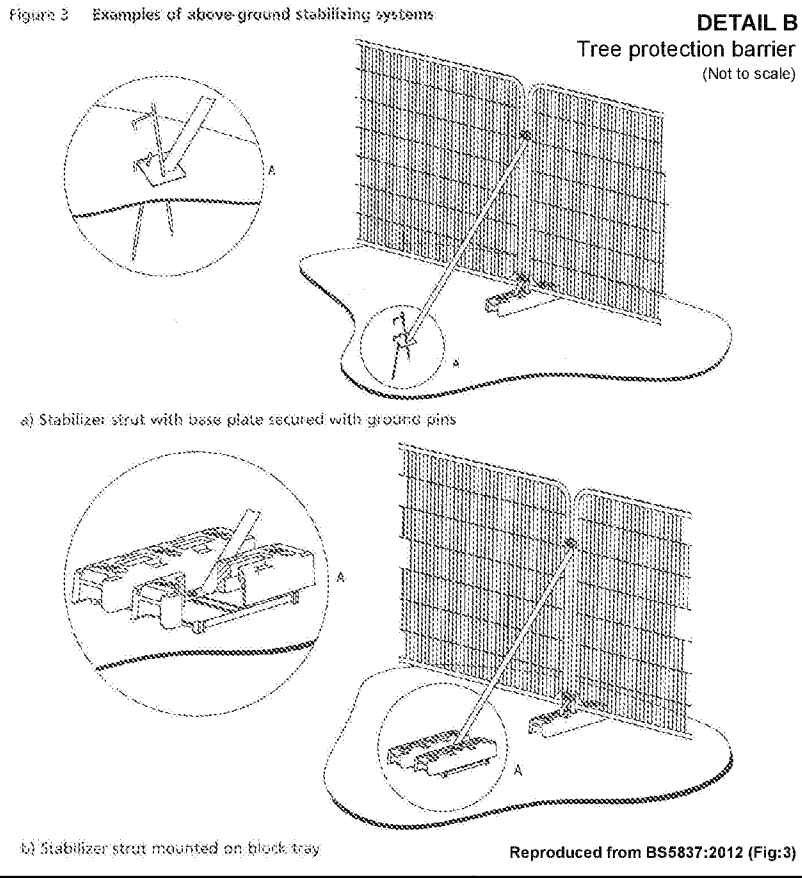
- Excavation to be completed by hand, any required root pruning to be in accordance with BS 3868. Pruning of roots over 25mmØ to be monitored by arboriculturalist, with ongoing monitoring of trees condition by an arboriculturalist being recommended.

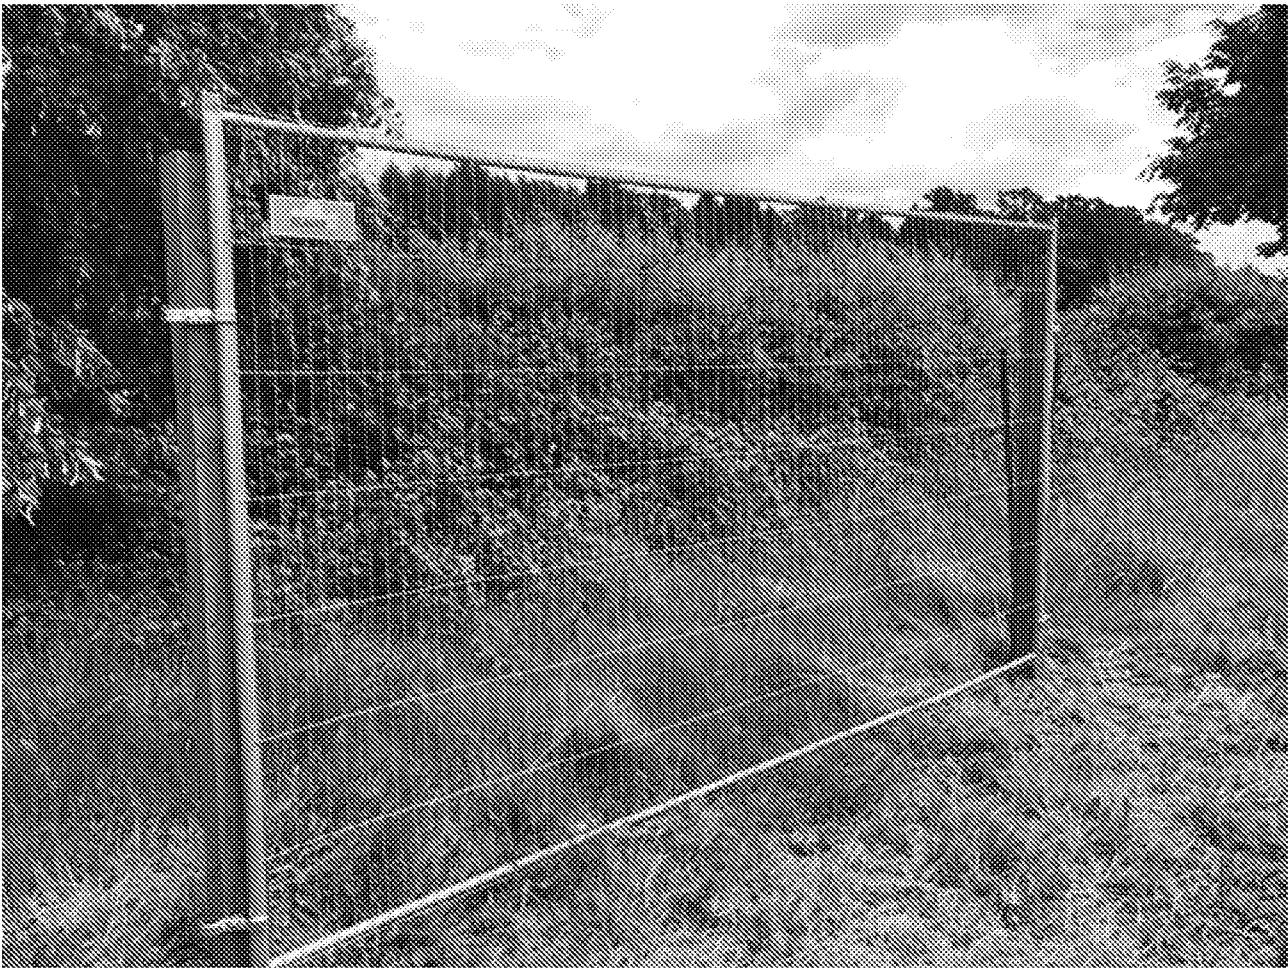
**Figure 1**

**Proposed Barrier specification**

Barriers should be erected before any works commence on site with the exception of recommended tree work. Areas of retained and future structure planting should be similarly protected.
