# **Oak Tree Lane, Woodgate**

## **Ground Investigation Report**

Pye Homes

CS-J-0132

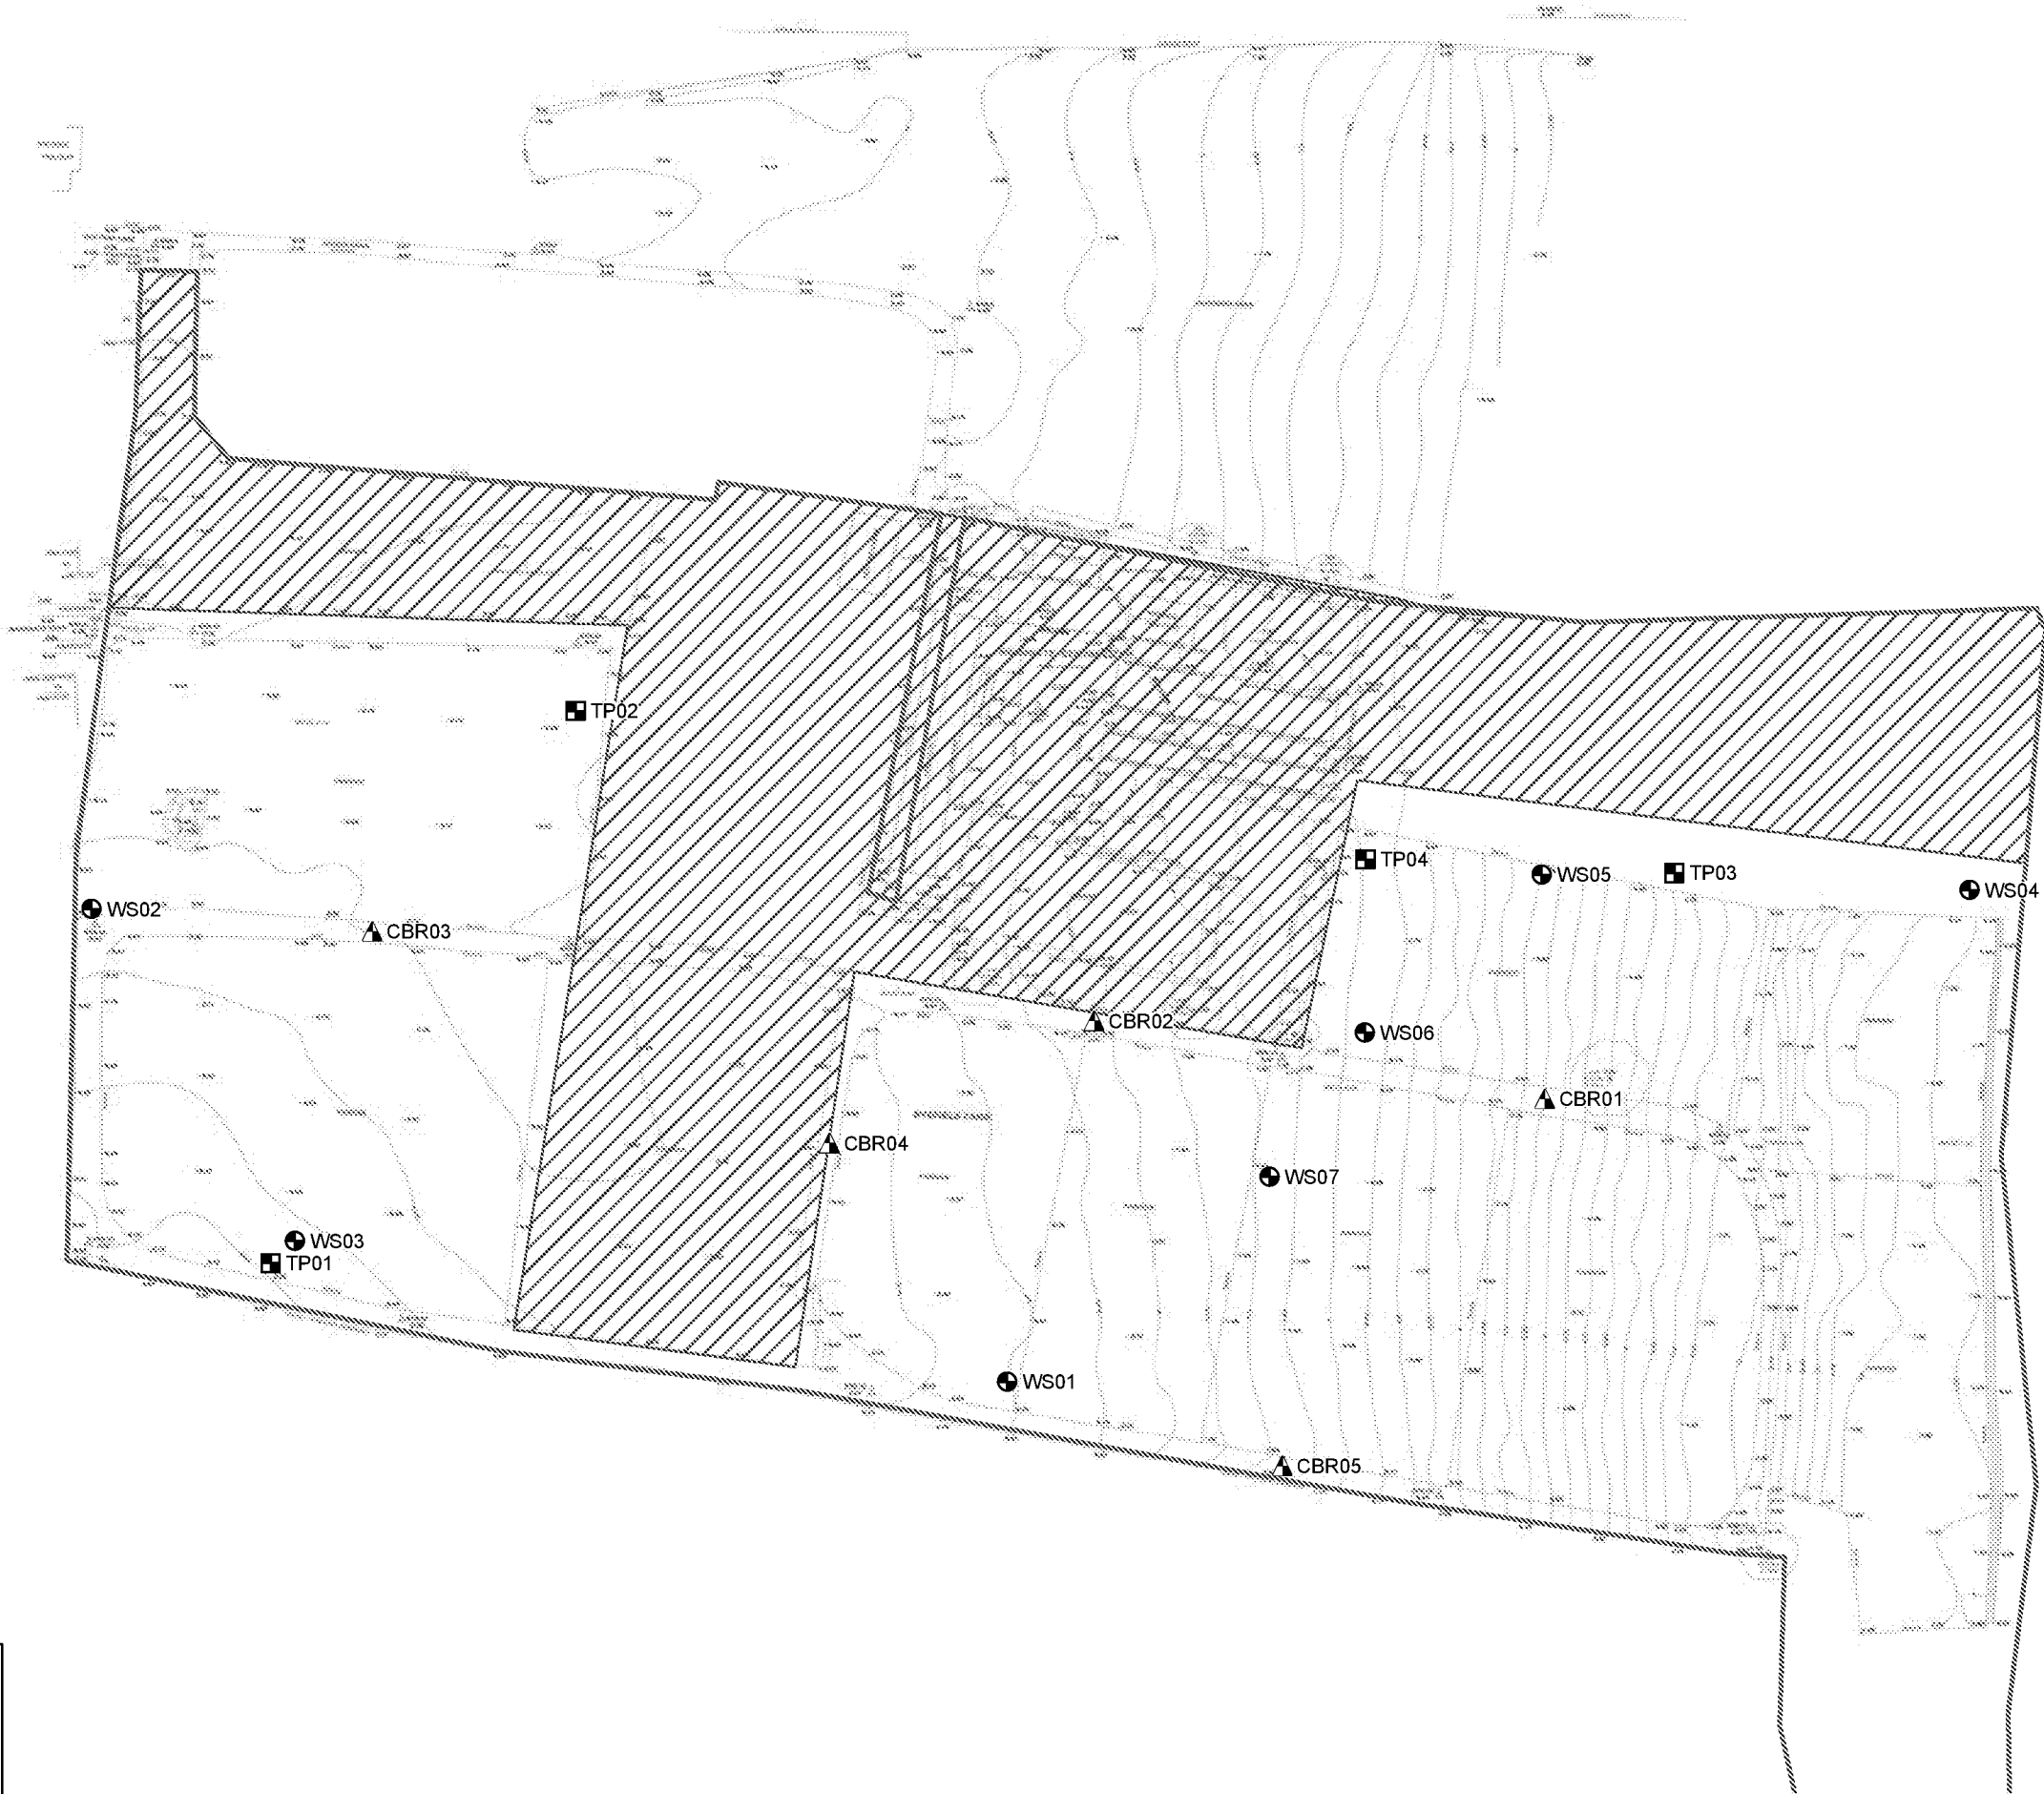
- Windowless Sampling Locations  
(WS01 - WS07)
- Trial Pit Locations  
(TP01 - TP04)
- CBR Locations  
(CBR01 - CBR05)
- No Access
- Site Boundary

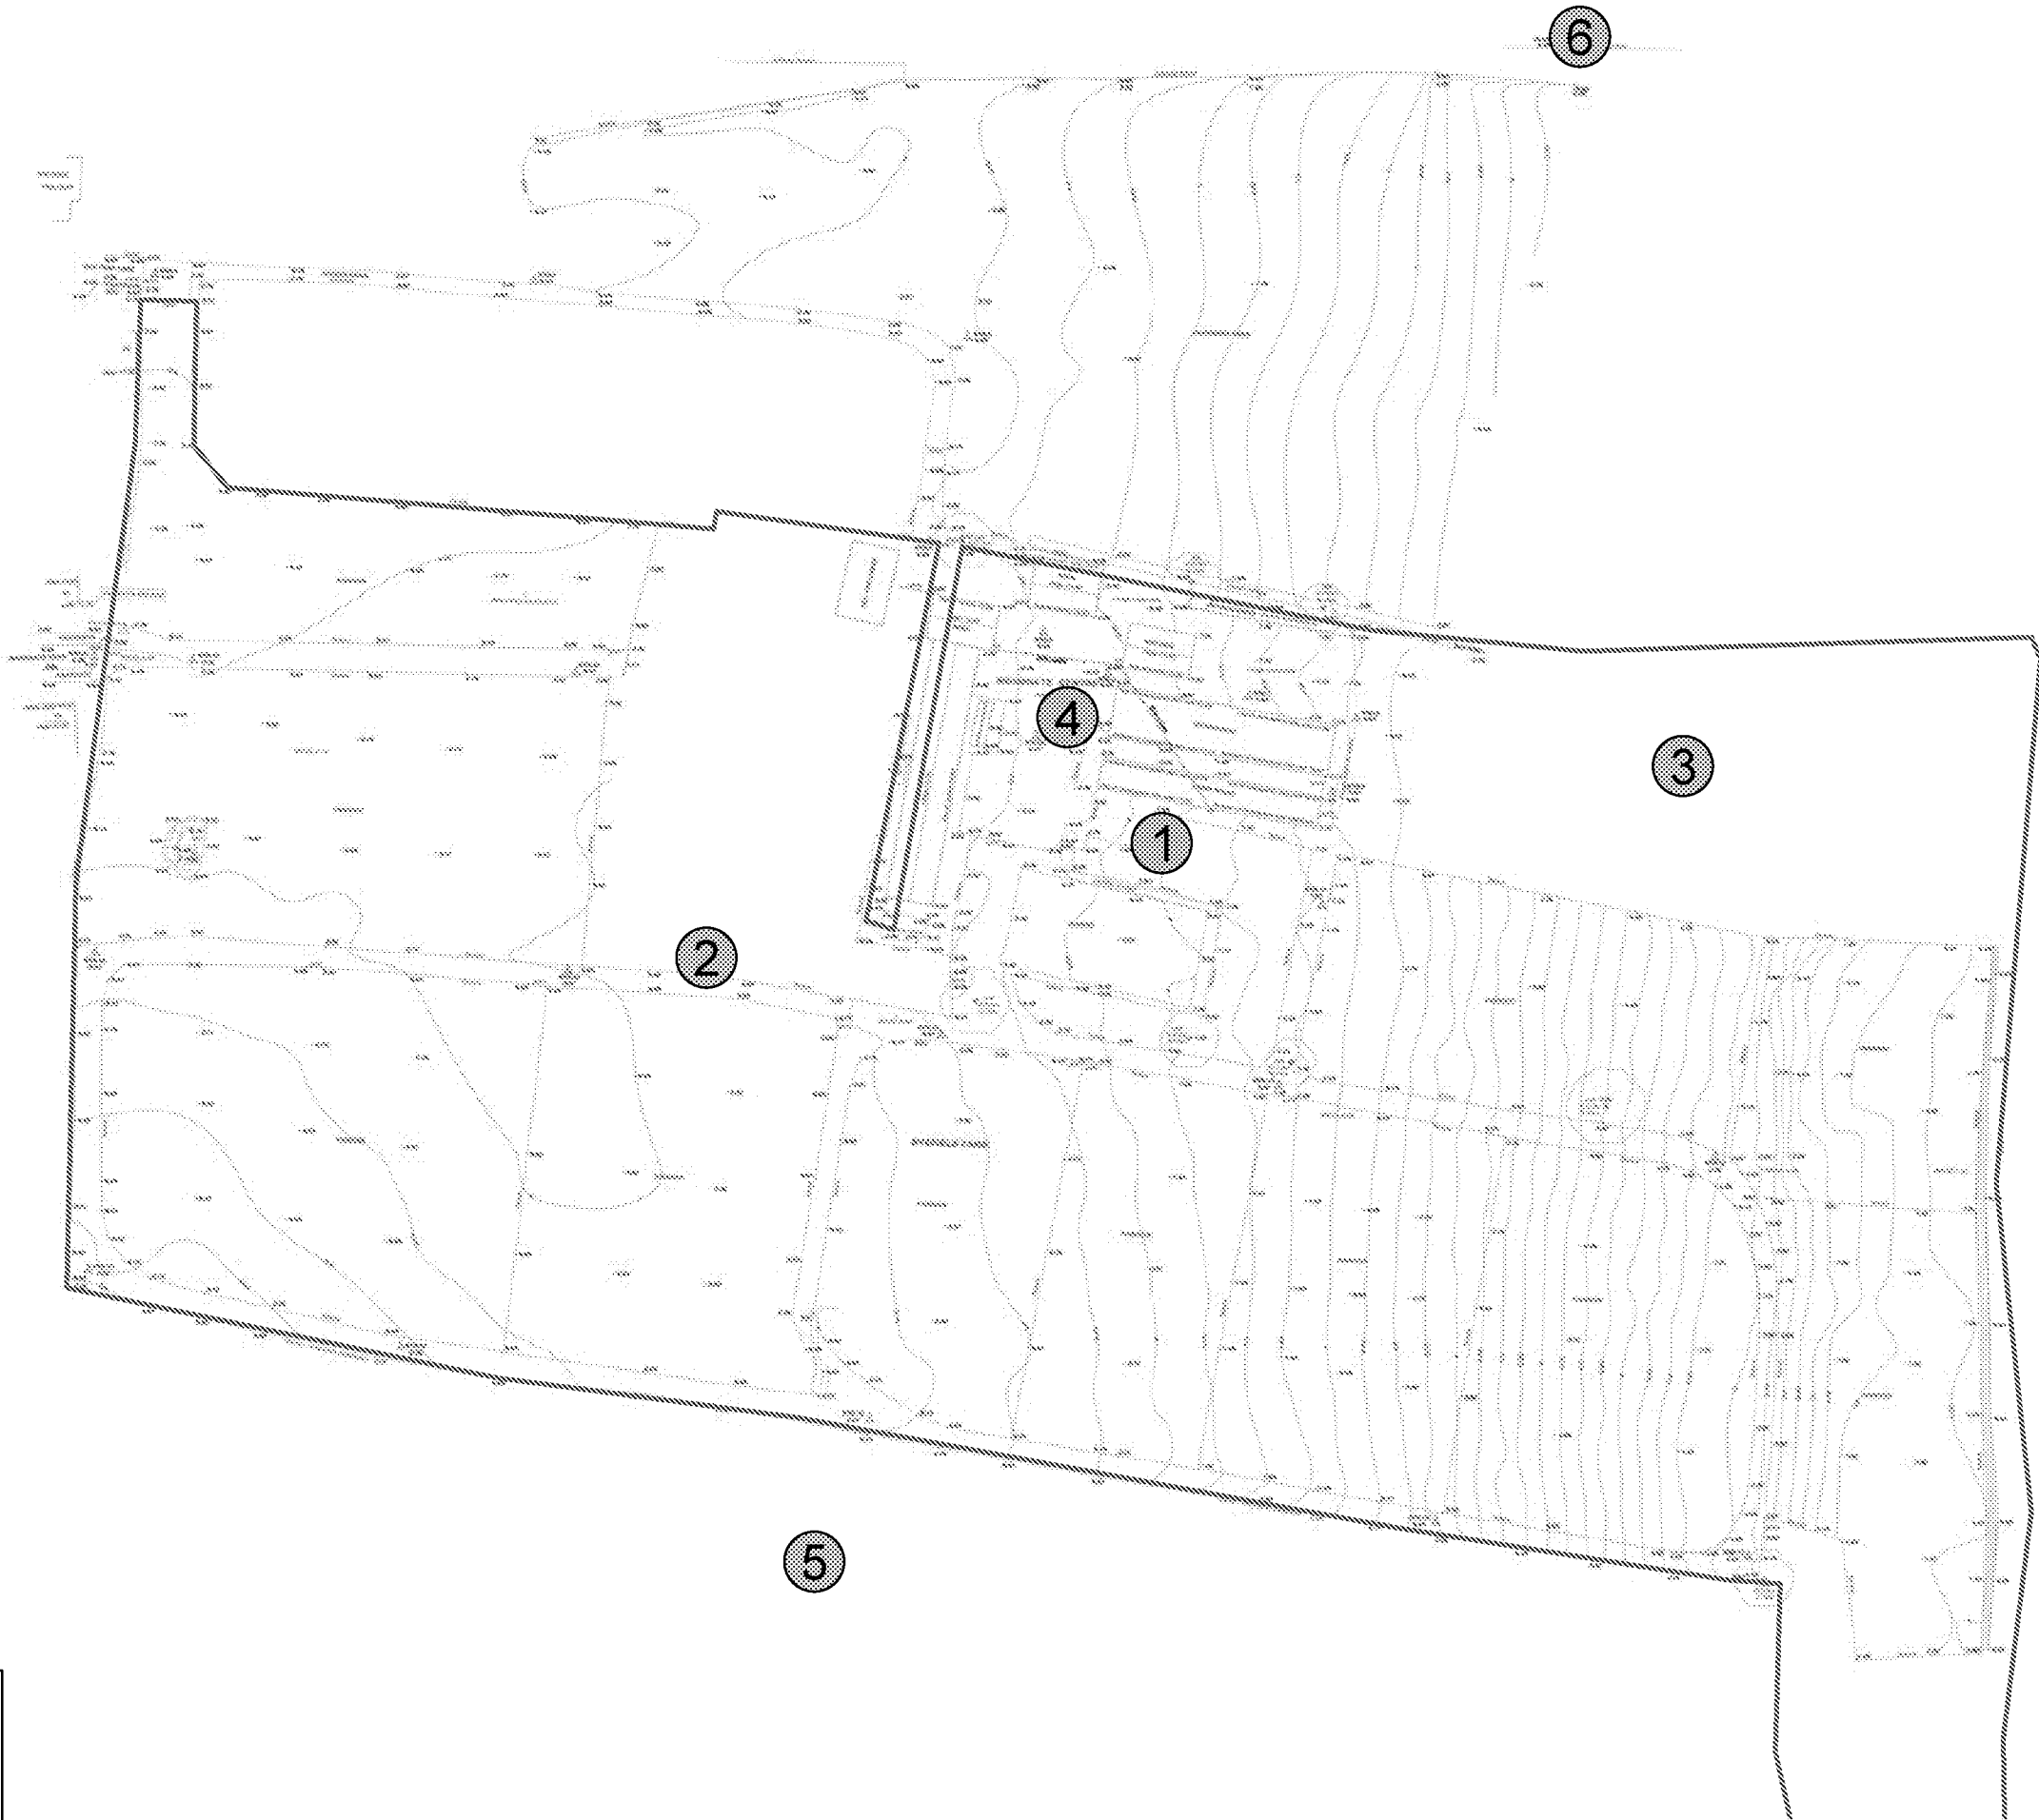
- ① Made ground associated with previous/ current site uses and development of unknown composition.
- ② Agricultural pest/weed control associated with former agricultural practice.
- ③ Made ground associated with landfilling in the north eastern site area.
- ④ Historic tanks with unconfirmed storage/ contents.
- ⑤ Potentially infilled pit located adjacent to the southern boundary.
- ⑥ Possible contaminants migrating from railway located 100m north of the site boundary.

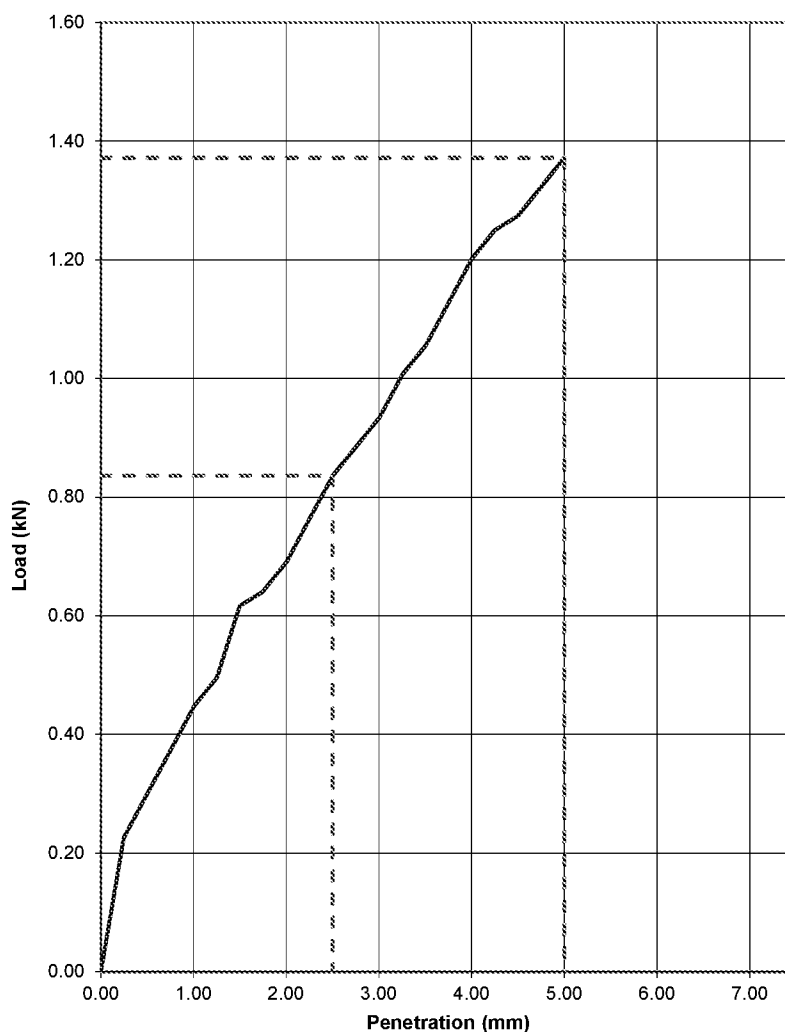
| Moisture Content (%) | Penetration (mm) | Load (kN) | CBR (%) |
| 11% | 2.5 | 0.84 | 6.3% |
| Design CBR Value | | | 6.6% |

Penetration and force readings zeroed after seating load. Particle size below plunger <20mm. Loading applied at a rate of 1.0mm/min.

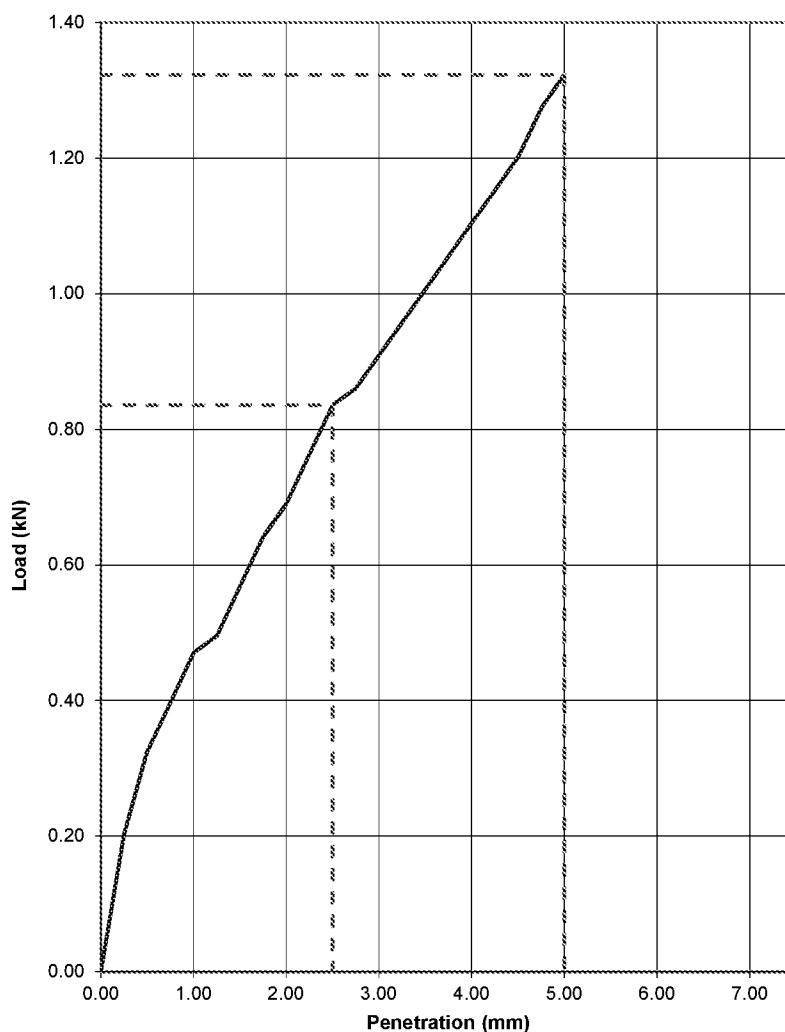
| Moisture Content (%) | Penetration (mm) | Load (kN) | CBR (%) |
| 24% | 2.5 | 0.84 | 6.3% |

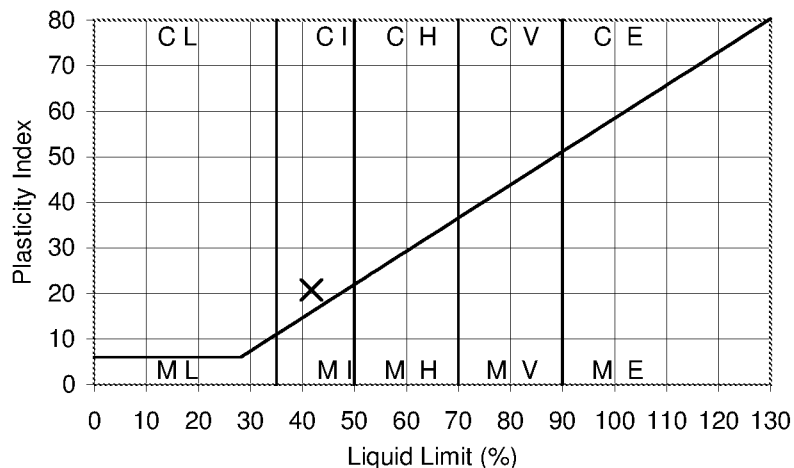
Non Engineering Description : Brown CLAY.

As Received Moisture Content : (BS1377:Part 2:Clause 3:1990) 24 %  
 Percentage retained on 425µm sieve : 0 %  
 Liquid Limit : 42 %  
 Plastic Limit : 21 %  
 Plasticity Index : 21

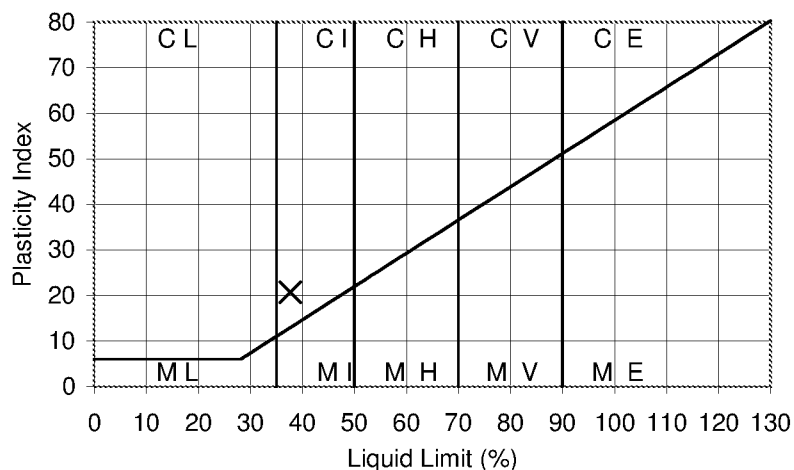
Non Engineering Description : Brown sandy CLAY.

As Received Moisture Content : (BS1377:Part 2:Clause 3:1990) 20 %  
 Percentage retained on 425µm sieve : 1 %  
 Liquid Limit : 38 %  
 Plastic Limit : 17 %  
 Plasticity Index : 21

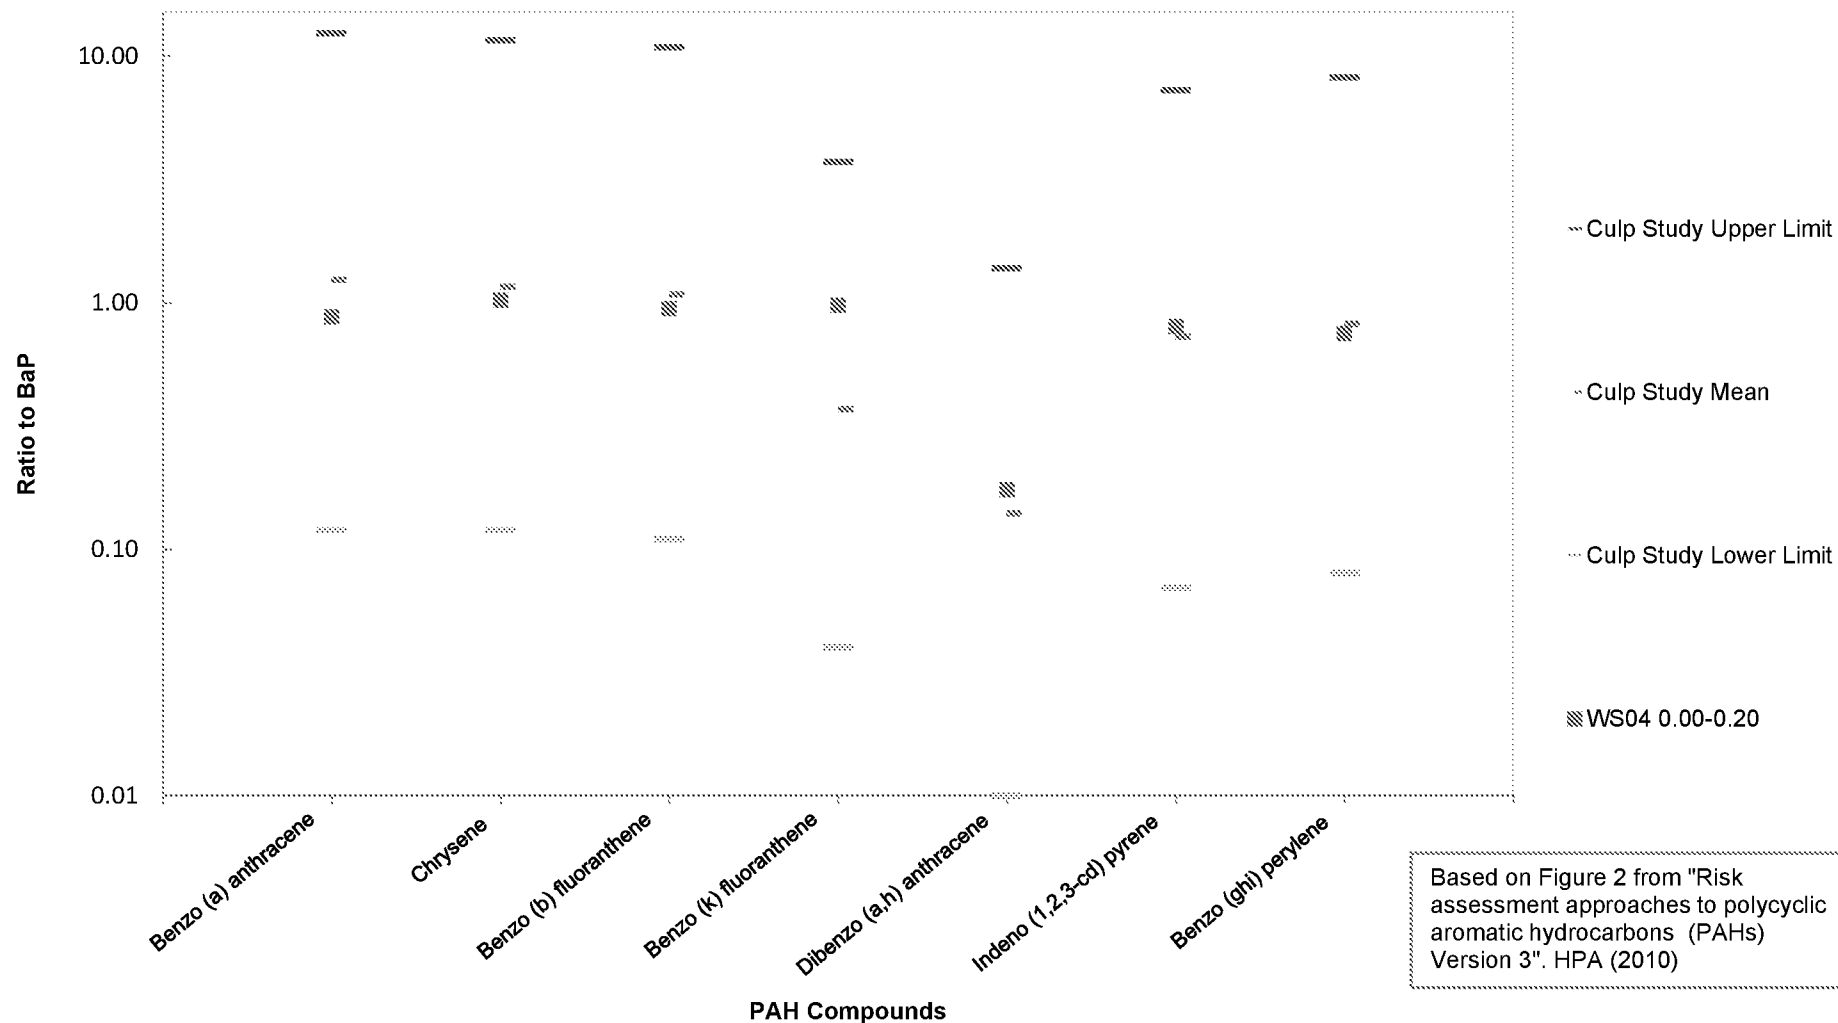
Profile of PAHs in selected soil samples expressed as a ratio to benzo(a)pyrene compared with Culp Study results (Culp, S.J., et al., 1998)

However, an elevated soil concentration of benzo(a)pyrene (BaP) was recorded within the made ground in WS04 (0.00-0.20mbgl) at 4.0mg/kg. All other concentrations recorded within the made ground and natural ground were found below levels of concern.

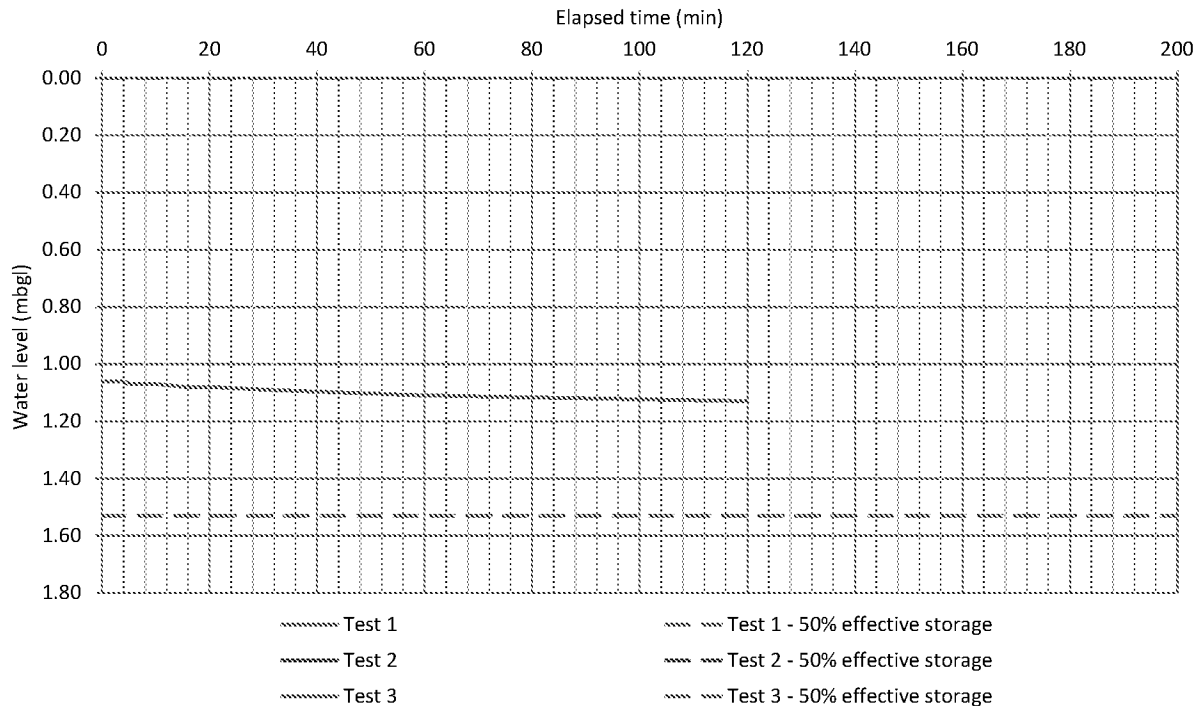
| | | | | | | | | | | Soil infiltration rate $f$ (m/s) | | | | N/a | | |
| | | | | | | | | | | Design soil infiltration rate $f$ (m/s) | | | | n/a (not BRE365 compliant) | | |

Where highlighted in red, calculations have been inferred from the graph.

| <b>Infiltration testing</b> | <p>Based upon infiltration testing, site observations that recorded shallow groundwater, it is considered unlikely that traditional soakaways are likely to offer a viable solution for surface water discharge.</p> |
