## Appendix B Existing Services Records – Not affected

## Appendix C Utility Trace

Oak Tree Lane  
Woodgate  
West Sussex

PAS 128:2014 Utility Survey

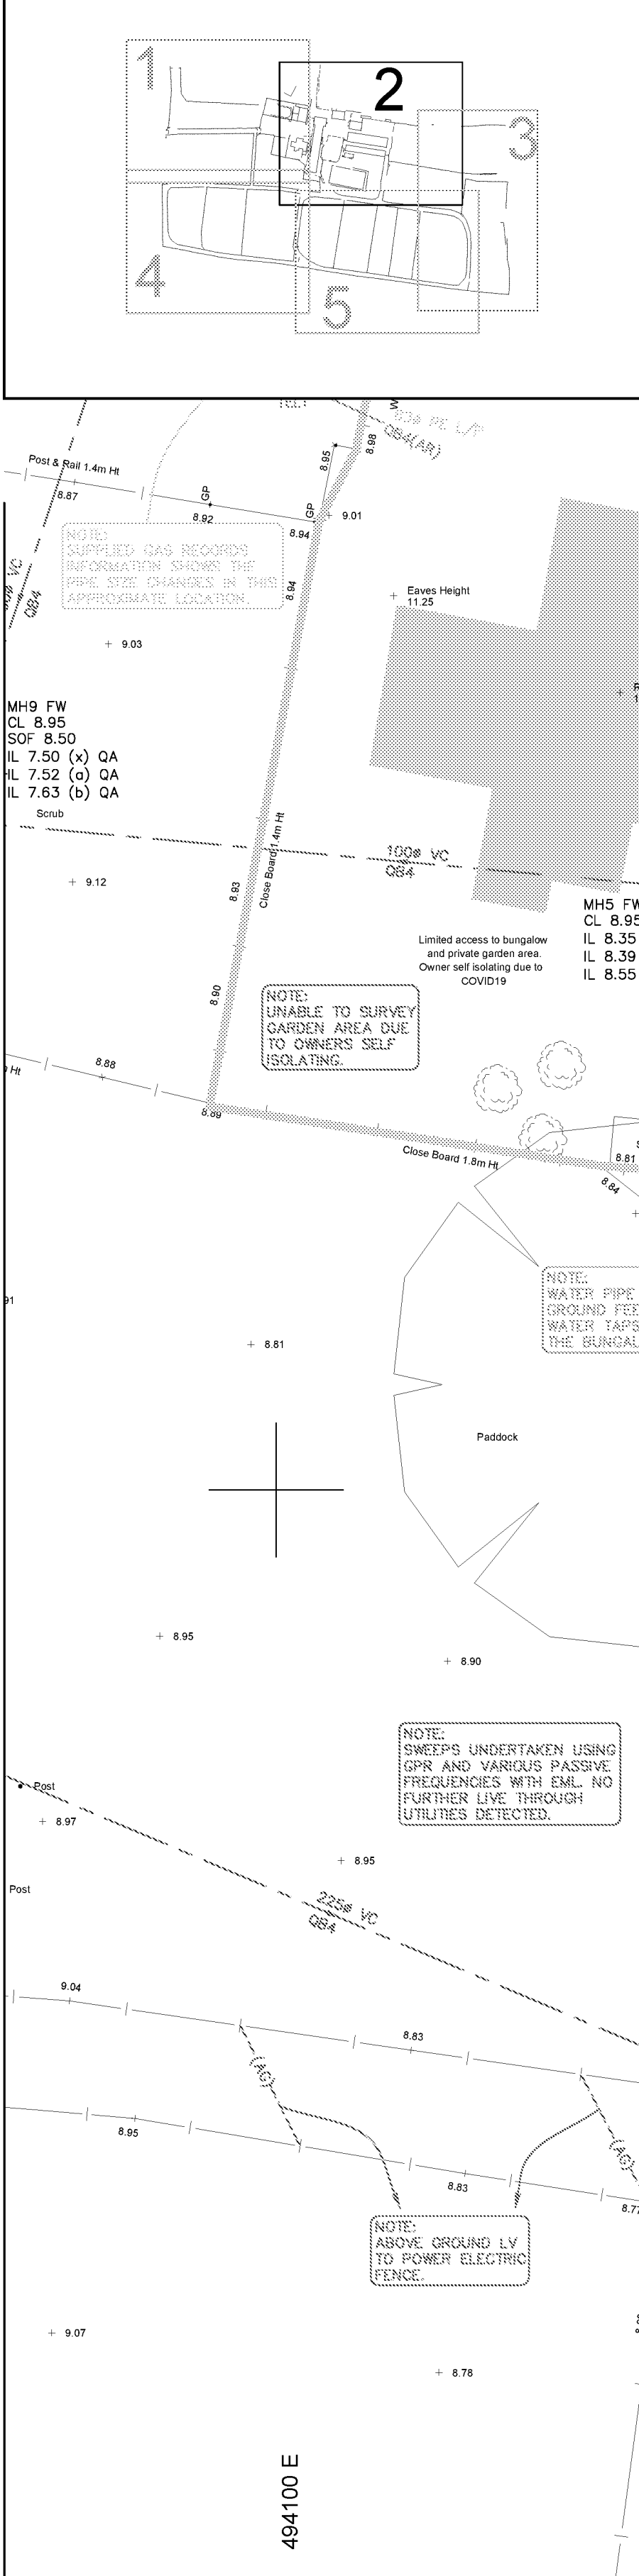
#### Sheet Layout: (Not to Scale)

This survey was carried out in accordance with PAS 128:2014 (Publicly Available Specification from BS). After a pre-survey consultation with the client it was agreed to carry out the detection survey using methodology M1 as per Table 2 of the PAS 128:2014. The survey boundary has been shown on the drawing; please see freestyle section of the key for reference.

**DRAINAGE**  
Drainage pipes were traced with pipe stons and invert levels recorded. Whenever possible the chamber sizes have been recorded and positioned on the drawing. All connections from gullies, external rainwater pipes and external soil stacks have been recorded wherever possible with manholes, streetlights and sewer runs by radio sonde location and/or GPR. Where a saddle connection is present the position is assumed only until proven to GED or above. In instances where other detection methods were unsuccessful connections between manholes have been assumed to be straight and labelled as GED. All drainage should be cross checked in critical areas by CCTV survey or verification survey type A. MH102 was unable to be located with a aerial detector. We have located a foul water pipe out of MH8 but due to the pipe being blocked we were unable to trace the full route of the pipe.

**WATER**  
Water utilities located using EML, with electronically derived depths or GPR detected depths to the crown of the pipe. Where utilities have not been successfully detected, the position has been drawn in relation to the supplied utility records information. Recommend trial excavations to confirm depth and position in critical areas.

**GAS**  
Gas utilities located using EML, GPR derived depths to the crown of the pipe. Where utilities have not been successfully detected, the position has been drawn in relation to the supplied utility records information. Recommend trial excavations to confirm depth and position in critical areas.

Electric cables within the survey area have been located using EML methods with electronically derived depths recorded. Unable to confirm amount of cables within ducts from surface inspection. Record information shows a 11kV HV cable in the carpark park to the south of the site. Survey result confirms this doesn't enter the site boundary. Recommend trial excavations to confirm depths and position in critical areas.

Telecom ducts have been traced with depths recorded. Due to laws protecting British Telecom apparatus all ducts have been located using remote detection techniques only and compared with record information. Chamber sizes have been recorded using GPR techniques wherever possible. For further information regarding BT apparatus please contact Openreach directly.

Some unknown targets identified on the drawing using GPR are classified as 'non-linear targets'. These are not consistent with what we expect to see when identifying a buried utility and appear on the drawing as single targets with depths < 6 not taking two or more depth readings). This does not mean they are not utilities, we are just unable to positively identify them as a utility. We would strongly recommend that further verification surveys (PAS 128:2014 survey type A) are carried out to identify these targets in critical areas. All unknown anomalies were located using EML or GPR techniques. Recommend trial excavations to confirm identity position and depths in critical areas.

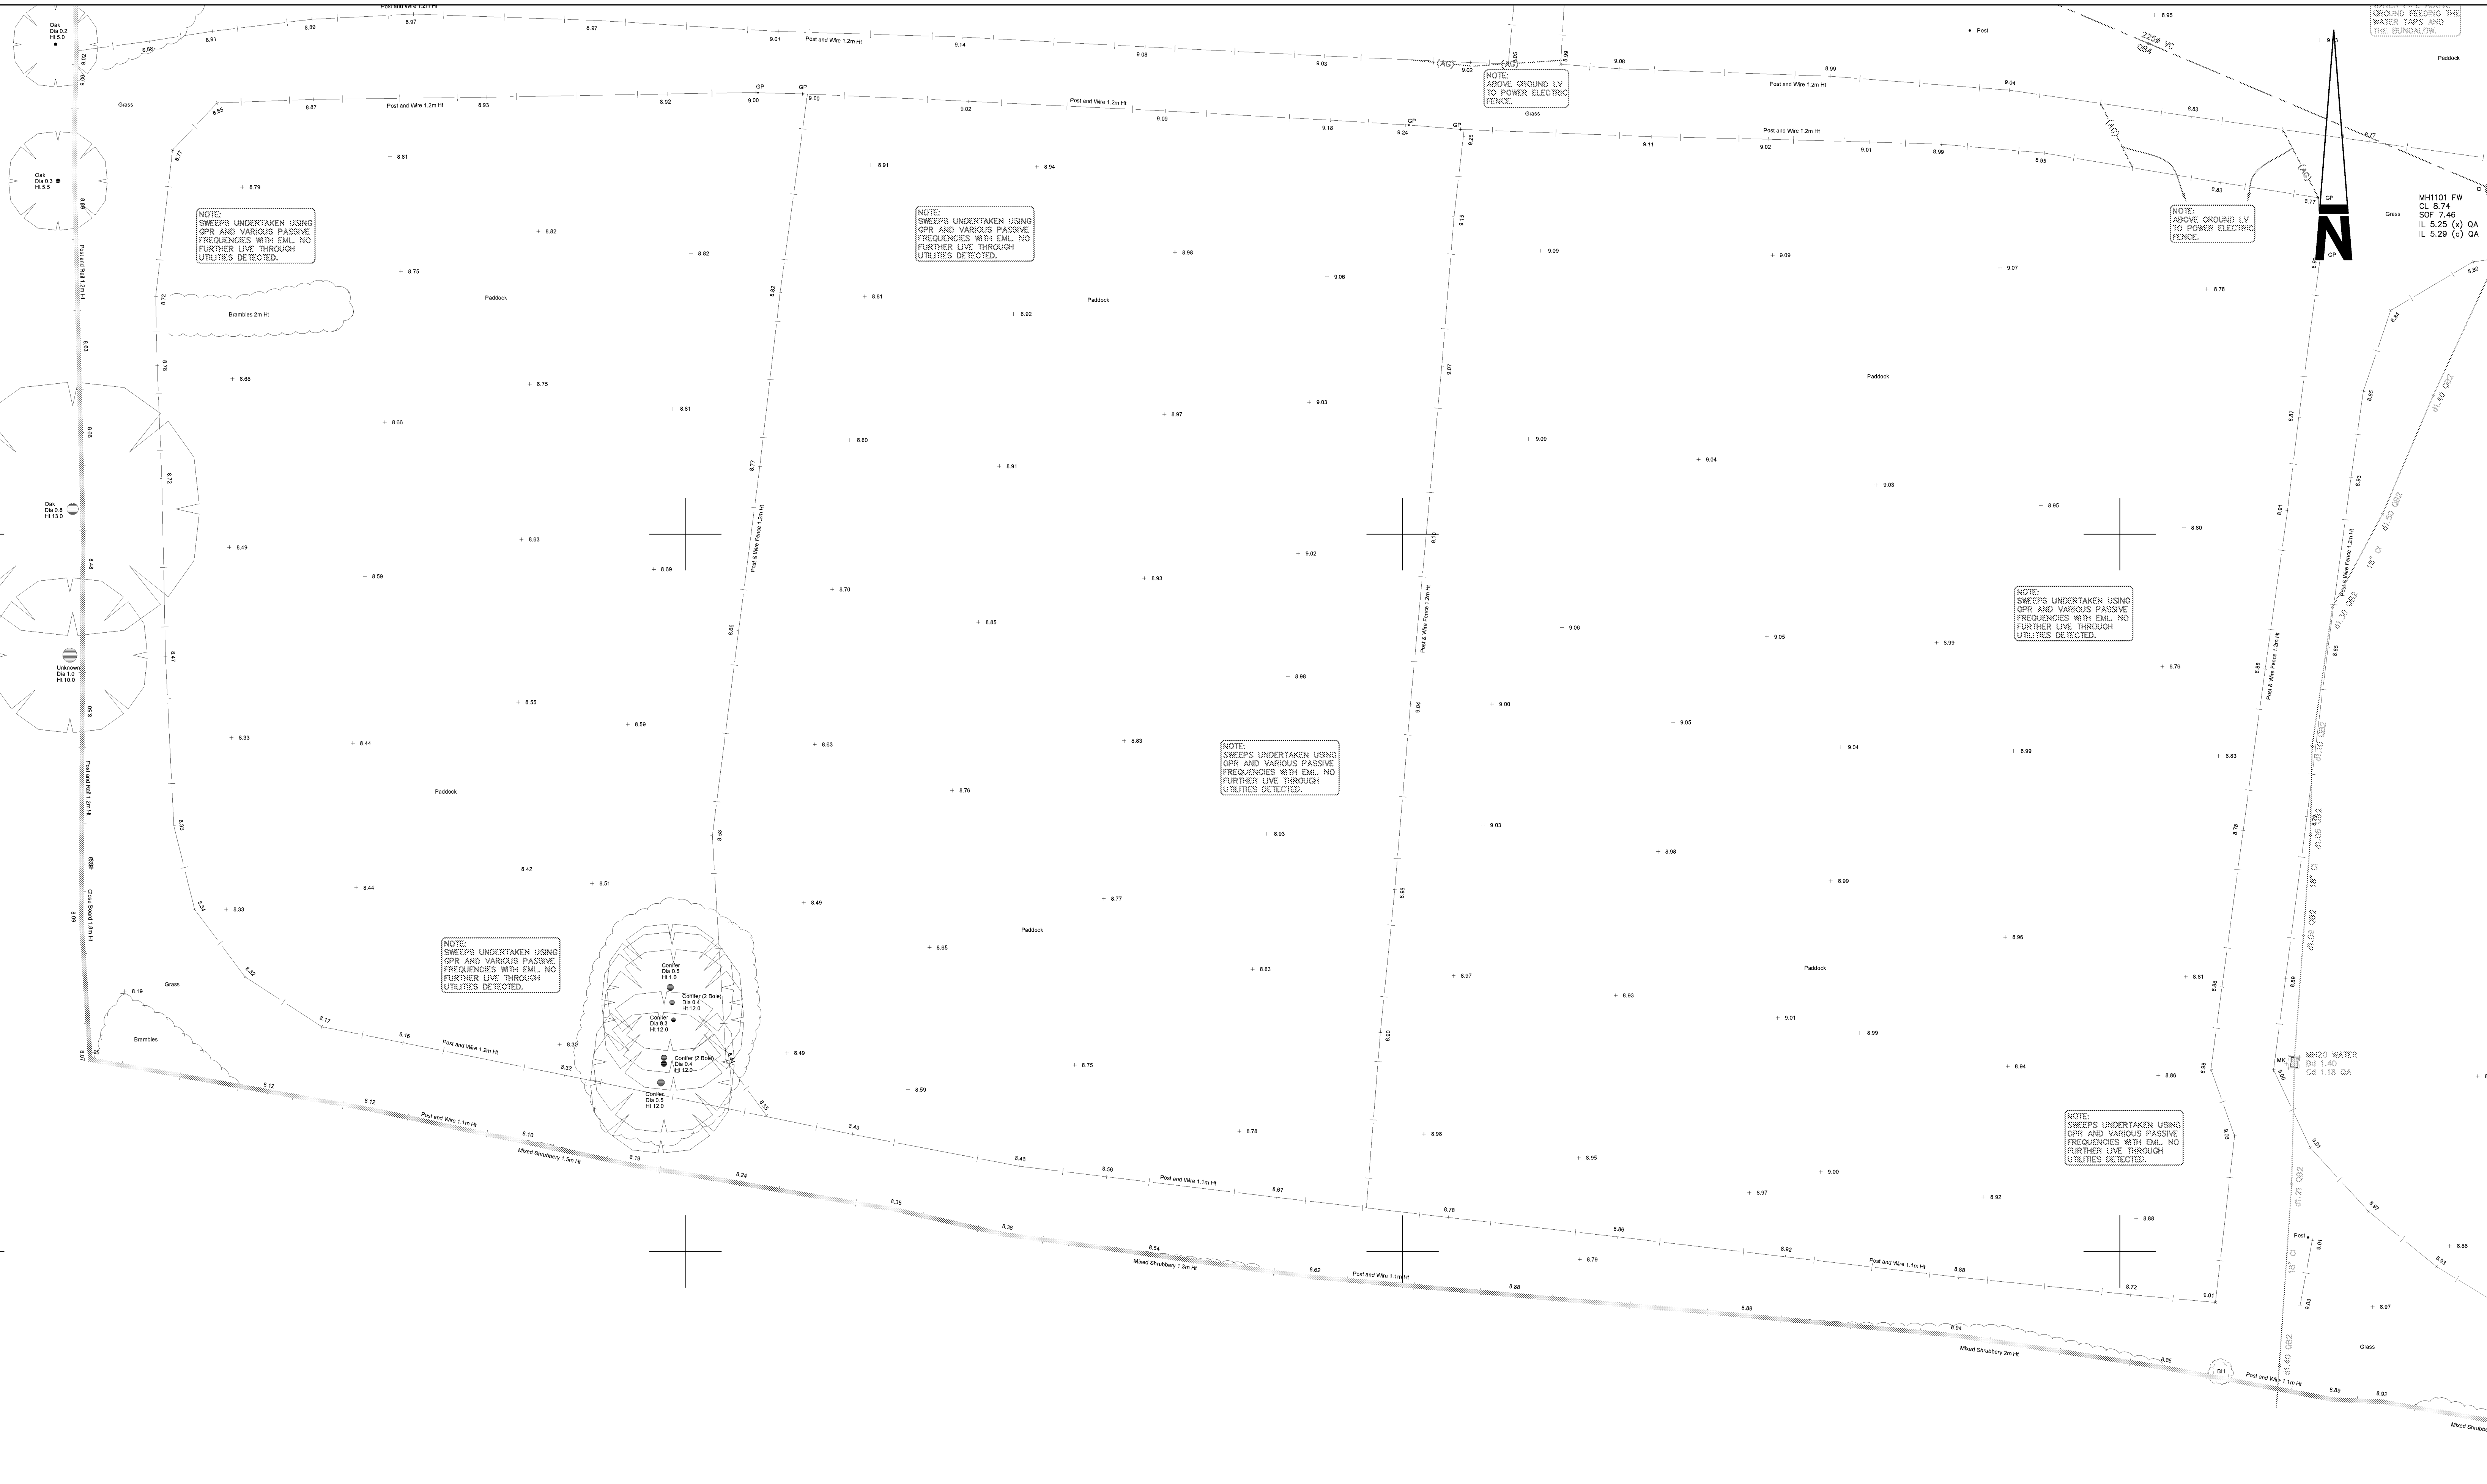
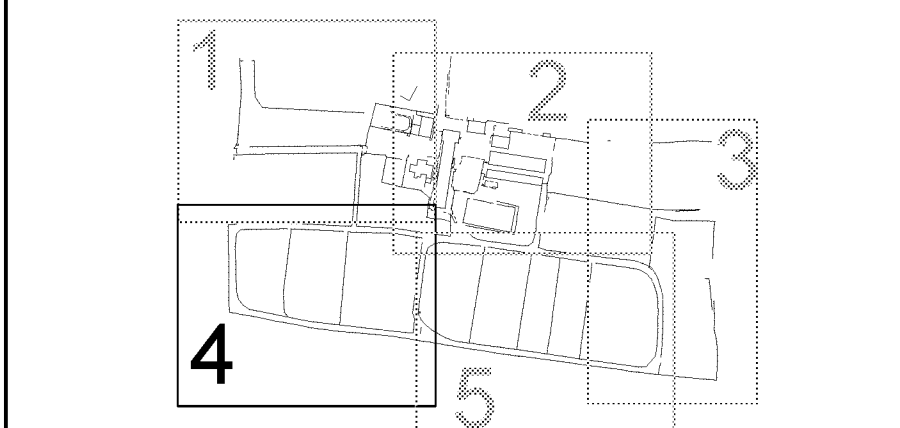
This survey was carried out in accordance with PAS 126:2014 (Publicly Available Specification) under BS 7688-1 pre-survey consultation with the client it was agreed to carry out the detection survey using methodology M1 as per Table 2 of the PAS 126:2014. The survey boundary has been shown on the drawing, please see location section of the key for reference.

Drainages were fitted with pipe sizes and invert levels recorded. Wherever possible the chamber dates have been recorded and positioned on the drawing. All connections from gullies, external drains and pipes and surface drain stacks have been proven wherever possible. Inlet manholes and sewer runs by radio scans located inside GPR or above. In instances where other detection methods were unsuccessful connections between manholes have been assumed to be present and are labelled as GPR. All drainage should be cross checked in critical areas for CCTV survey or verification survey type A. MH9102 was unable to be located at a manual detector. Video traced a blockage from the MH9102 down to the pipe being blocked but were unable to trace the full route of the pipe.

San utilities located using EMU, with electronically derived depths or GPR derived depths to the crown of the pipe. Where utilities have not been successfully detected, the position has been estimated using GPR depth records information. Recommended trial excavations to confirm depth and position in critical areas.

San utilities located using GPR derived depths to the crown of the pipe. Where utilities have not been successfully detected, the position has been drawn in relation to the supplied utility information. Recommended trial excavations to confirm depth and position in critical areas.

Electric cables within the survey area have been located using EMU, methods with electronically derived depths recorded. Unable to confirm amount of cables within ducts from surface inspection. Record information shows a 11kV HV cable in the carpark on the south of the site. Survey result confirms this directly under the site boundary. Recommended trial excavations to confirm depths and position in critical areas.

Telecom ducts have been traced with positions recorded. Due to laws protecting British Telecom separate all ducts have been located using remote detection techniques only and compared with recorded information. Chamber sizes have been recorded using GPR techniques wherever possible. For further information regarding BT arrange direct contact Openreach directly.

Surveys targets identified on the drawing using GPR are classified as "non-linear targets". These are not considered with what we expect to see when identifying a "linear target", and appear on the drawing as single targets with depths 1 ft not linking two or more depth readings. This does not mean they are not utilities, we are just unable to confidently identify them as a utility. We would strongly recommend that further verification surveys PAS 126:2014 survey type A be carried out to identify these targets in critical areas. All unknown anomalies were located using EMU, or GPR techniques. Recommended trial excavations to confirm depths and position in critical areas.

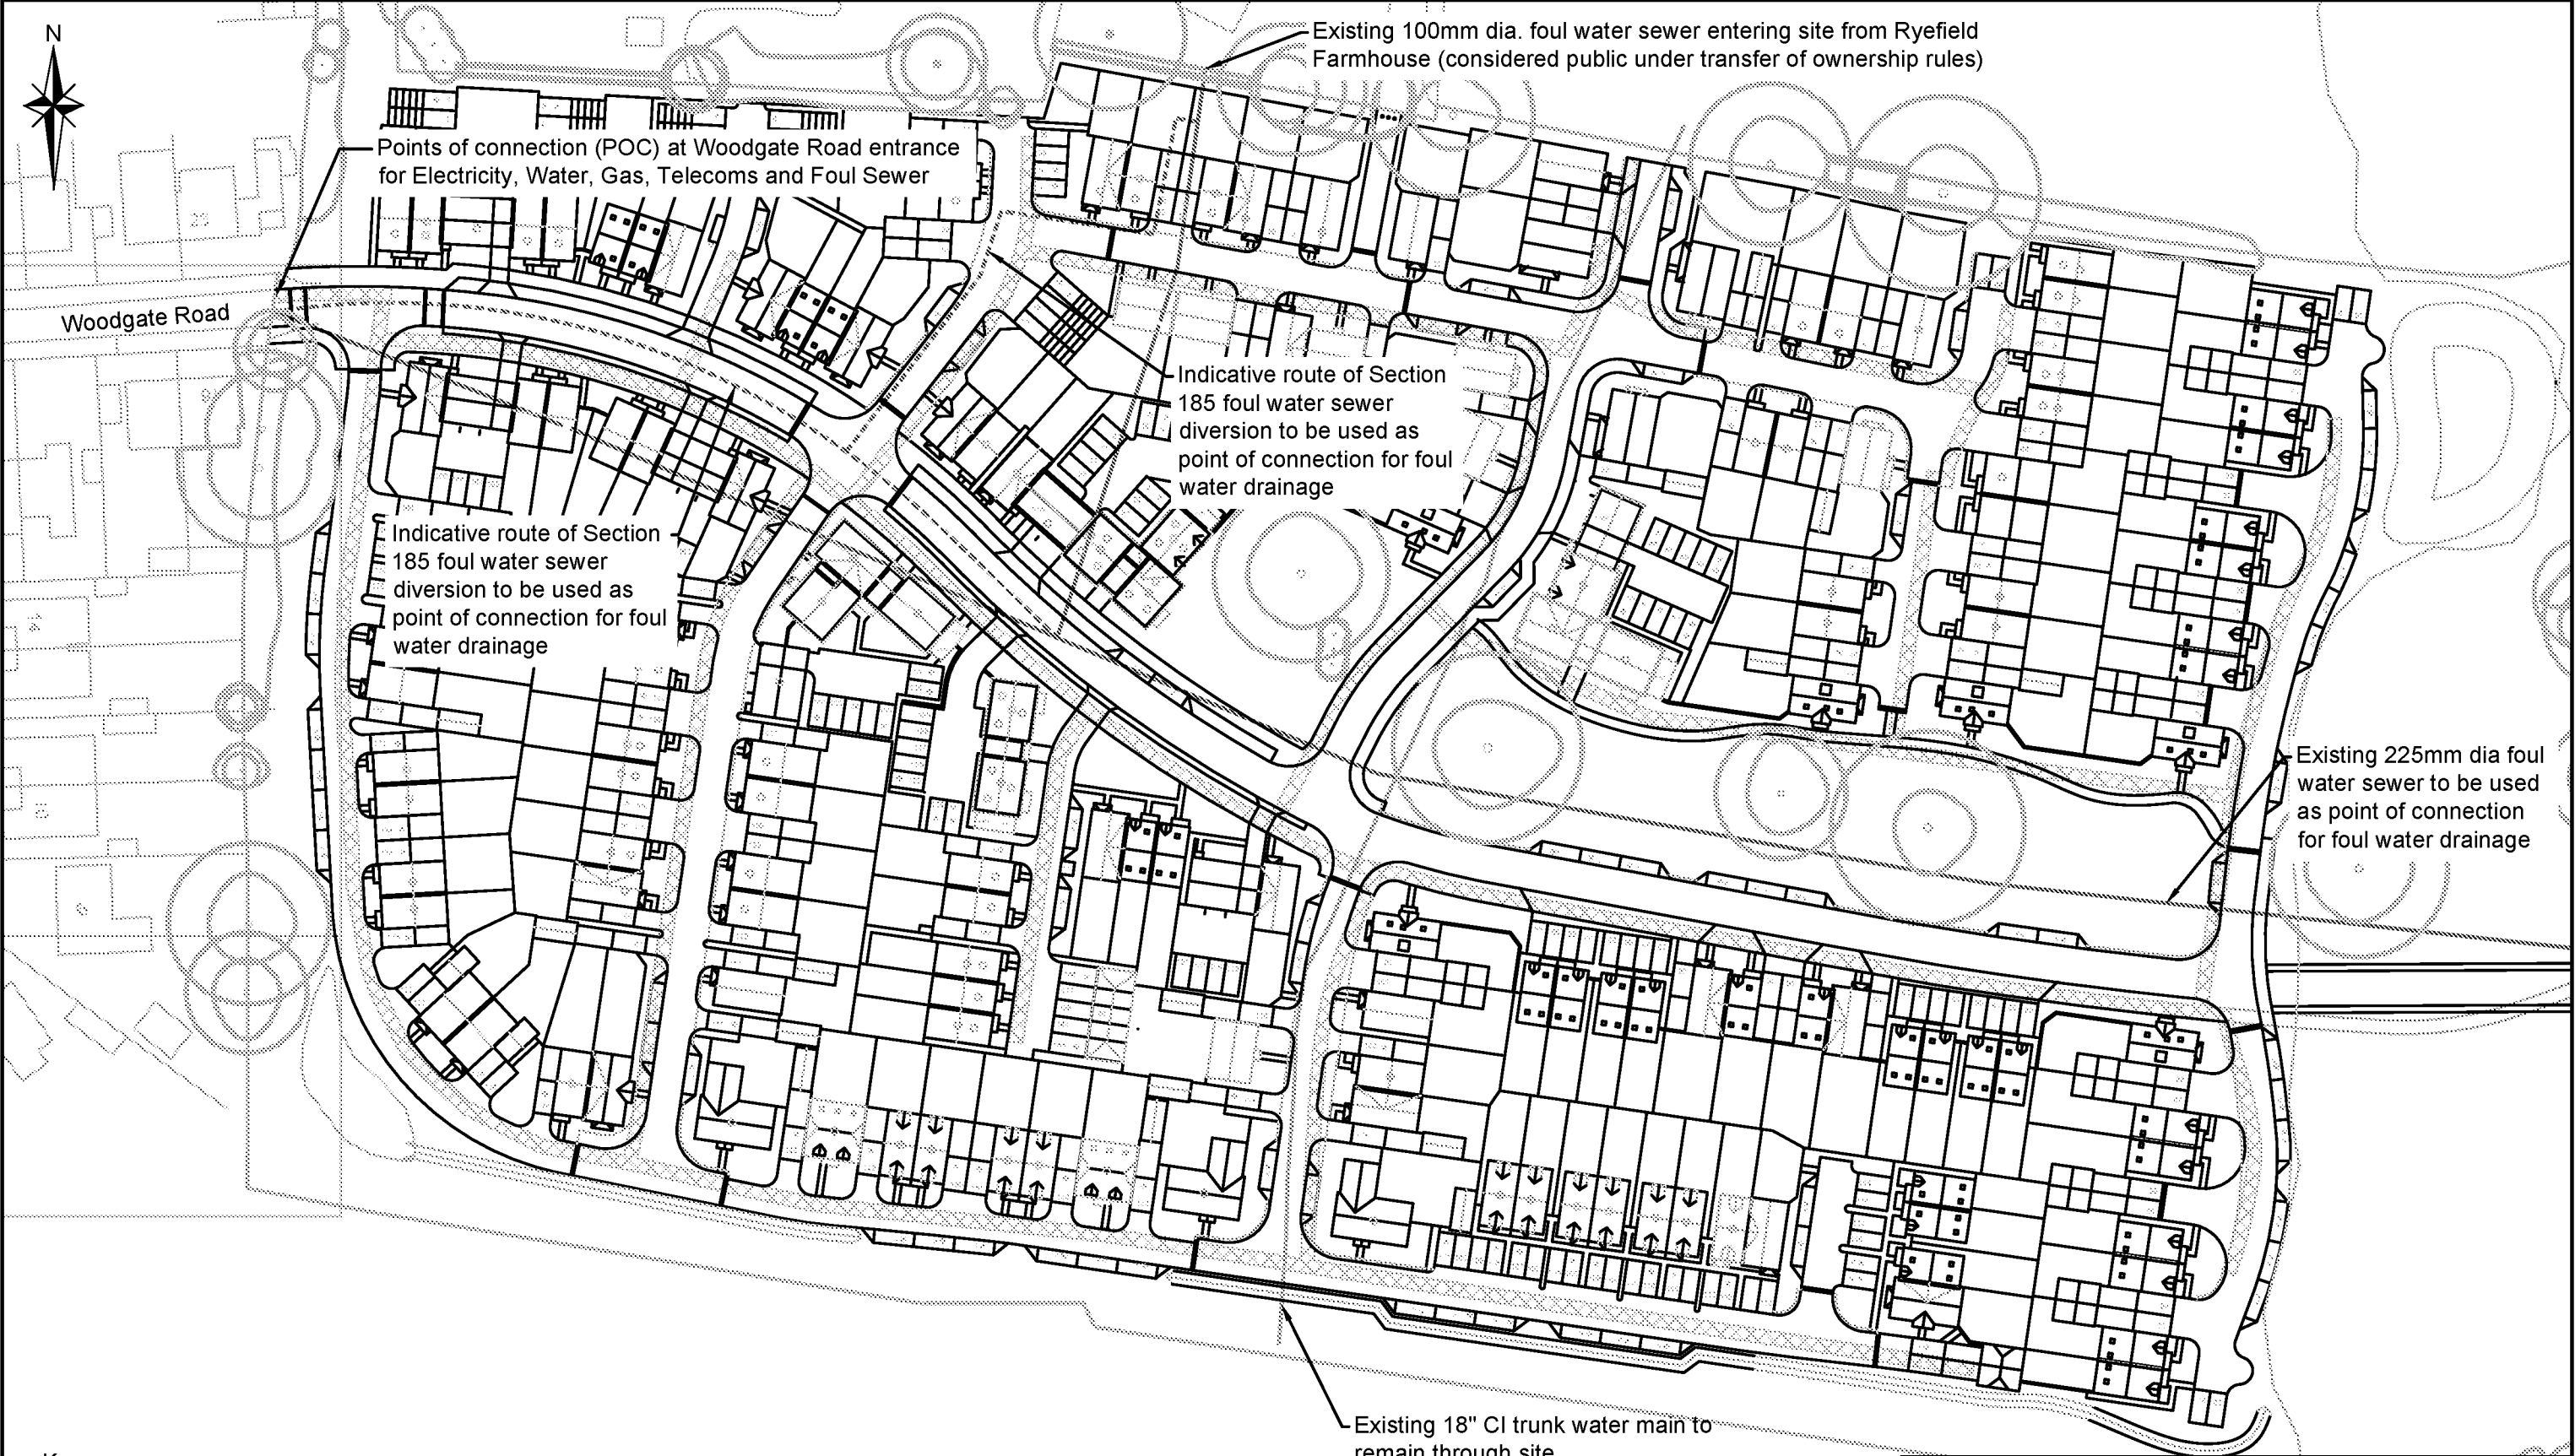
## Appendix E Preliminary Services Appraisal Plan

Indicative 2m Service Margin

Future Extension to 2m Service Margin
