**Site Address:** *Land Adjacent to Woodgate nurseries, Lidsey Road, Aldingbourne*

**Application:** *Discharge of condition 13b – Submission Note*

**Application reference:** *AL/116/25/DOC*

**Combined Geotechnical and  
Quantitative Ground Contamination Risk Assessment**

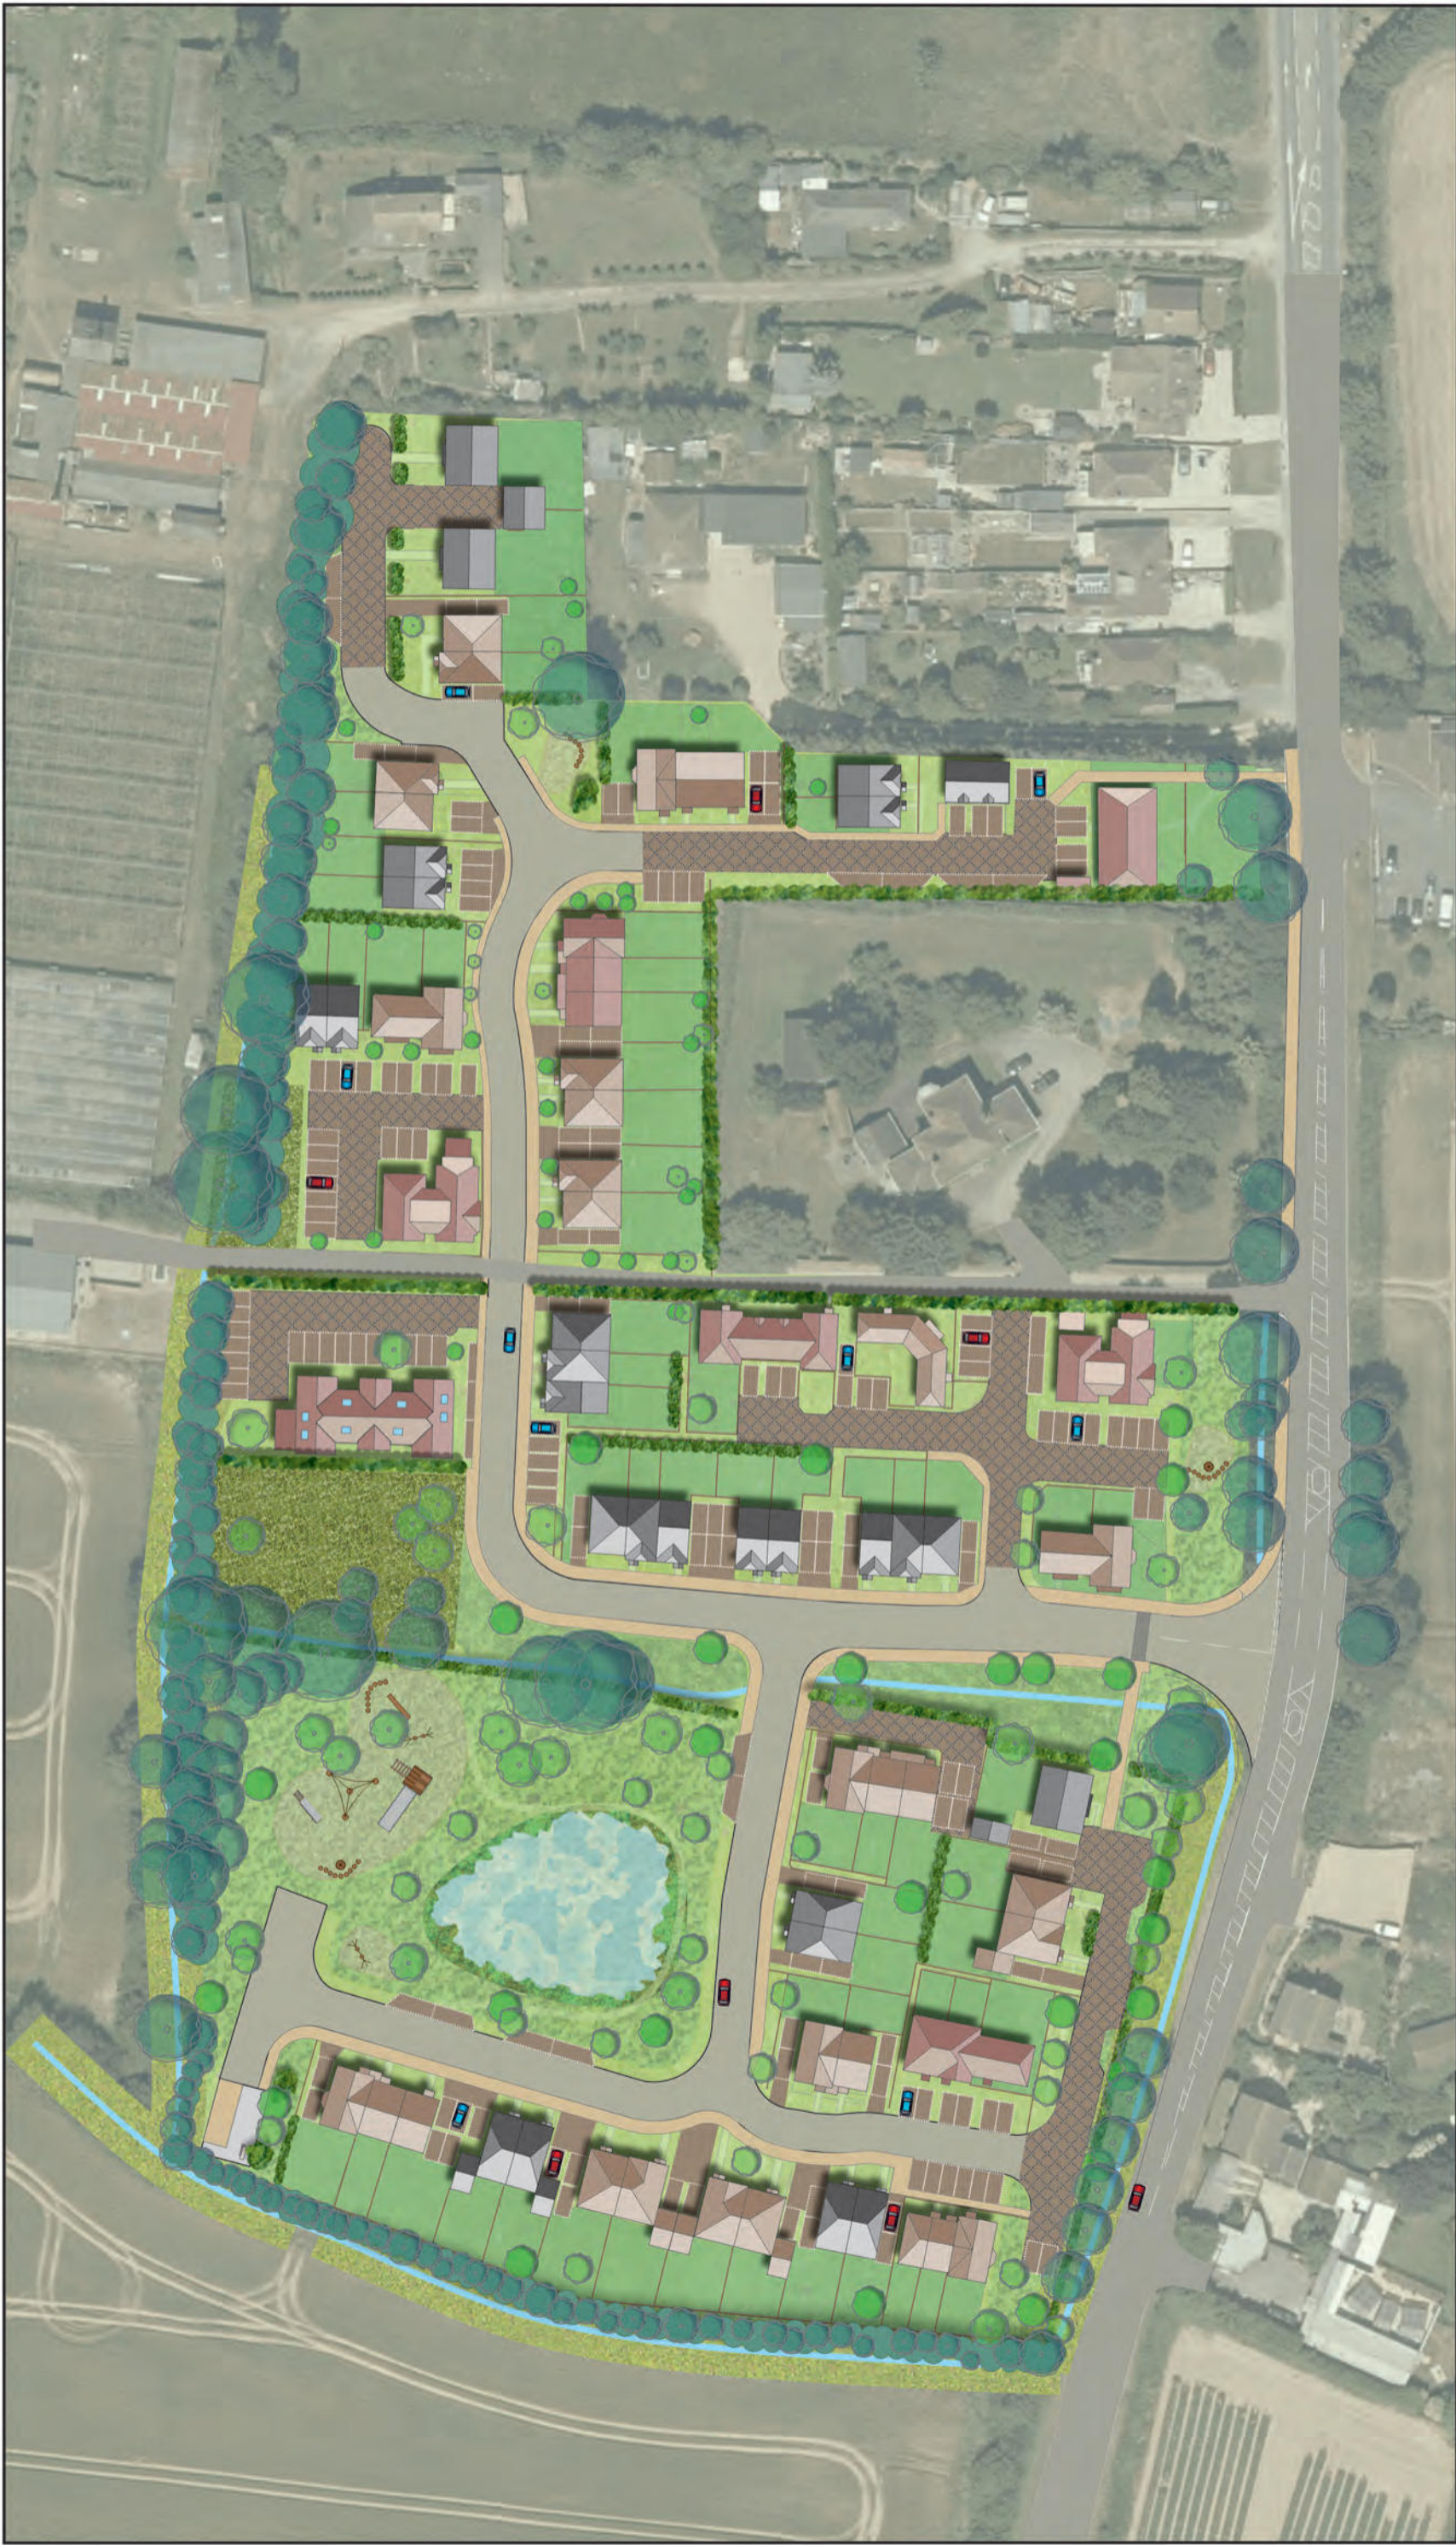
### Proposed Development Layout

- Existing Trees
- Proposed trees
- Hedges
- Garden
- Amenity Open space
- Natural and Semi-Natural Open Space
- SUDS Feature
- Play area
- Car parking
- Permeable surfaces
- Tarmac

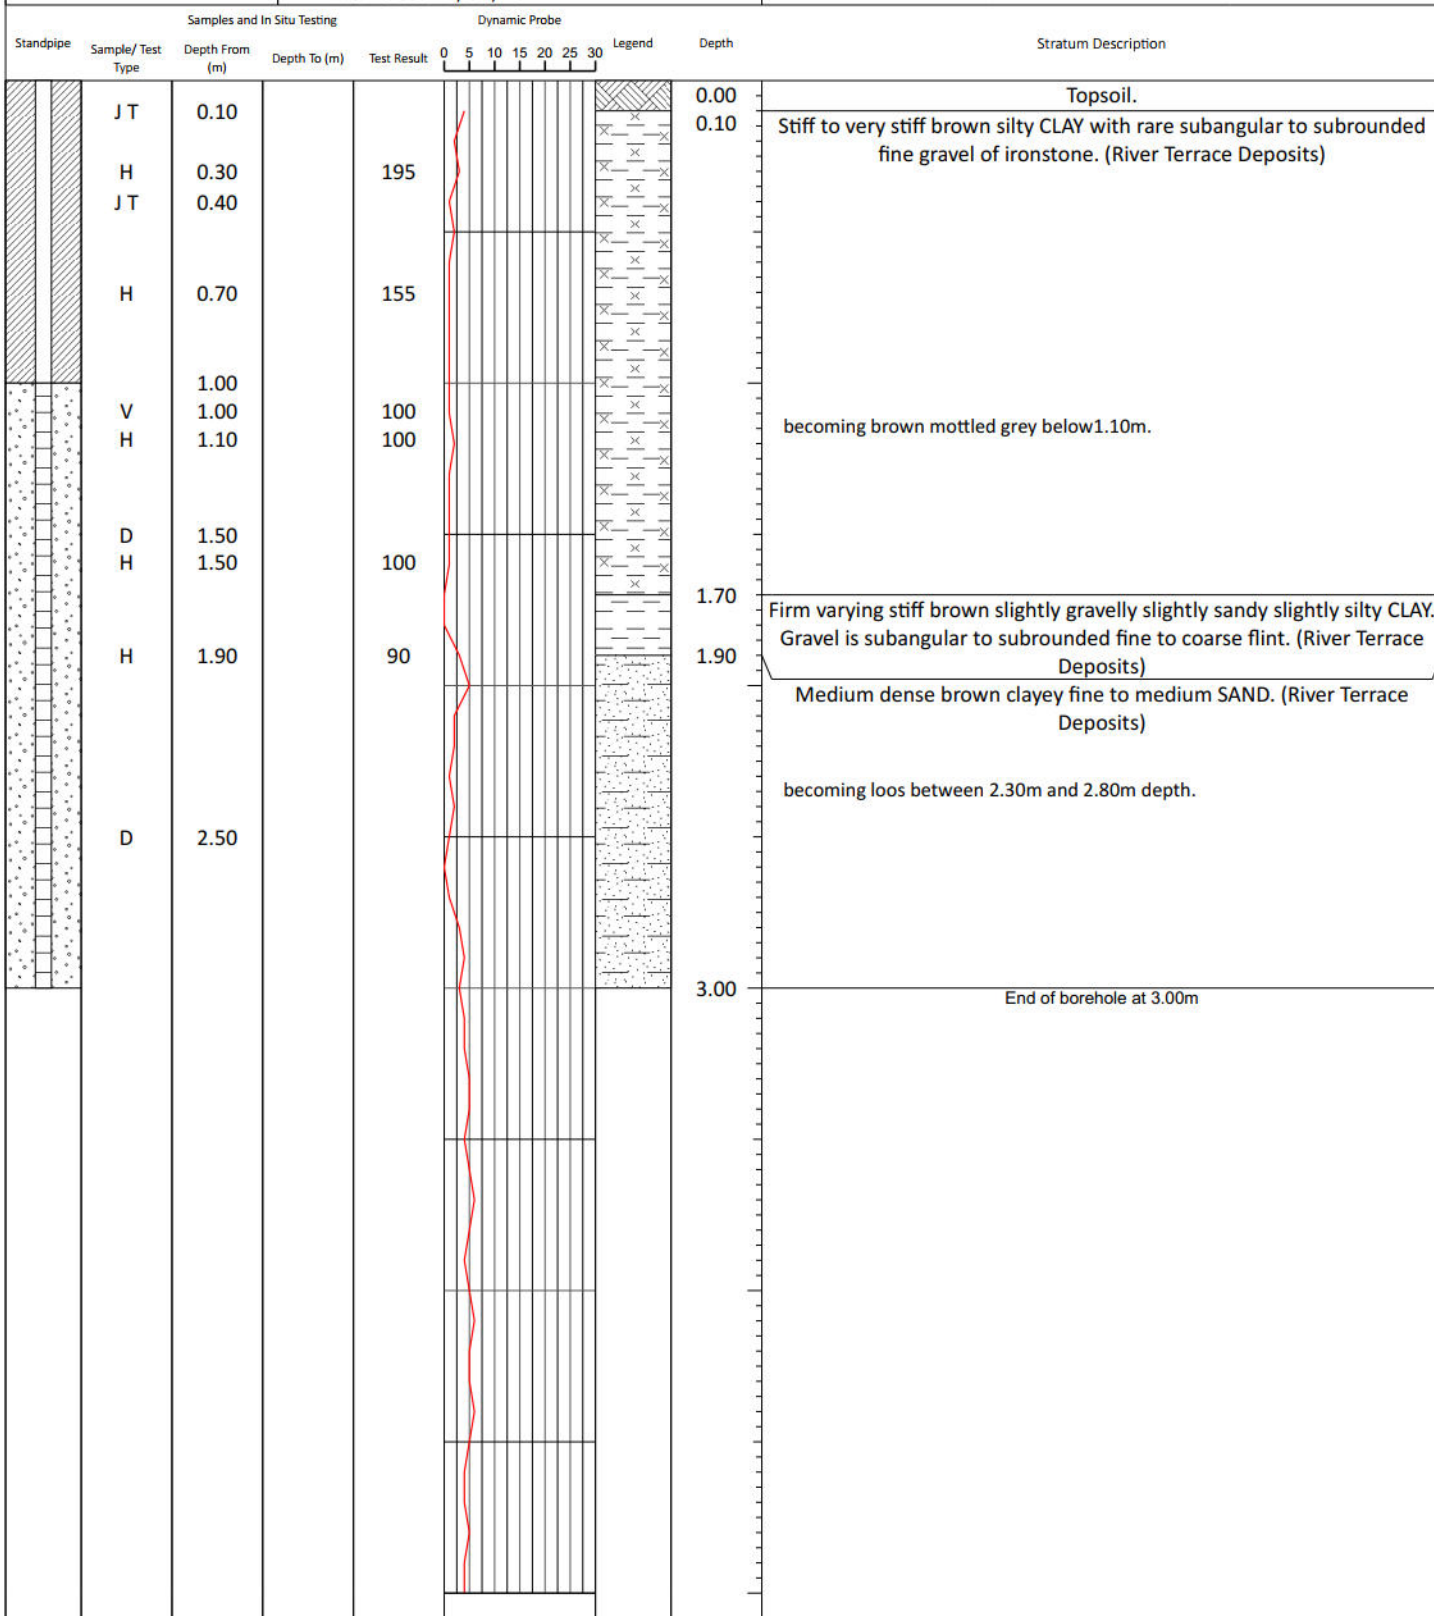
**Borehole Number:** **WS201**

**Groundwater:** Borehole dry on completion.

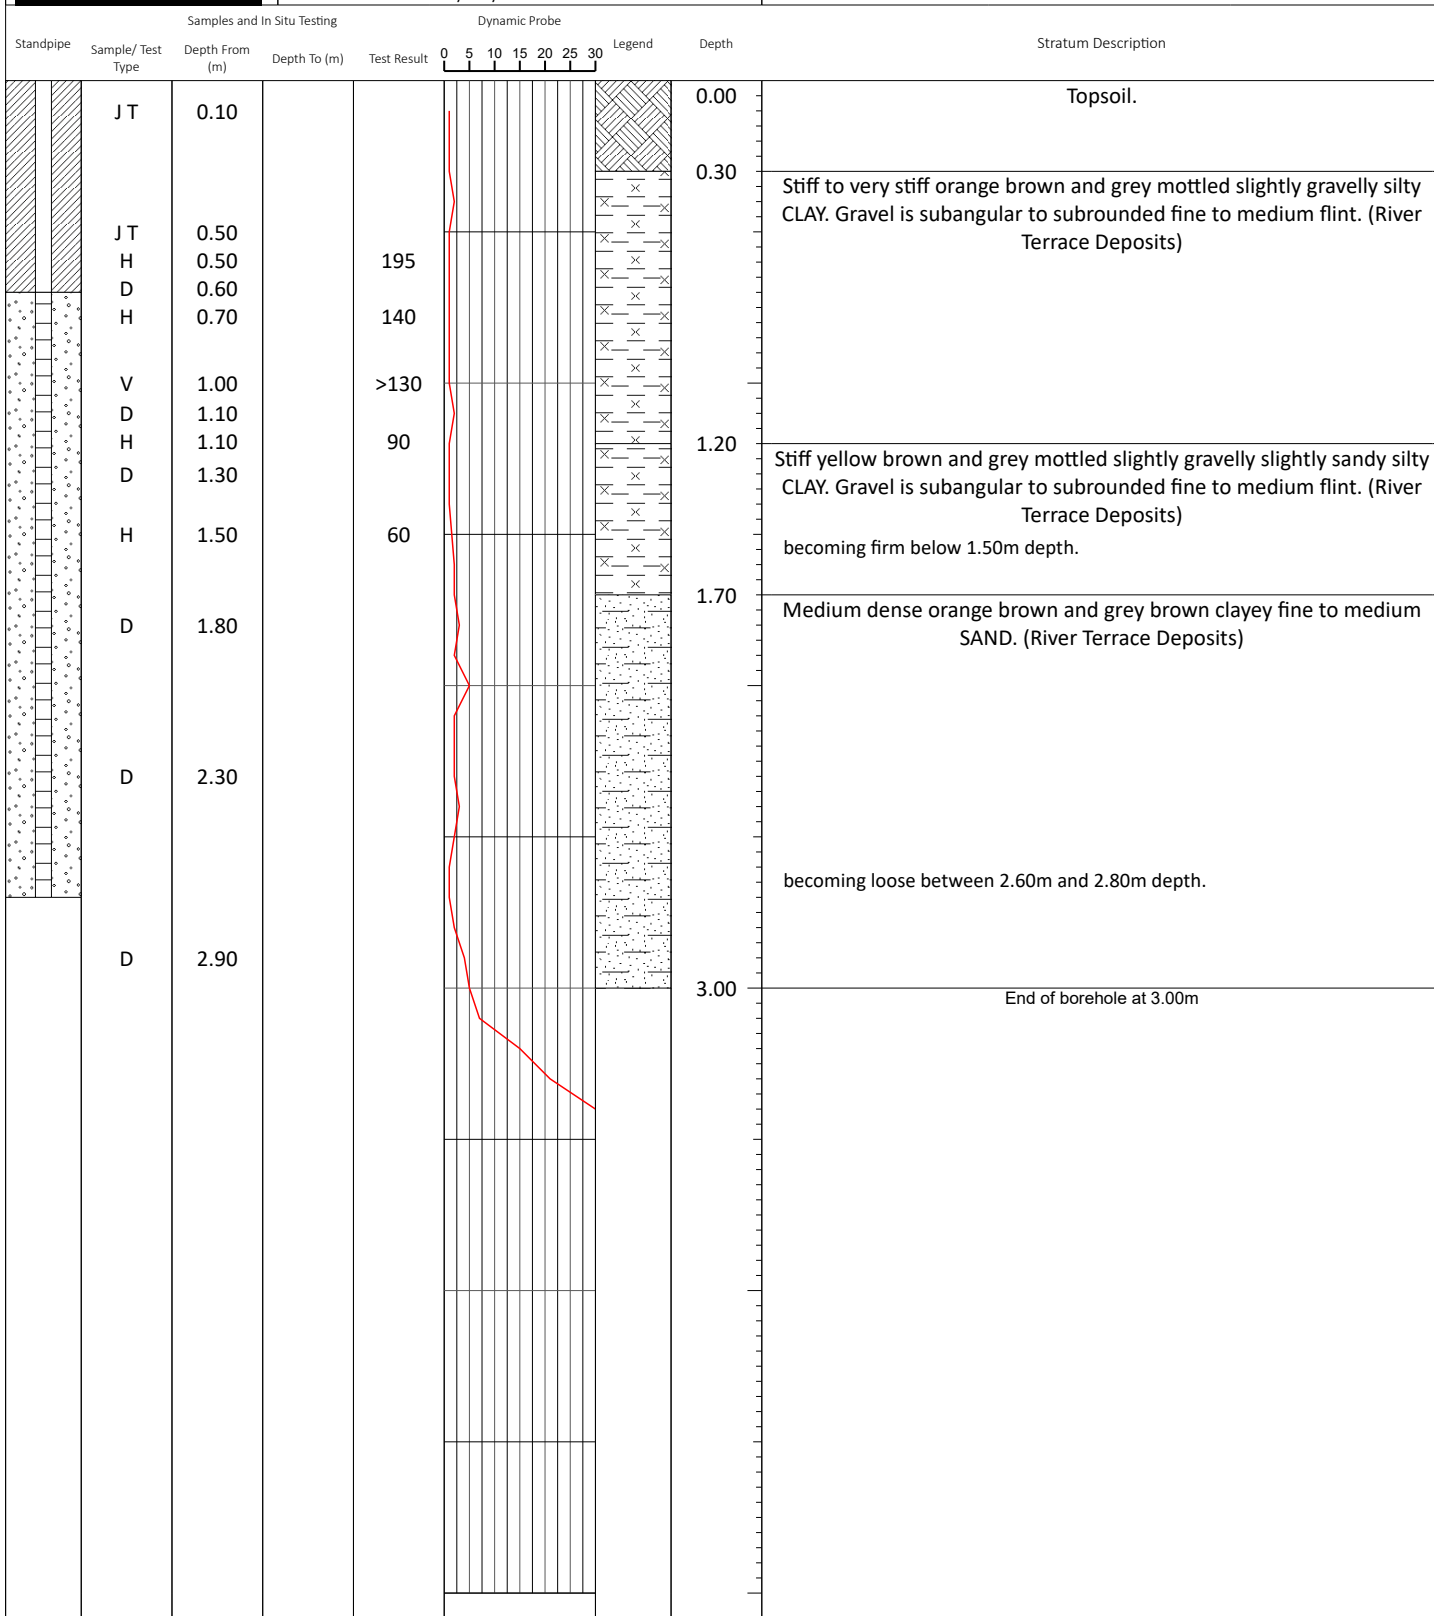
**Borehole Number:** **WS209**

**Groundwater:** Groundwater at 2.30m depth on completion of borehole.

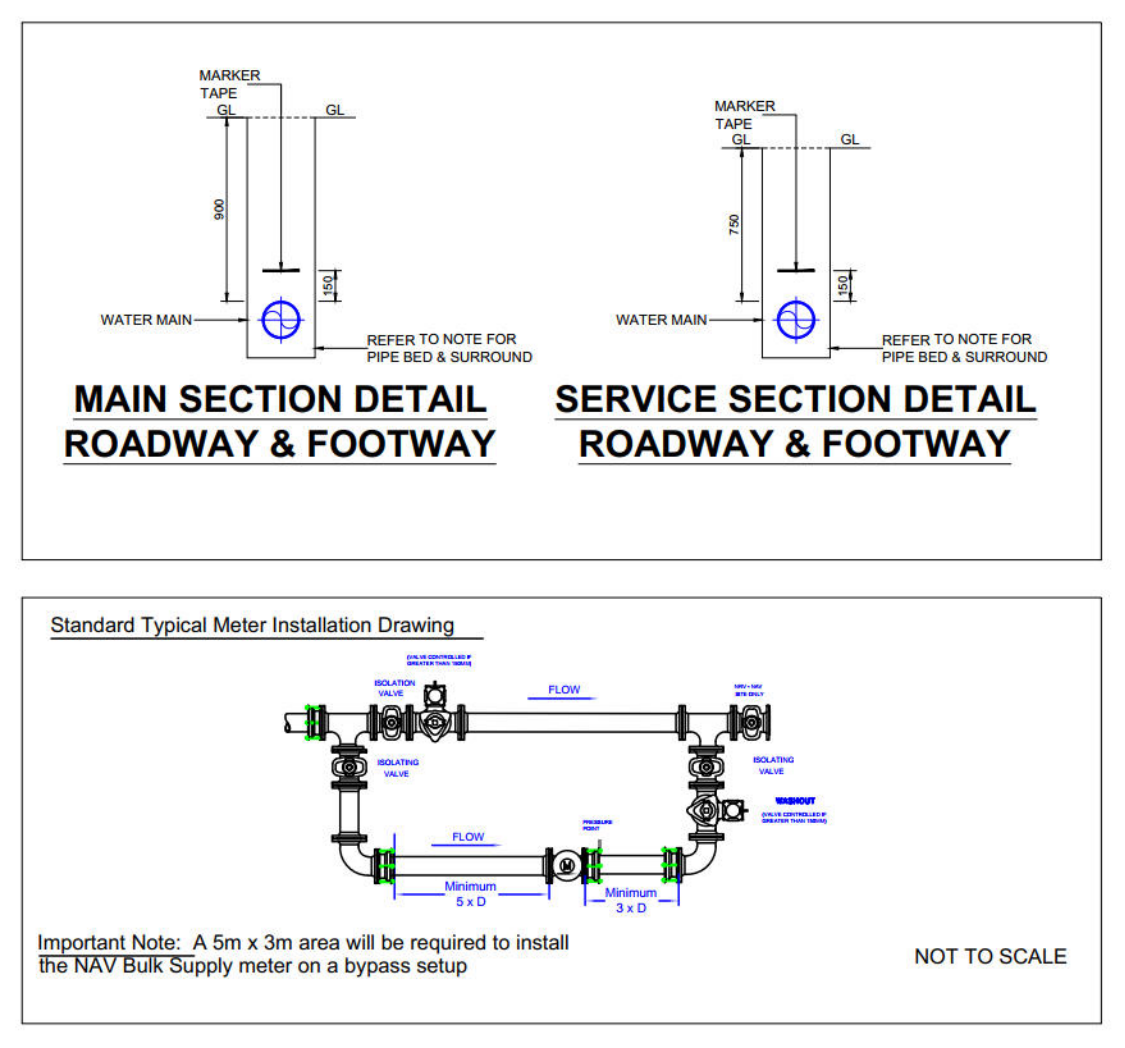
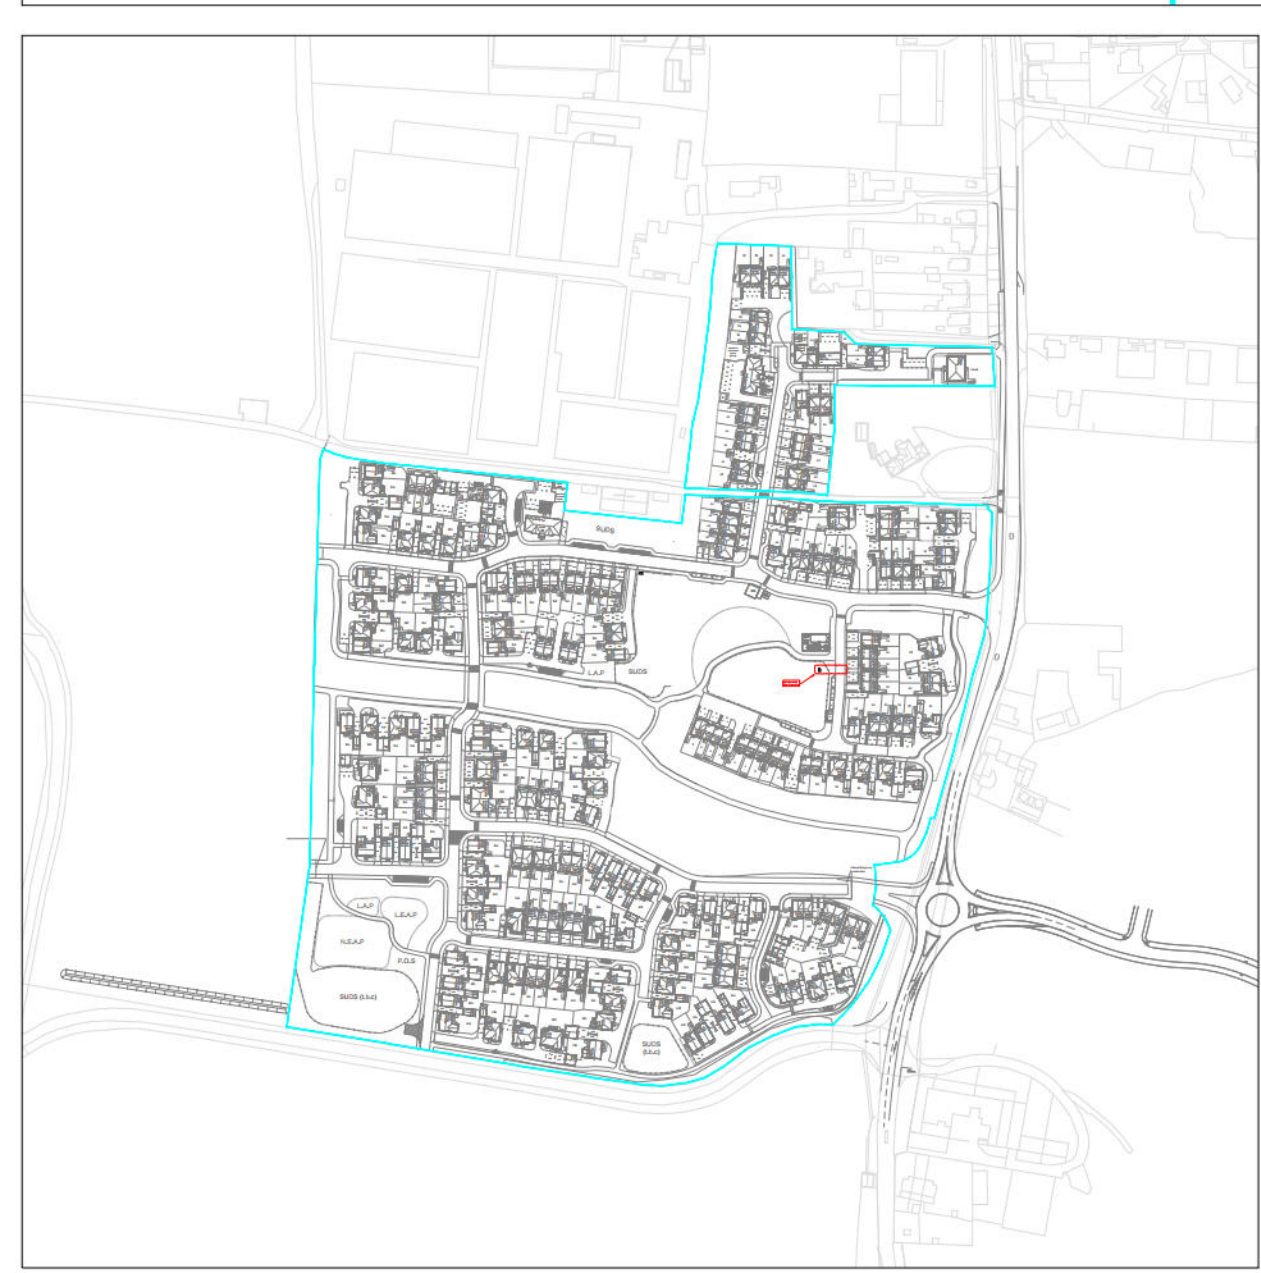
### **Approved water main designs**

This approach has been approved based on agreement with BDW Southampton to carry out a topsoil strip in those areas of the site found to have higher levels, along with the installation of PE barrier pipe where subsoil hydrocarbon levels are also elevated. These approved water layouts show on plan where the appropriate PE supply pipes will be installed, (Appendix C).
