# Mineral Resource Assessment

## Westergate, West Sussex

### Cala Homes South Home Counties

SLR Project No.: 424.064829.00001

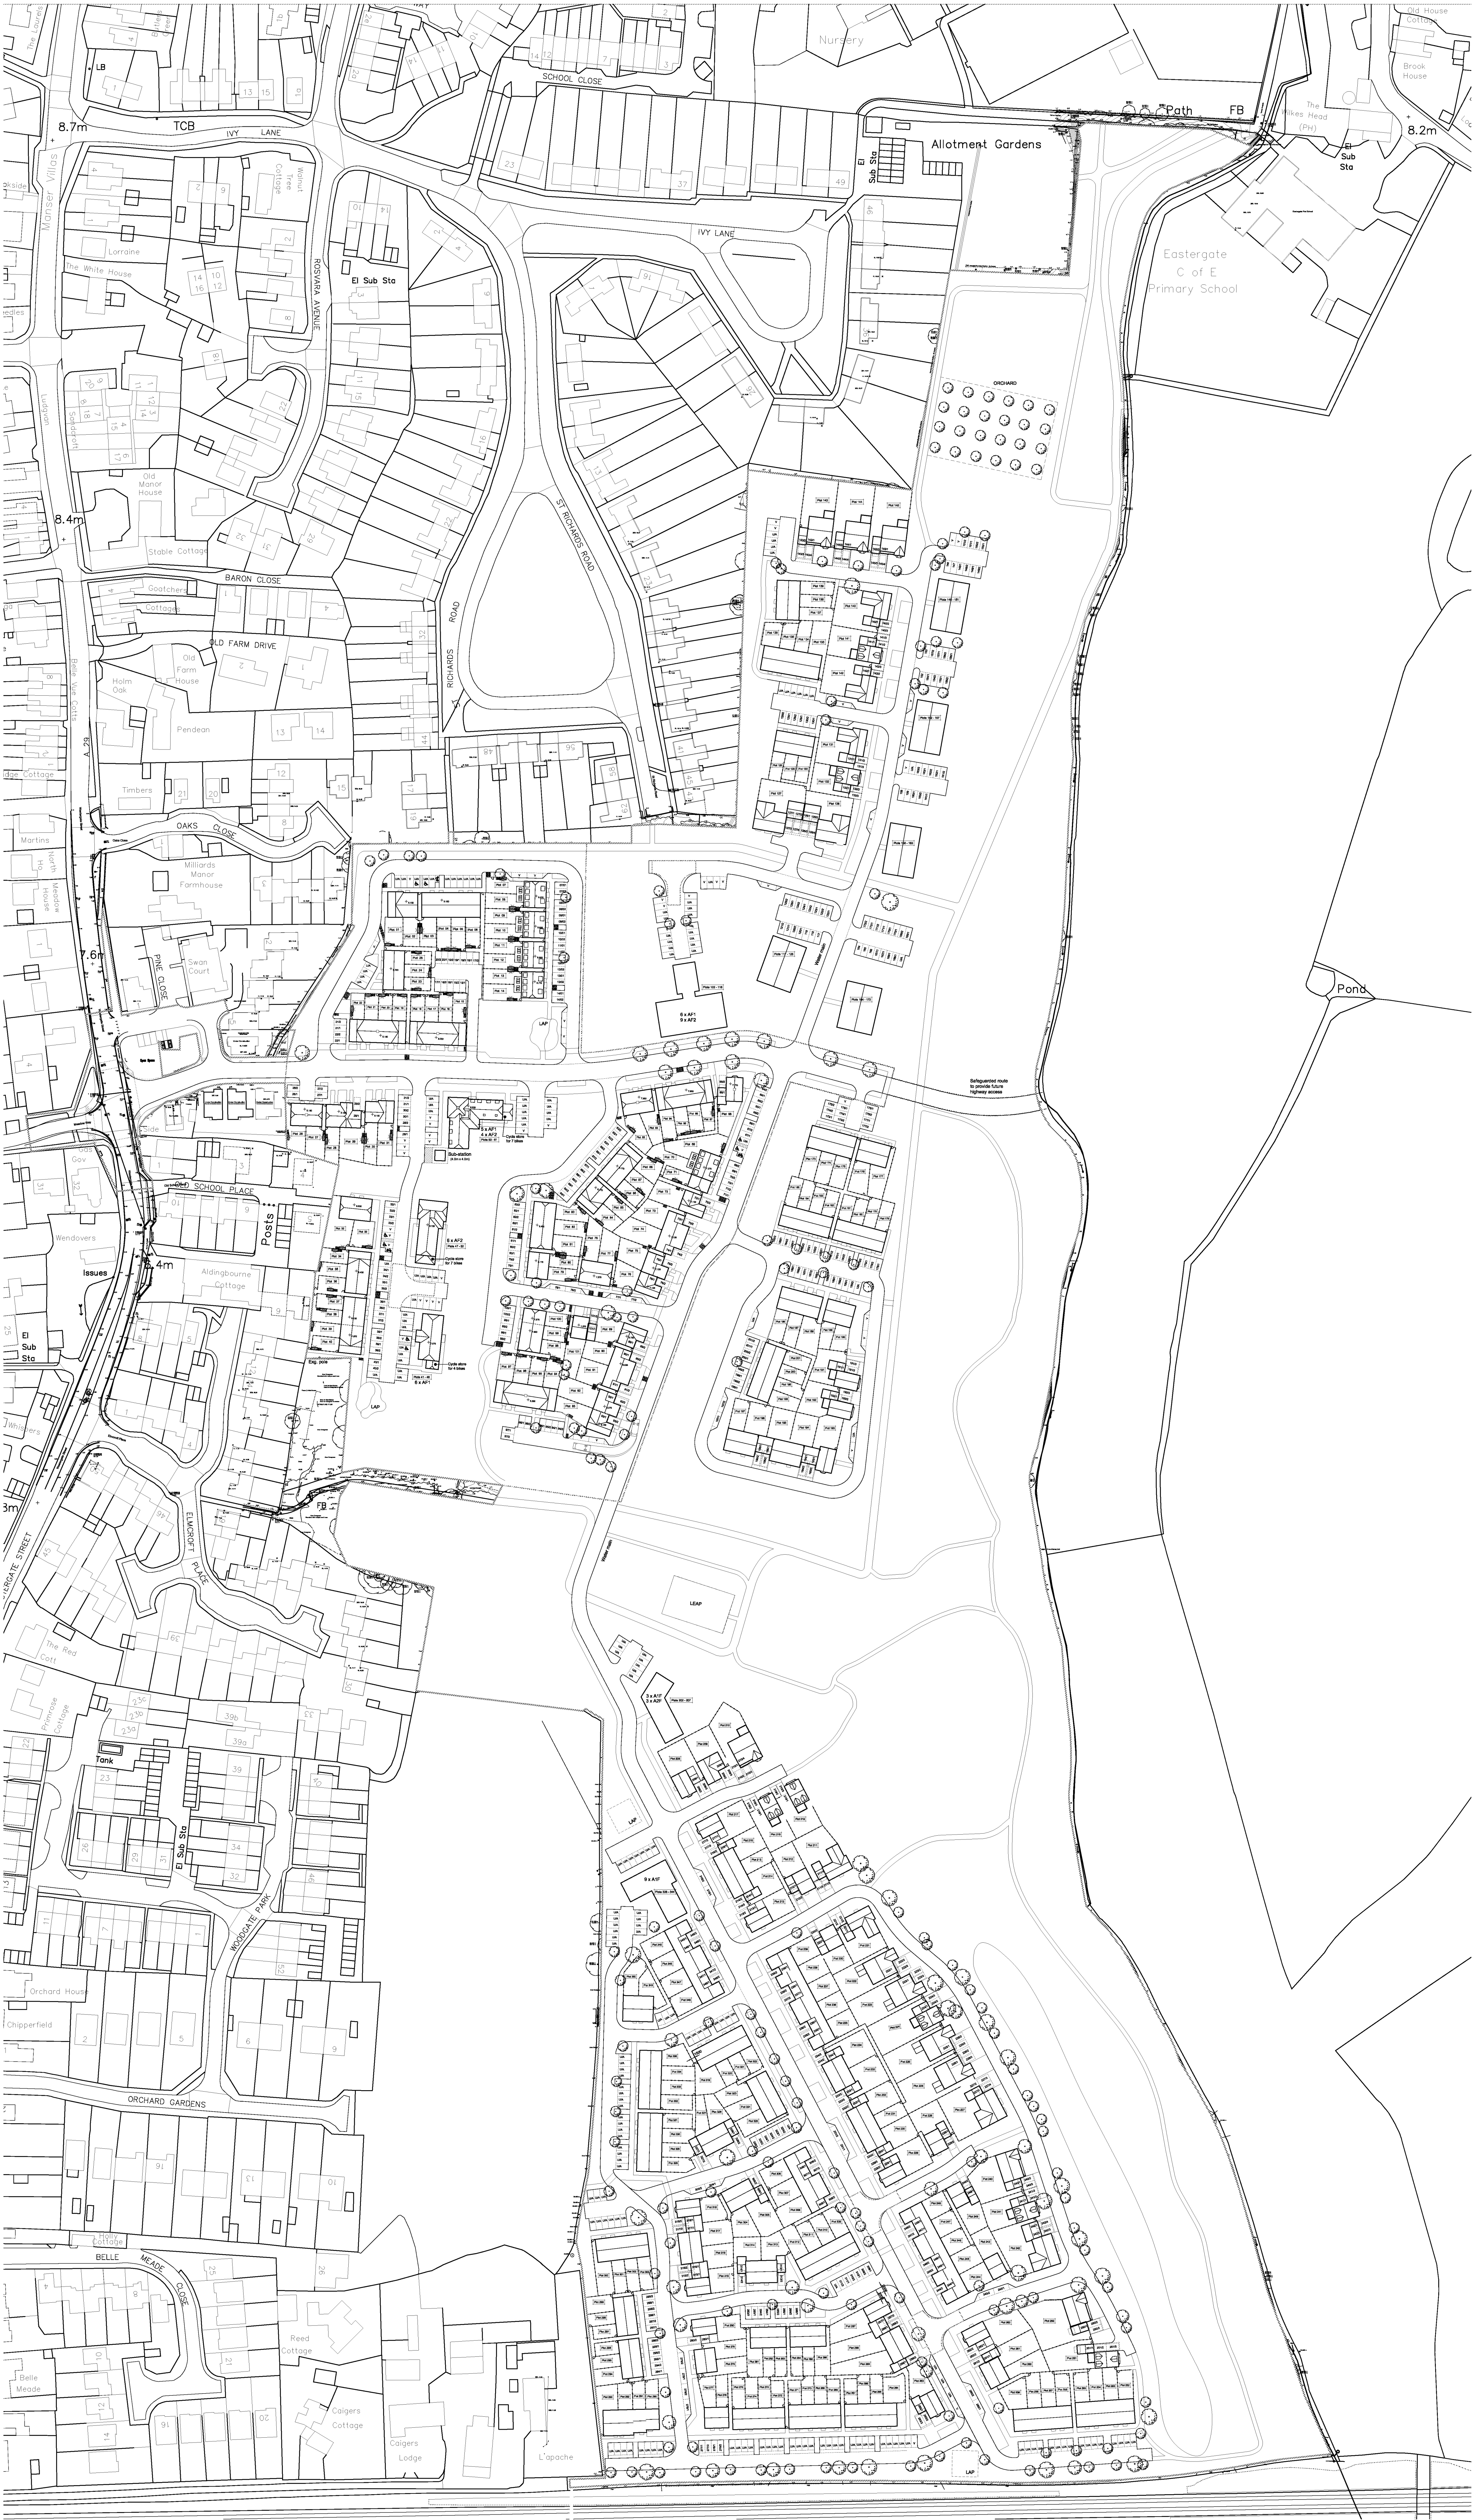
Appendix A: Illustrative Site Layout

| E 07-11-16 | | Disabled and motorcycle parking bays added.<br>Safeguarded route indicated and other footpaths added, hard landscaping updated as per Landscape Architects proposals. (BH) | | | | | | SCALE: | | 1:1000<br>(A0 ORIGINAL) | | DRAWING: | | Proposed Site Layout Roof Level | | | | | |
