## 14.1 Minerals Assessment

# Mineral Resource Assessment

## Westergate, West Sussex

### Cala Homes South Home Counties

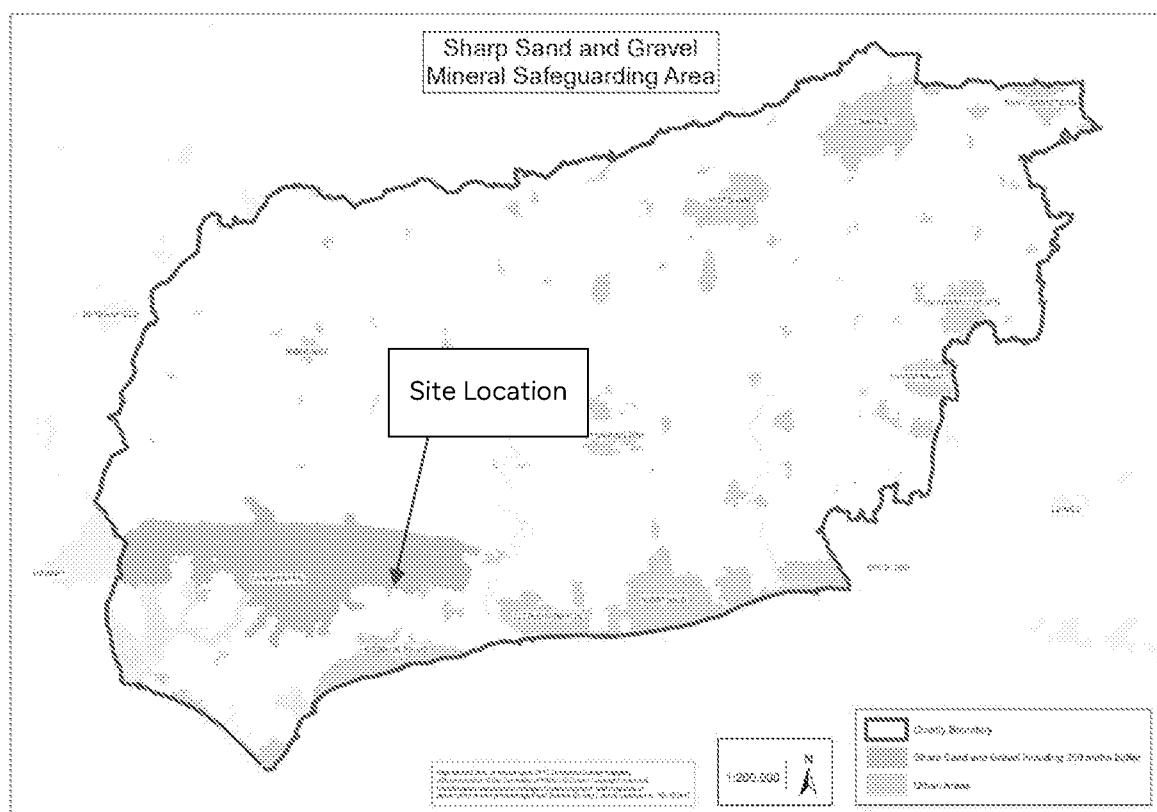
**Figure 1: WSCC JMLP Sharp Sand and Gravel MSA (2021)**

The site area is partially covered by the WSCC JMLP Sharp Sand and Gravel MSA and MCA (Drawing 01).

A large area of the site encompassing an area approximately 700m south of the sites far northern boundary falls within the WSCC's JMPL sharp sand and gravel MSA and MCA (Drawing 01). The same area noted above also falls within the Arun District Council's Sharp Sand and Gravel MCA.

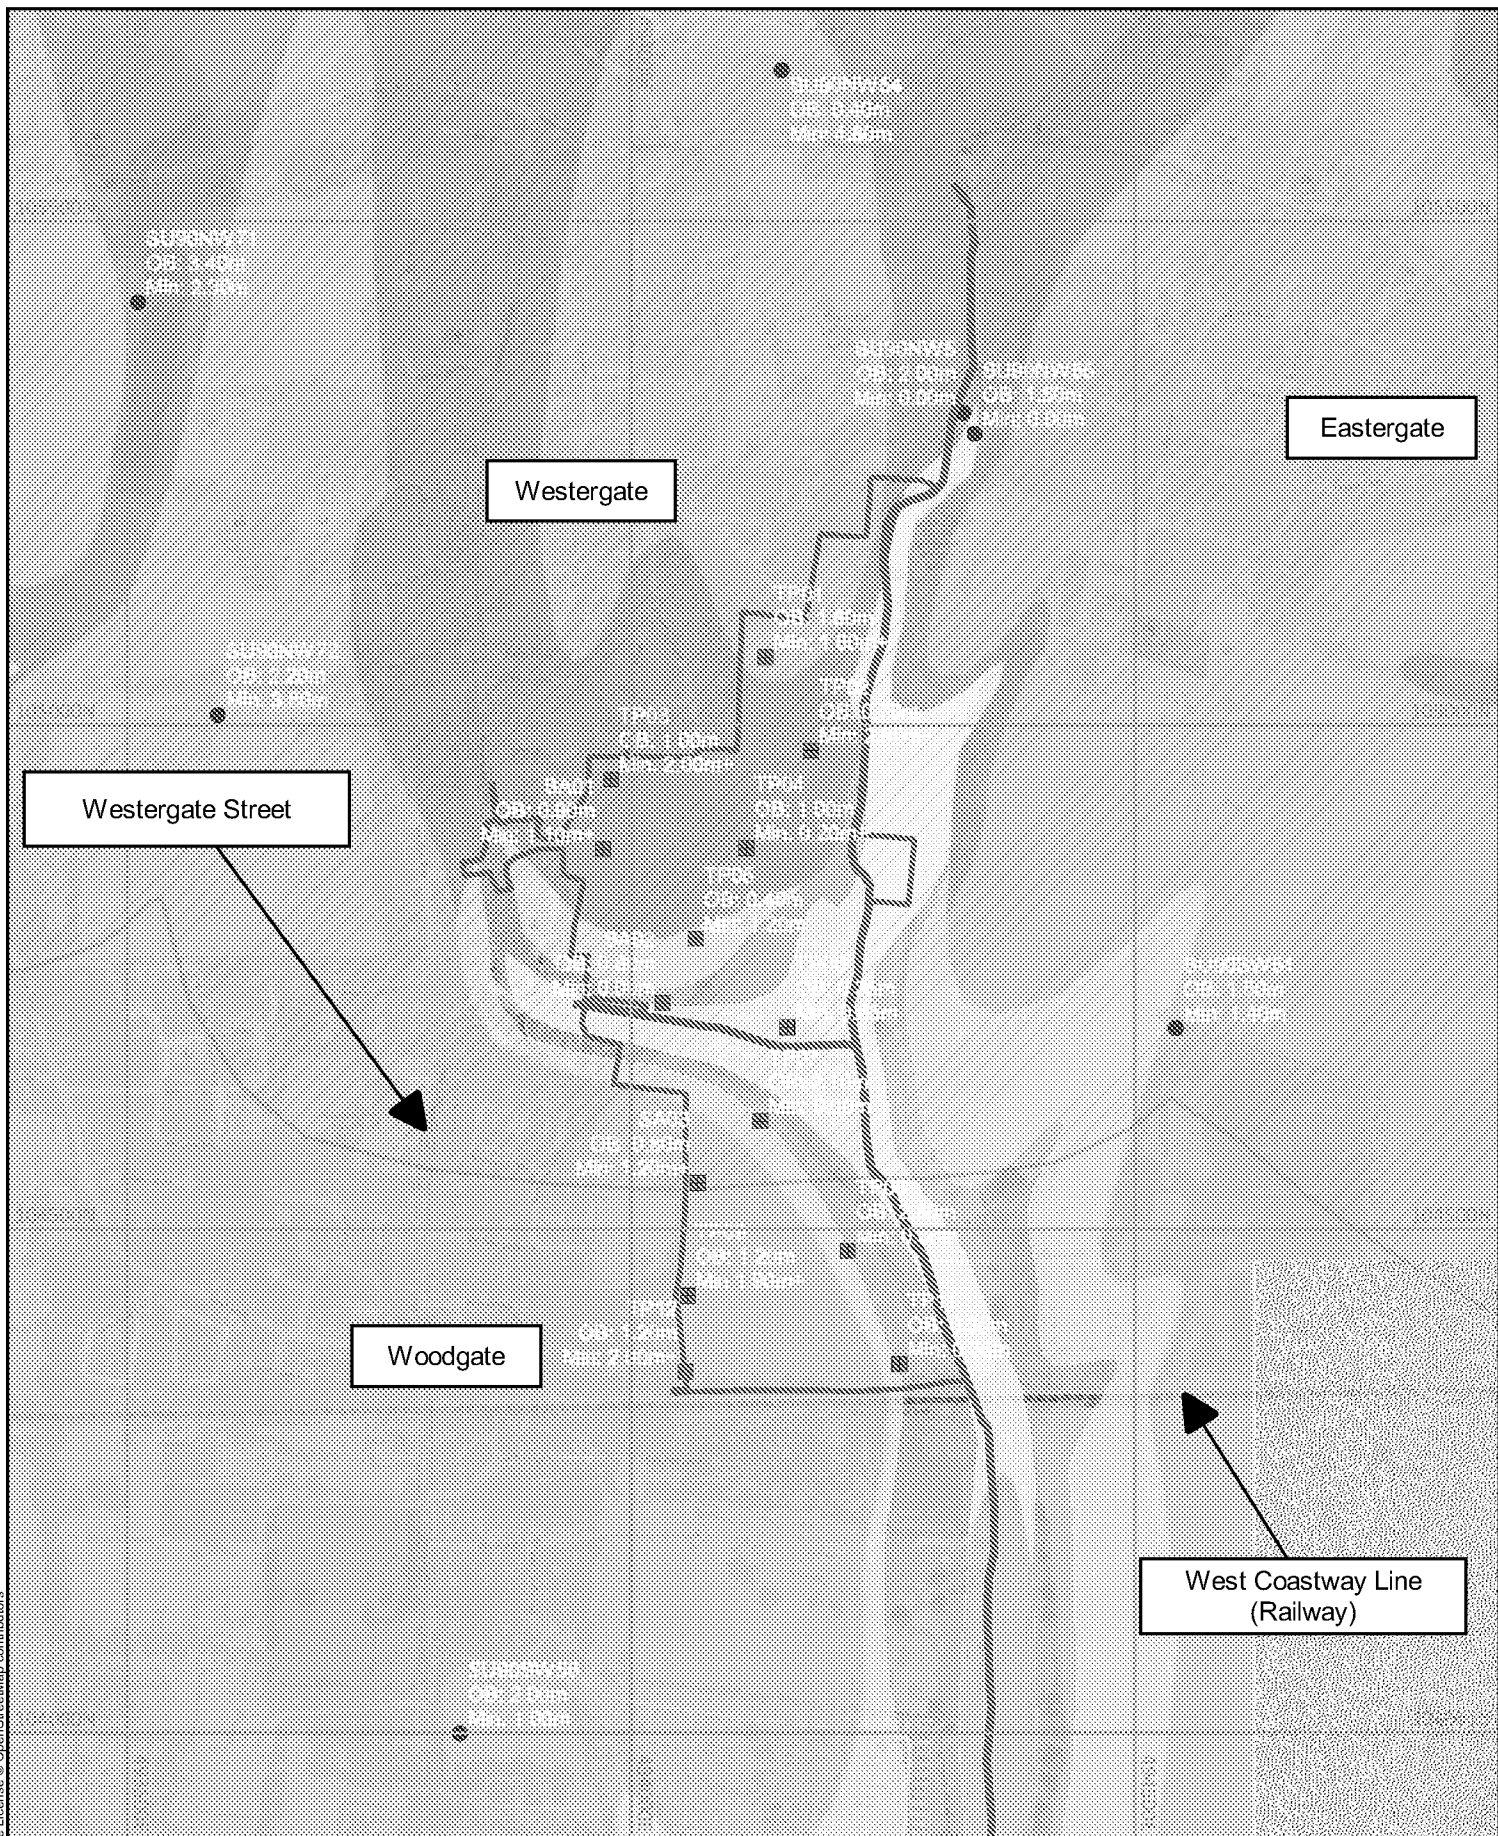
| 03 | |

- Site Boundary
- Watercourses
- Minerals and Waste Consultation Area
- GI Trial Pit locations
- BGS BH locations

The published information indicates that superficial deposits are not mapped across the entirety of the site. Where present, the site is mapped as having a range of superficial geological units, mainly following the trend of the present and historic water courses. The deposit types are described in more detail below and shown on Drawing 03. The general stratigraphy of the area can be found in Table 1 below.

A programme of geotechnical and geo-environmental ground investigation trial pits was undertaken by Bingham Hall Associates (Geotechnical Ground Investigation Report, Land East of Westergate, Bingham : Hall Associates, 2017). A total of 15 trial pits were excavated to approximately 3.50m below ground level. These trial pits were excavated to glean information for appropriate foundation design; however, the trial pit logs include geological description of the superficial deposits encountered. Approximate trial pit locations are shown on Drawing 02 and Drawing 03.

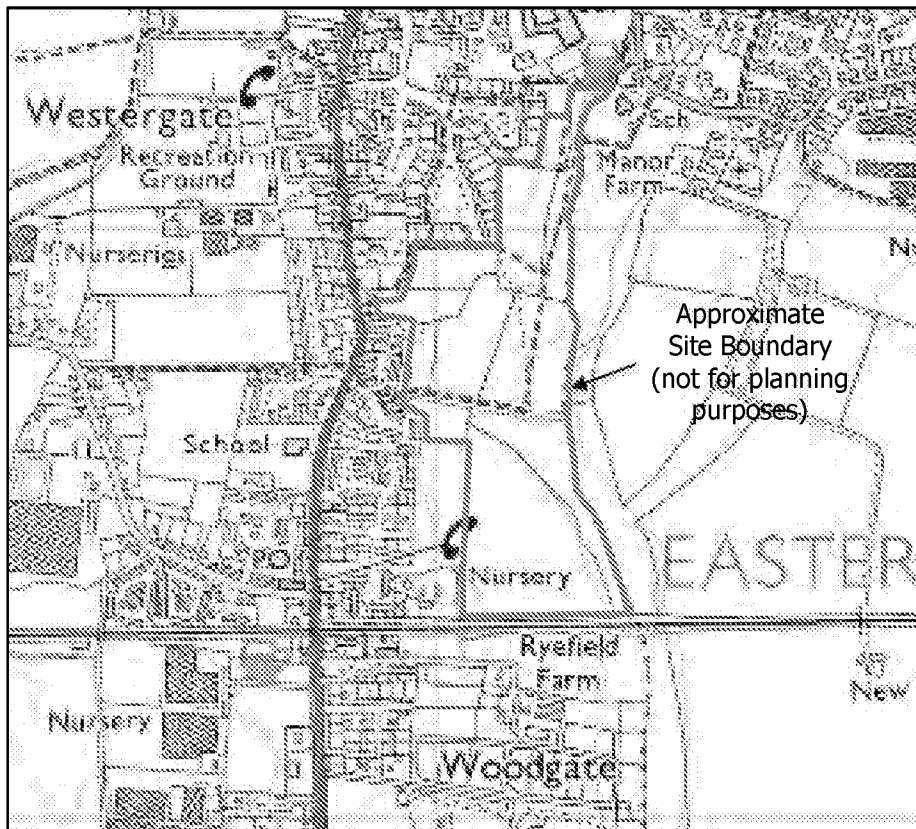
Figure 2.1: Site Location Plan

- 2.1 The Site is currently undeveloped arable land covering approximately 18.4ha as shown in Figures 2.1 and 2.2:

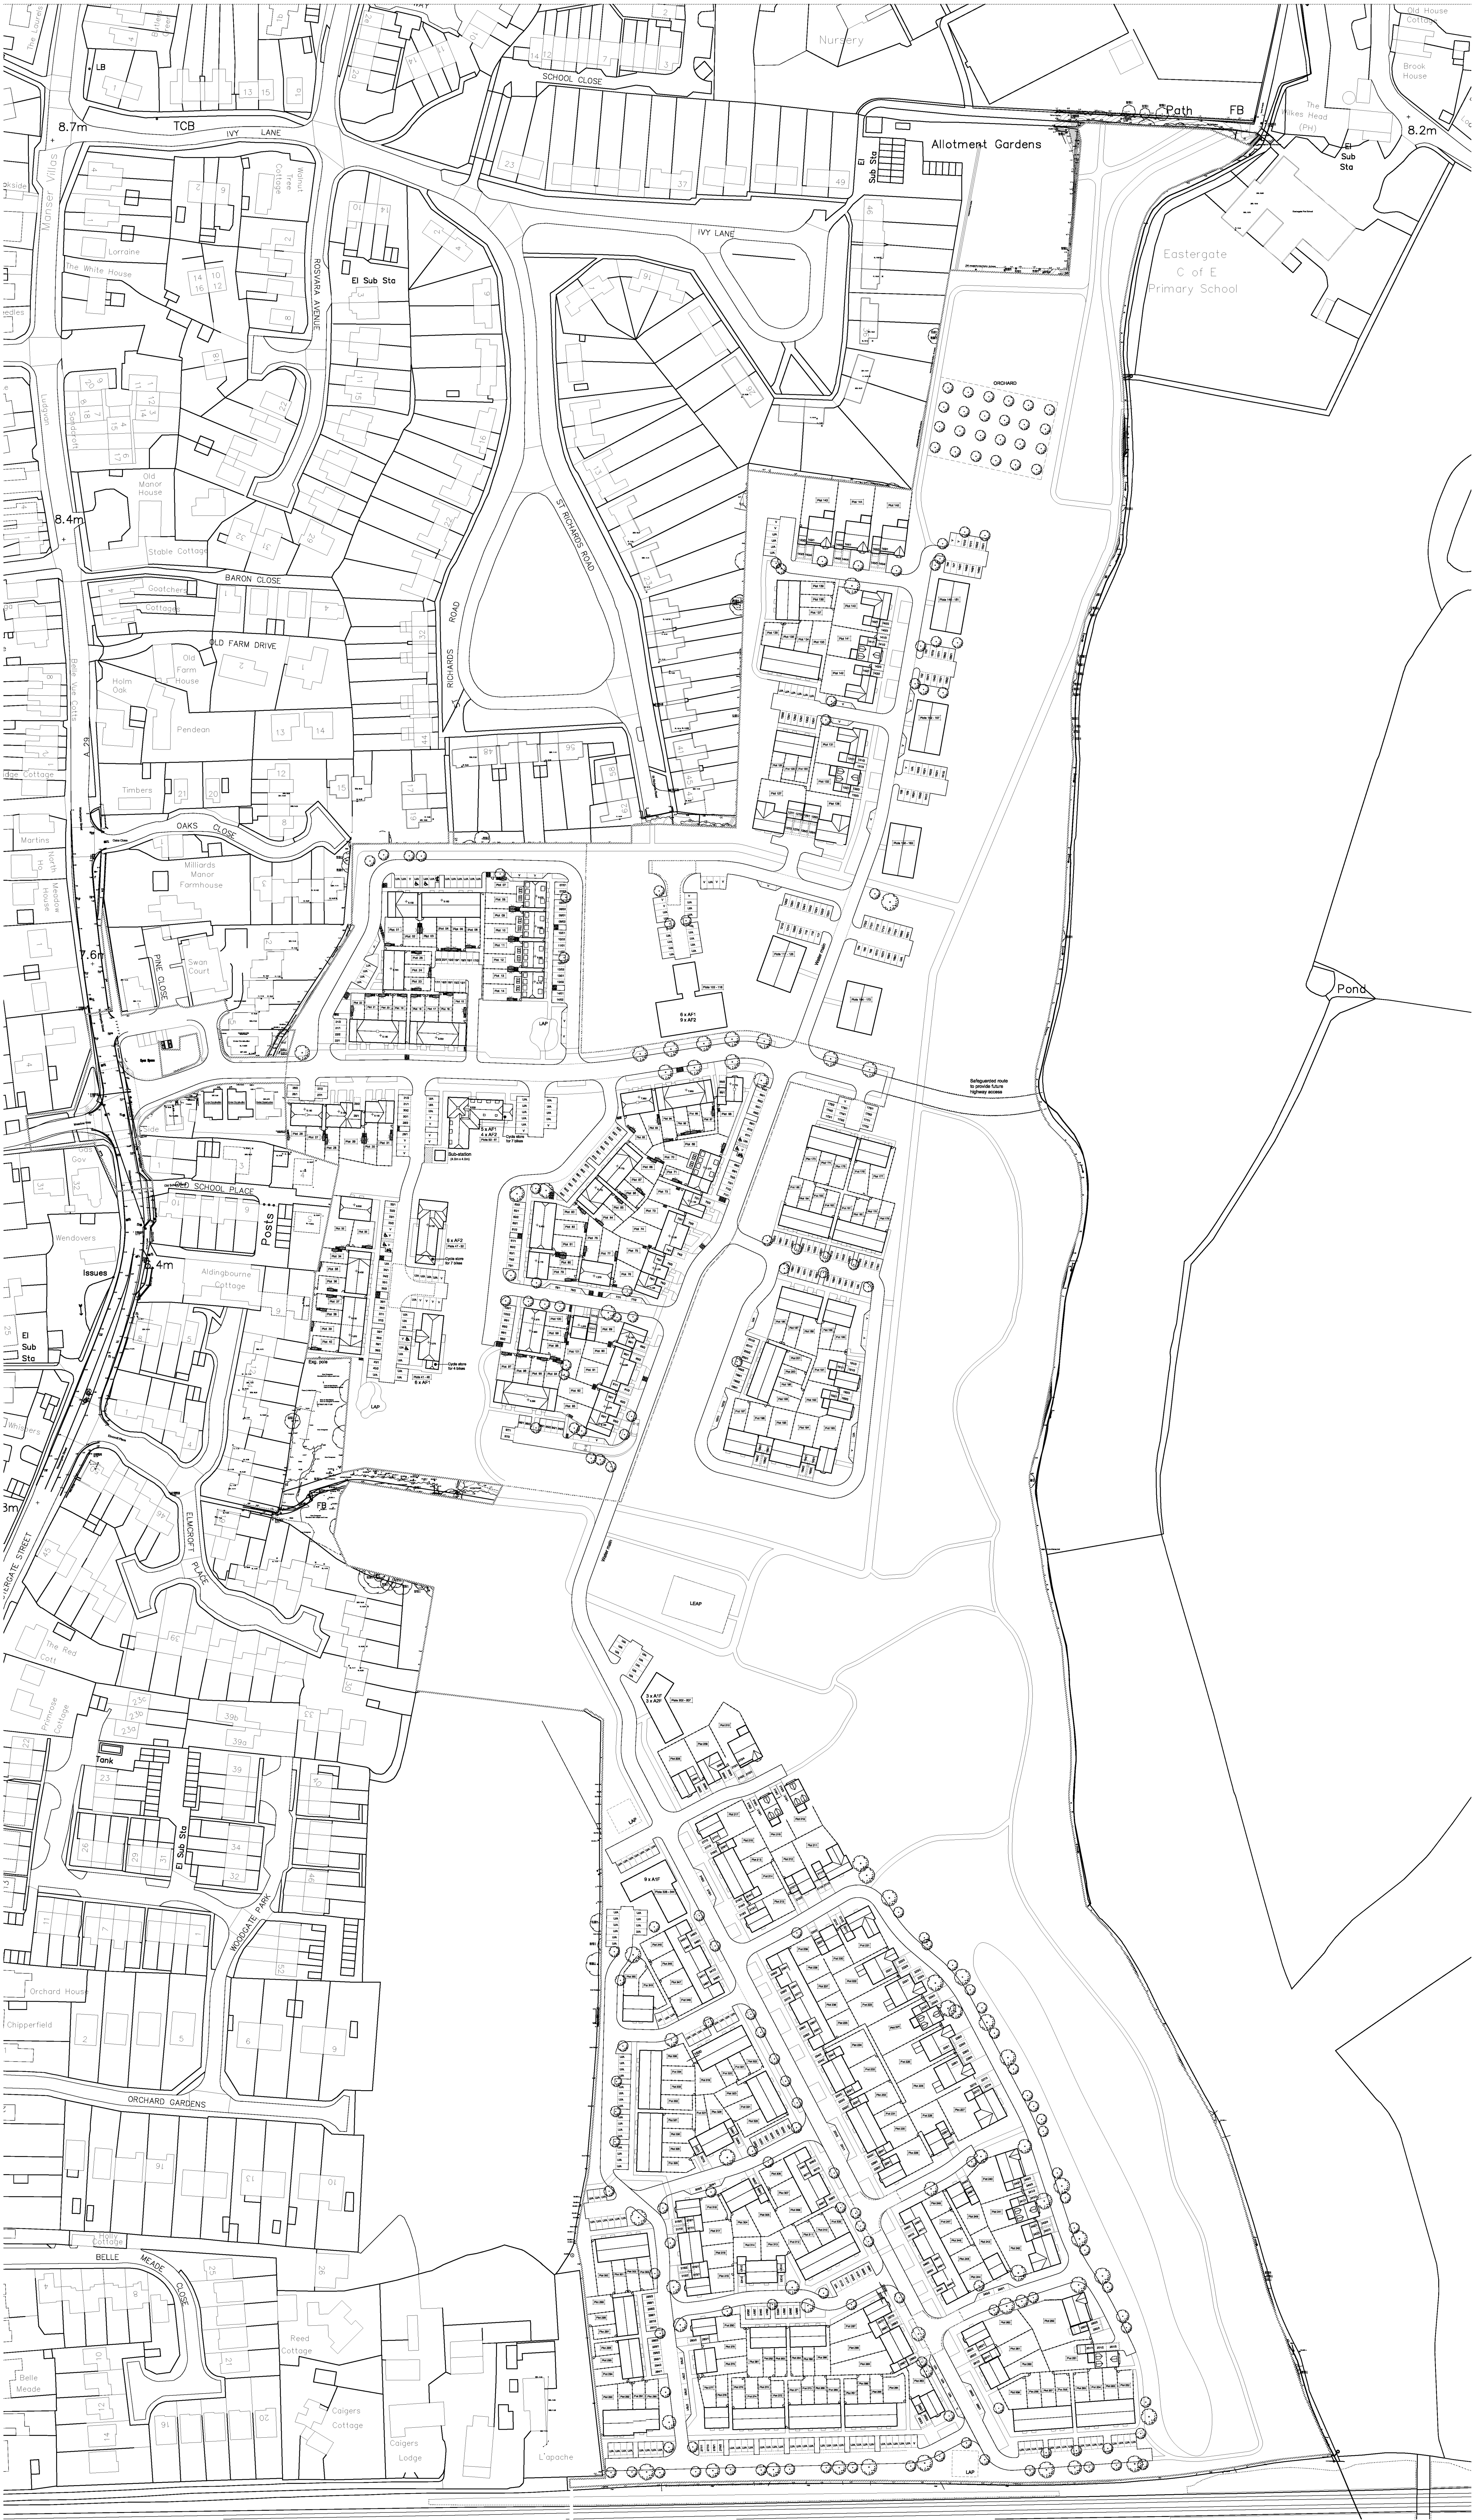
Appendix A: Illustrative Site Layout

| E | 07-11-16 | Disabled and motorcycle parking bays added, safeguarded route indicated and other footpaths added, hard landscaping updated as per landscape architects proposals. (BH) | | | | | | | | | | SCALE: 1:1000 (A0 ORIGINAL) | | DRAWING: Proposed Site Layout Roof Level | | | | | |

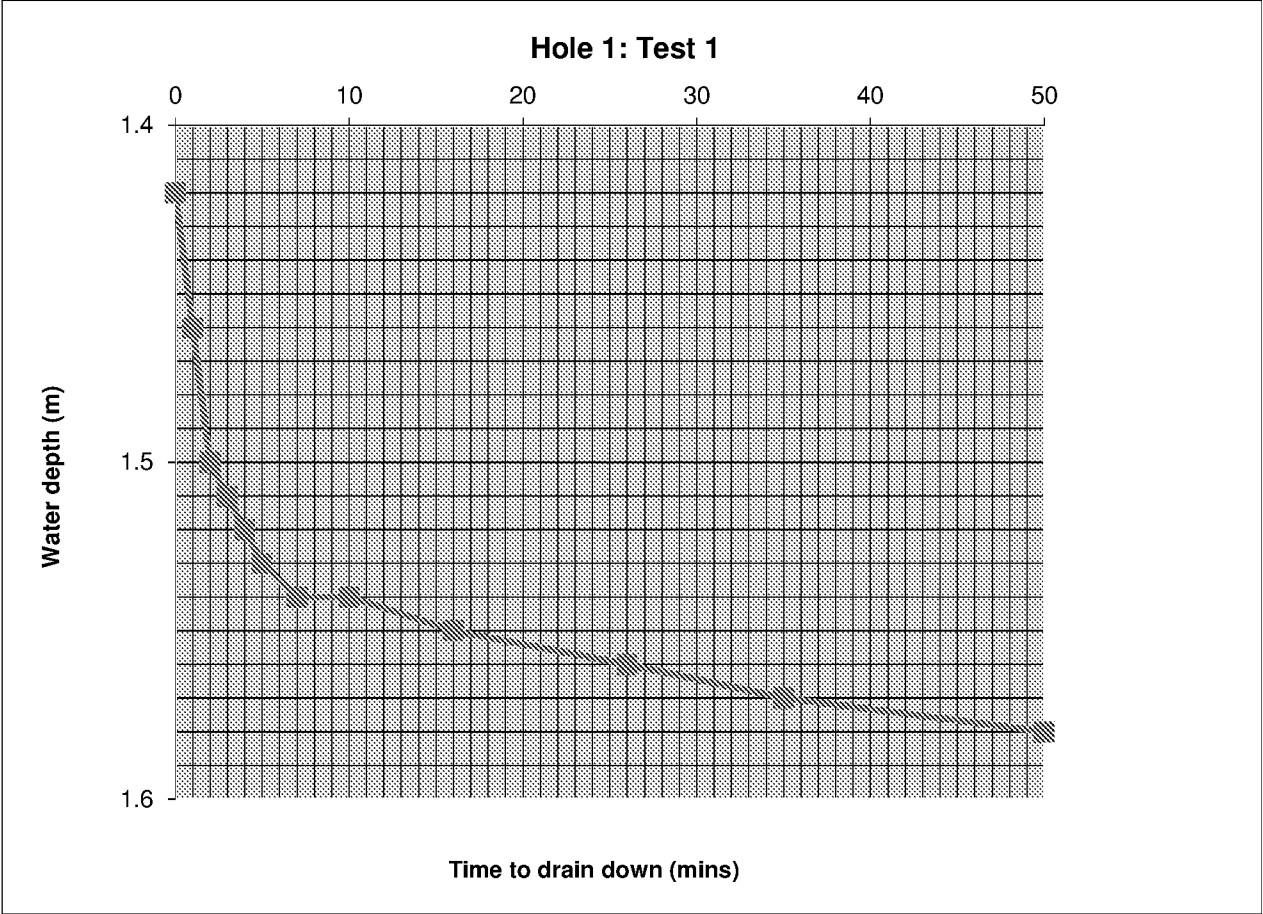
| V (75-25) | 0.088 cu m |
| T (75-25) | 7.500 mins |
| Infiltration rate m/hr | 0.45953 m/hr |
| <b>Infiltration rate m</b> | <b>1.276E-04 m/s</b> |

- 6.13 The Soil Infiltration Rates suggest infiltration drainage methods are viable within the superficial Head Deposits. However, should be limited to permeable pavings as deep infiltration structures are not considered viable due to the high groundwater table and variable depth to the impermeable London Clay which is not considered suitable for soakaway drainage.

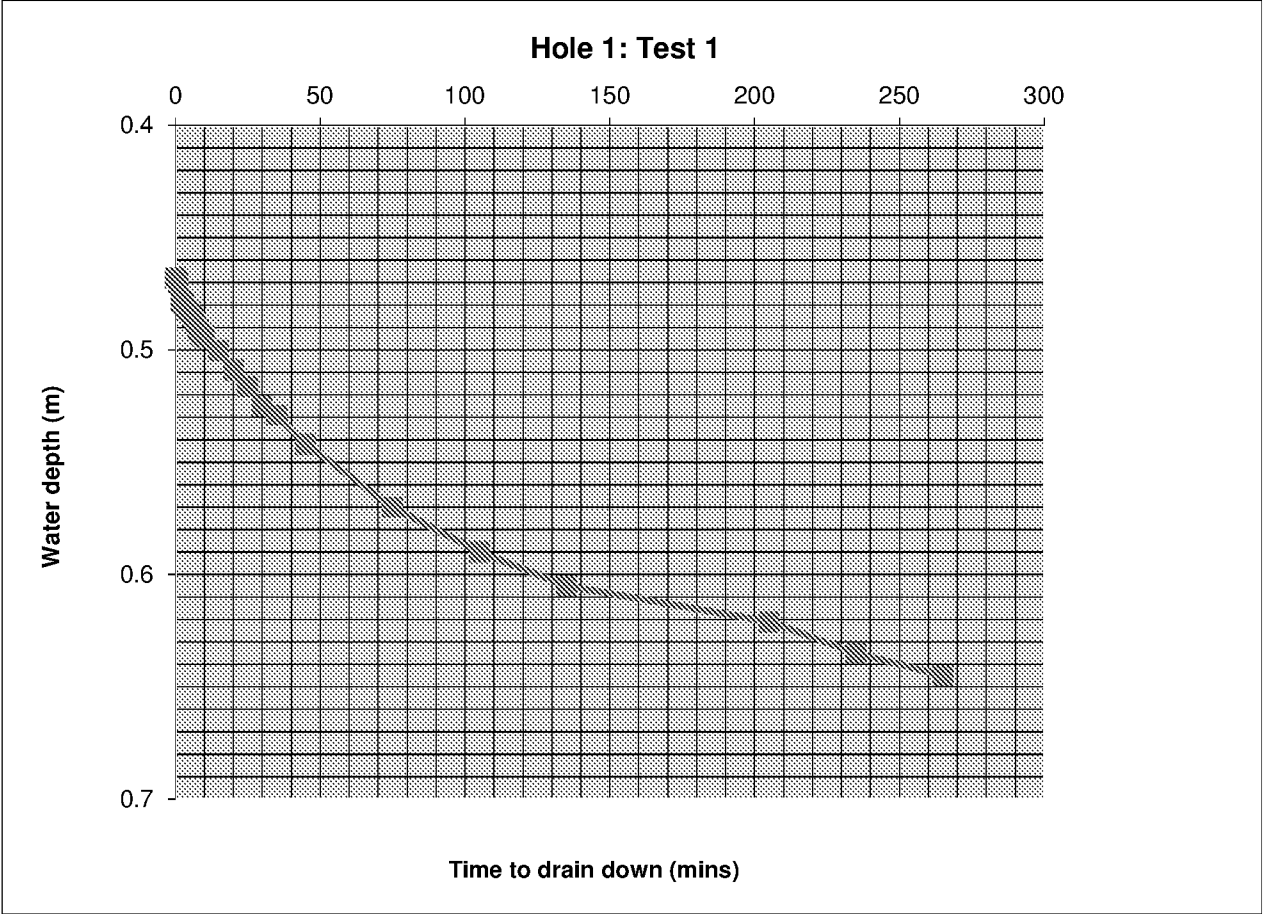
| V (75-25) | 0.099 cu m |
| T (75-25) | 97.000 mins |
| Infiltration rate m/hr | 0.03861 m/hr |
| <b>Infiltration rate m</b> | <b>1.073E-05 m/s</b> |

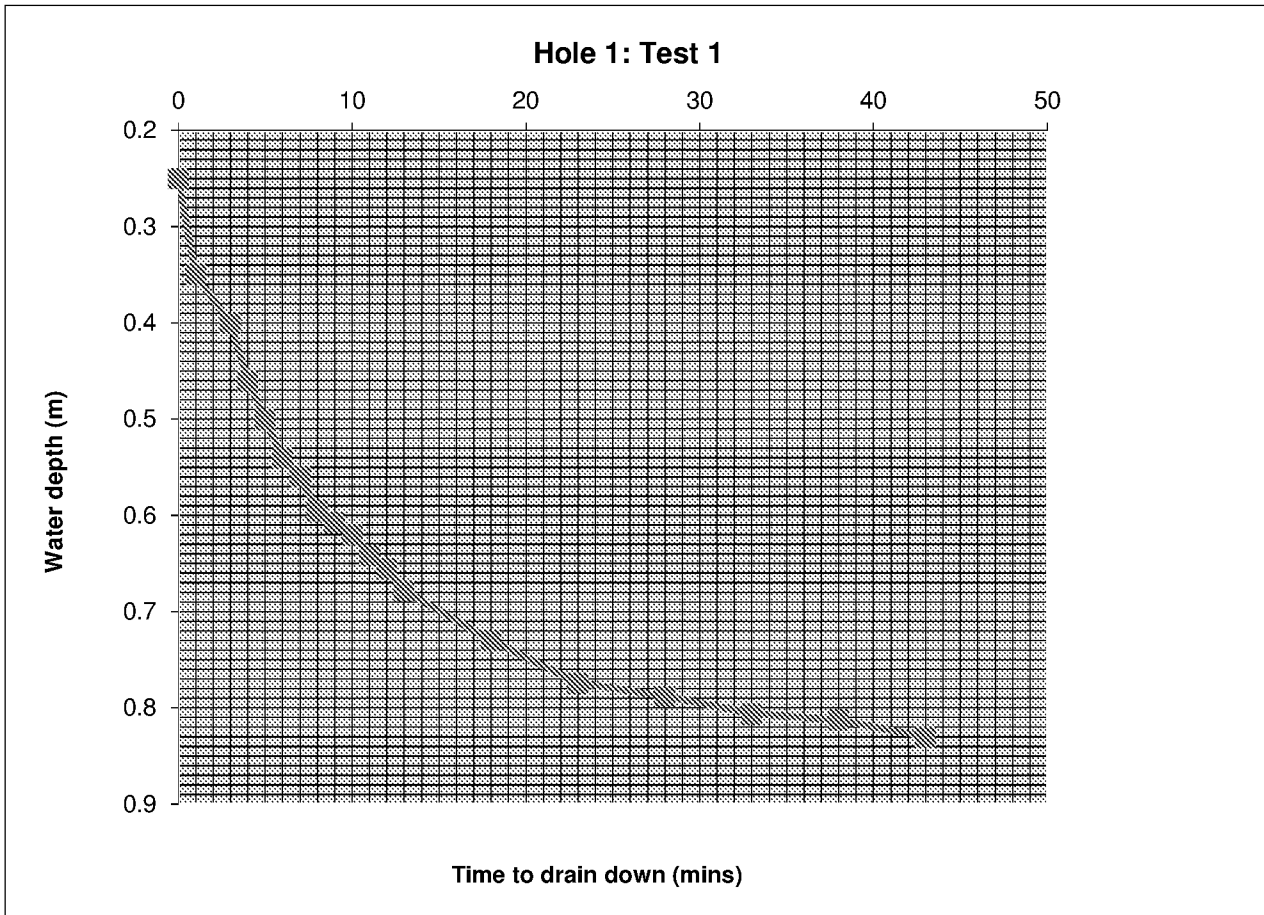
V (75-25) 0.305 cu m

T (75-25) 9.500 mins

Infiltration rate m/hr 0.75182 m/hr

**Infiltration rate m 2.088E-04 m/s**
