## Biodiversity Enhancement Strategy

### Land at Hook Meadow, Westergate

The Ecology Partnership, Thorncroft Manor, Thorncroft Drive, Leatherhead, Surrey KT22 8JB

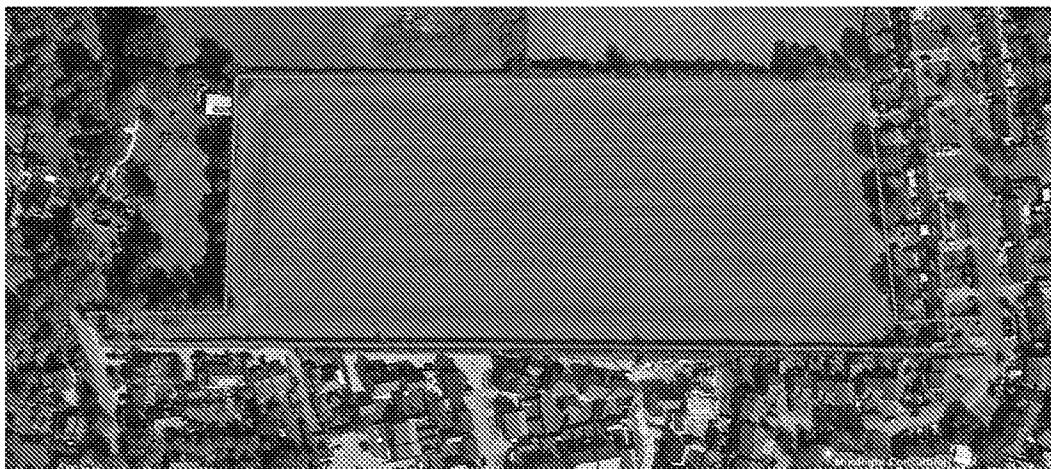
1.1 The Ecology Partnership was commissioned by Redrow Homes to produce a report to support the discharge section 8 of Condition 4 from the appeal decision. The red line boundary of the site is shown below in figure 1.

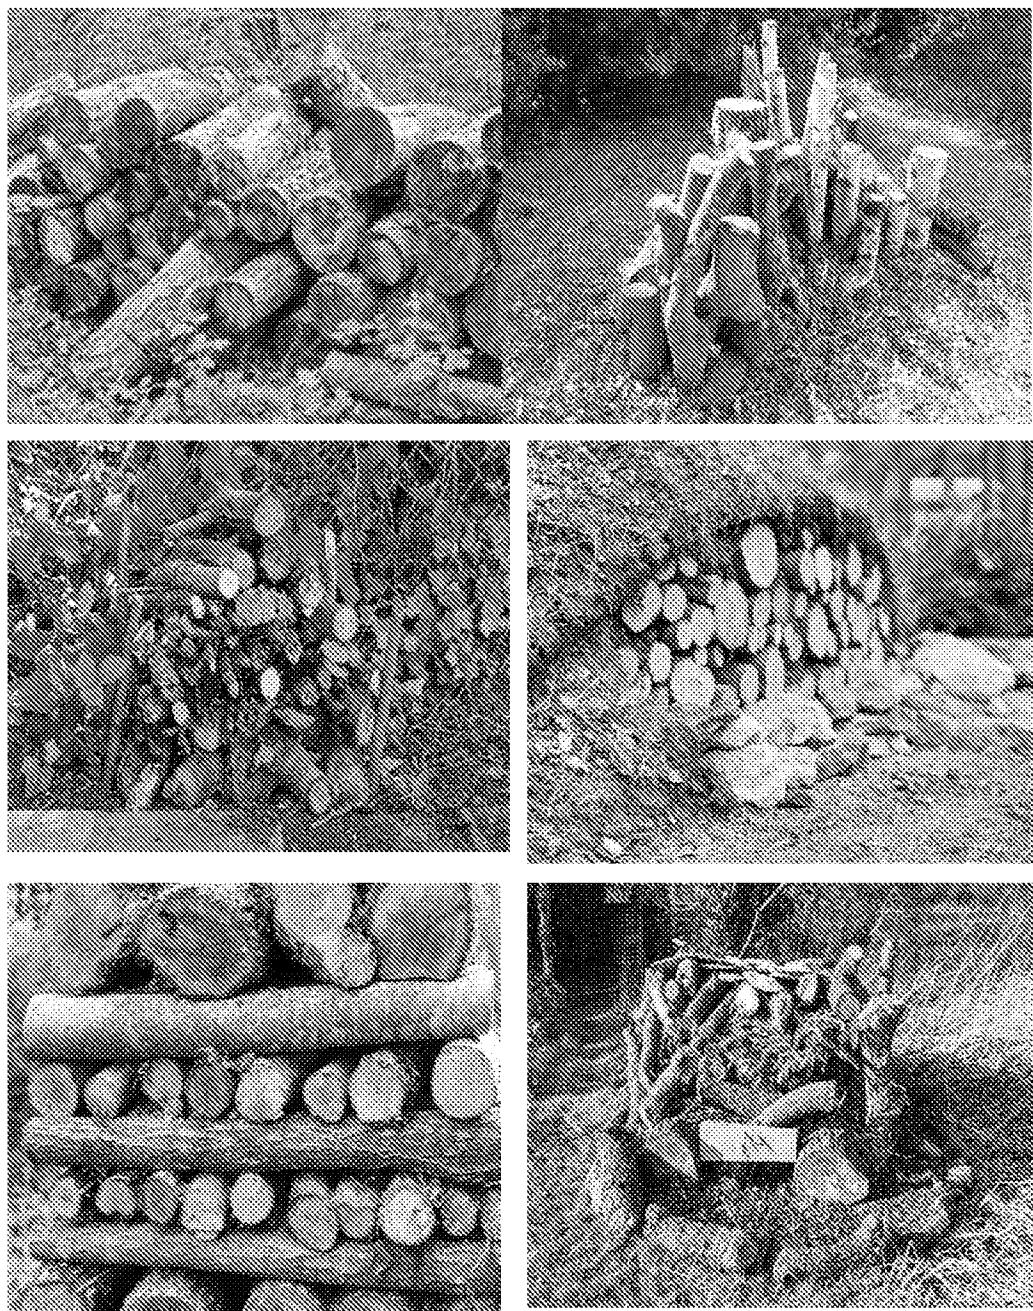
*Figure 2: Examples of log pile creation*

3.2 Log piles are created using any woody material removed during works or bring in locally sourced wood / brash for use as refugia by reptiles, amphibians, small mammals and invertebrates such as stag beetles.

3.3 These can be located within the retained grassland site boundaries and scrub / grassland creation areas. These should be stacked, and leaf litter added. Examples of log piles are shown in Figure 2 below. It is recommended that two formalised log piles (which logs dug in) are utilised, with the remaining 4 piles a mixture of larger stacked logs and smaller brash. Leaf litter and the use of turf can also add value. The locations of the log piles are shown in Appendix 1.

3.4 The created log piles must be covered with a wire mesh nailed into the logs to provide a deterrent to vandalism and residents removing the logs for personal use.

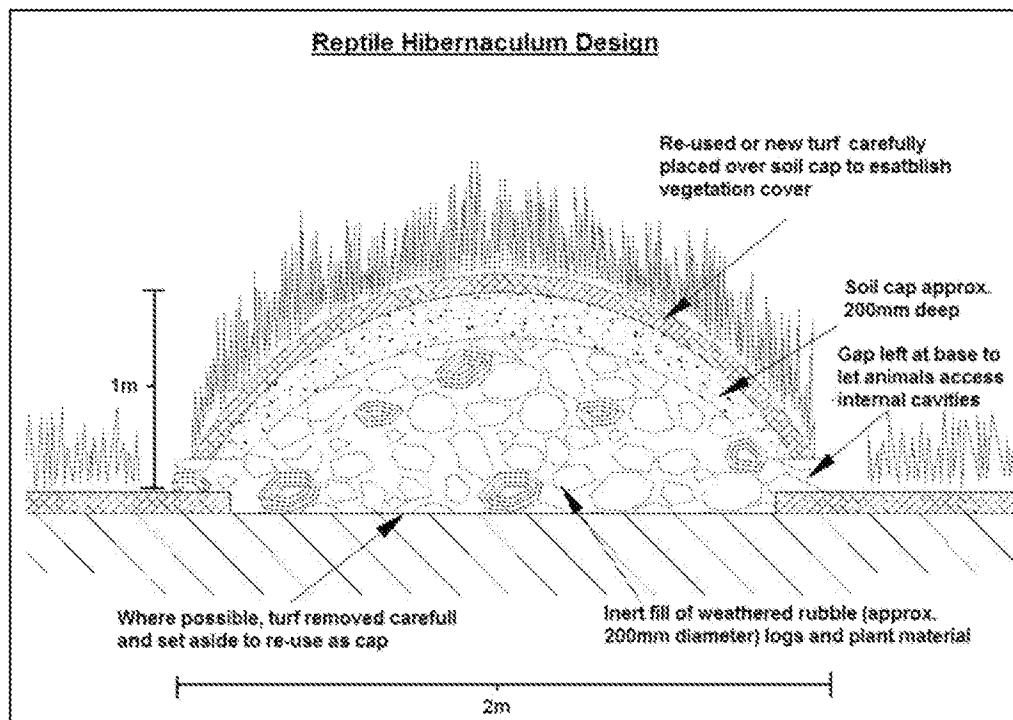
*Figure 3: Reptile Hibernacula (Taken from London Gatwick Northern Runway Project, 2024)*

3.5 Reptile rubble hibernacula will be created on site. These will be formed by taking the turf up from the ground where the feature is to be situated. Then a pile of rubble will be formed with cracks and cavities for reptiles to access. Finally, the feature will be covered over with

earth and the turf that was removed at the beginning of the process. (See Figure 3, Locations are shown in Appendix 1).

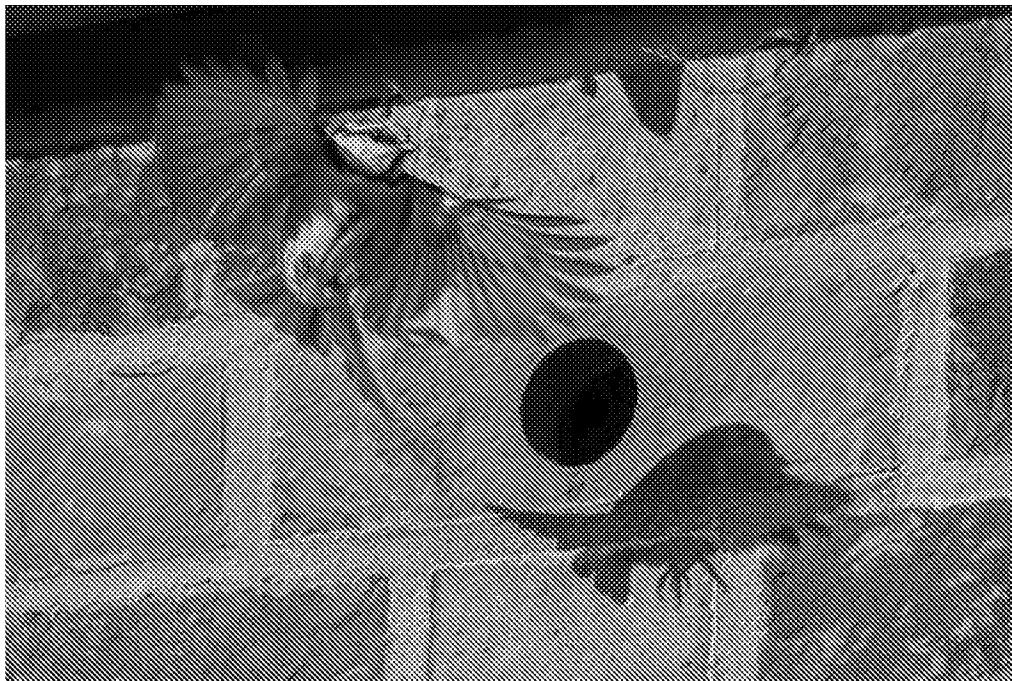
*Figure 4: An example of a Bird Brick Houses bird box (Bird Brick Houses, 2024)*

3.6 Integral bird and bat boxes will be built into new houses on site. The locations are shown in Appendix 1. These should be built high up on the external wall of new buildings, a minimum of 4m from the ground. The boxes can be built to match brick types or can be rendered over in keeping with the rest of the build. These features contain a sealed unit which wildlife can use within the wall and will not be able to access other areas of the building. These features require no maintenance. Models by Bird Brick Houses are recommended although alternative long-lasting models maybe used to best match the design of the new dwellings.

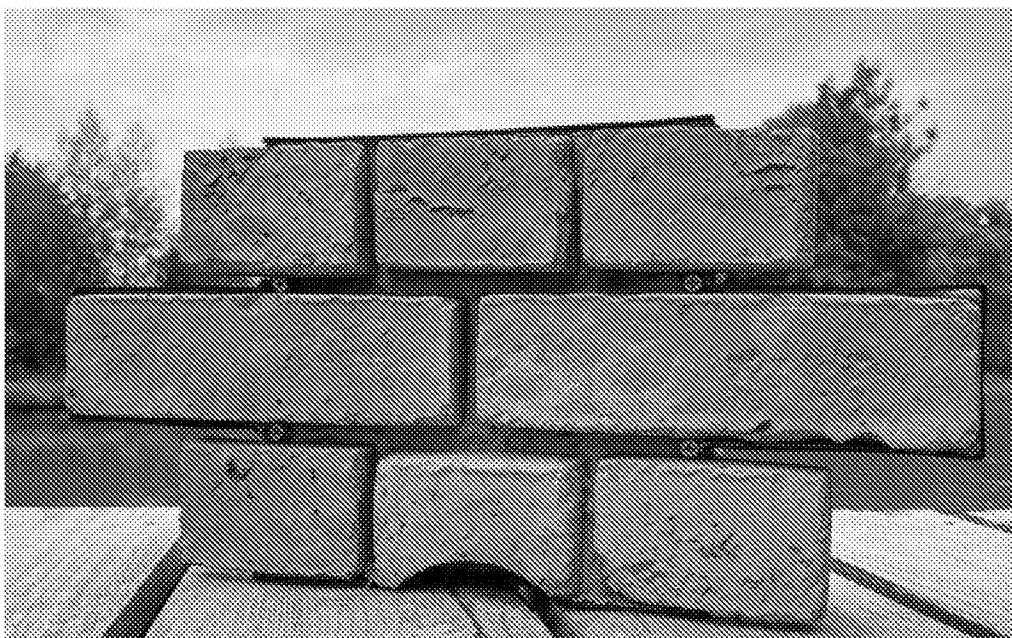
*Figure 5: An example of a Bird Brick Houses bat box (Bird Brick Houses, 2024)*

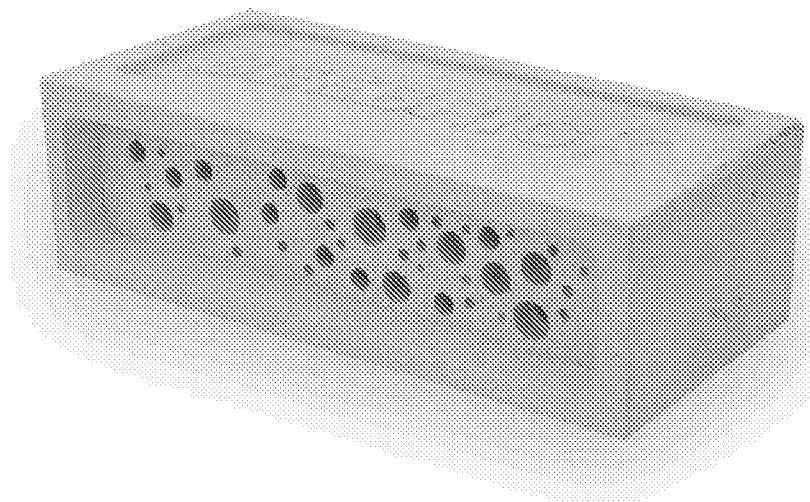
*Figure 6: Integrated Bee Brick*

Twelve Bee Bricks will be built into the south facing walls within the development. These provide breeding habitat for solitary bees.

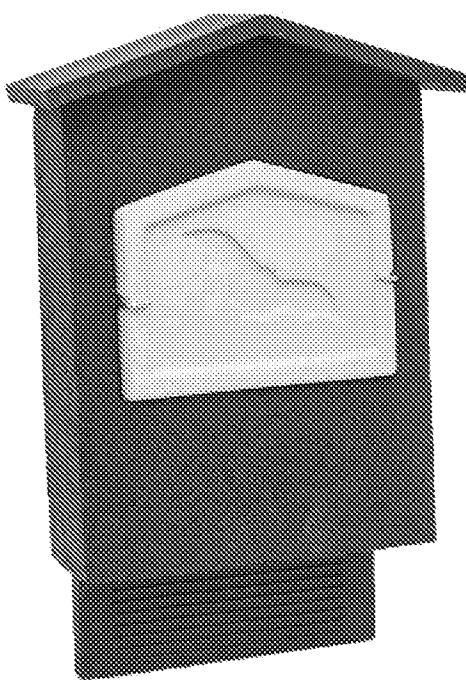
*Figure 7: Vivara Pro Low Profile WoodStone Bat Box*

- 3.7 In addition two bat boxes will be installed on mature trees to the north and southwest of the site. It is recommended that a woodcrete box is used such as the Vivara Pro Low Profile WoodStone Bat Box, for a long-lasting maintenance free bat box. These should be cited a minimum of 4m from ground level with an orientation of southwest, south or southeast and should be exposed to the sun for at least a part of the day.

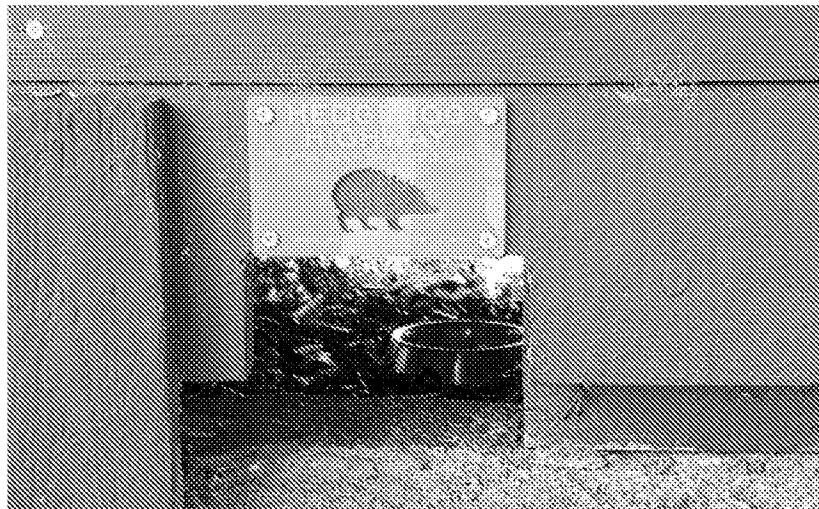
*Figure 8: Hedgehog Highway Hole*

- 3.8 Hedgehogs have suffered substantial decline in recent decades for a variety of reasons, one of which is a decline in suitable habitat and connectivity around developments. As such hedgehog highways shall be designed into the wooden fencing on site. These gaps will also allow movement of other species across the site such as reptiles, amphibians, and small mammals. The hedgehog highway gaps will be 13 x 13 cm and will be marked with a small sign so residents know of their significance.

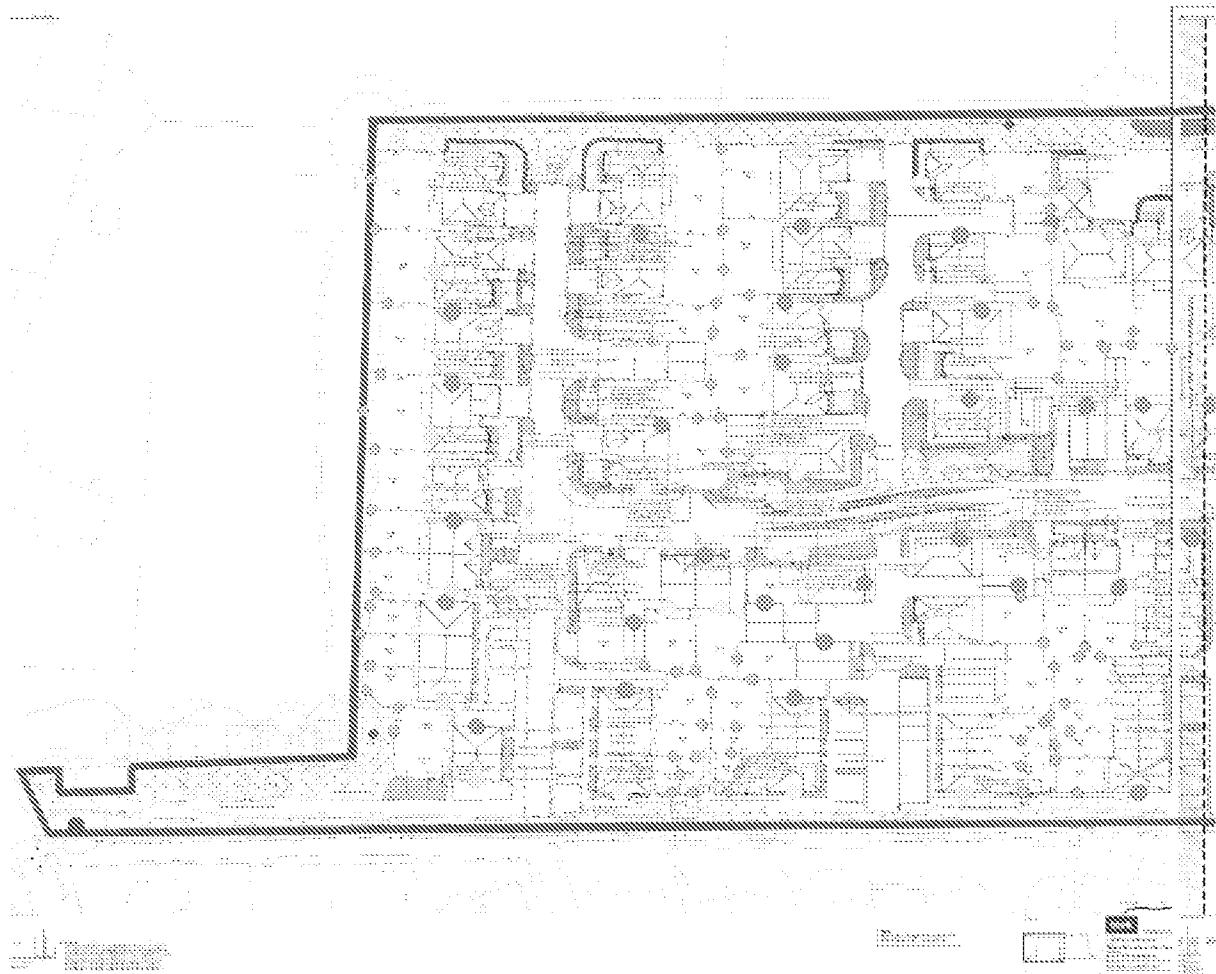
Title: Ecological Enhancements 1 of  
2

Integrated Bat Box	●
Integrated Bird Box	●
Bat Box in Tree	●
Integrated Bee Brick	●
Log Pile	▲
Hedgehog Highway	●
Reptile Rumble Hibemacula	●
Red Line Boundary	■

3.1 Due to the nature and extent of the development, ecological enhancements are restricted to the use of log piles around the edges of the site to support common reptile species which are known to be present in around existing site boundaries and within the landscape and hedgehogs, which are known to be present within the residential adjacent to the site and potentially utilising the habitat edges. In addition, bird and bat boxes as well as bee bricks are also proposed. Locations of ecological features are shown in Appendix 1. These will total:

- 20 x Integrated Bat Boxes within Buildings;
- 45 x Integrated Bird Boxes within Buildings;
- 12 x Integrated Bee Bricks within Buildings;
- 2 x Bat Boxes on Trees; and
- 3 x Log Piles
- 3x Rubble Hibernacula
