# **DEVELOPMENT ARCHAEOLOGY SERVICES LTD.**

## **AN ARCHAEOLOGICAL DESK BASED ASSESSMENT STUDY OF LAND AT LIDSEY LODGE FARM, SACK LANE, LIDSEY, WEST SUSSEX.**

**[Site Centred at approximately National Grid Reference SU 9454 0258]  
West Sussex HER Reference: 202021-211**

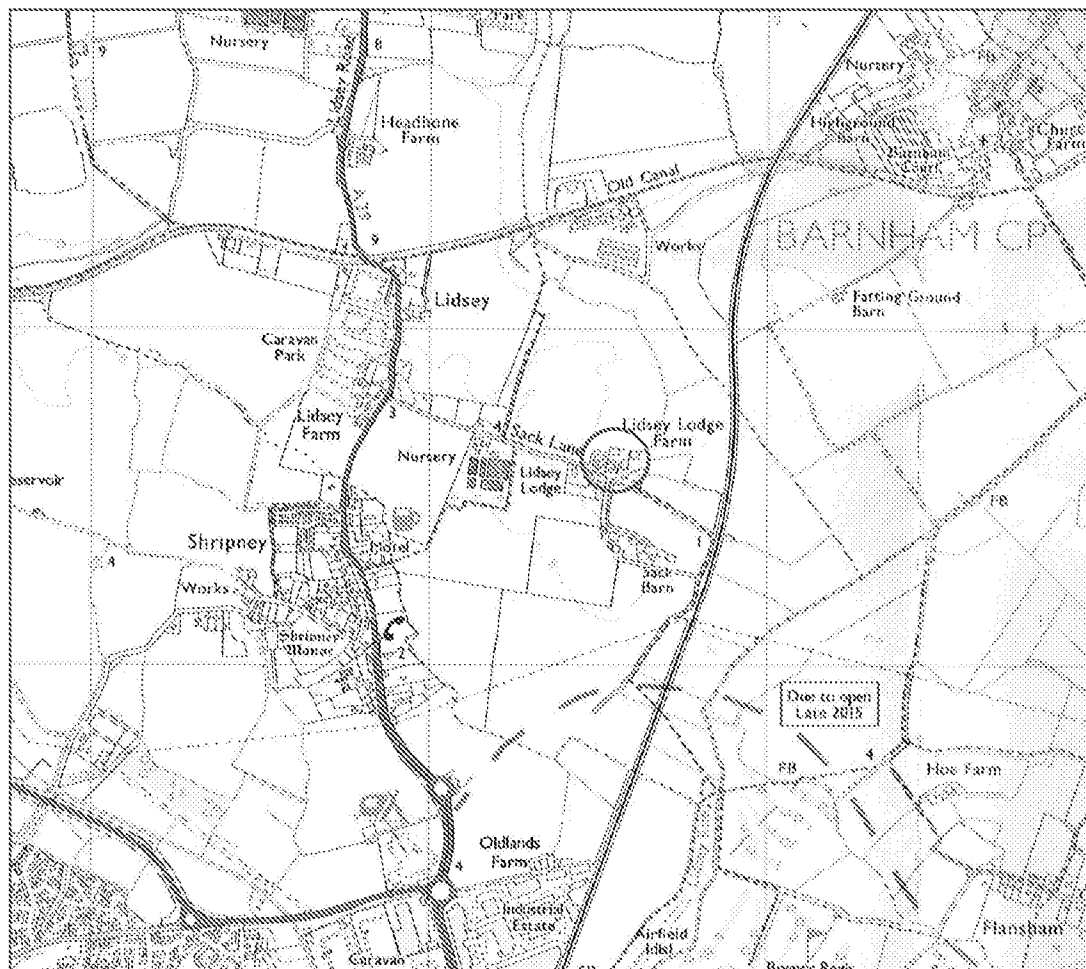
**Figure 1:** General site location at a scale of 1:25,000. The area of the proposed development site is shown encircled in red. (O.S. copyright licence number 100048723)

## **2.0 Location and description [Figures 1 and 2]**

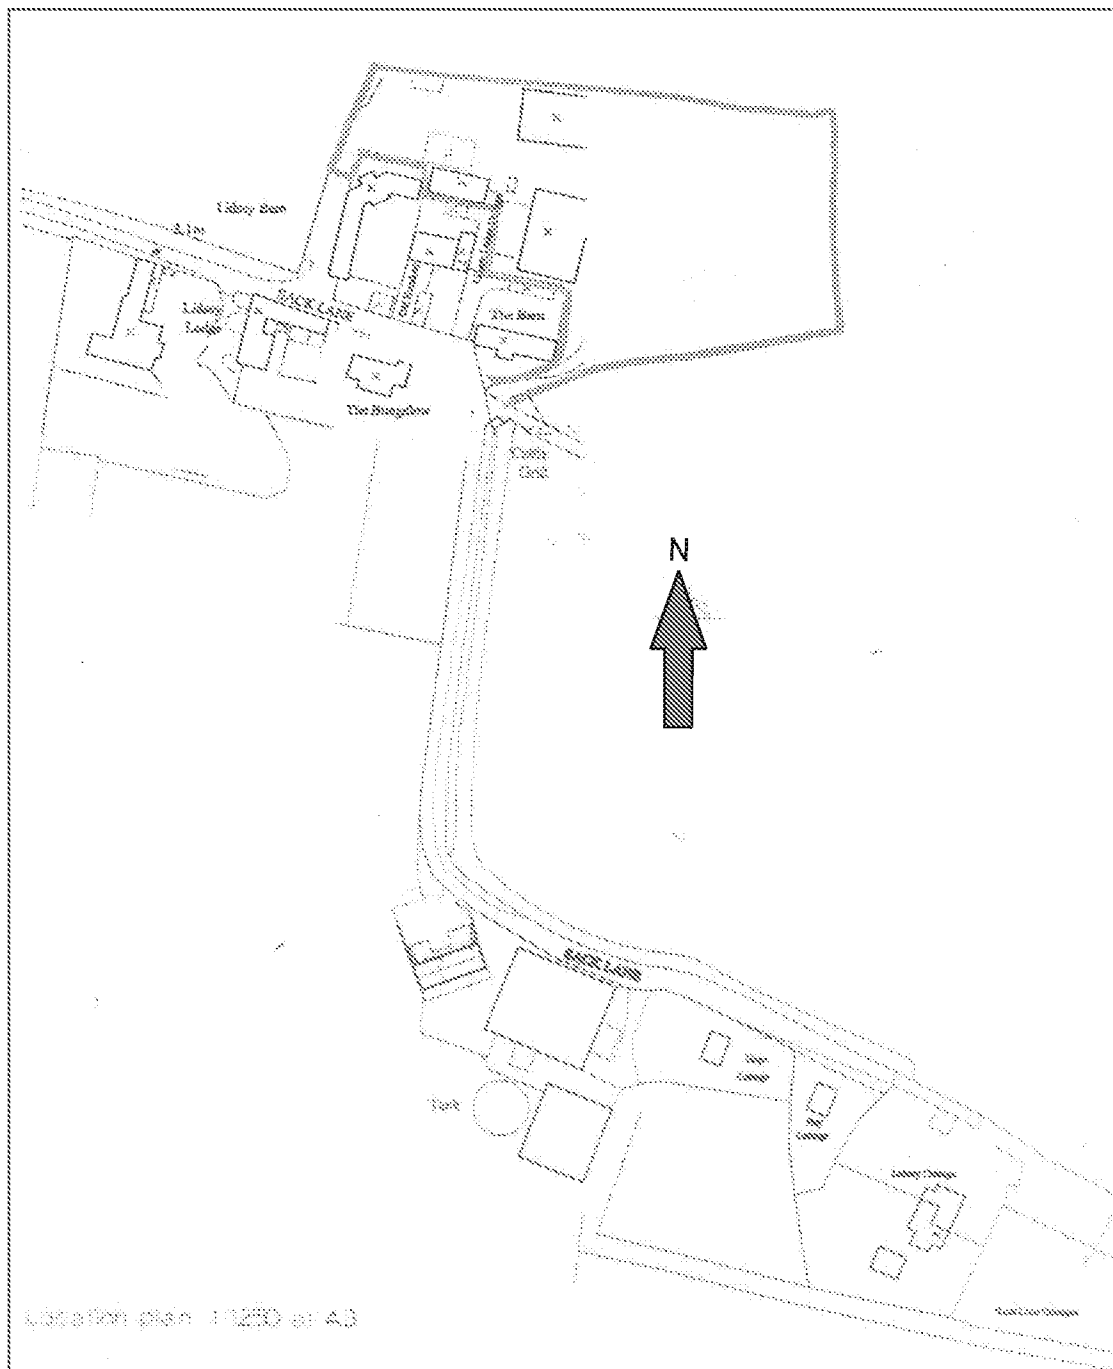
**Figure 2:** Site location at an original scale of 1:1,250 at A3, (extract from Architects plan)

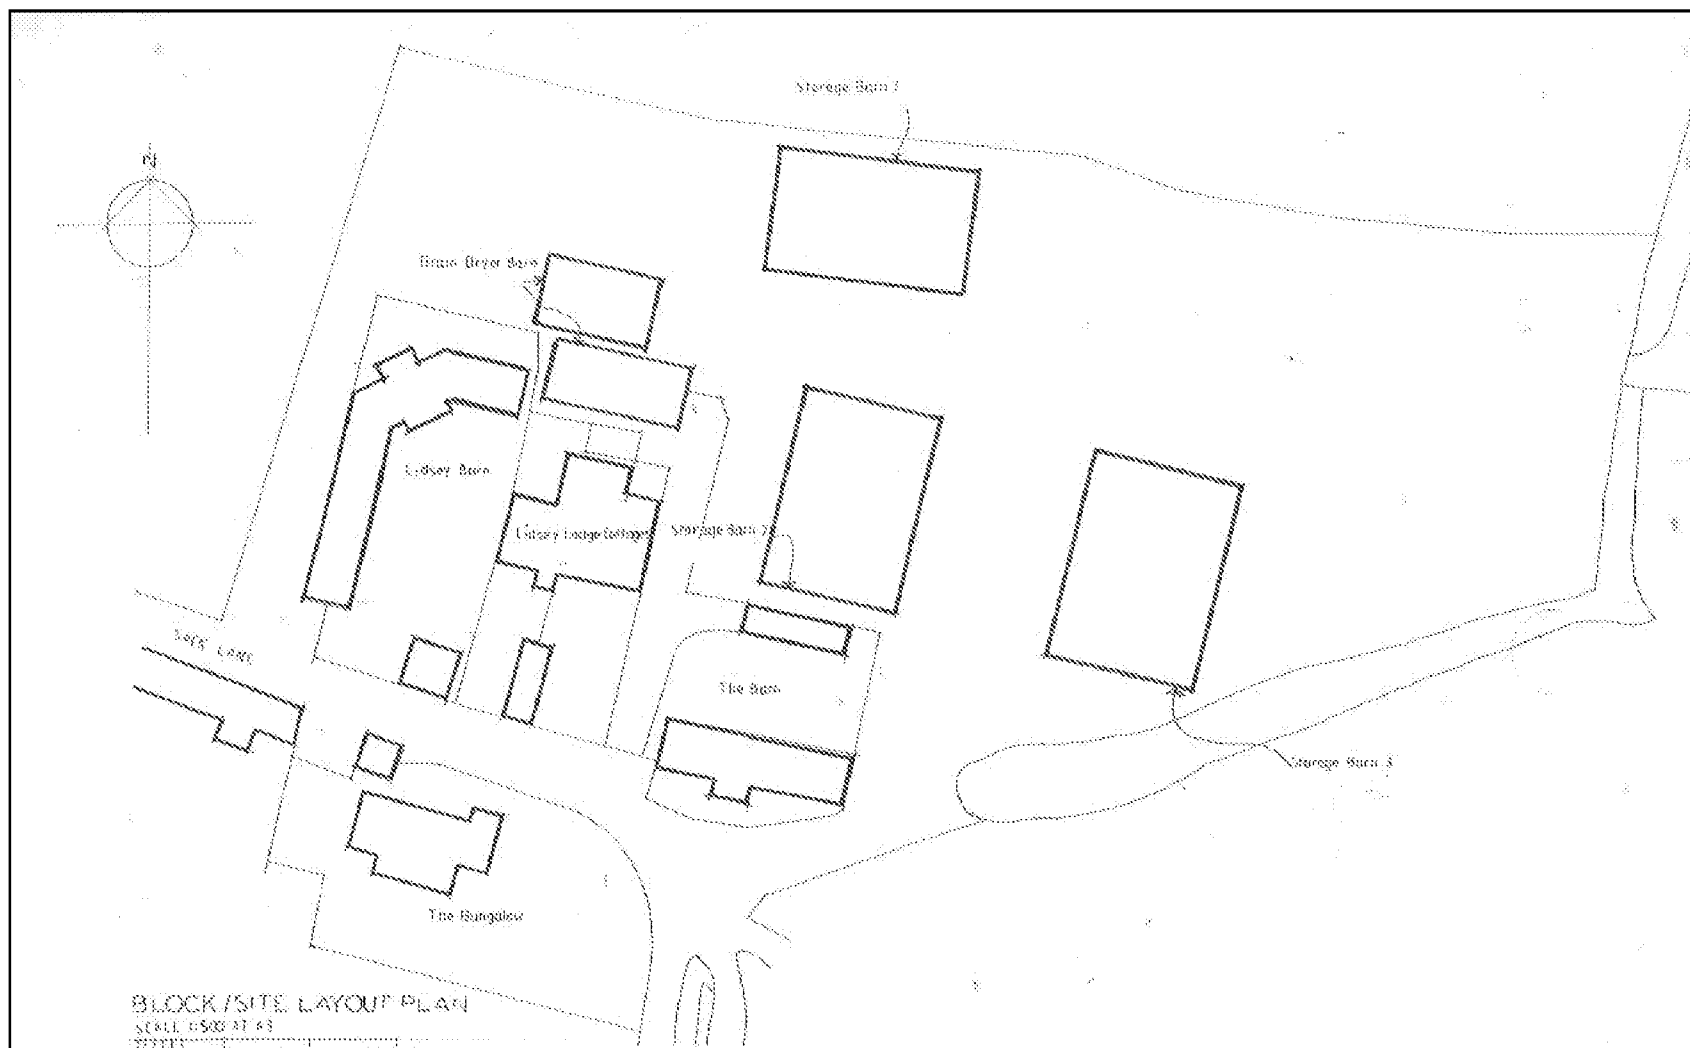
**Figure 3:** Plan showing the existing layout of the development site at an original scale of 1:500 at A3, (extract from Architects plan)

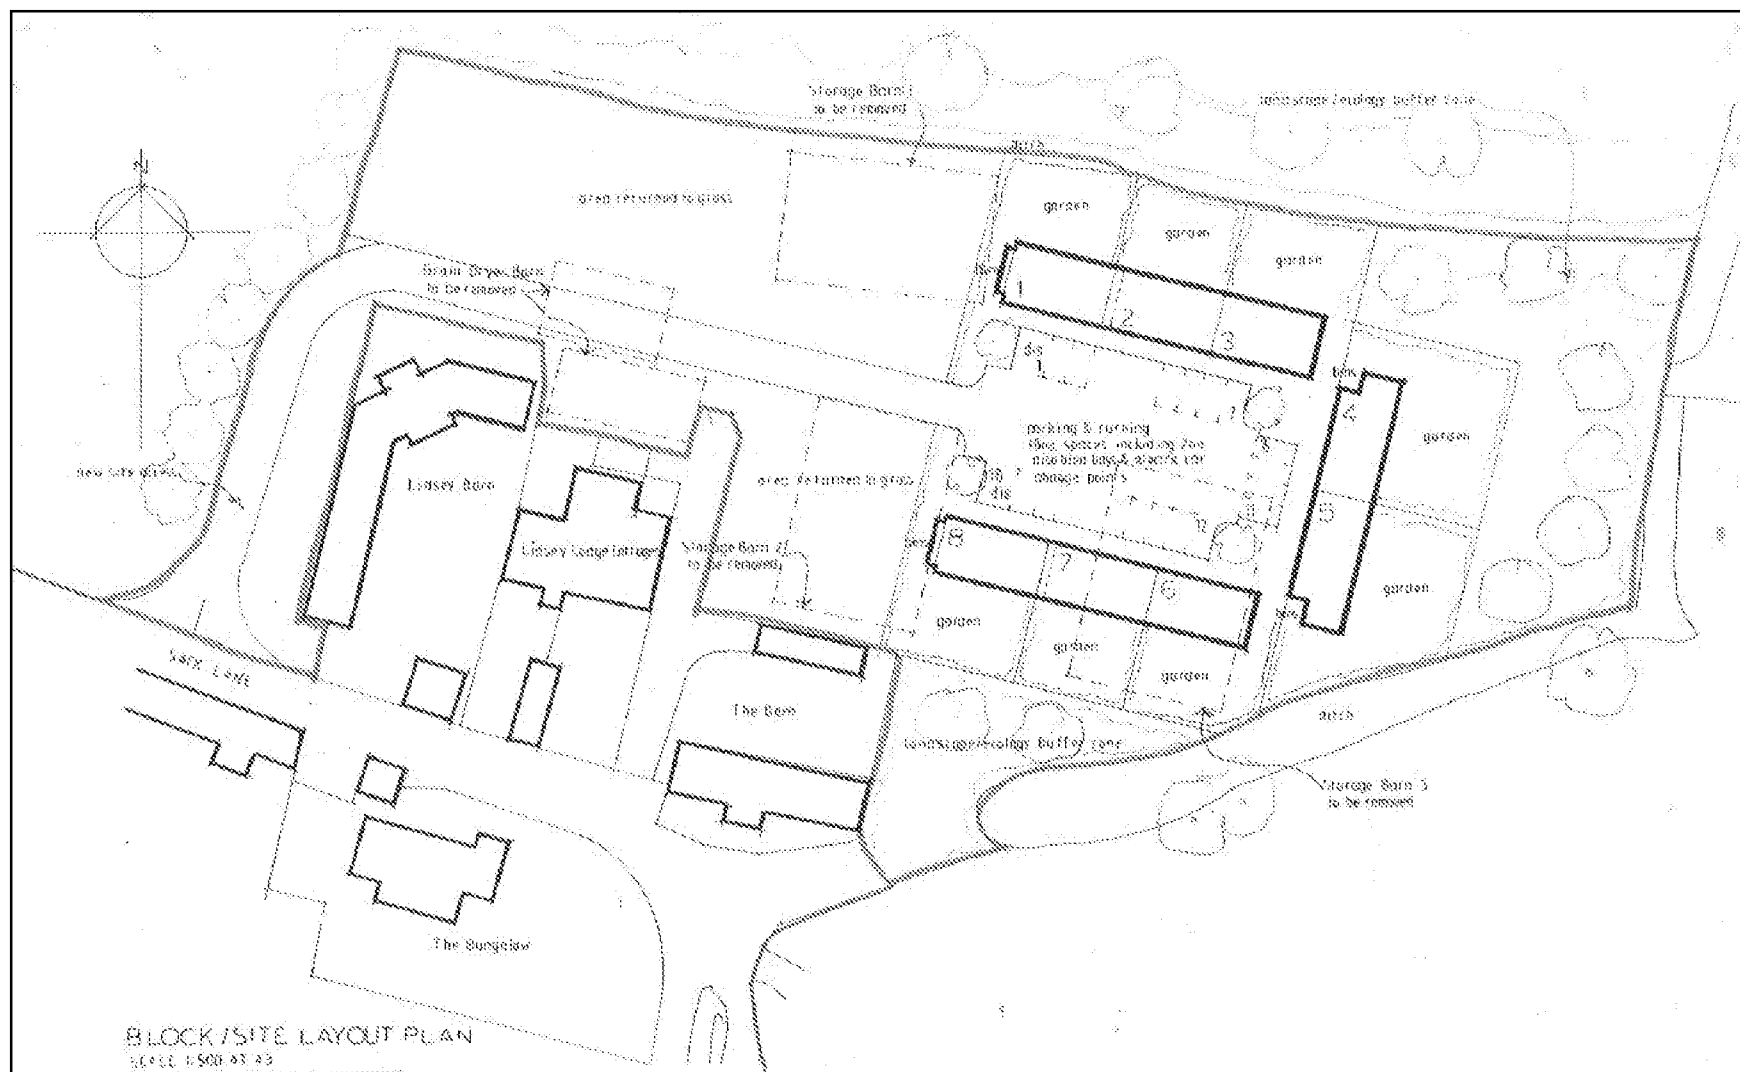
**Figure 4:** Plan showing the proposed layout of the development site at an original scale of 1:500 at A3, (extract from Architects plan)

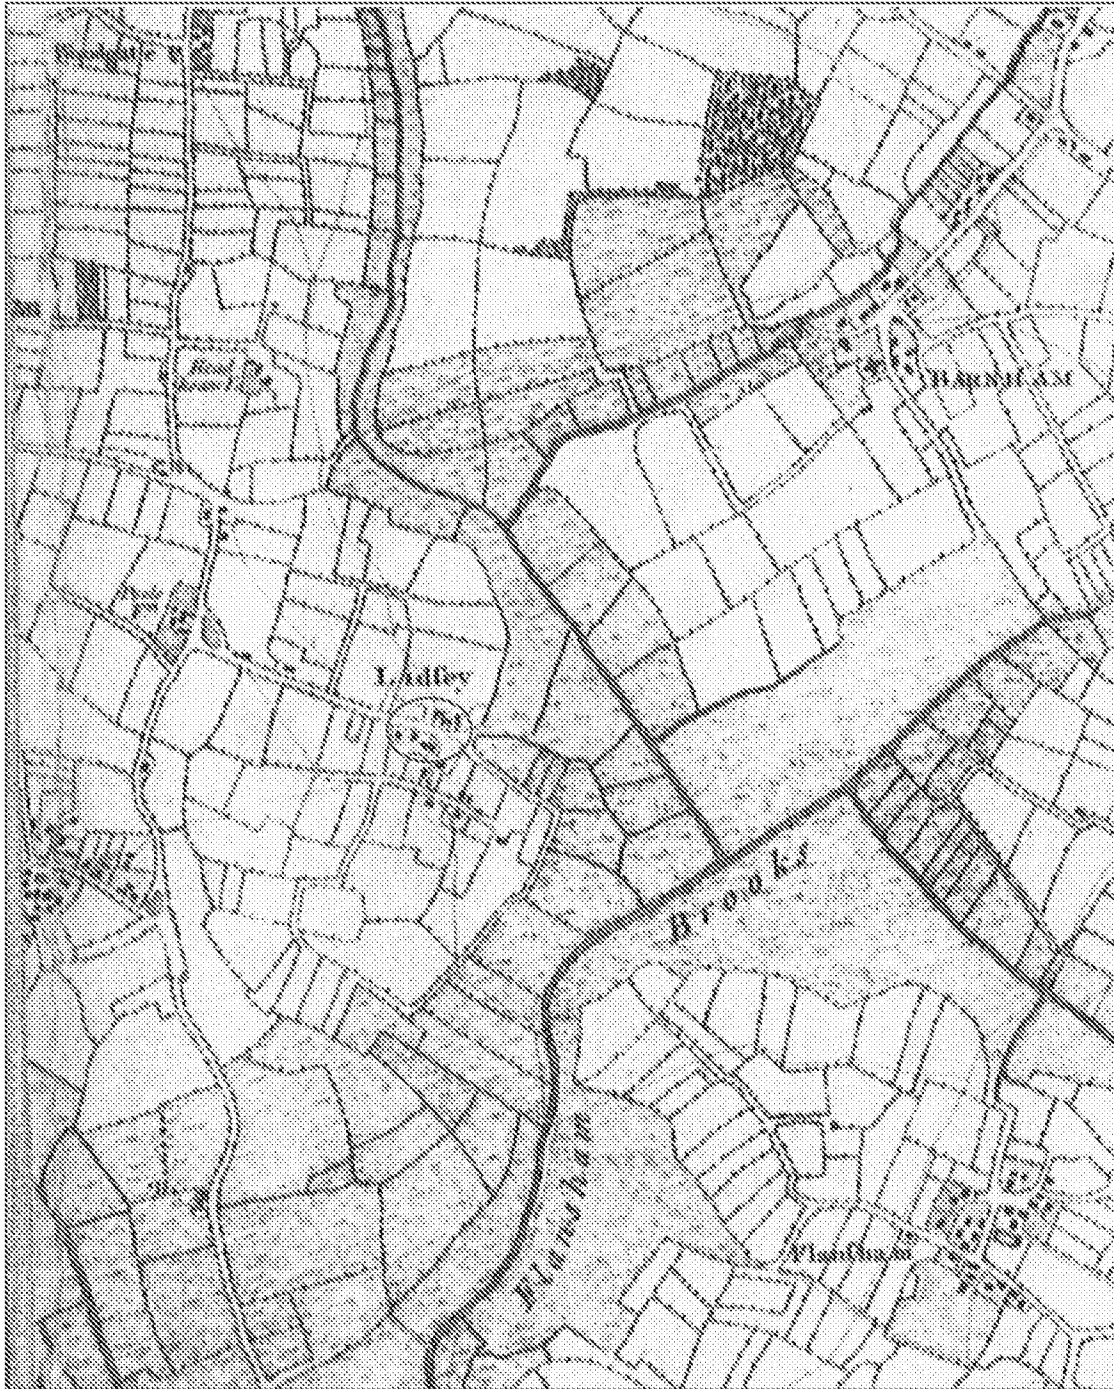
**Figure 5:** Extract from Yeakell & Gardner's map of the county of West Sussex of 1778. The area of the assessment site is shown encircled in red.

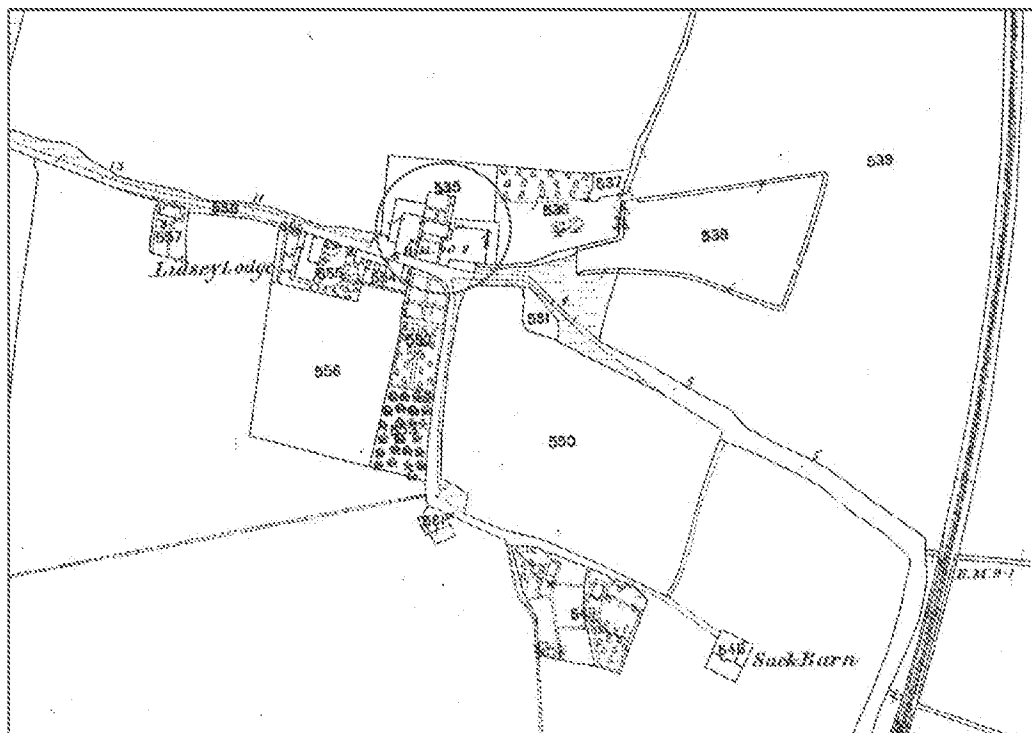
**Figure 6:** Extract from the First Edition 25 inch to one-mile scale Ordnance Survey (O.S.) map of 1876, map sheet no. Sussex 62.9. The area of the assessment site is shown encircled in red.

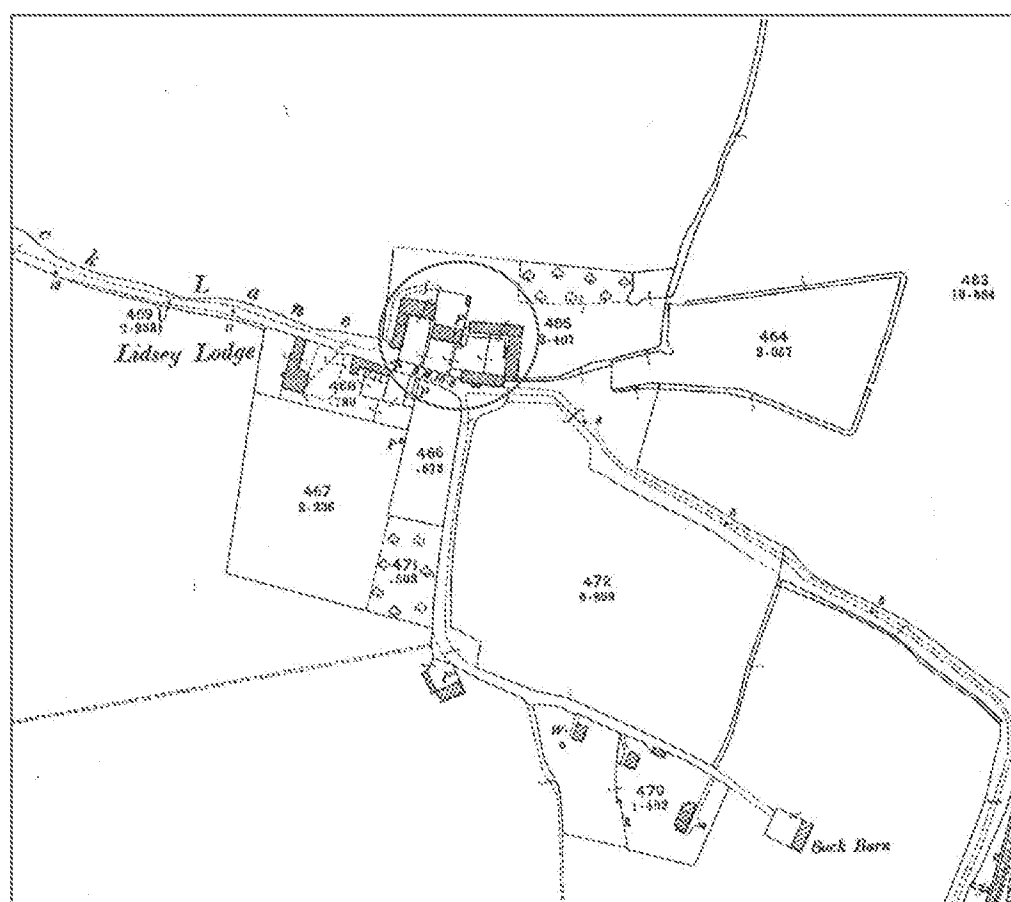
**Figure 7:** Extract from the Second Edition 25 inch to one-mile scale Ordnance Survey (O.S.) map of 1898, map sheet no. Sussex 62.9. The area of the assessment site is shown encircled in red.

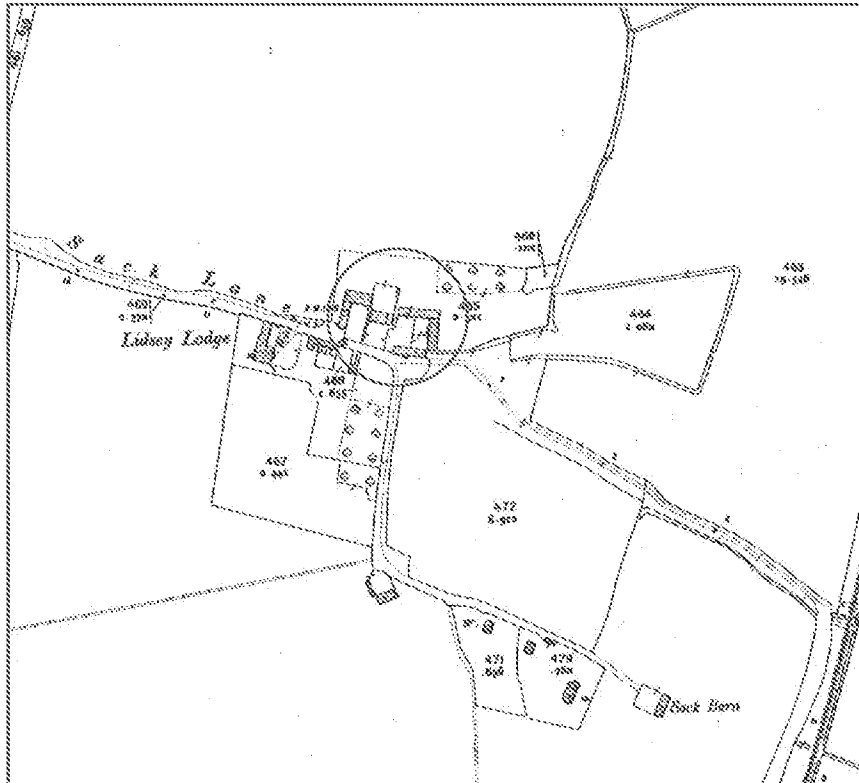
**Figure 8:** Extract from the Third Edition 25 inch to one-mile scale O.S. map of 1912, map sheet no. Sussex 62.9. The area of the assessment site is shown encircled in red.

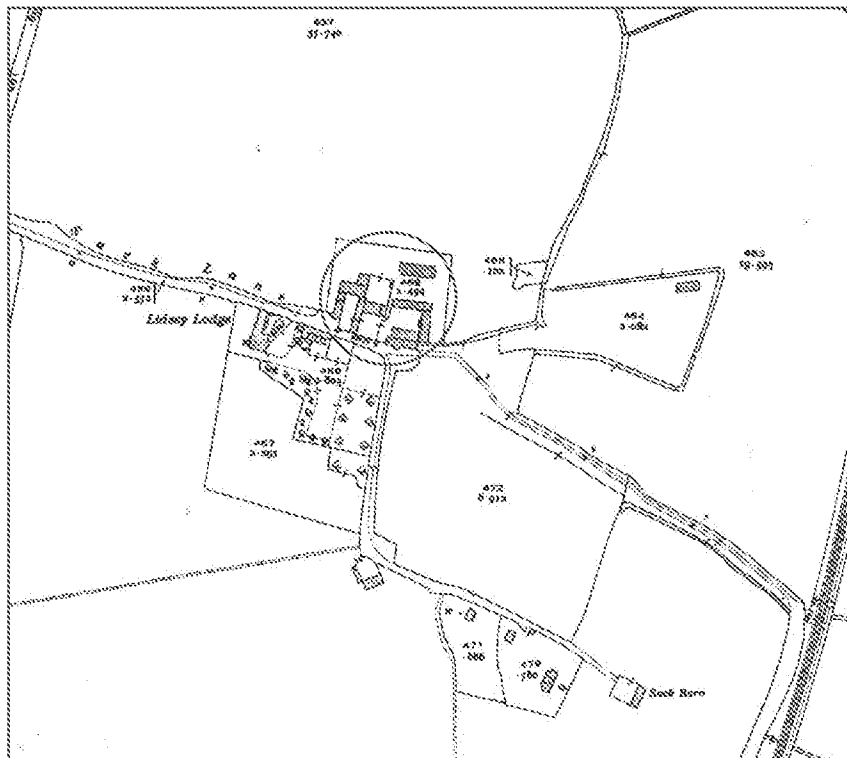
**Figure 9:** Extract from the Fourth Edition 25 inch to one-mile scale Ordnance Survey (O.S.) map of 1940, map sheet no. Sussex 62.9. The area of the assessment site is shown encircled in red.

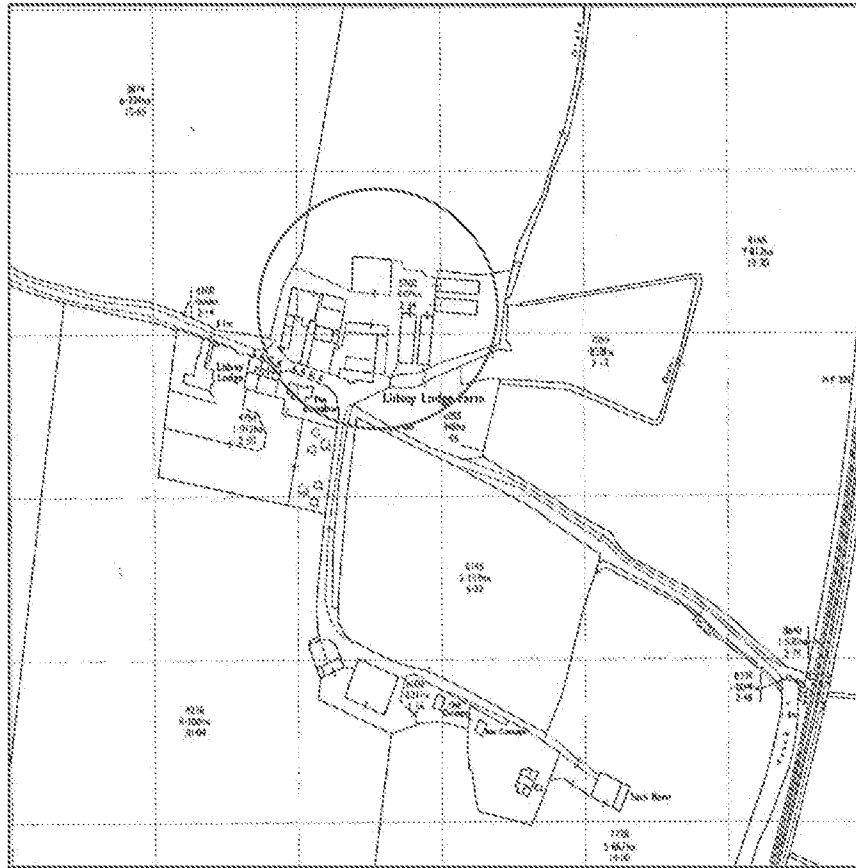
**Figure 10:** Extract from the 1:2,500 scale Ordnance Survey (O.S.) map of 1974. The area of the assessment site is shown encircled in
