### The Old Cottage & Bridge Cottage, Lidsey

- Preliminary Ecological Appraisal Survey
- Preliminary Bat Roost Assessment
- HSI Assessment

### Planning Issue

| Document Reference | LLD1349-ECO-PEA |

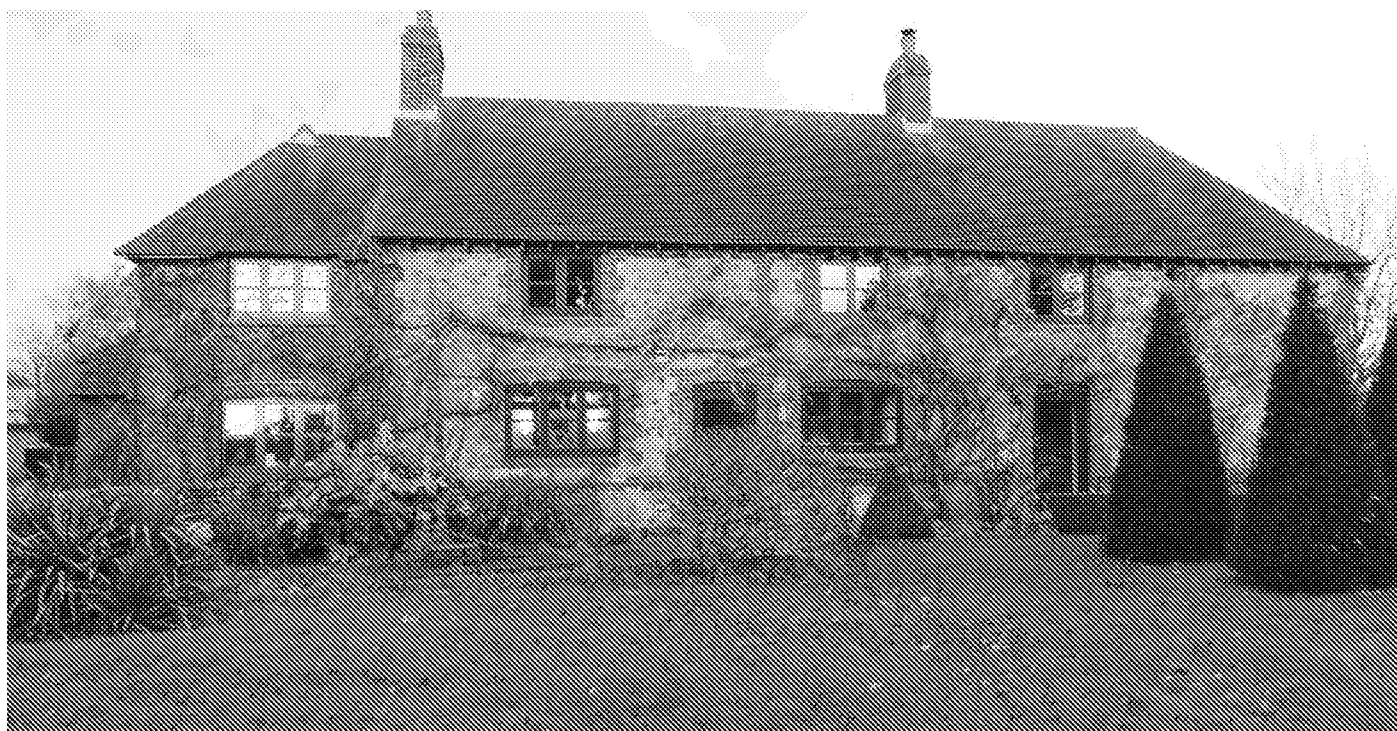
Photograph No. 1 - View of the south-western aspect of Building B1. - The Old Cottage

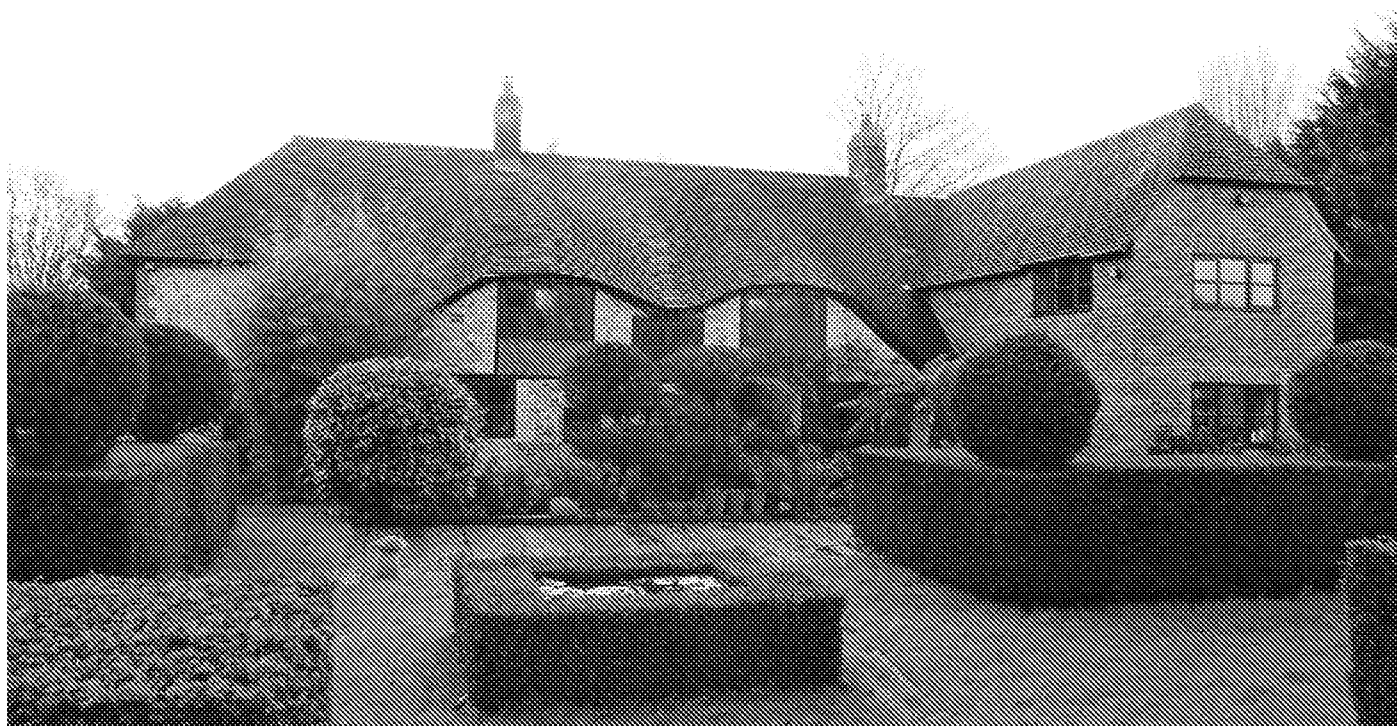
Photograph No. 2 - View of the north-eastern aspect of Building B1. - The Old Cottage

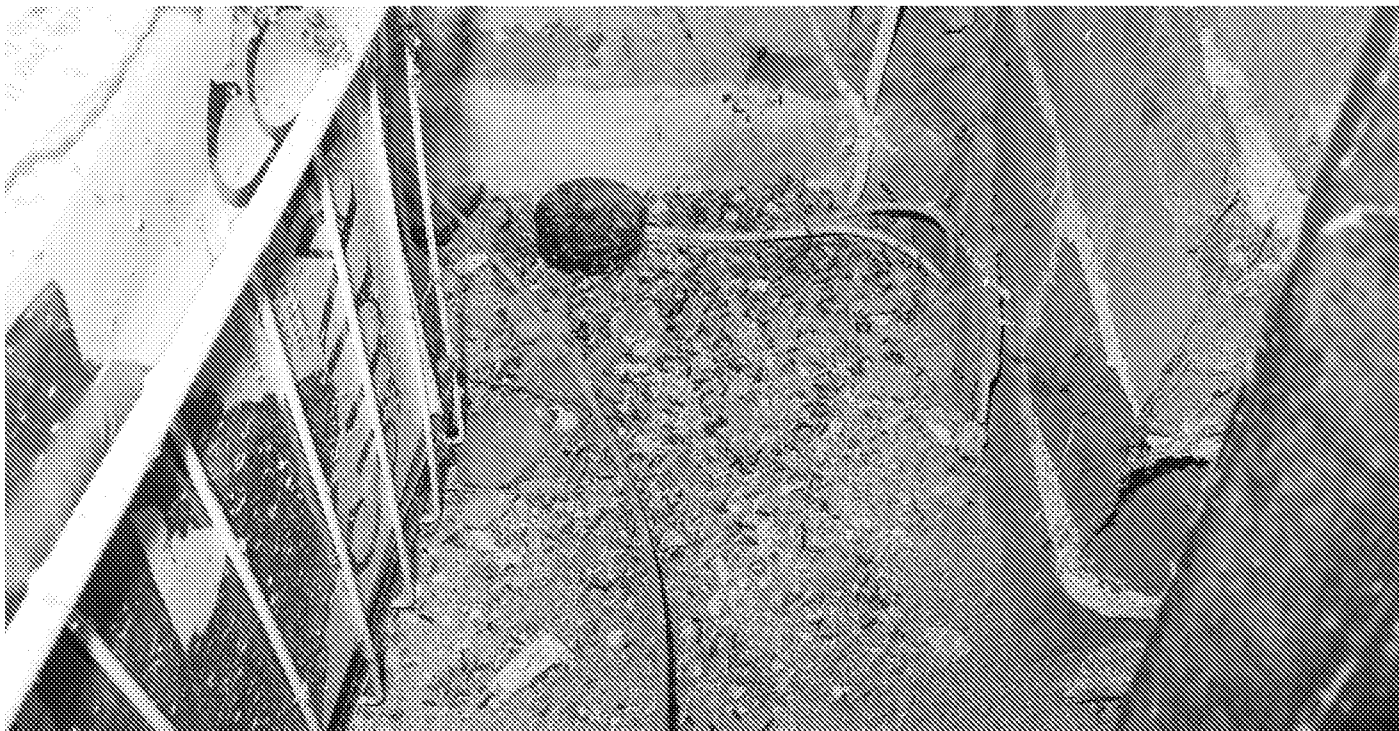
- 5.8 The evidence found on site is indicative of a small day bat roost of single male / non-breeding females of a common species. Bat roosts such as these are classed as being of '*low conservation status*'. In order to assess how, and in what numbers (*if at all*) bats are currently using the buildings on site, full emergence surveys will be required before detailed design of the site. Data obtained will be used to apply for an EPSM licence from Natural England to allow destruction of the roost (*should an active bat roost be present*), a likely mitigation strategy is included in Section 7.0 below.

- 7.1 DNA analysis has confirmed the likely presence of a small roost of Common Pipistrelle bats to the southern aspect of the north-western chimney. The evidence found on site is highly suggestive of the roost being of '*low conservation status*' (small numbers of a common species).

Photograph No. 3 - Small accumulation of bat droppings to the southern aspect of the northern chimney of Building B1. - The Old Cottage.

- 6.4 A total of 1 no. dawn and 2 no. dusk emergence / re-entry surveys should be undertaken of **Building B1** during the optimal survey season (*May - September with at least 2 no. surveys during the peak months of May - August*) and in suitable weather conditions (*+10°C, dry, calm*) in accordance with best practice guidelines. **Buildings B2 and B6** require 1 no. dawn or dusk survey visit between May – August. Should an active roost be found a licence from NE will be required post planning approval.

- 7.4 Integrated bat boxes (*such as Schwegler bat tube or similar*) would be incorporated into the new buildings at a location and aspect which most closely matches that of the original. These bat boxes will provide long-term mitigation for the loss of the potential bat roost within the existing building on site.
- 7.5 Given the evidence found on site, the building is likely to support a small bat roost of male / non-breeding females. No evidence which would indicate the presence of a maternity colony was recorded. Given the likely low conservation status of the roost it is felt that any mitigation could easily be incorporated into the design of the scheme at a later date.

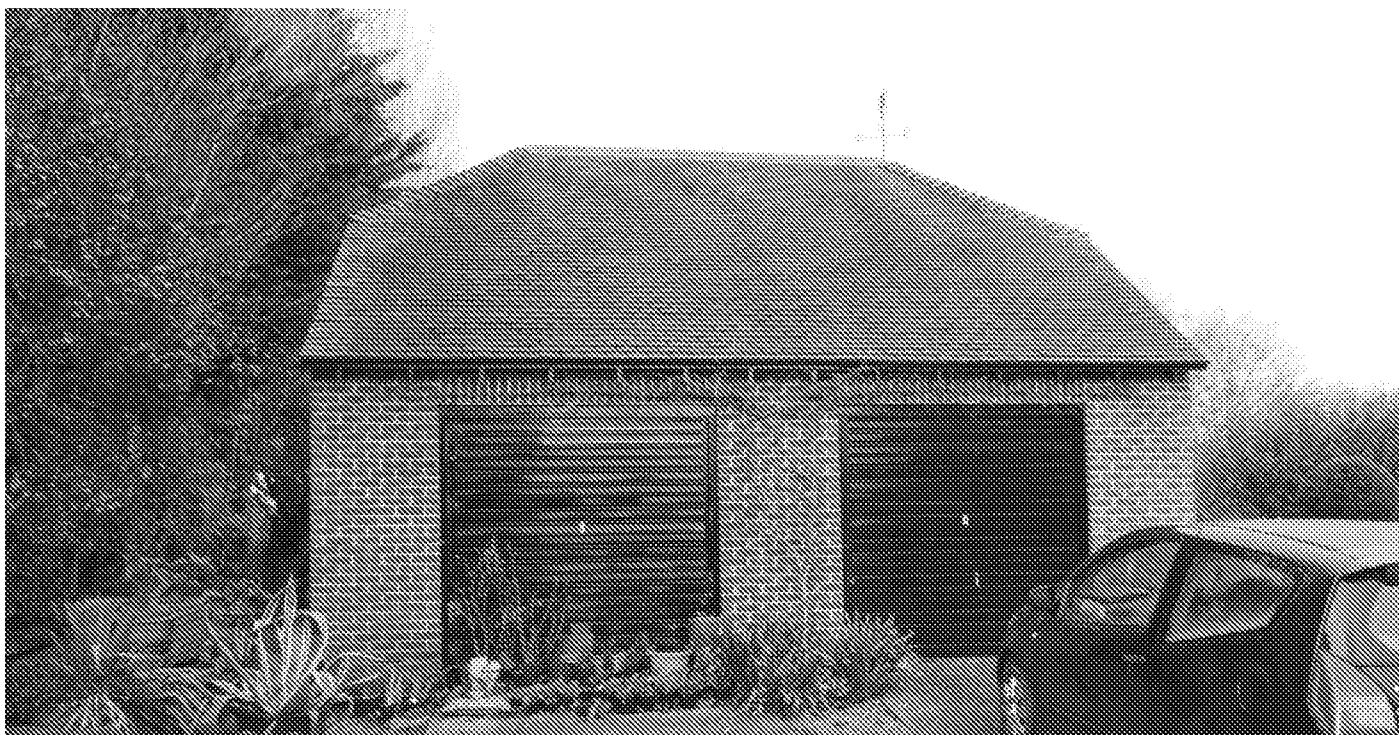
- 4.3.5 **Building B2** is a single-storey double garage of brick construction with clay tile roof. Tiles are backed by roofing membrane while the void is open to the room below. The garage is used for storage and as such not all areas were accessible. No evidence of bats was recorded internally, however, a number of slipped / lifted roof tiles were noted which could allow access into the fabric of the building.

Photograph No. 4 - Building B2, assessed as providing 'low' bat roost suitability - the Old Cottage.

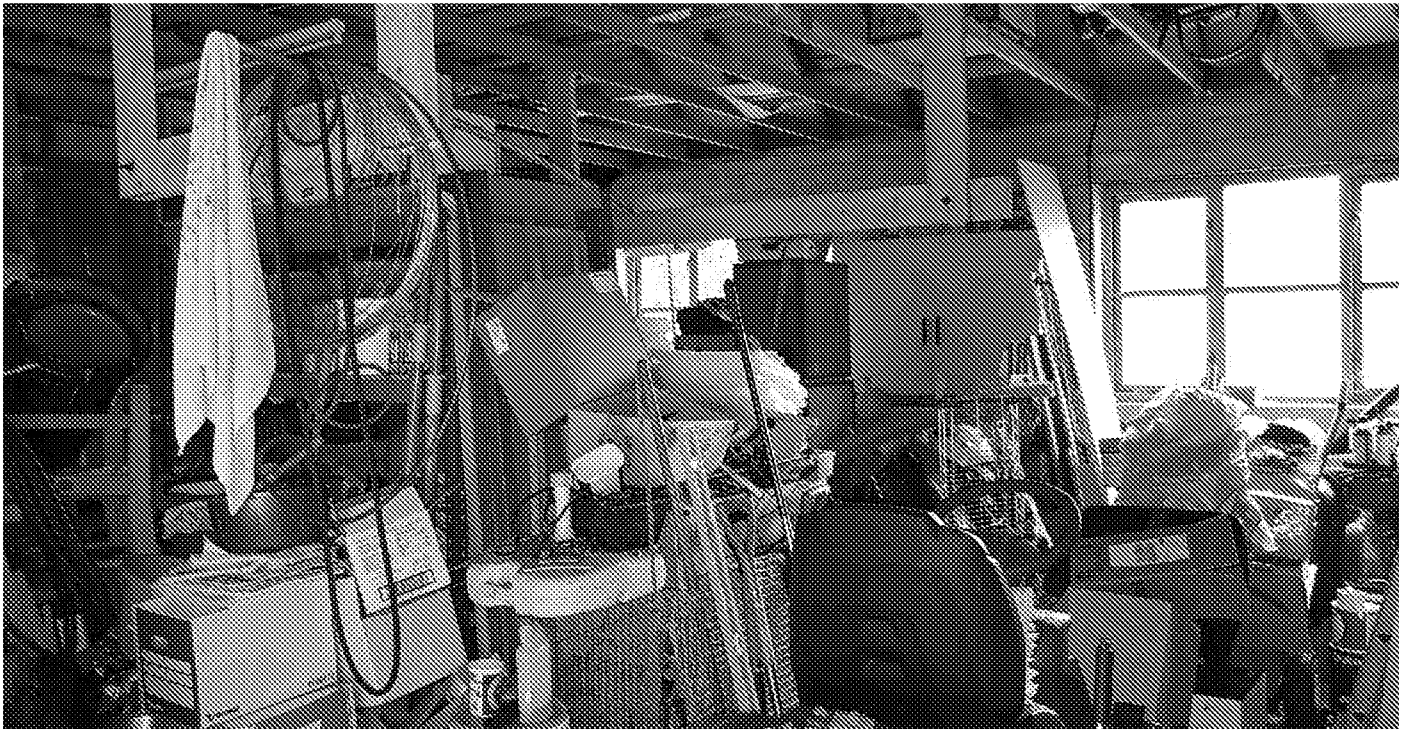
Photograph No. 5 - Internal view of Building B2. - The Old Cottage.

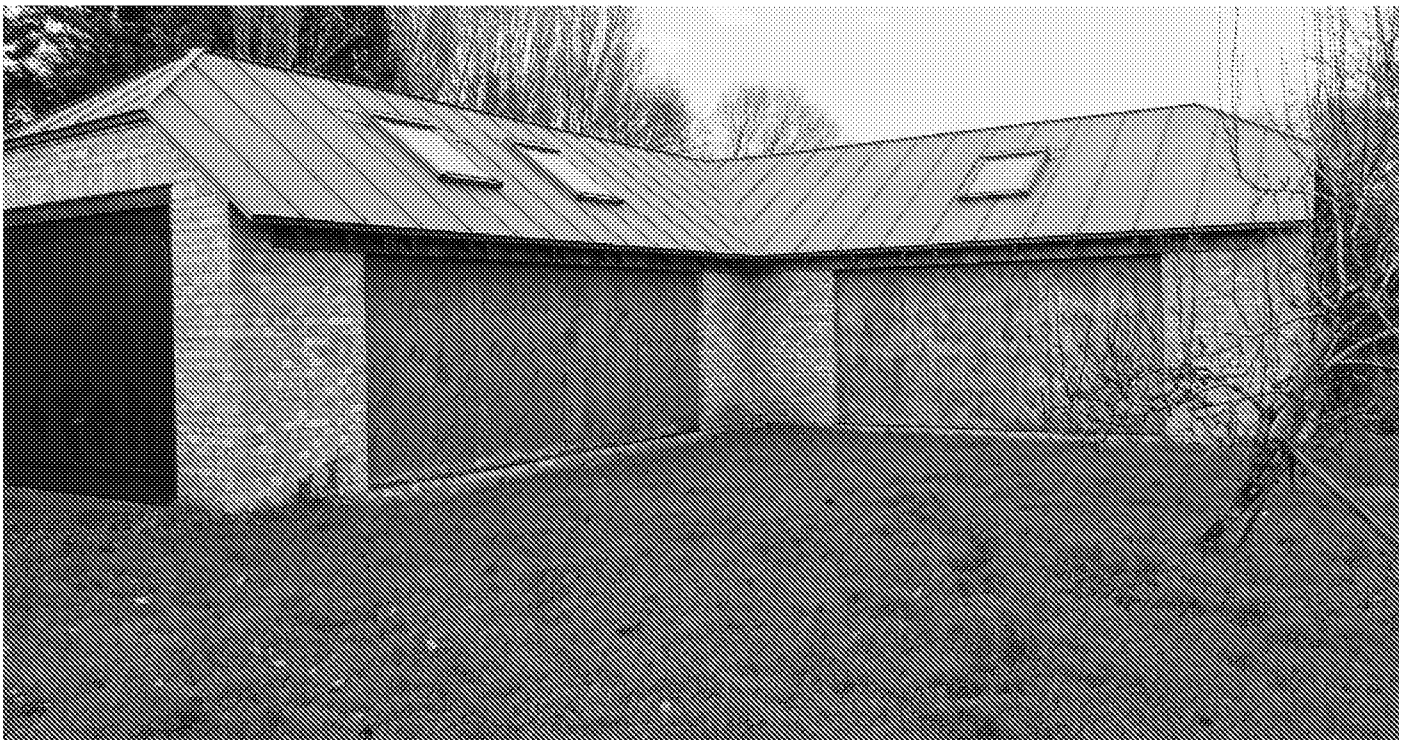
Photograph No. 6 - Building B3, assessed as providing 'negligible' bat roost suitability. - The Old Cottage.

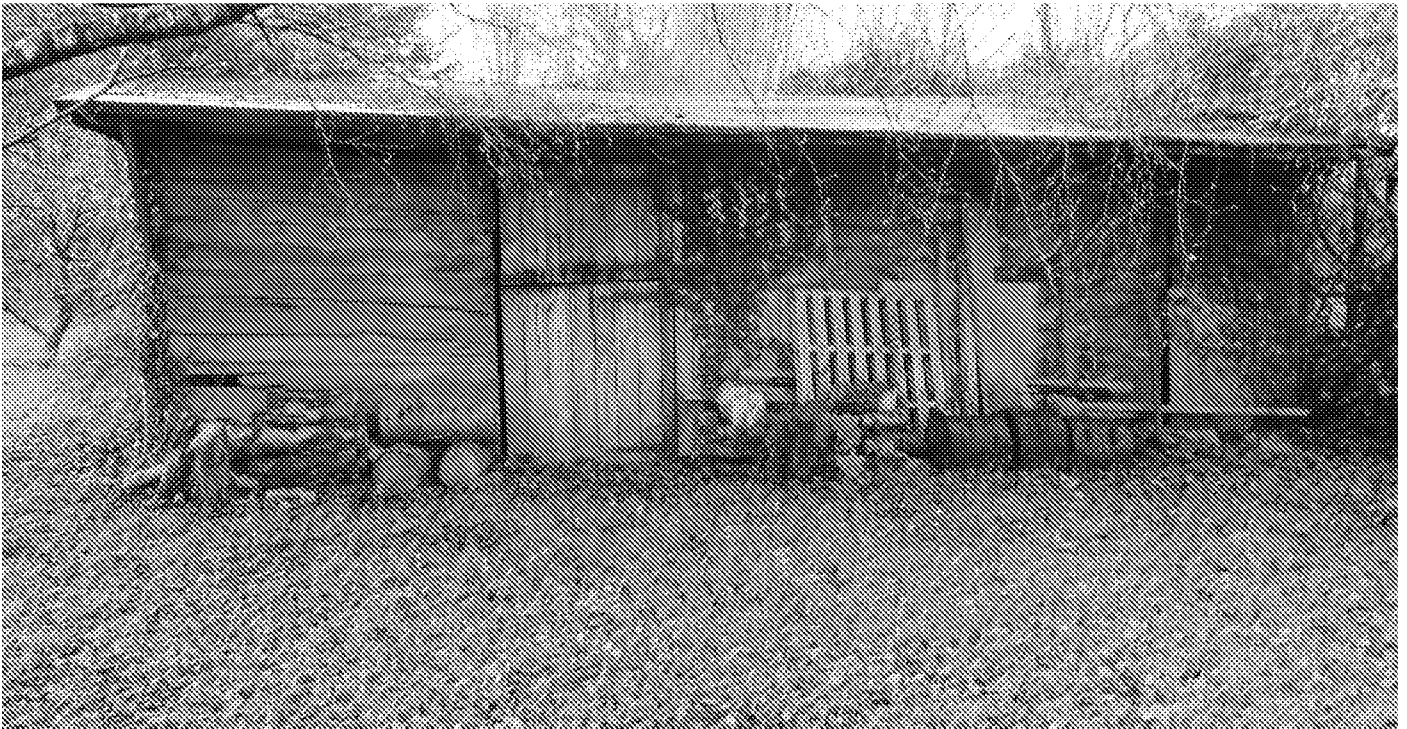
- 4.3.7 **Building B4** is a disused stable block of typical wooden construction with felt roof. The building is in poor condition and is considered to be too wet and thermally instable to support a bat roost.

Photograph No. 7 - Building B4, assessed as providing 'negligible' bat roost suitability.

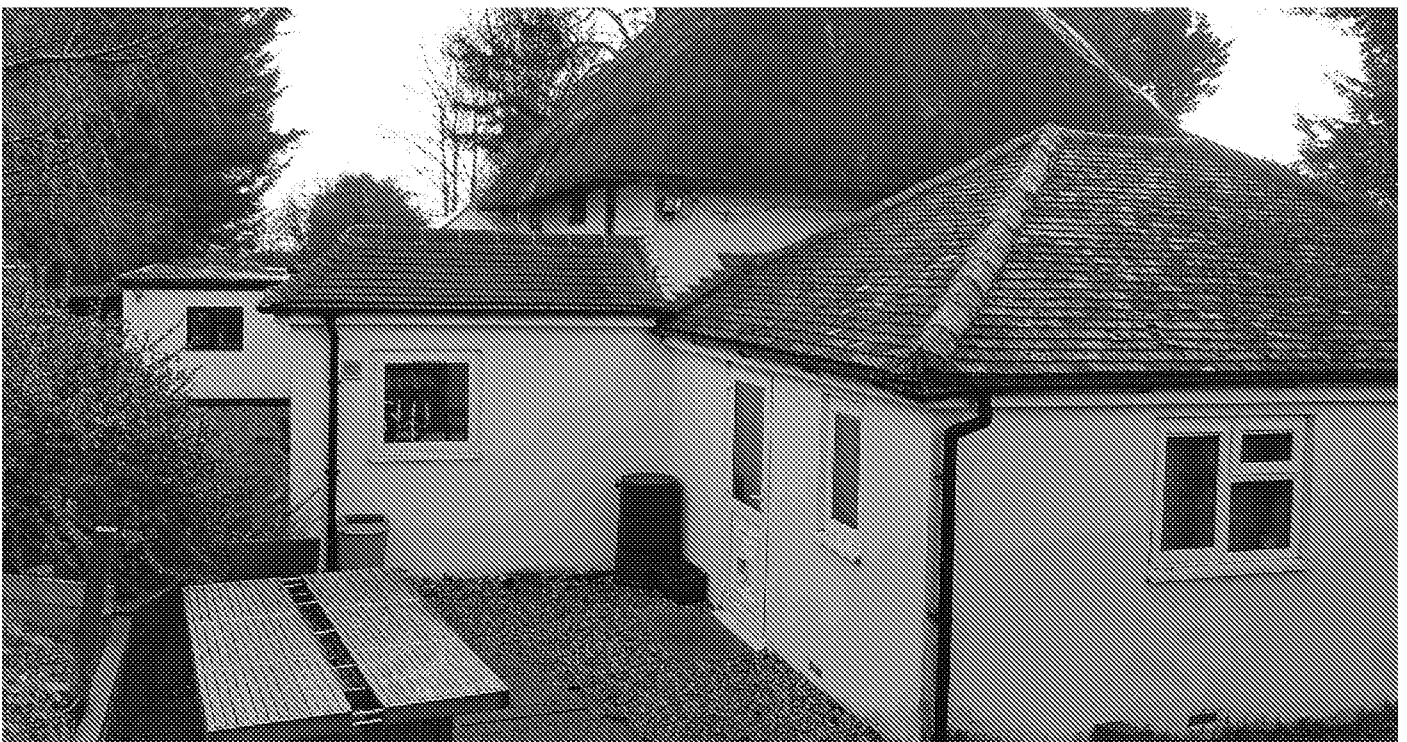
- 4.3.9 Bridge Cottage (**Building B6**) is a two-storey painted brick building with thatched roof. Windows and brick work appeared to be in good condition. 2 no. recent extensions exist to the northern and north-western sections of the site, these are of brick construction with tile roof in good condition. Small gaps were recorded between wooden panels at the eaves of the main house. No evidence of bats was recorded with the roof voids of the building.
- 4.3.10 **Building B7** is a detached double garage with small lean-to constructed to the north-east. The building is of block construction with flat felt roof.

Photograph No. 8 - Building B6, assessed as providing 'low' bat roost suitability.

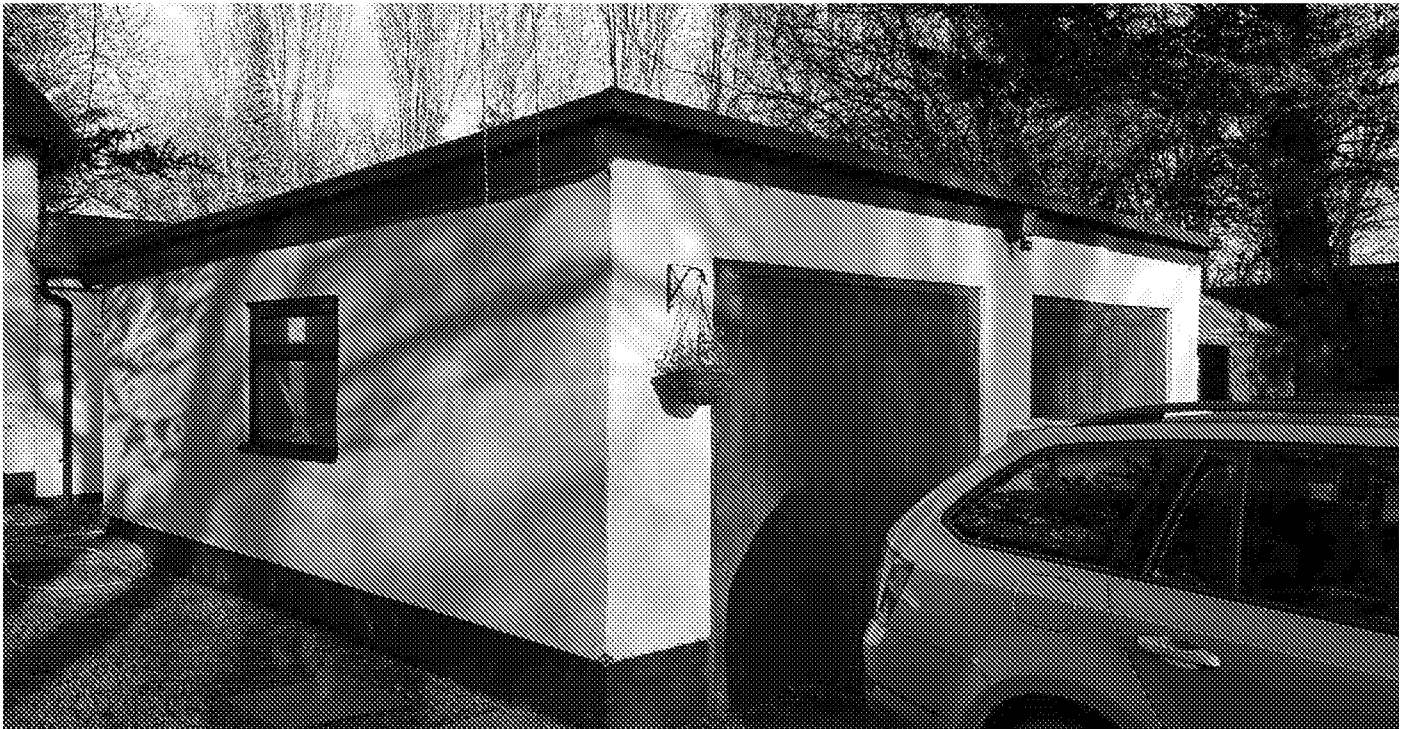
Photograph No. 9 - Building B7, assessed as providing 'negligible' bat roost suitability. - Bridge Cottage.

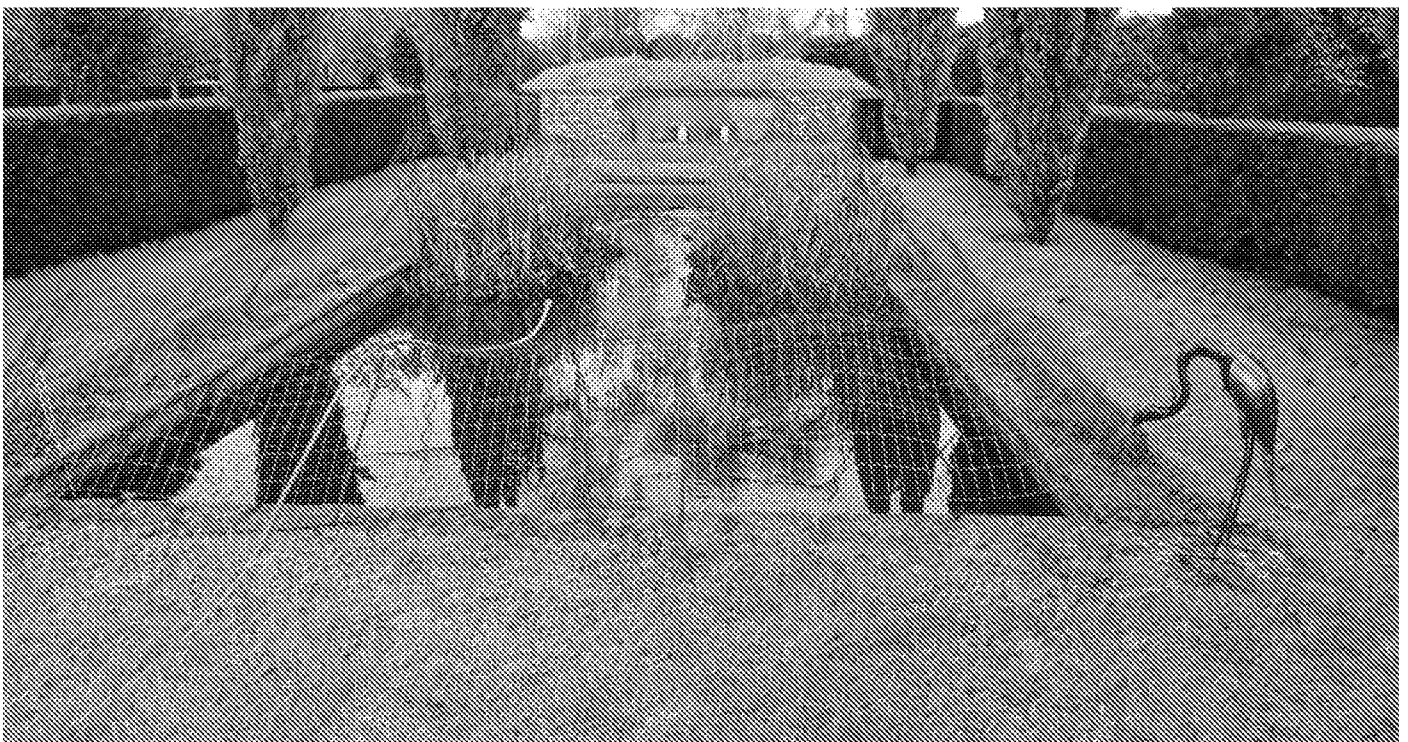
Photograph No. 10 - Pond P1, assessed as providing '*below average*' habitat suitability for Great Crested Newts. - Bridge Cottage.

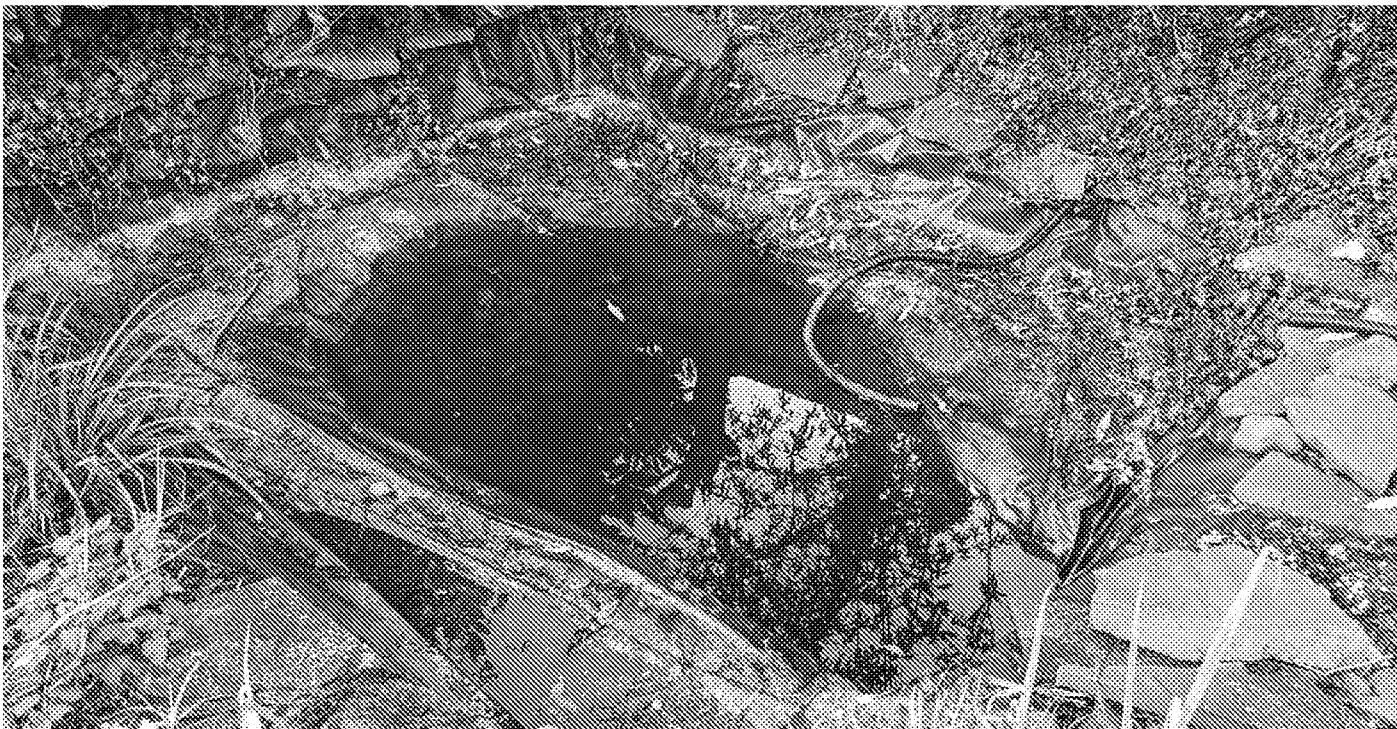
4.4.3 **Pond P2** is a small defunct pond c. 3.0 x 5.0 m located to the western section of the site. The pond was holding approximately 10cm of water at the time of the survey. The pond usually contains fish, however, these were recently removed when the pond began leaking. No macrophytes or emergence vegetation was noted.

Photograph No. 11 - Pond P2, assessed as providing 'poor' habitat suitability for Great Crested Newts.

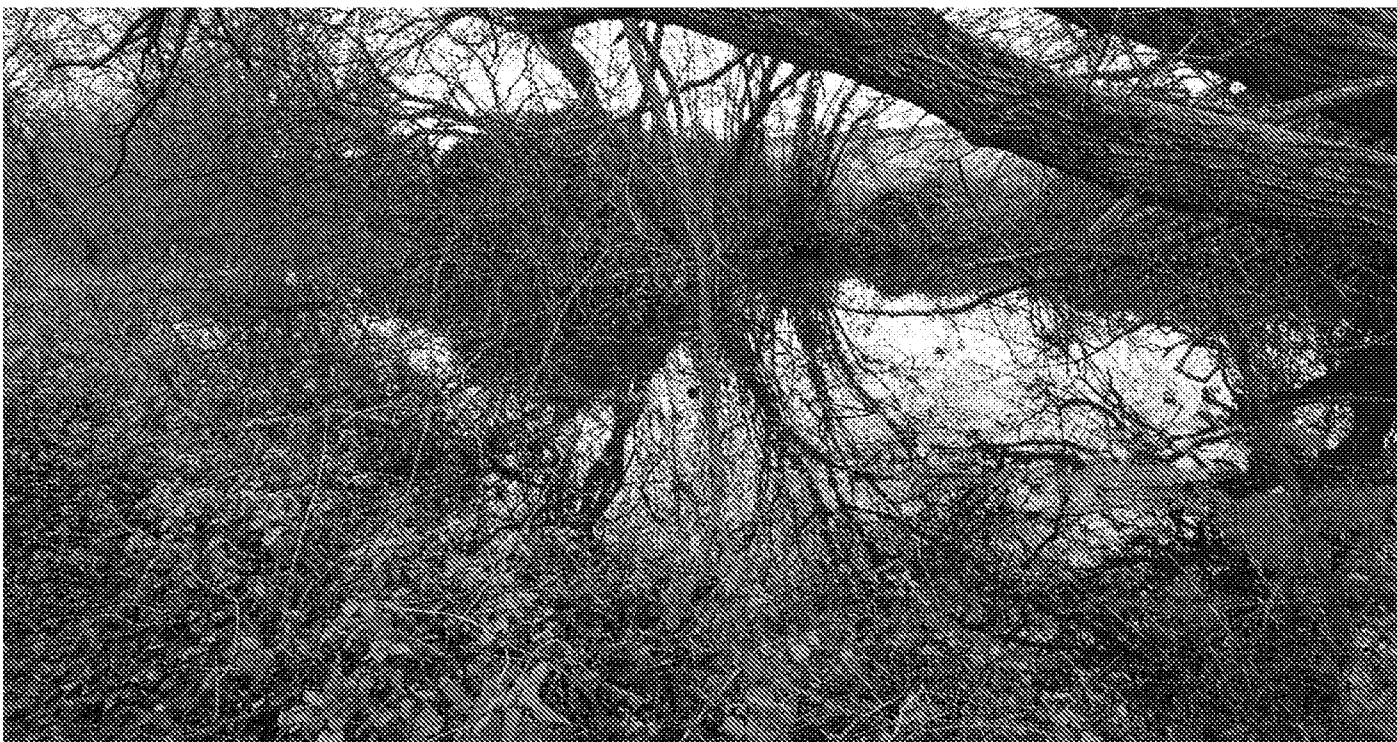
Photograph No. 12 - Pond P3, assessed as providing '*below average*' habitat suitability for Great Crested Newts.

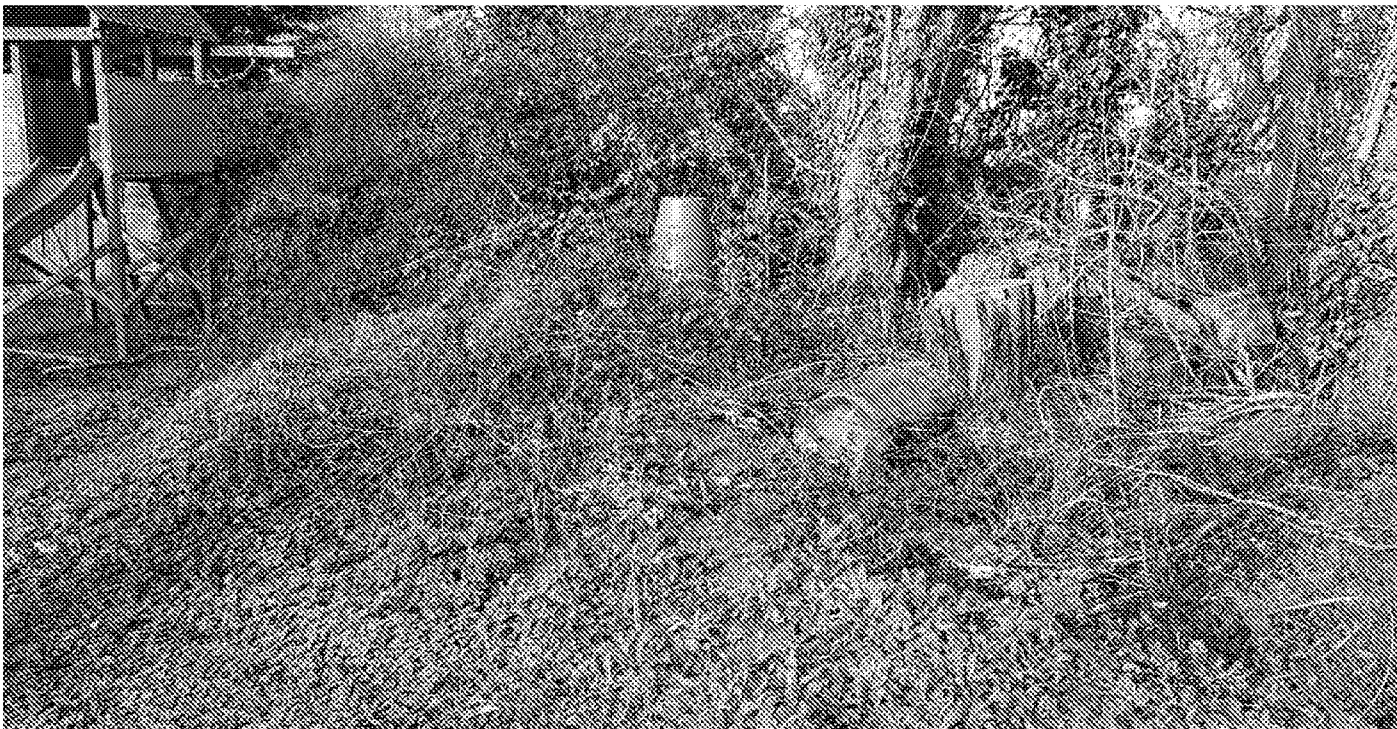
- 4.2.5 Artificial mounds and bunds within the Old Cottage site are dominated by tall ruderal species between 20 - 60cm in height. Species present include occasional Bristly ox-tongue (*Picris echinoides*); hogweed (*Heracleum sphondylium*); Canadian fleabane (*Conyza canadensis*); and smooth-sow thistle (*Sonchus oleraceus*); with cocks-foot (*Dactylis glomerata*); and yorkshire fog (*Holcus lanatus*); grasses dominating.
- 4.2.6 Small areas of tall ruderal and rough vegetation exists to the boundaries of the Bridge Cottage section of the site, particularly to the northern and eastern boundaries. These areas are interspersed with areas of scrub, log and compost piles.

Photograph No. 13 - Small areas of tall ruderal / rough grassland on site which are considered to offer 'low – moderate' reptile suitability.

- 6.1 As all suitable reptile habitat on site is likely to be lost as part of this development, a full reptile survey is recommended to ascertain the presence / absence and numbers of any reptile species present. The survey will consist of 7 no. survey visits undertaken during the reptile active season (*mid - March – October*).

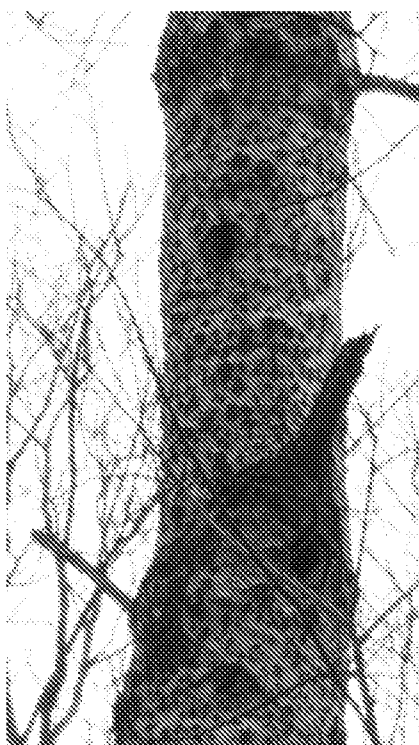
Photograph No. 14 - Tree T01, assessed as offering '*moderate*' bat roost suitability.

- 5.6 2 no. trees on site were considered to offer some level of bat roost suitability during the ground-level inspection. Should these trees require removal / be subject to disturbance it is recommended that an aerial inspection of the features identified from the ground is undertaken. Should these features then be found to contain evidence of a bat roost, further emergence surveys will be required to assess whether the trees support an active bat roost. Should a bat roost be found, a licence from Natural England will be required prior to removal of these trees.
